AIRCRAFT ACCIDENT REPORT

**AVAIR INC. FLIGHT 3378
FAIRCHILD METRO III, SA227 AC, N622AV
CARY, NORTH CAROLINA
FEBRUARY 19, 1988**

NTSB/AAR-88/10

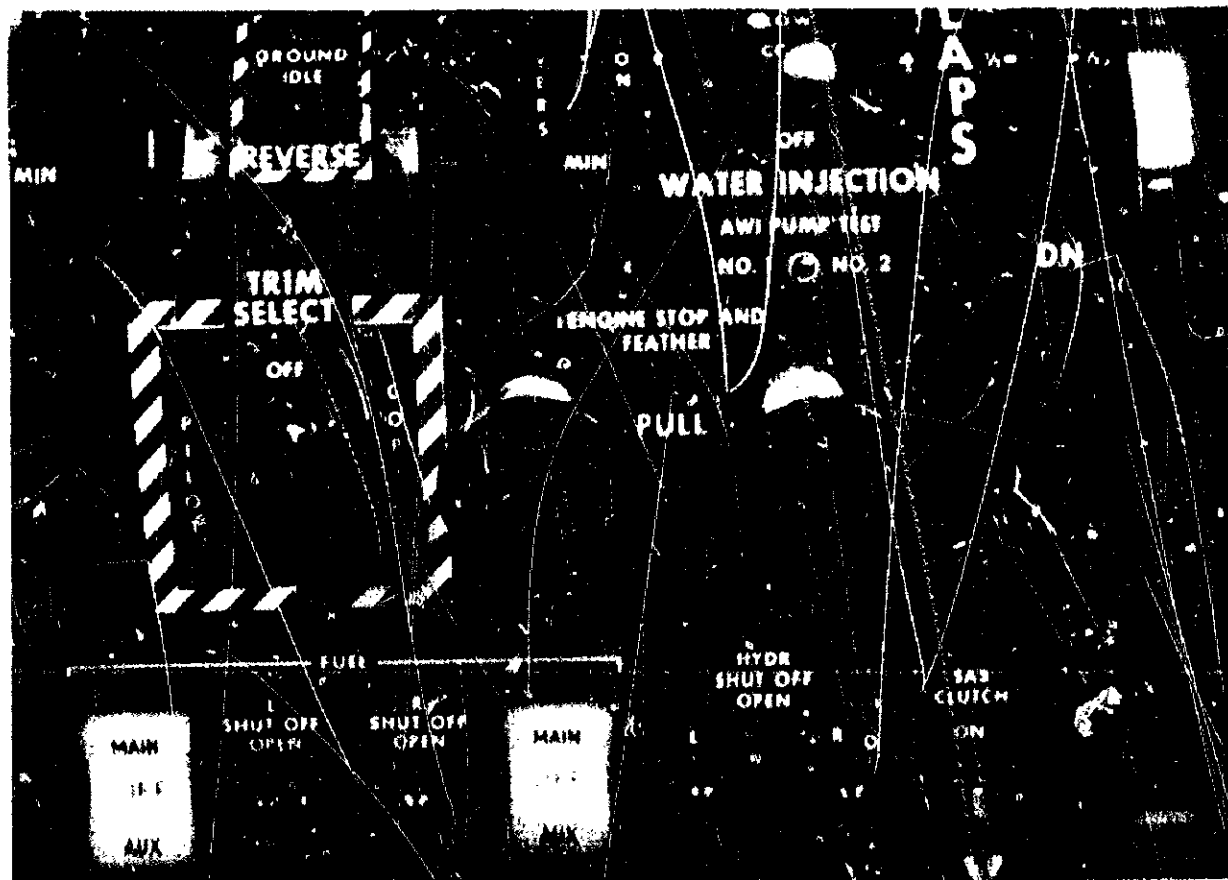
Figure 2.--SAS disengage switch

The SAS disengage switch was found in the DOWN or disengage position. The switch was then disassembled for closer examination. There was no evidence of movement of the switch after impact.

The Safety Board considered the likelihood that a SAS malfunction, specifically an inadvertent stick pusher actuation, occurred in the short time that AVAir 3378 was airborne. The SAS clutch switch was found in the disengage position, and a filament in one of the annunciator panel's two SAS fault indicator light bulbs was found stretched at impact, indicating that the bulb most likely was illuminated at that time. The illuminated bulb also could be explained by the fact that

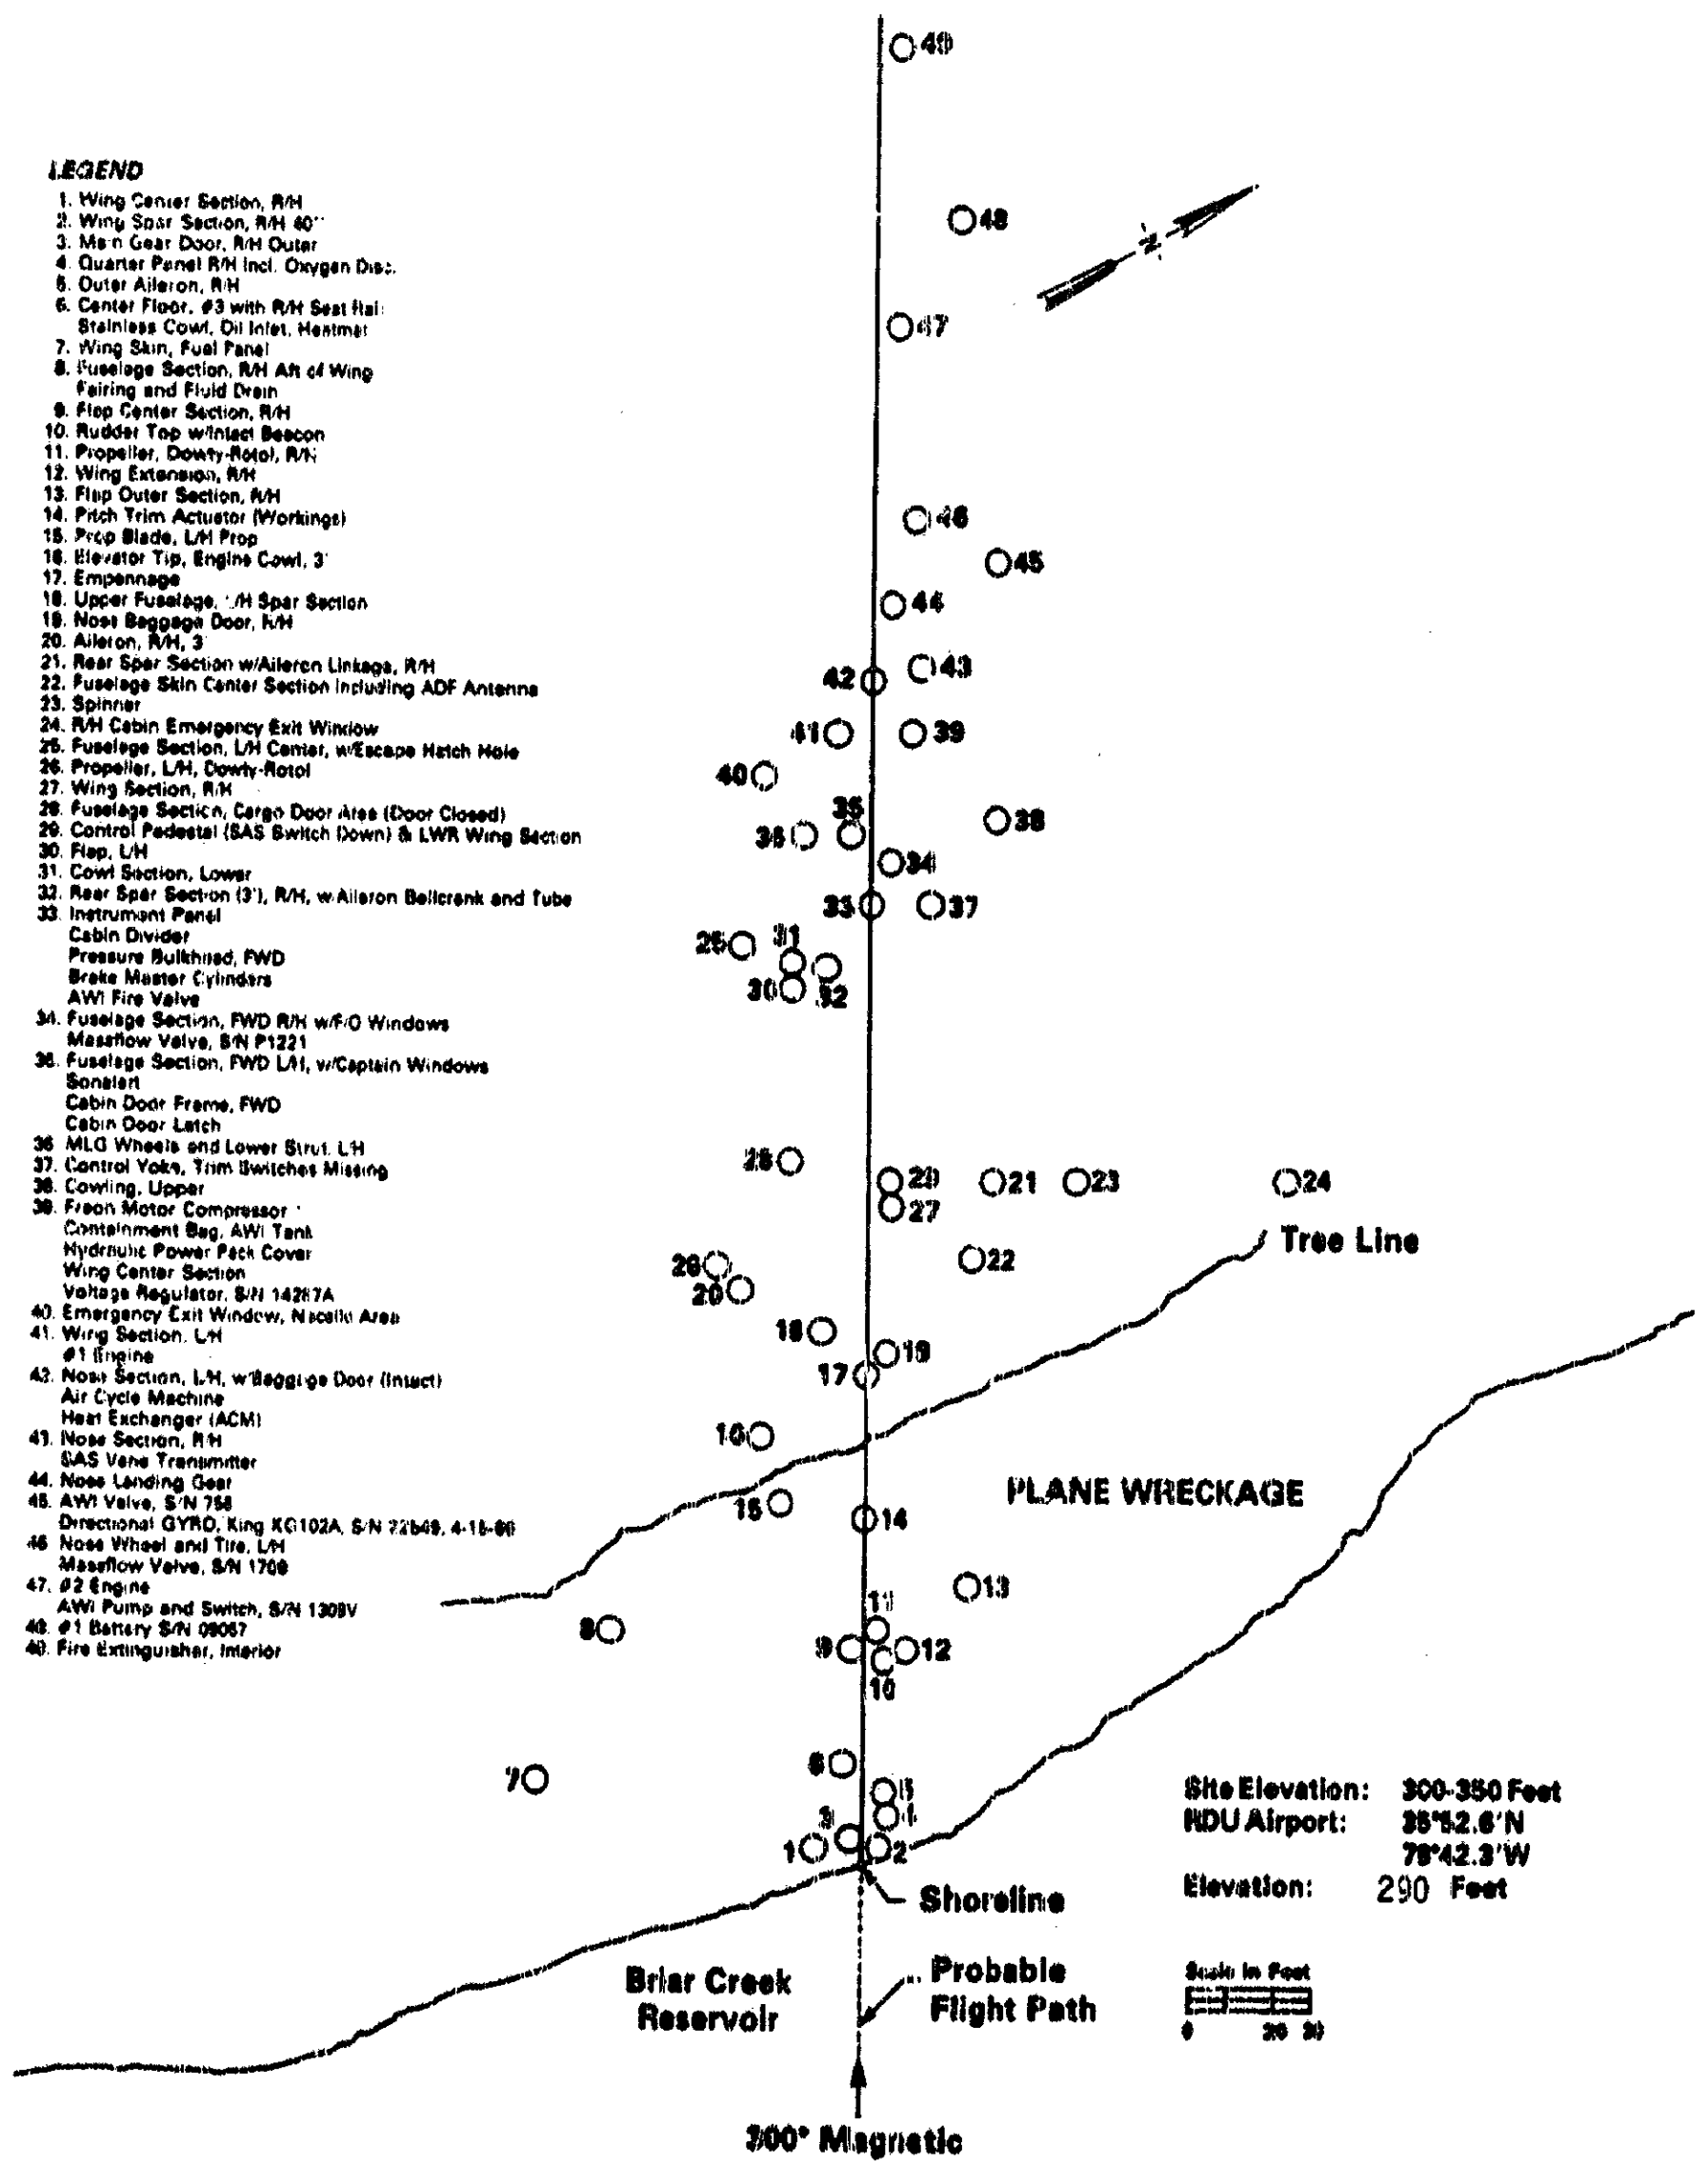
Figure 3.--Wreckage diagram

The airplane was extensively damaged and fragmented from its initial impact with the water and its more than 100-foot path through a wooded area beyond the shore of the reservoir. The wreckage path extended about 425 feet from the shoreline on a magnetic heading of about 300°. (See figure 3.)

The fuselage from the nose to the empennage was extensively fragmented. The tail cone, which had separated with the aft pressure bulkhead, was found intact and with minimal damage. The vertical stabilizer and horizontal stabilizers were attached to the empennage.

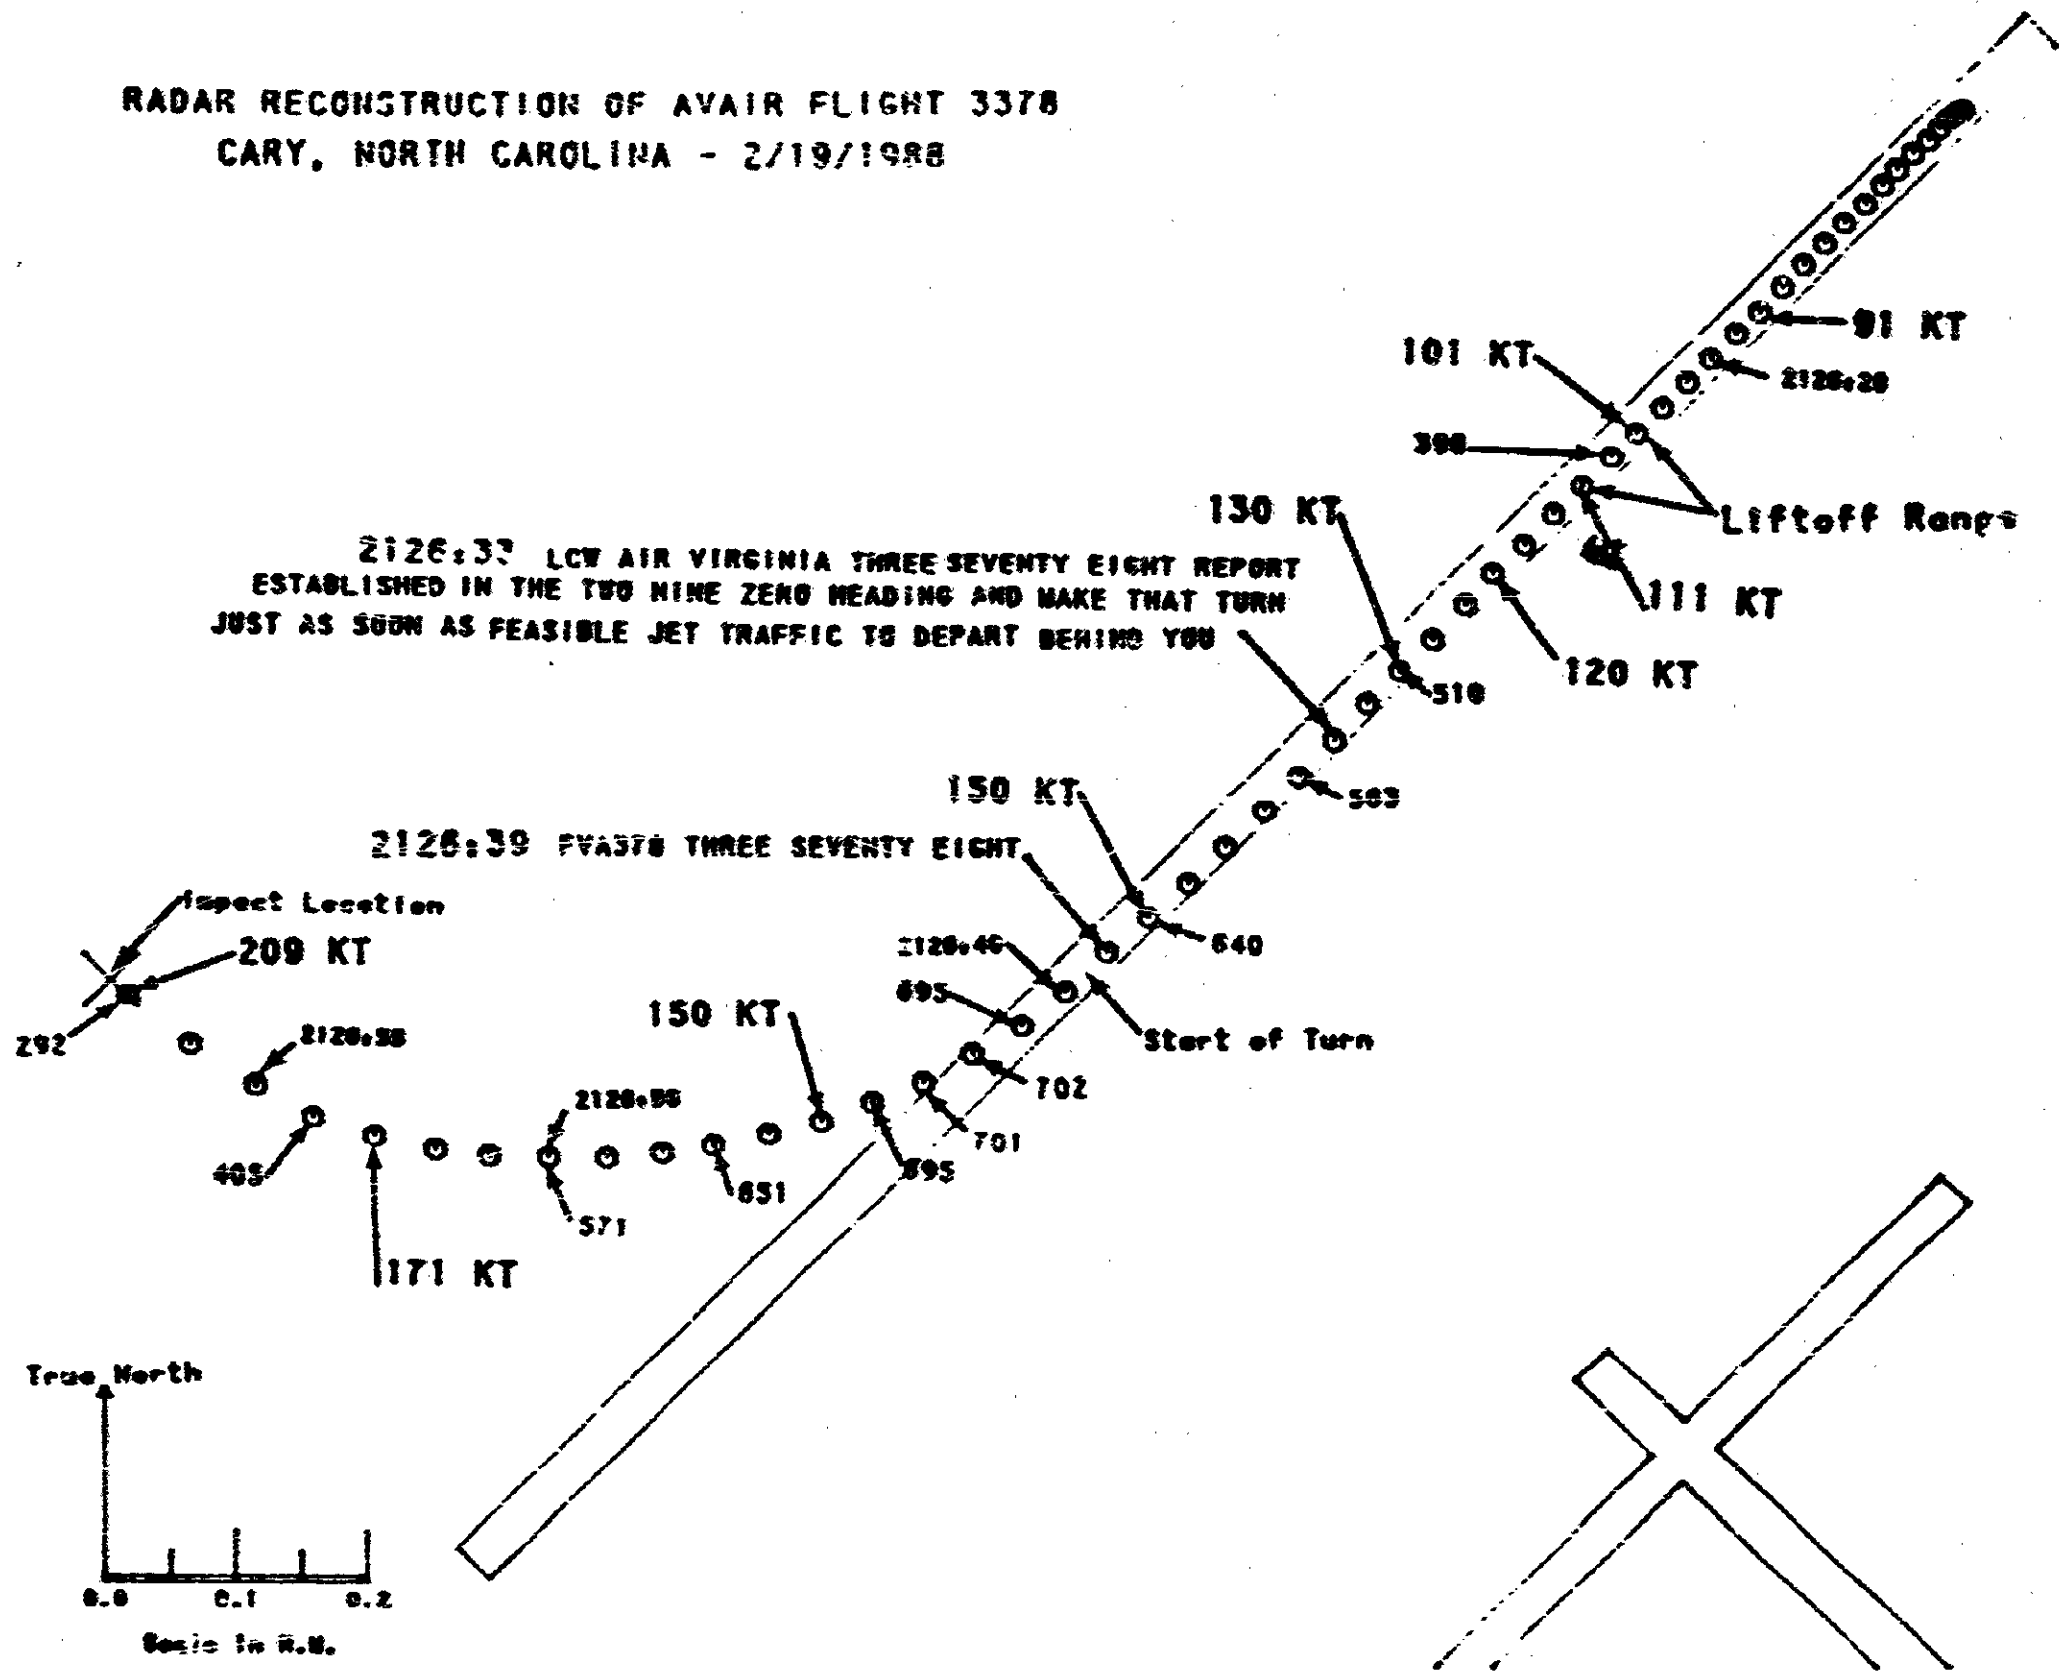
**Figure 4.—Overhead view of flight of AVAIR 3378
Data not identified refers to mean sea level altitude, in feet.**

The Safety Board applied data from the Metro III Type Inspection Report concerning the pitch trim at various airspeeds, power settings, CG conditions, and flap positions to the obtained pitch setting on AVAir 3378. Given a mid-range CG, the pitch trim position found on AVAir 3378 corresponded to an approximate 157-knot airspeed.
