PB89-910406
NTSB/AAR-89/04

AIRCRAFT ACCIDENT REPORT

DELTA AIR LINES, INC.
BOEING 727-232, N473DA
DALLAS-FORT WORTH INTERNATIONAL
AIRPORT, TEXAS
AUGUST 31, 1988

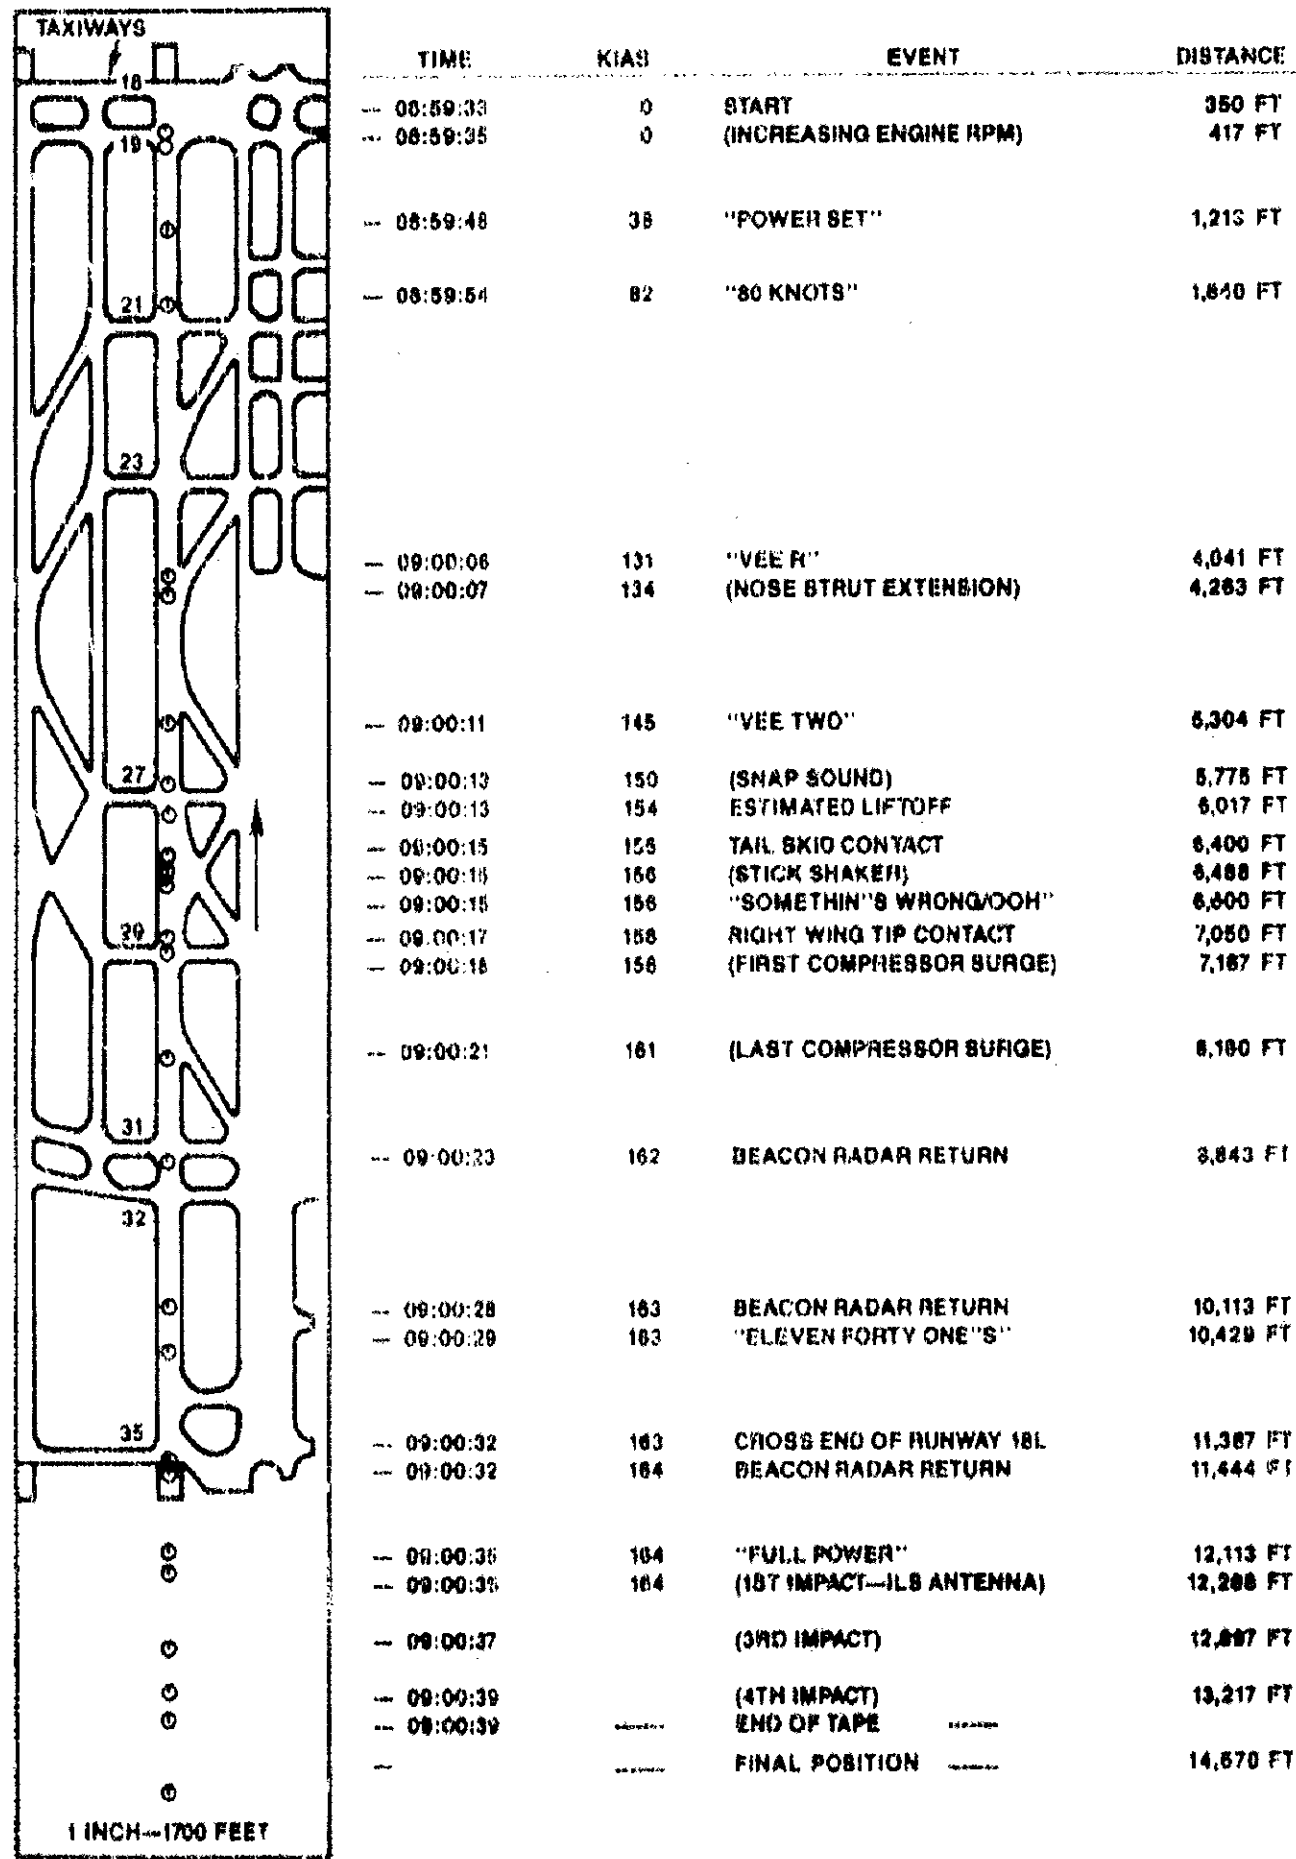
Figure 5.-- Flight 1141 takeoff events.

The first impact mark was made by the tail skid contacting the runway centerline and a runway centerline light between taxiways 27 and 29, at a distance of approximately 4,990 feet prior to the departure end of runway 18L (see figure 5). About 650 feet from this point, the right wing tip struck the right side of the runway near taxiway 29, approximately 4,340 feet prior to the departure end of runway 18L. The taxiway markers for taxiways 31 and 32 were found knocked over, but they did not exhibit any impact damage. Additionally, the grass was found to be scorched between the end of the runway and the ILS antenna. Approximately 5,300 feet from the point of the right wing tip runway contact, and approximately 900 feet beyond the departure end of runway 18L, the airplane impacted and destroyed the ILS localizer antenna. From this point and beyond, airplane component such as the right wing tip and portions of the right inboard and outboard ailerons began separating from the airplane.

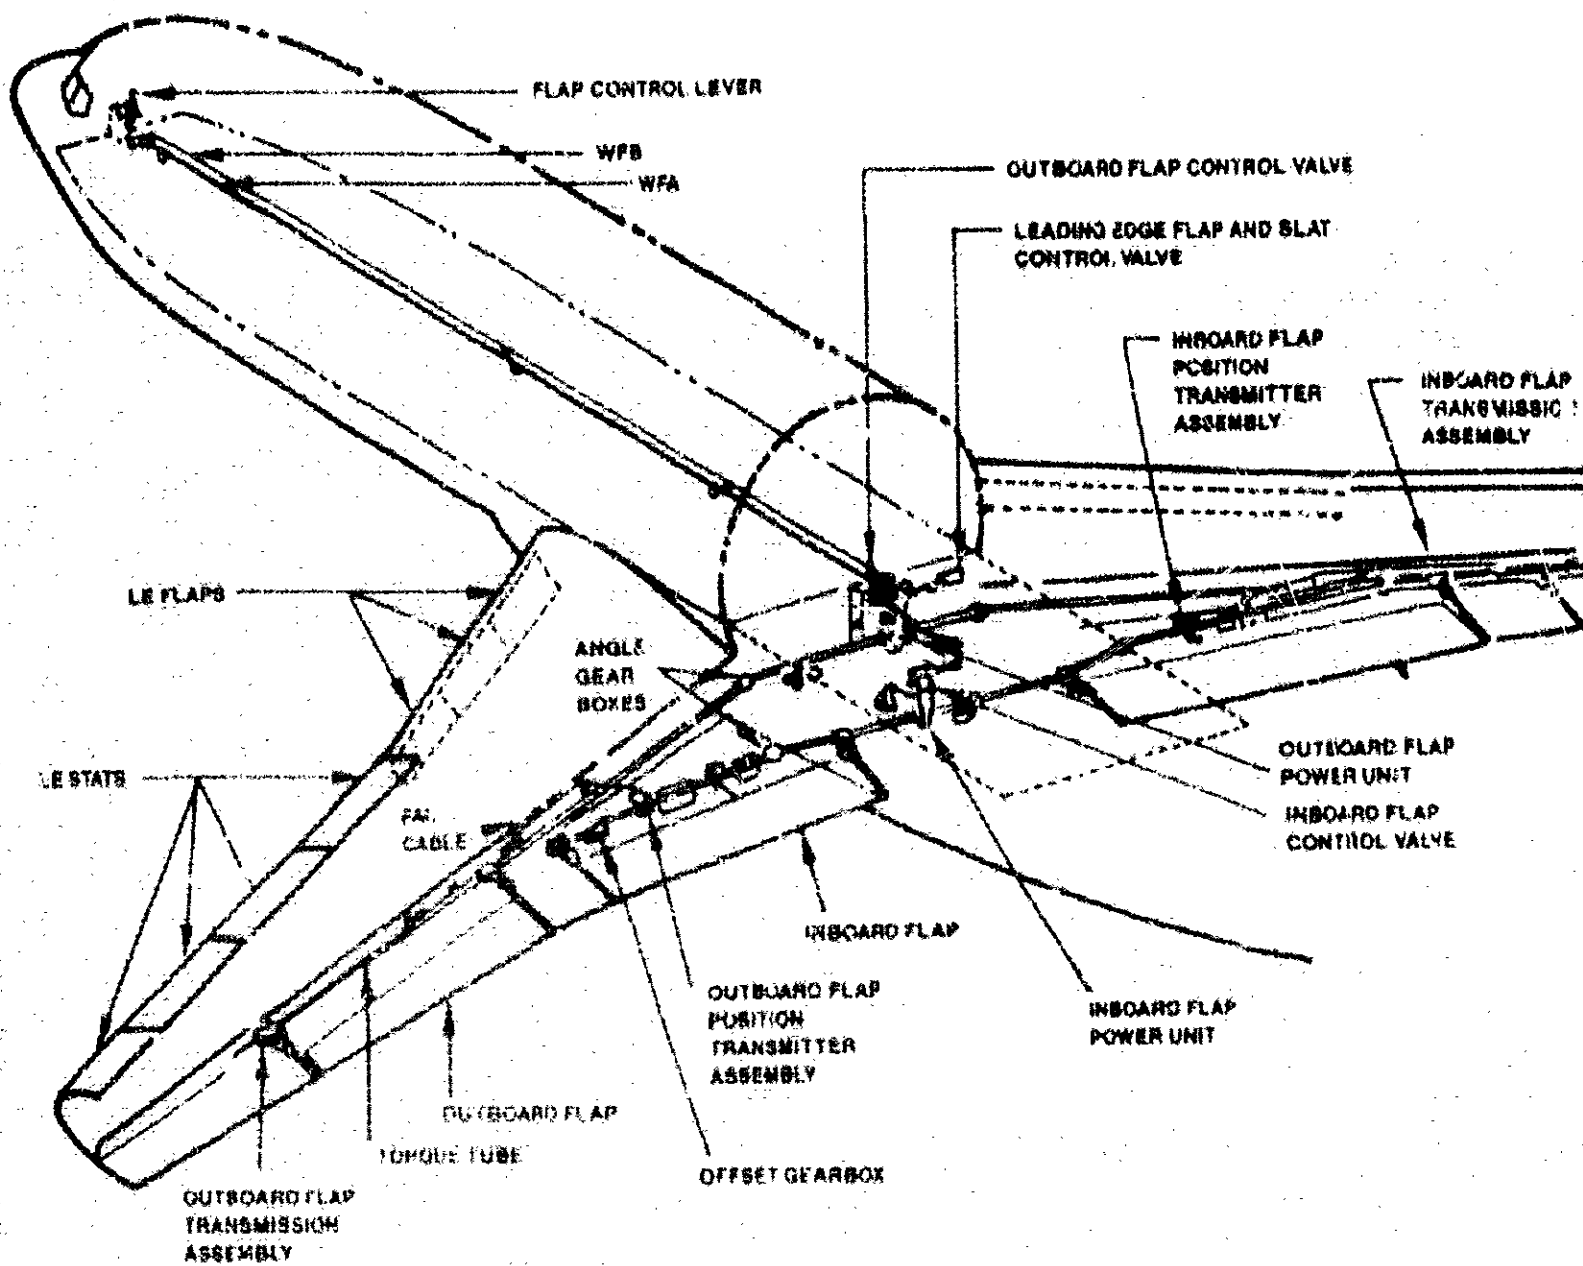
Figure 7.--Trailing edge flap system.

Trailing Edge Flap System.--The flap control mechanism in the cockpit area was found in the flap up position. (See figure 7.) The mechanism was intact and functional. The flap handle spring tension was normal. The flap control cables were attached, and continuity was established to the forward fuselage break. From the fuselage break, further continuity of the cables was established to the outboard flap control valve

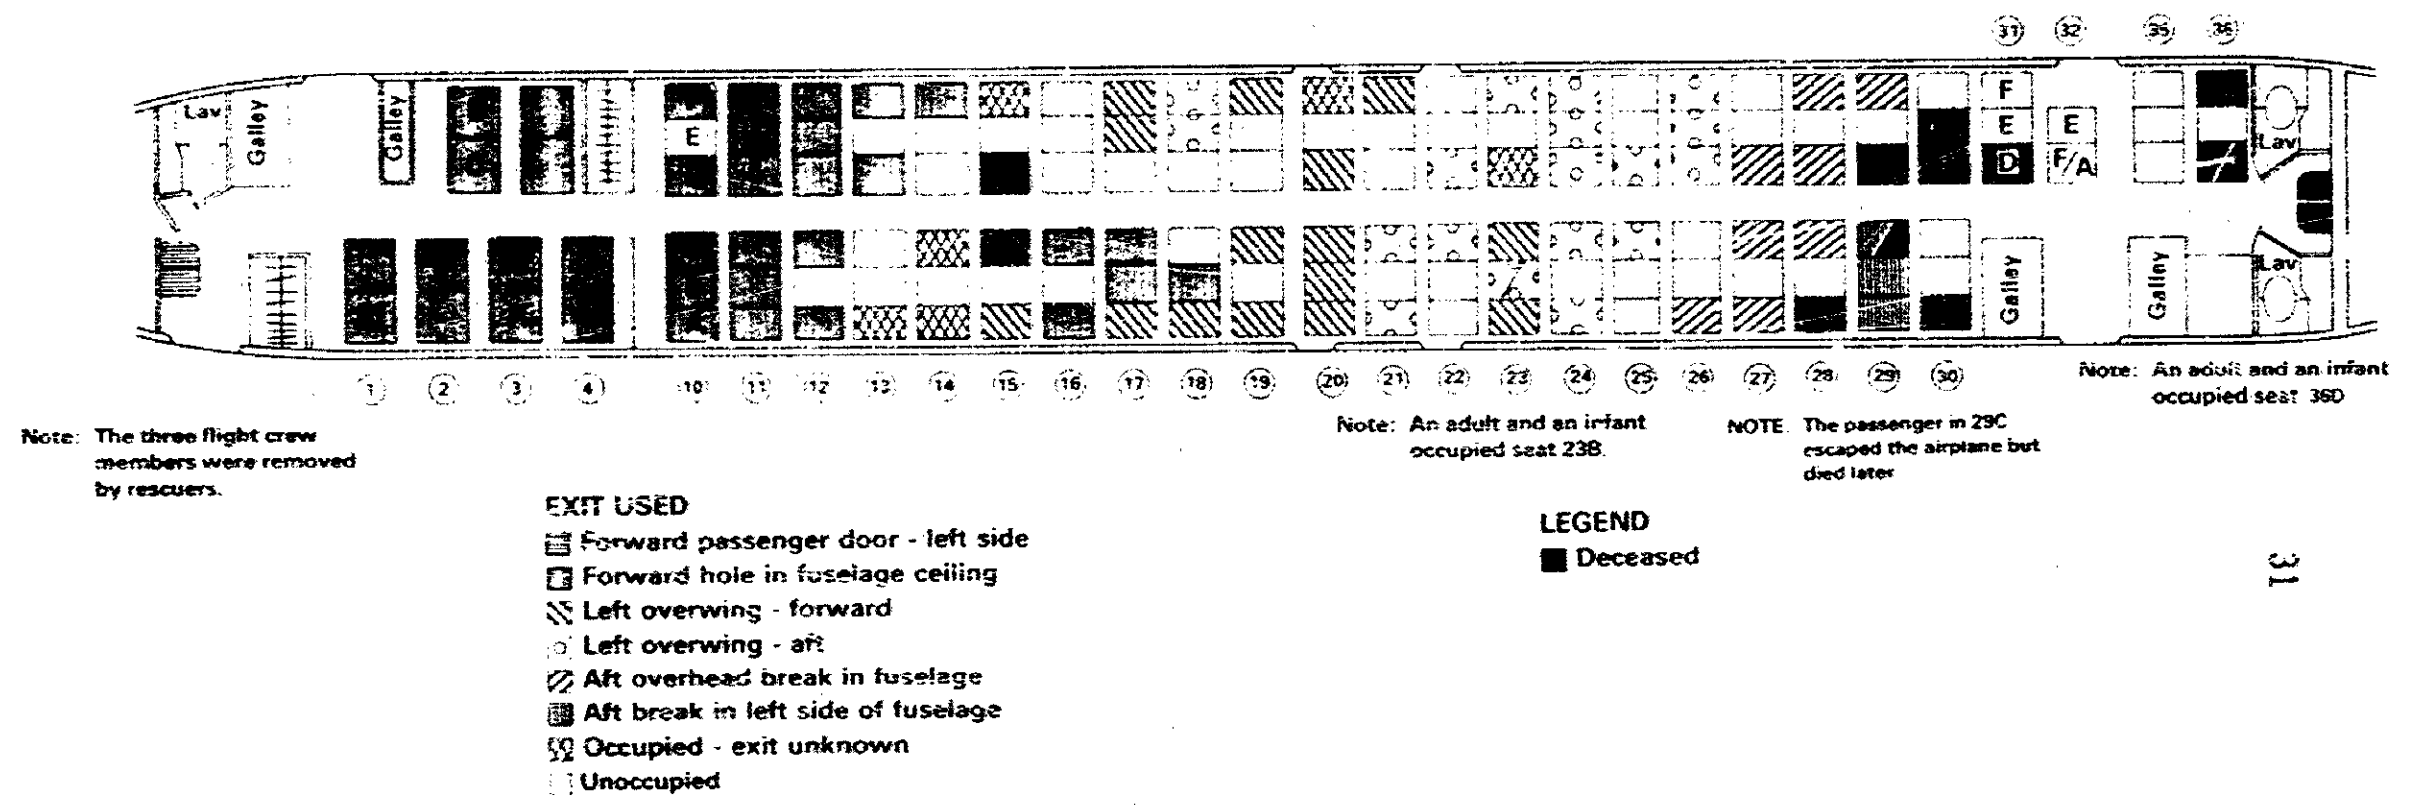
Figure 8.--Configuration of B727-232 and escape routes used.

The investigation found that although the fuselage had separated in several places, the occupiable volume of the cabin was not substantially compromised. Passengers generally stated that impact forces were not severe. Further, the cause of deaths of the passengers in the aft section of the cabin were attributed to smoke inhalation and fire rather than impact injuries. Exit from the aft cabin was hampered by the fire that impinged on the right side of the airplane. Exit from the mid and forward cabin was through breaks in the fuselage and through the left side exits, except for the left aft service door which was not opened.

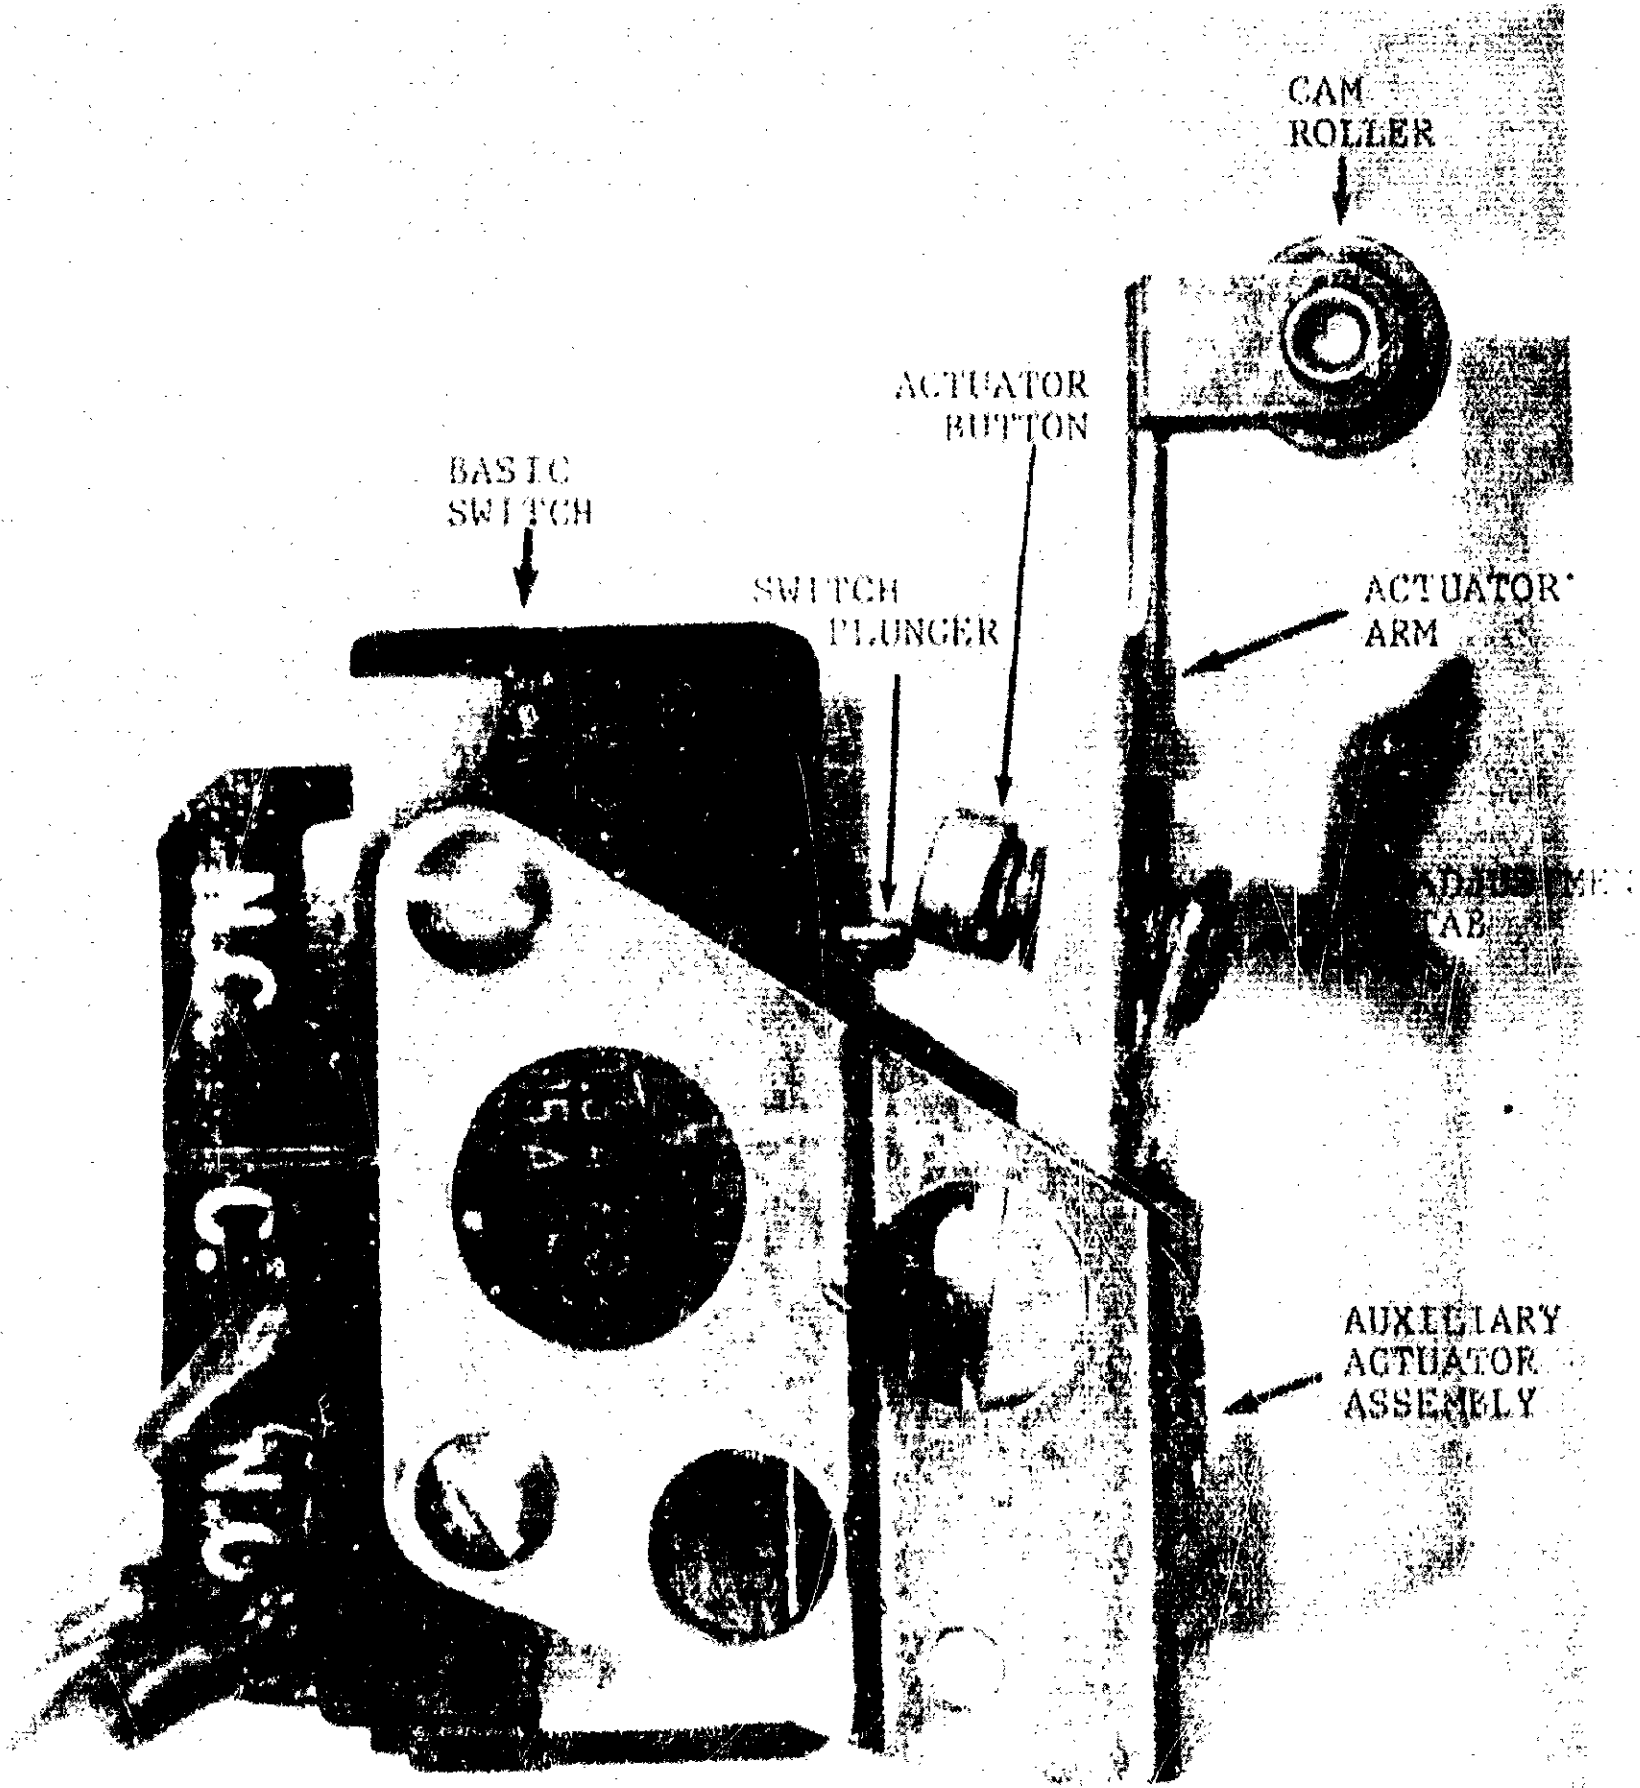
Figure 9.--Photo of throttle switch.

Switch activation movement, with the switch assembly still installed in the clutch pack assembly, was observed through a microscopic TV camera and recorded. The outer bottom edge of the actuator button would initially contact the top center of the switch plunger and would remain in this position as the plunger was being depressed and the switch tripped. As the switch tripped, the exposed portion of the switch plunger would slide slightly inward toward the bottom of the actuator button and become perpendicular to the switch casing. Approximately 10 switch activations were observed, and each time the switch properly tripped.

The cables that were still attached to the clutch pack assembly containing the switch assembly were then removed to free the jammed cam which moves the switch actuator mounted on the clutch pack assembly structure. Proper orientation of the cam to the switch, as it would relate to thrust lever position, was then established. During this procedure, numerous switch activation sounds were heard. Other switches are installed in the clutch

pack assembly. It is not known if the takeoff warning switch activated each time the outermost surface of the cam made contact with the switch actuator.
