**PB90-910406  
NTSB/AAR-90/06**

**AIRCRAFT ACCIDENT REPORT**

**UNITED AIRLINES FLIGHT 232  
McDONNELL DOUGLAS DC-10-10  
SIOUX GATEWAY AIRPORT  
SIOUX CITY, IOWA  
JULY 19, 1989**

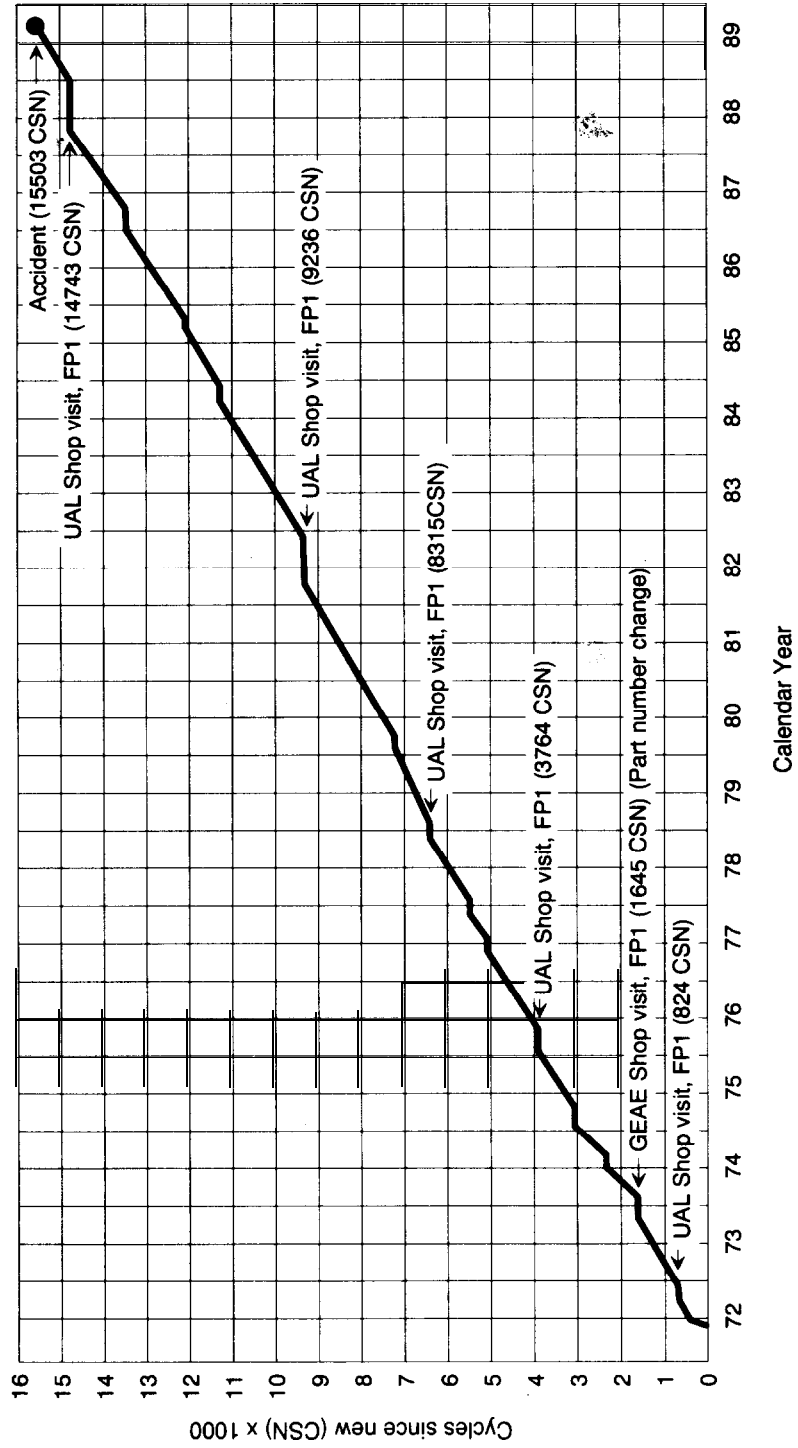
Figure 9.--- Inspection history of accident fan disk.  
(Data source GEAE)

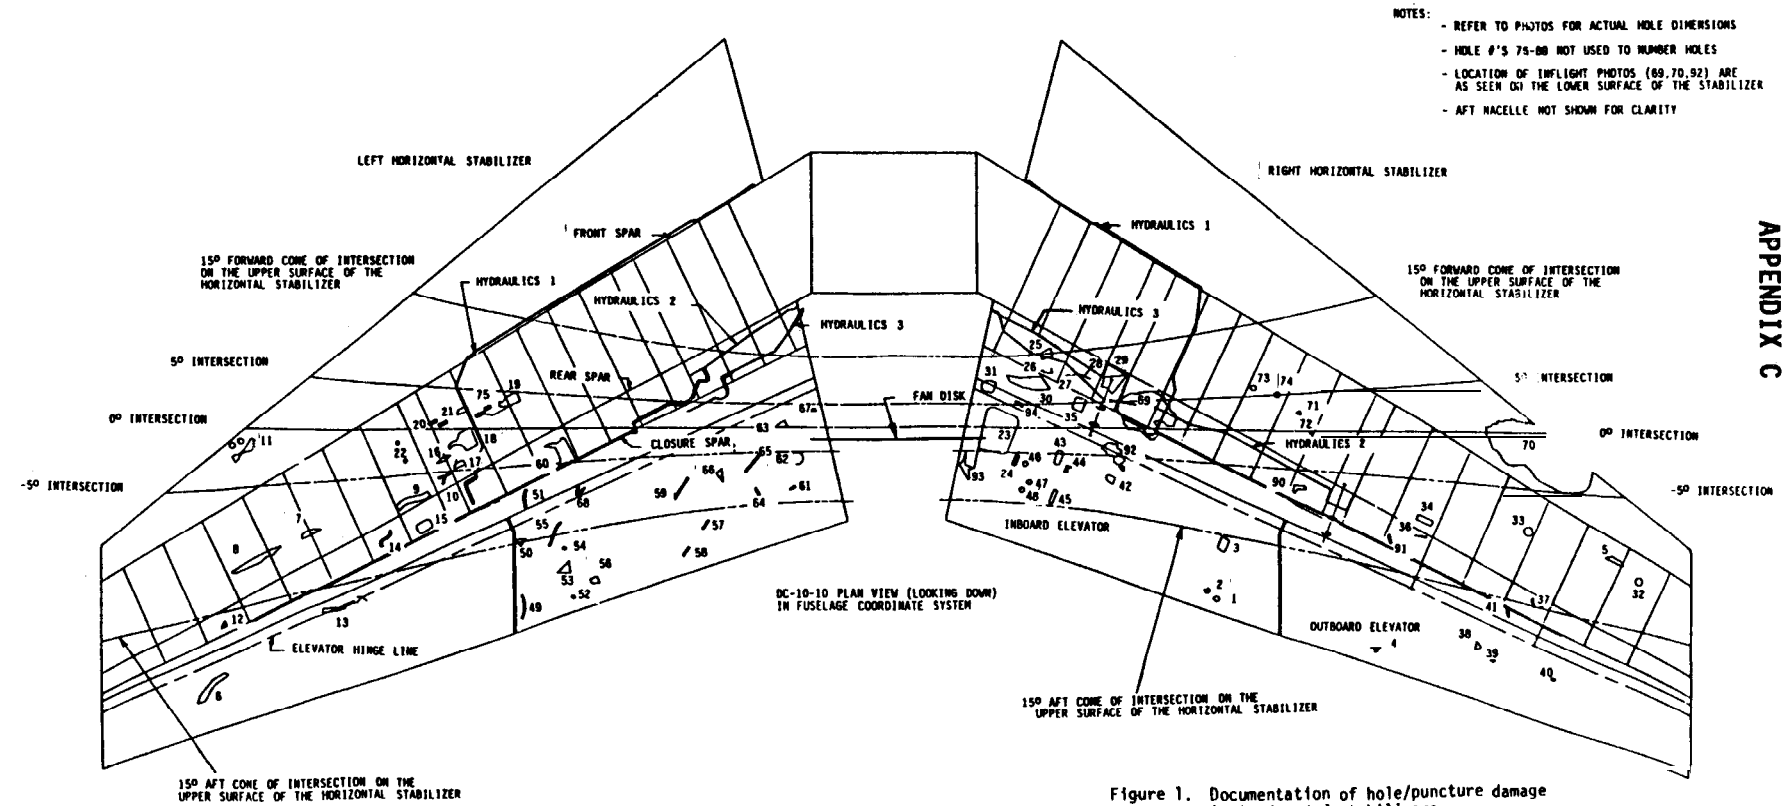
# HORIZONTAL STABILIZER DAMAGE DIAGRAM

Four punctures on the vertical stabilizer were noted as probable fragment damage prior to ground impact. Documentation of hole/puncture damage to the horizontal stabilizers is contained in Appendix C. There were 79 punctures recorded from fragment damage and one large hole, about the same size as the large piece of recovered fan disk. The flight control surfaces were recovered in the aircraft wreckage and had varying degrees of damage that could have occurred before or after impact.
