# NATIONAL TRANSPORTATION SAFETY BOARD

## AIRCRAFT ACCIDENT REPORT

NORTHWEST AIRLINES, INC.  
FLIGHTS 1482 AND 299  
RUNWAY INCURSION AND COLLISION  
DETROIT METROPOLITAN/WAYNE COUNTY AIRPORT  
ROMULUS, MICHIGAN  
DECEMBER 3, 1990

**ADOPTED: June 25, 1991  
NOTATION 5416B**

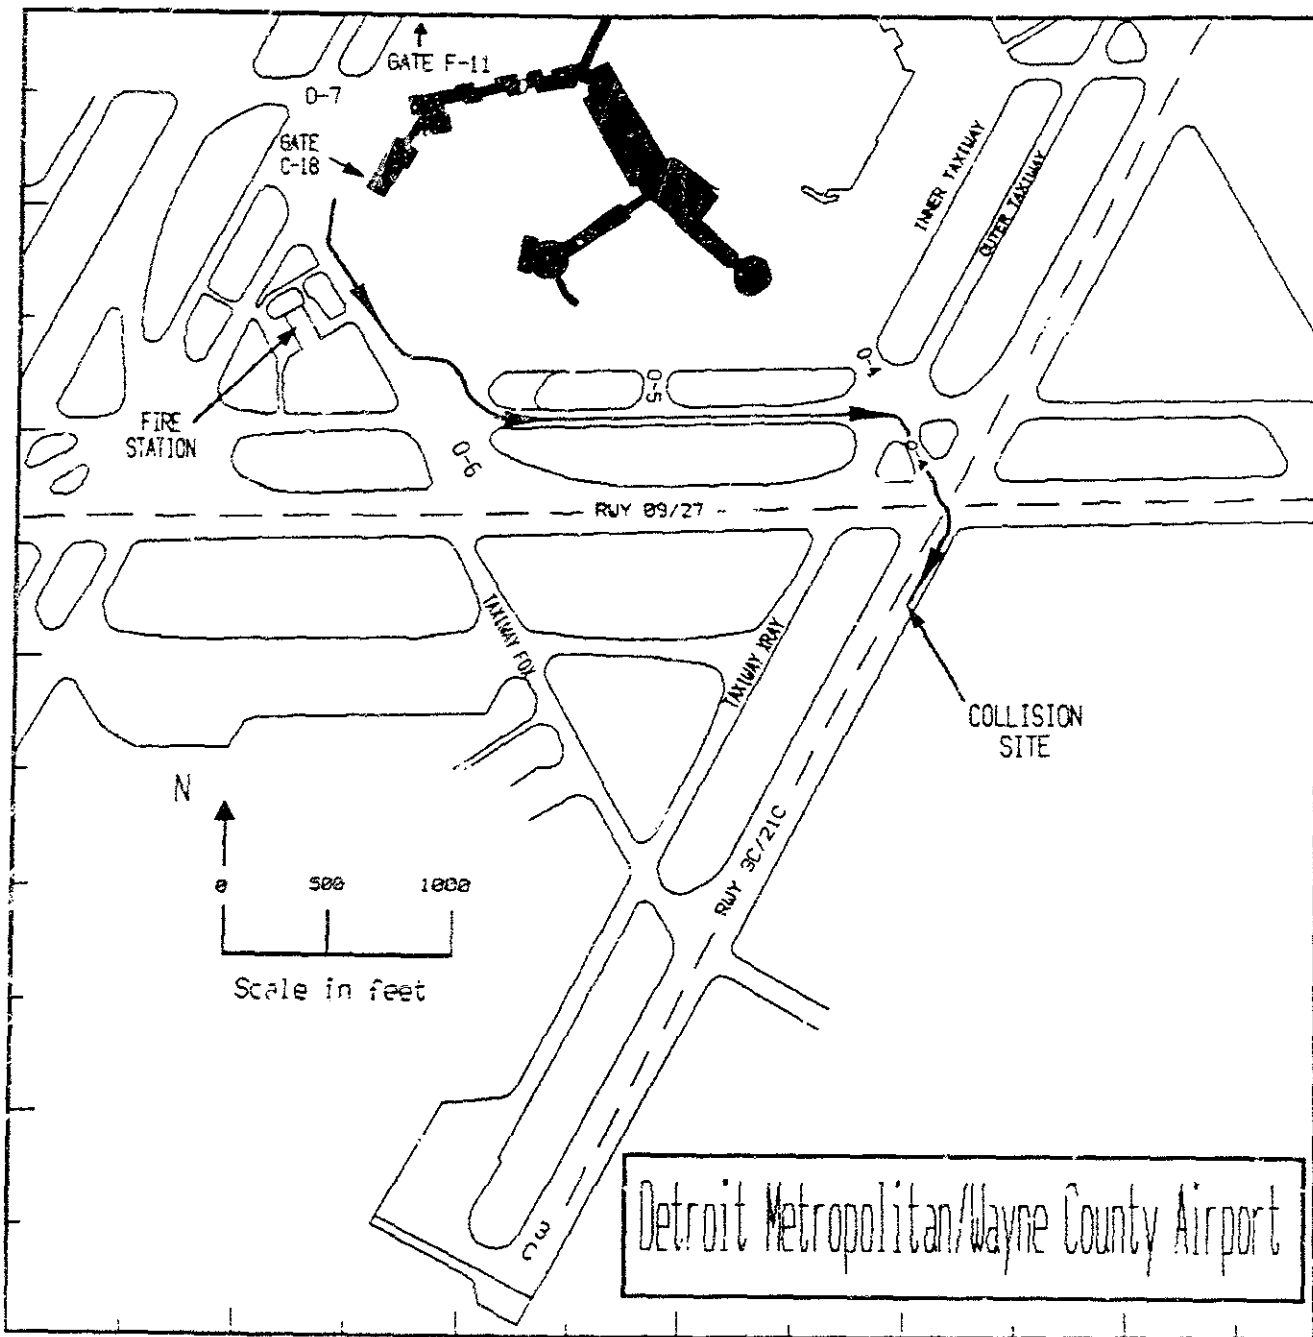
Figure 1.--DTW layout and DC-9 taxi route.

The captain stated that the visibility was deteriorating as they began taxiing, but he was able find and follow the "yellow line" [the taxiway centerline]. The captain testified that he intercepted the taxiway centerline at or near the point where it forks to the left to become the centerline of the Outer taxiway heading east. About this time, the first officer stated, "Hey, it looks like it's goin' zero zero out here." Shortly thereafter, ground control requested their position. The first officer reported that they were abeam the fire station. At this time, they were given an additional taxi clearance: "Roger, Northwest 1482, taxi Inner, Oscar 6, Fox, report making the, ah, right turn on Xray." About 1/2 minute later, the first officer stated, "Guess we turn left here." When the captain expressed some doubt about this left turn, the first officer replied, "Near as I can tell. Man, I can't see [expletive] out here."

In a subsequent discussion with ground control about their position, the first officer stated to the controller: "approaching the parallel runway on Oscar 6...headed eastbound on Oscar 6 here...." He then said that they had missed Oscar 6 and that they "...see a sign here that says, ah, the arrows to Oscar 5. Think we're on Foxtrot now." According to the first officer, he realized that they had missed taxiway Oscar 6 after he observed the sign for that taxiway behind him. The controller then stated "Northwest 1482, ah, you just approach[ed] Oscar 5 and you are you on the Outer?" The first officer then responded "yeah, that's right."

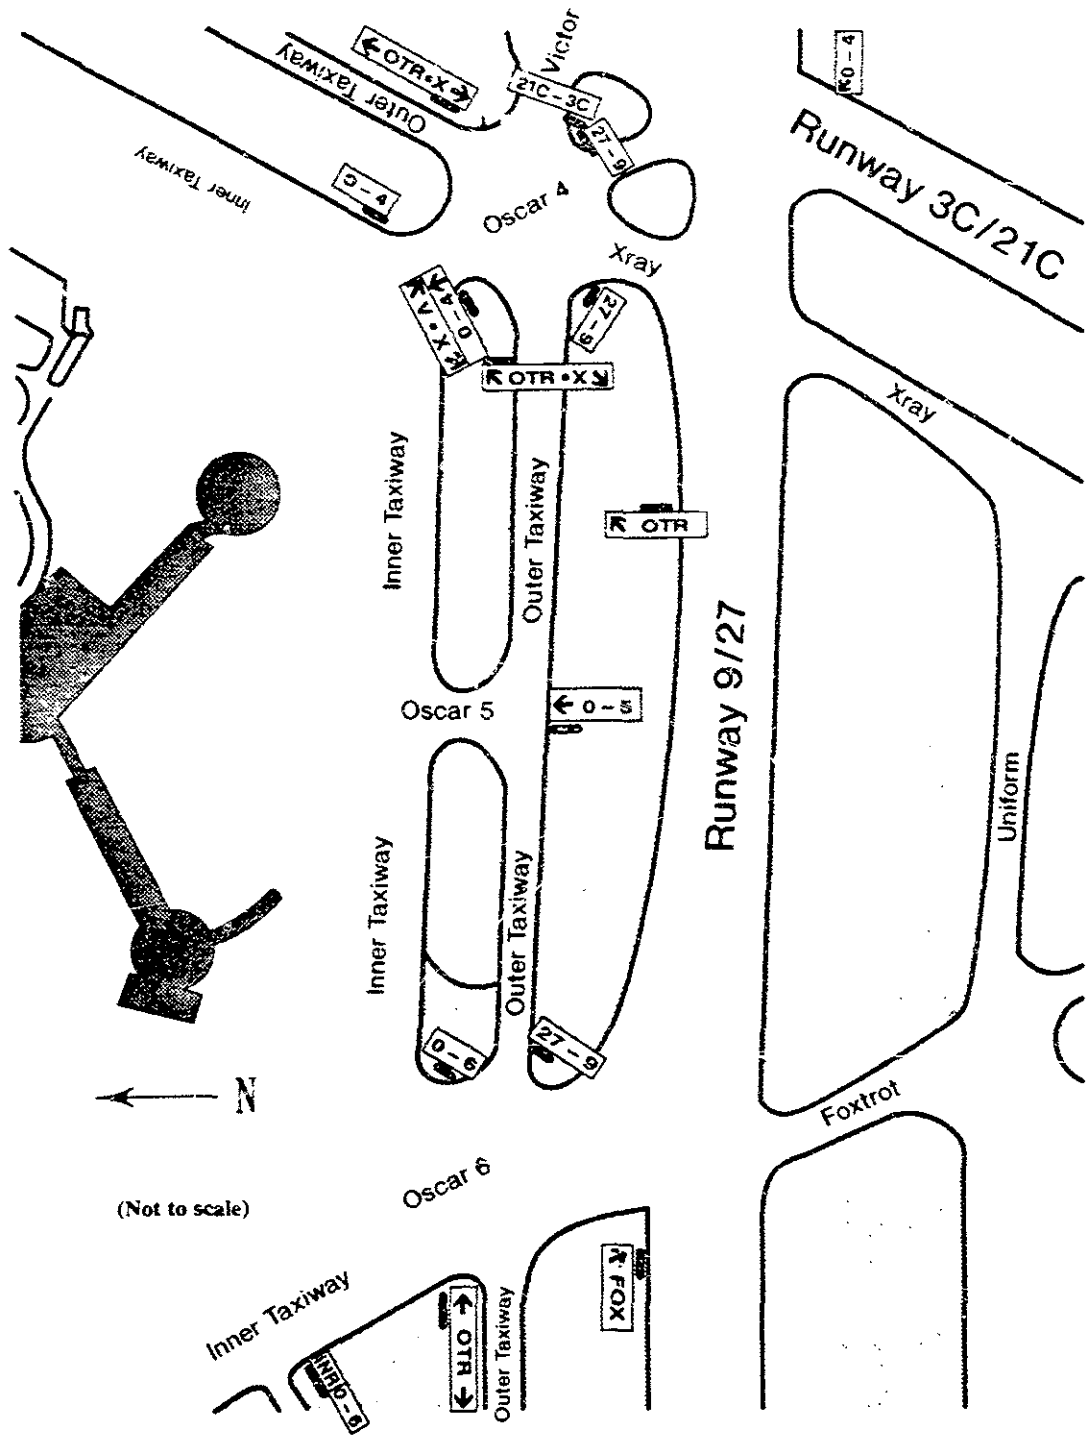
Figure 3.--DTW taxiway signs in the Oscar 4, Oscar 5 and Oscar 6 areas.

The captain continued to taxi eastbound on the Outer taxiway at a very slow rate. The first officer estimated later that during this period the visibility was about 500 to 600 feet. (See figure 3.)

Reflective paint was not used for taxiway centerline or hold line markings, and its use was not required. The inner taxiway centerline from gate C18 eastbound past the fire station was visible. However, about 200 feet of the centerline as it curved through the Oscar 6 area varied in conspicuity between "very faded" to "not visible" under day VFR conditions, according to investigators who observed the taxiway. The taxiway centerline that led from the inner taxiway to taxiway Oscar 5 toward runway 9/27 was visible. The inner taxiway centerline between Oscar 6 and Oscar 4 varied in conspicuity from "faded" to "visible." On the Outer taxiway, the painted taxiway centerline was observed to vary in visibility from "faded" to "visible" between Oscar 4 and Oscar 6. About 50 feet of the centerline on the Outer taxiway near Oscar 5 was unpainted because of recent pavement surface maintenance. An airport management official stated during the public hearing that taxiway centerlines are painted twice a year and that because of weather, the lines were to be repainted in the spring of 1991.

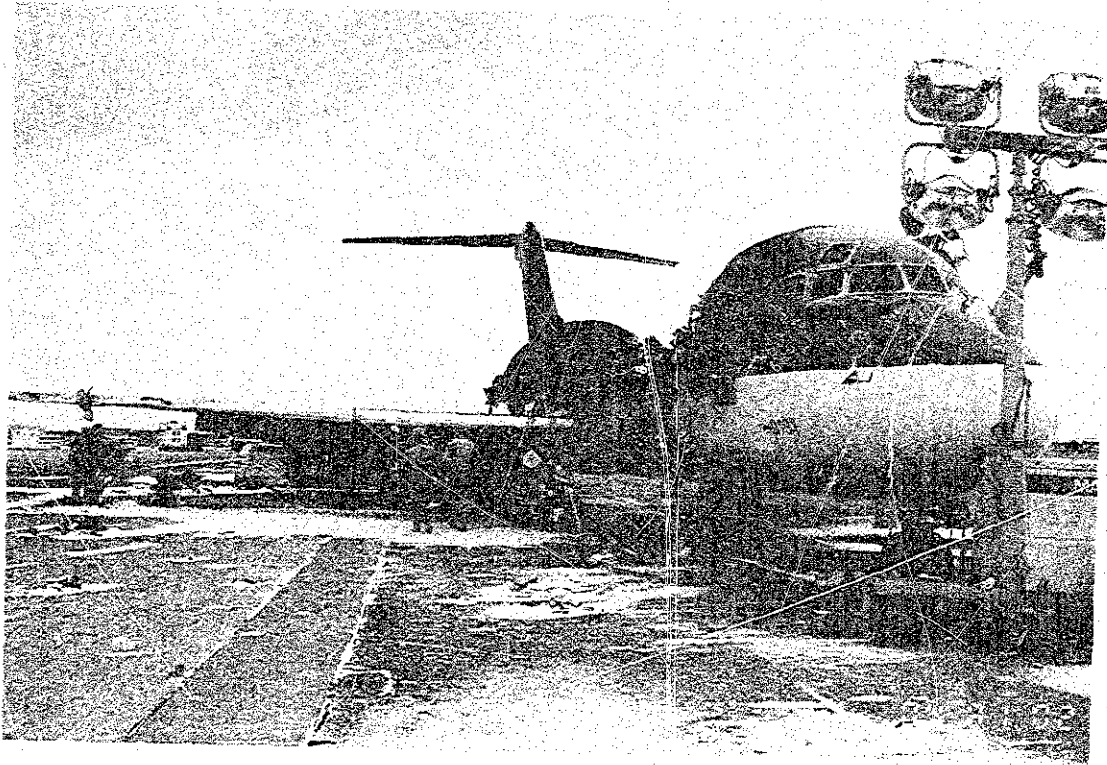
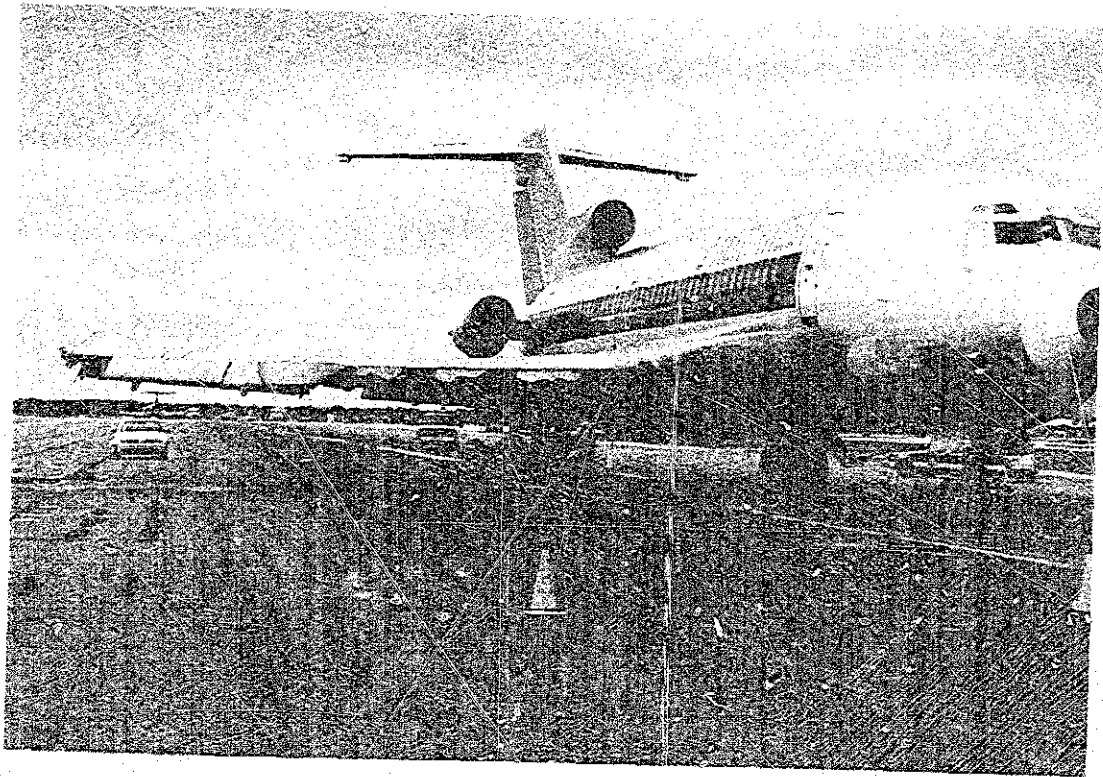
Figure 4.--Photographs of the DC-9 and the B-727.

The B-727 was only damaged on its right side, most of which affected the right wing. Approximately 13.5 feet of the outboard wing had been sheared off during the collision. Much of the debris from this wing area was found in and around the DC-9. The remaining portion of the wing was attached to the fuselage but was heavily damaged. Most of the Nos. 4, 5, and 6 leading edge flaps had broken off, but the actuators were still in place. Most of the forward, lower fixed leading edge panels aft of the No. 4 leading edge flap had also broken off. The Nos. 7 and 8 leading edge slats and slat tracks had separated from the wing and were found on the runway beside the DC-9. The mid fairing and most of the aft fairing for the outboard flap track of the inboard trailing edge flap had been torn off during the collision and were found lodged in the leading edge of the right wing of the DC-9. Among other wing components, the lower, outboard end of the inboard aileron was slightly damaged, as was the outboard end of the outer spoiler.

The three fuselage-mounted engines did not appear to sustain any damage as a result of the collision. They were not examined internally. Both right tires exhibited several cuts on their treads and sidewalls. (See figure 4.)

The airplane's fuselage was cut in a straight line just below the bottom of the windows on the right side of the airplane. The cut line remained along the right side of the fuselage, and the fuselage structure above this cut line to the top was destroyed by fire. The majority of the fuselage was burned from just aft of the cockpit to just forward of the aft bulkhead, from the top to just above the window line on the left side of the airplane.

The left wing was undamaged and all left wing control surfaces were intact. The right wing was heavily damaged, and about 3.5 feet of the wing tip was missing. Portions of the right wing tip were found in the right main landing gear door of the B-727. Several areas of the wing's top skin just aft of the leading edge were torn. Scrape marks existed on several areas of the upper surface of the DC-9 right wing. These scrape marks and those on the right wing of the B-727 indicated a collision angle between the two airplanes of approximately 5°.

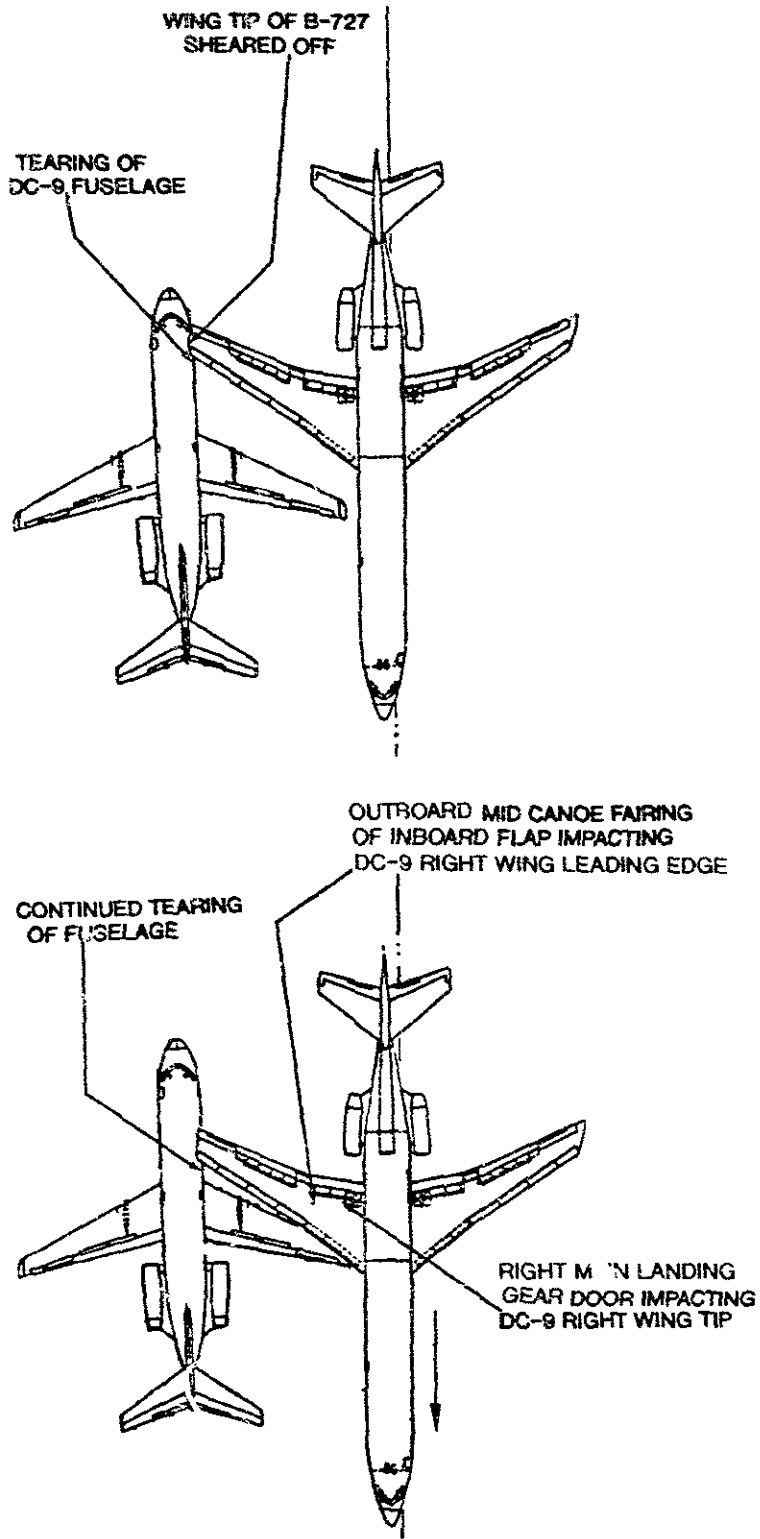
Figure 5a.--Impact sequence.

No. 8 LEADING  
EDGE SLAT COMING  
IN CONTACT WITH RIGHT HAND  
ENGINE COWL

DC-9 WING TIP SHEARS OFF  
AND LODGES IN B-727 GEAR DOOR

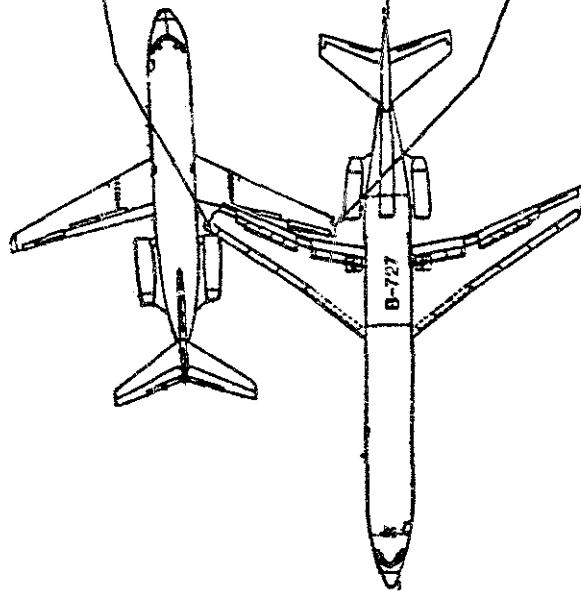
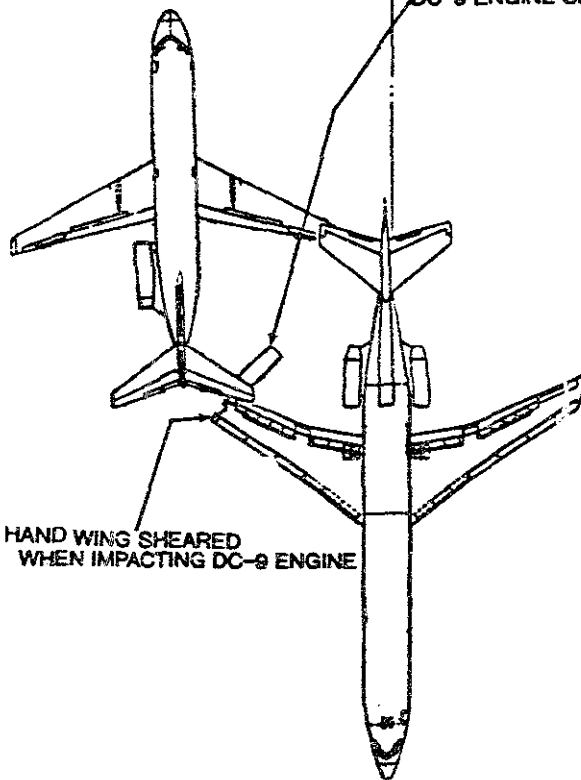
Figure 5b.--Impact sequence.

DC-9 ENGINE SHEARED OFF

RIGHT HAND WING SHEARED  
WHEN IMPACTING DC-9 ENGINE

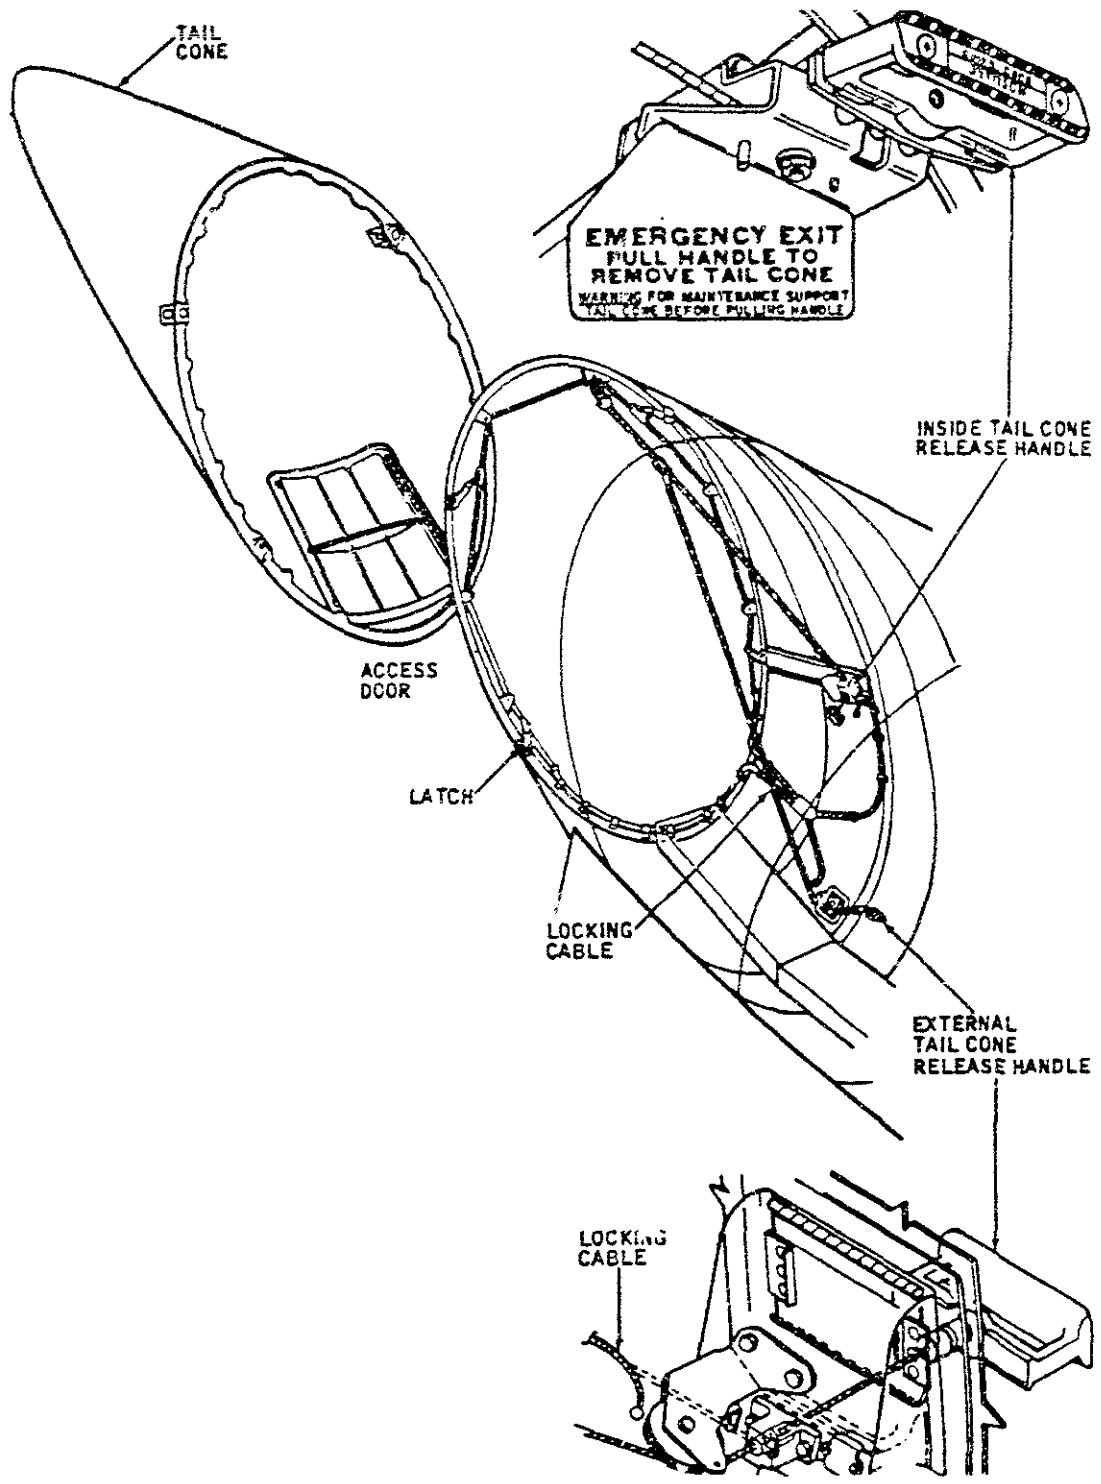
Figure 6.--Tailcone assembly.

The interior tailcone release handle was found out of its normally stowed position, free of its retaining clips, and its safety wire was not found. The handle was also rotated about 60° clockwise from its normal stowed position. Because of soot deposits on the handle, the lifting and identification of fingerprints was impossible. The red and white colored placard on the fuselage sidewall near the handle was readable through an even coating of soot, and the soot was not disrupted.

Although the routing of the tailcone release mechanism cabling was found to be in accordance with the Douglas DC-9 Maintenance Manual, there was excessive slack in the cable. Three of the four tailcone release latches were in their fully closed positions. The upper left latch was engaged but rotated counterclockwise 1/2 inch from its fully closed position. When tested, all four latches rotated within the limitations imposed by the cable system.

During an attempt to reinstall the release handle into its housing for further testing, handle's shaft was found to be fractured and separated near where the shaft jointed the main portion of the handle. The separated piece of the shaft remained within the lock housing and prevented the locking cable from being released. The main portion of the interior release handle was attached only through the release cable, which passes through the handle shaft.
