PB91-910409
NTSB/AAR-91/08

**NATIONAL
TRANSPORTATION
SAFETY
BOARD**

AIRCRAFT ACCIDENT REPORT

**RUNWAY COLLISION
OF USAIR FLIGHT 1493, BOEING 737
AND SKYWEST FLIGHT 5569 FAIRCHILD METROLINER
LOS ANGELES INTERNATIONAL AIRPORT
LOS ANGELES, CALIFORNIA
FEBRUARY 1, 1991**

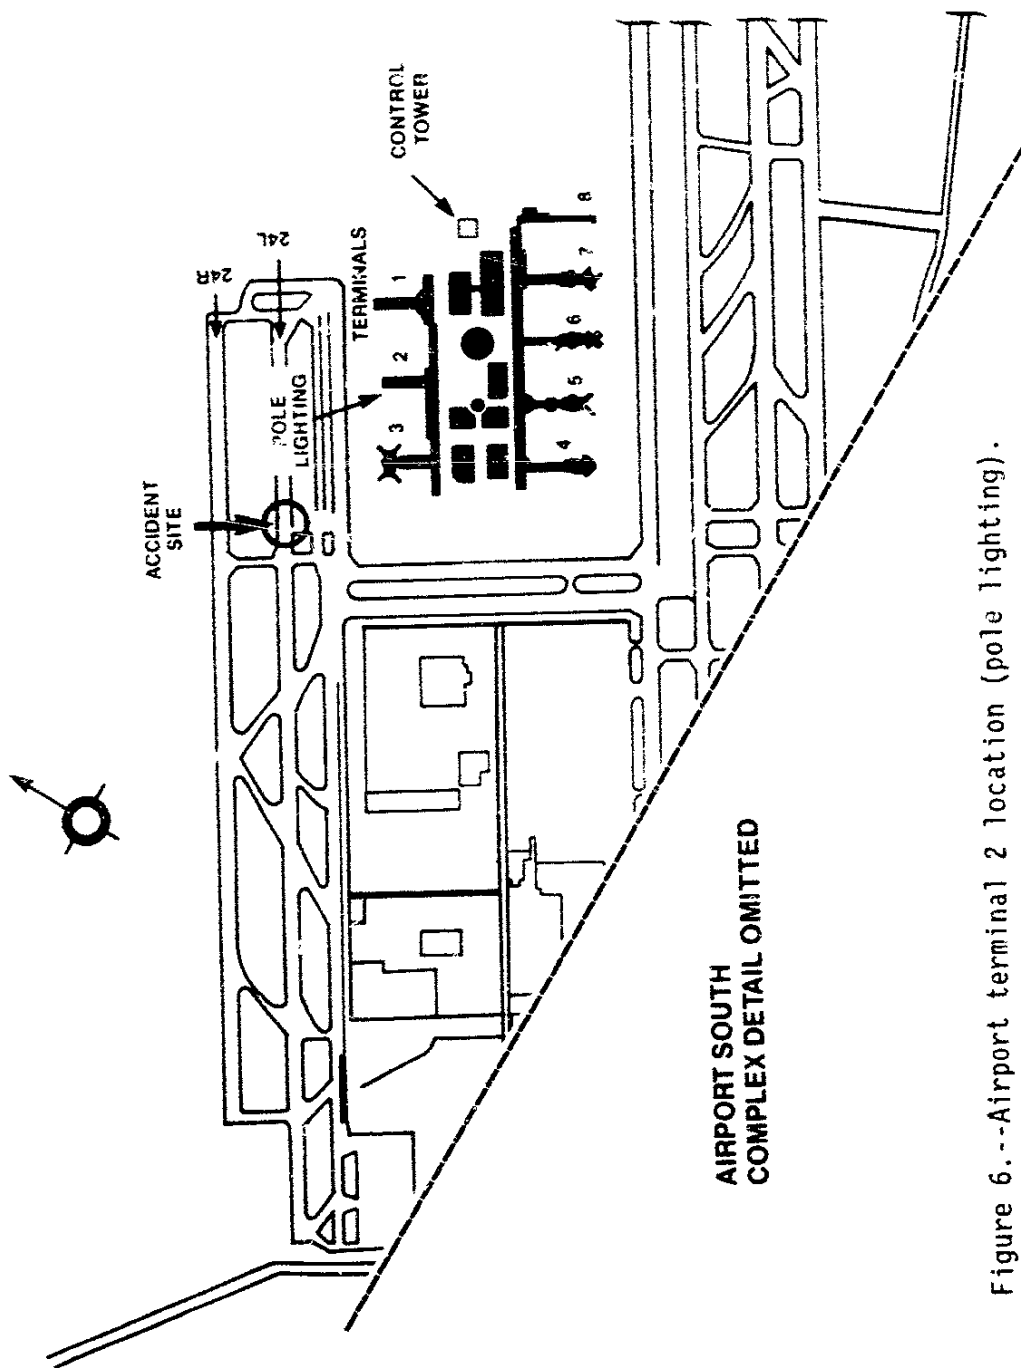
Figure 6.--Airport terminal 2 location (pole lighting).

During interviews, tower personnel stated that a series of four ramp lights on the northernmost portion of the Terminal 2 complex were a restriction to vision during the hours of darkness because of their height, brightness, and relative line-of-sight location to taxiways 45 and 47 and runway 24 left.

The only documentation regarding Terminal 2 lighting conditions relative to ATC operations was obtained from the manager of the Terminal 2 complex in the form of a letter dated February 6, 1991, to the Chief of Operations for the Los Angeles DOA. In his letter, the manager stated, based on his recollections shortly after phase I of the Terminal 2 complex opened on May 31, 1988, "...the tower contacted someone, I do not know who, regarding glare from the southernmost apron lights. The tower requested that the lights either be shielded or redirected. The Terminal 2 electrical contractor complied by redirecting the lights down, thus eliminating the glare. Upon completion of this work the tower was contacted and we were advised the problem had been taken care of satisfactorily. To the best of my knowledge, all conversations were telephonic and nothing was ever put in writing." The letter added that Terminal 2 personnel were never contacted regarding the repositioning or shielding of the northernmost apron lights that became operational upon completion of phase II construction, approximately June 1, 1989.

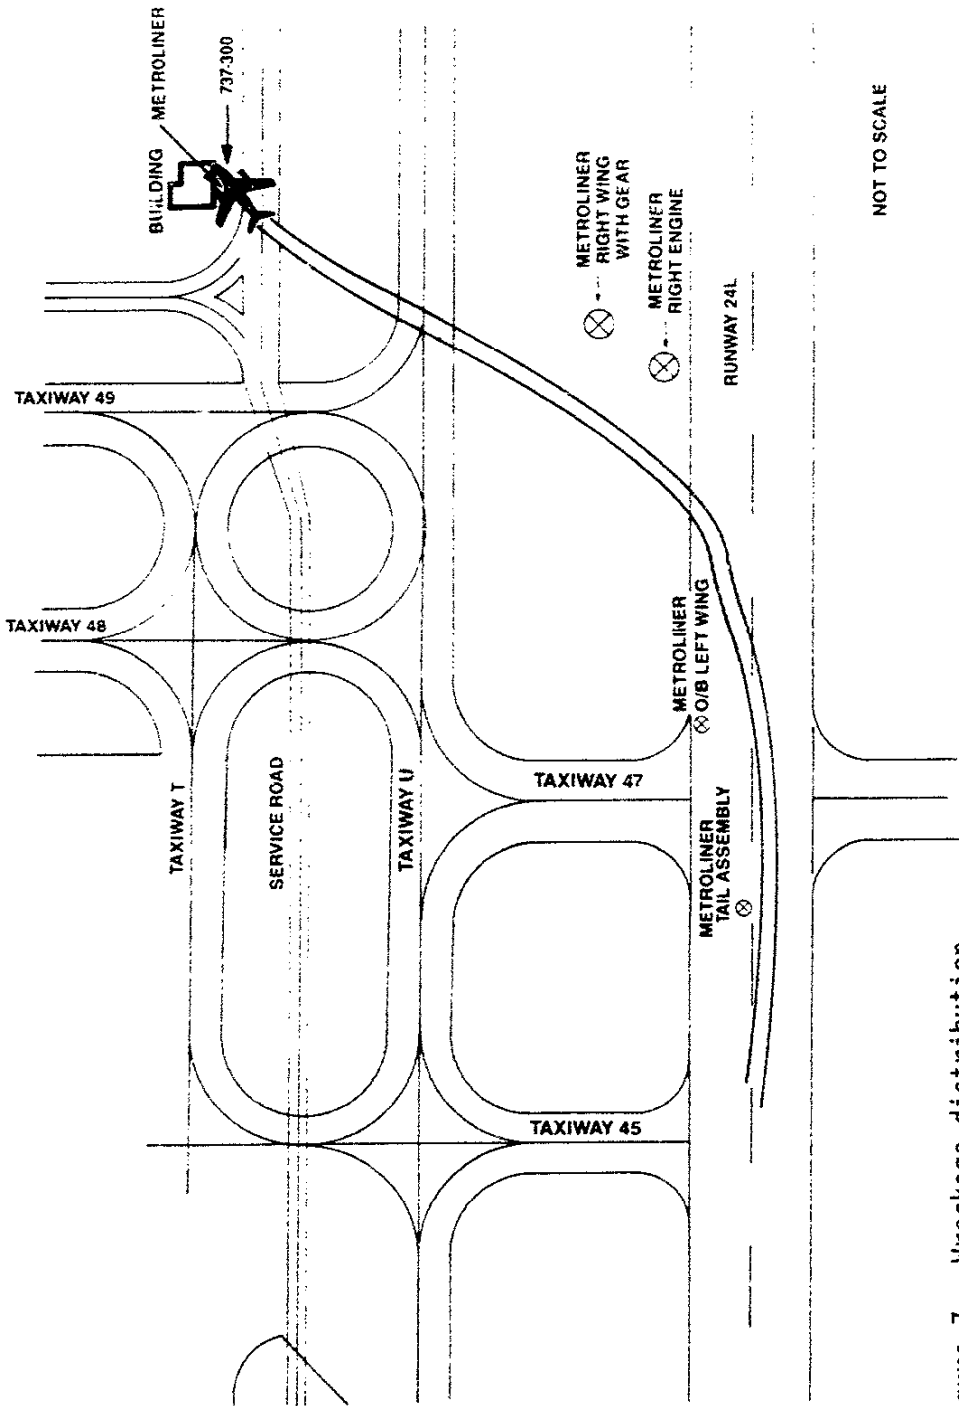
Figure 7.--Wreckage distribution.

After the collision, the B-737 and the part of the Metroliner that was crushed beneath the left side of the B-737 continued 300 feet down runway 24 left before veering left and impacting the vacant fire station, about 1,200 feet from the collision point and approximately 600 feet to the left (southeast) of the runway centerline (See figures 7 and 8). Although parts of the Metroliner were scattered among the wreckage, the only parts of the B-737 that separated from the airplane were the nose cone, nose gear doors, and left pitot tube. The B-737 was destroyed by the resulting ground fire, which burned through the top of the fuselage both forward and aft of the wing, the latter causing the aft fuselage to drop down. The impact with the building destroyed the B-737 cockpit and damaged the left engine and an area of the left wing leading edge. The top and left sides of the cockpit were crushed inward, and the forward section of the cockpit on the captain's side was crushed in, down, and to the right (See figure 9). Both forward cockpit windshields were cracked. Several propeller slashes were on the lower right side of the B-737 fuselage skin in the area of the forward galley door.

The empennage with the vertical stabilizer, rudder and left horizontal stabilizer were located approximately 240 feet from the initial impact location. The left wing section outboard of the engine was located at the intersection of taxiway 47 and the runway. The right wing separated at the root and was found, with the right landing gear attached, between the runway and taxiway Uniform.

The right engine (minus the propeller section) was found along the debris path. The right engine propeller was found embedded in the B-737's right engine lower cowling. The left engine and propeller remained attached to the main wreckage.

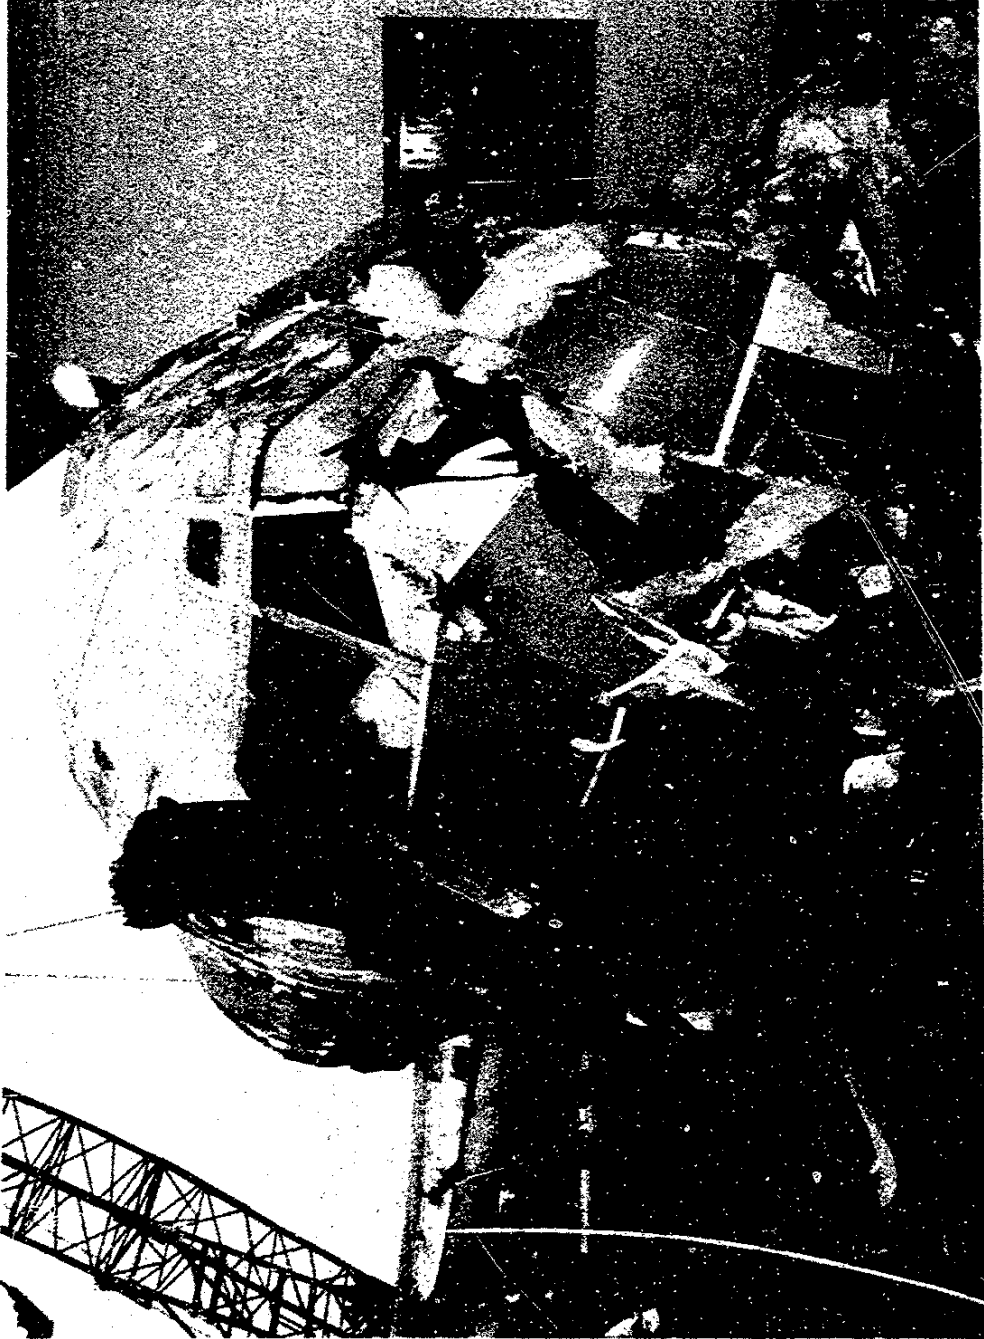
Figure 9.--Damage related to building impact.

The burned area in the top of the B-737's fuselage was in the forward cabin between the first-class and coach sections. Interior fire damage in this area was extensive. The right forward area of the forward cargo compartment, including the cargo liners, the cargo floor, and the cabin floor, was also severely damaged by fire. Several small holes in the right side of the fuselage below the floor line indicated inward penetrations and fire damage. This area also housed the crew oxygen cylinder, which was found loose. The cylinder contained heavy amounts of soot, except for the area of an attaching strap. The pressure gauge and regulator were extensively fire damaged, and the overpressure and supply lines were broken (See section 1.16.2 for further information).

Soot and fire had damaged both sides of the fuselage exterior from the forward area to the break in the fuselage aft of the wing. The most severe fire damage was on the left side of the fuselage around the wing, where much of the skin below the window line had burned through.

The top of the fuselage was also burned away from just aft of the wing to the aft doors. The fuselage along the floor beams was still attached near the fuselage break aft of the wing. However, the entire tail section drooped to the ground.

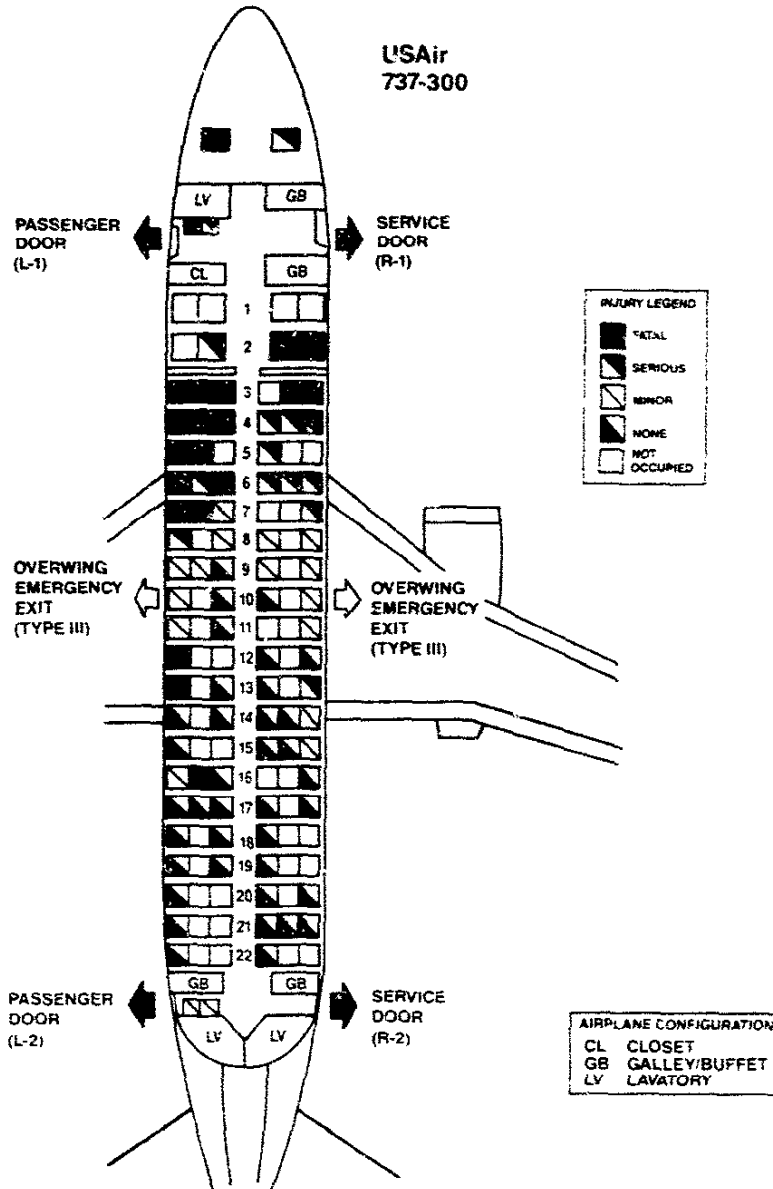
Figure 10.--Seating and injury chart.

The outboard seatback at 10-F adjacent to the right overwing exit was found folded forward after the accident blocking approximately 25 percent of the exit opening. The retaining bolt at the seat's pivot point was sheared. The timing of this occurrence could not be determined.
