## AIRCRAFT ACCIDENT REPORT

Uncontrolled Descent and Collision With Terrain  
United Airlines Flight 585  
Boeing 737-200, N999UA  
4 Miles South of Colorado Springs  
Municipal Airport  
Colorado Springs, Colorado  
March 3, 1991

**NTSB/AAR-01/01  
PB2001-910401  
Notation 5498C  
Adopted March 27, 2001**

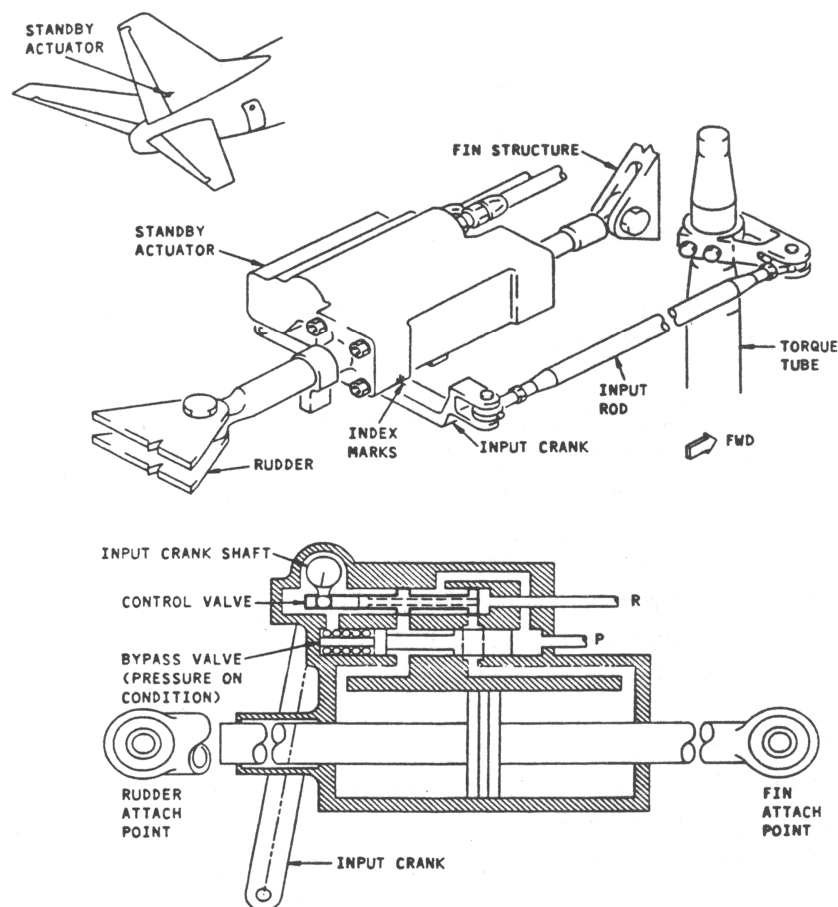
**Figure 11.** Standby rudder actuator.

A review of the design of the B-737 rudder control system revealed that binding of the input shaft to the bearing that is threaded in the actuator body could potentially cause flight control problems even though the standby rudder hydraulic system is not pressurized. In the rudder control system, the pilot pedal movement is applied through a mechanical control system to a lever arm to rotate a torque tube in the empennage. Other lever arms attached to the torque tube transmit linear motion to the ends of the input cranks for both the MPCU and the standby rudder actuator. (See figure 11).

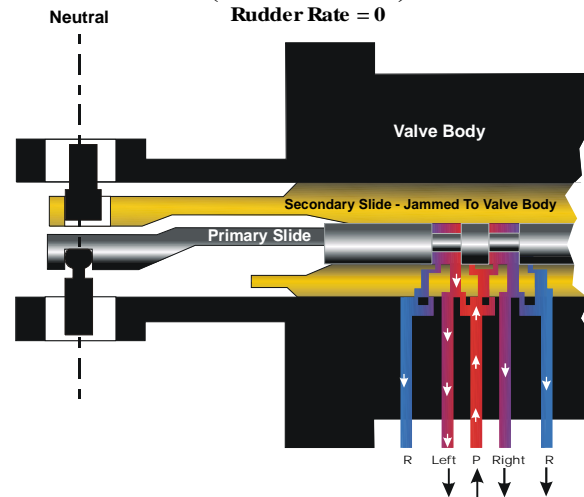
**Intended Operation:**  
**Secondary Slide Jammed Full Open, Primary Slide Opposing**  
 (Full Cross Flow)  
 Rudder Rate = 0

**Figure 14.** PCU servo valve intended operation with the secondary slide jammed to the servo valve housing and primary slide opposing.

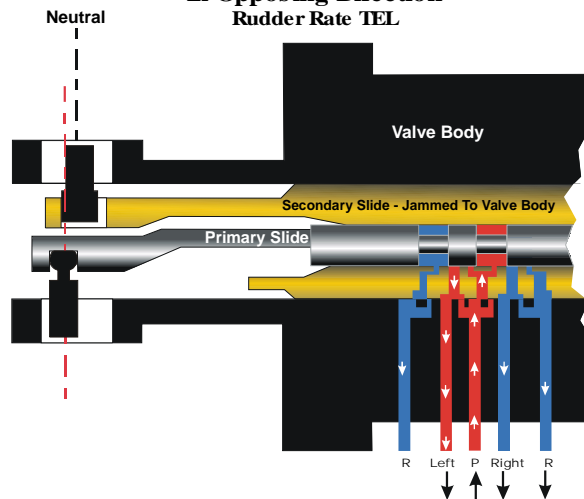
The National Transportation Safety Board determines that the probable cause of the United Airlines flight 585 accident was a loss of control of the airplane resulting from the movement of the rudder surface to its blowdown limit. The rudder surface most likely deflected in a direction opposite to that commanded by the pilots as a result of a jam of the main rudder power control unit servo valve secondary slide to the servo valve housing offset from its neutral position and overtravel of the primary slide.

**Newly Discovered Failure Effect:**  
**Secondary Slide Jammed Full Open, Primary Slide Over-Stroke**  
**In Opposing Direction**  
 Rudder Rate TEL

**Figure 15.** PCU servo valve with the secondary slide jammed to the servo valve housing and the primary slide in the overtravel condition.
