**PB92-910405
NTSB/AAR-92/04**

**BRITT AIRWAYS, INC., d/b/a
CONTINENTAL EXPRESS FLIGHT 2574
IN-FLIGHT STRUCTURAL BREAKUP
EMB-120RT, N33701
EAGLE LAKE, TEXAS
SEPTEMBER 11, 1991**

**Adopted: July 21, 1992
Notation 5612B**

Abstract: This report explains the structural breakup in flight and crash of Continental Express Flight 2574, an Embraer 120, in a cornfield near Eagle Lake, Texas. The safety issues discussed in this report include the feasibility of developing a means to advise flightcrews of recent maintenance work on aircraft and the need for reviewing regulations, policies and practices for establishing required inspection items (RIIs) with a view toward developing more specific identification of RIIs. Safety recommendations concerning these issues were made to the Federal Aviation Administration.

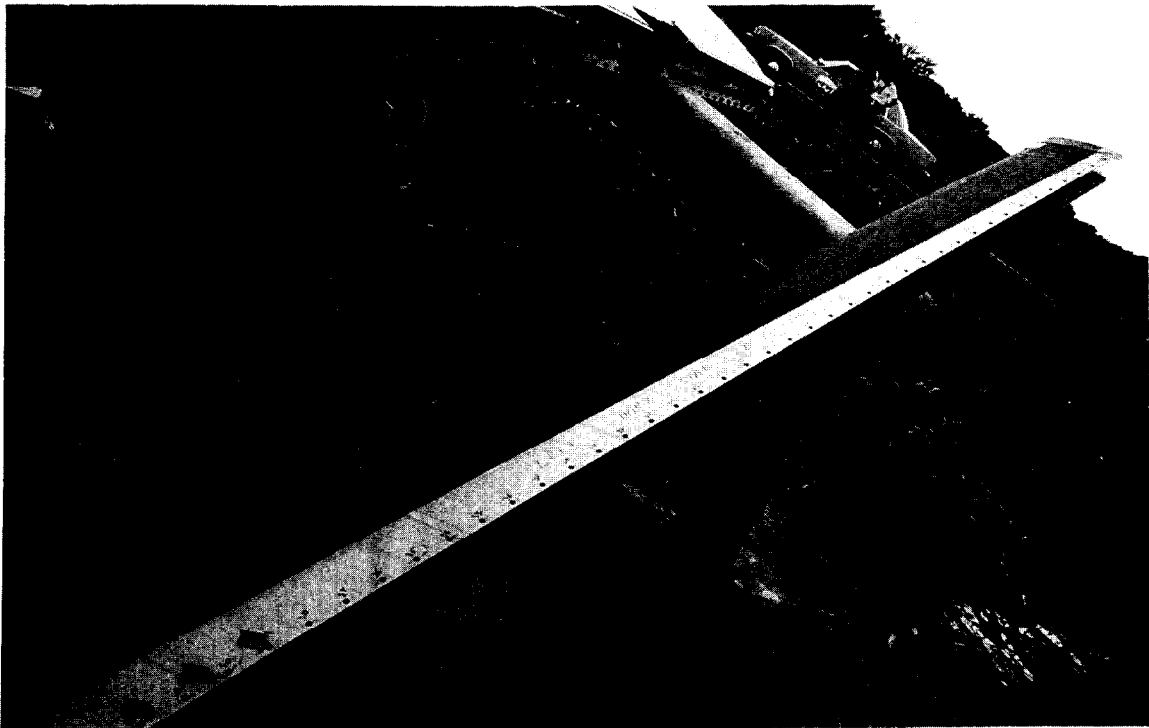
During the Safety Board's examination of the wreckage, none of the 47 screws that would have attached the upper surface of the leading edge assembly for the left side of the horizontal stabilizer was found. There was no evidence of distress in the upper attachment holes for the left side leading edge assembly or indication that the attaching screws were installed when the left side leading edge assembly separated from the horizontal stabilizer. In addition, a "lip" was formed on the forwardmost frame on the left lower side of the horizontal stabilizer spar cap. That frame (spar cap), with receptor holes for the lower attaching screws, was the area into which the screws mounted the underside of the left side leading edge assembly to the stabilizer. This lower frame area showed signs of distress. Figures 1a through 1d show the condition of the left horizontal stabilizer leading edge.

Figure 1 b.--Leading edge assembly and outboard portion of left side of horizontal stabilizer.

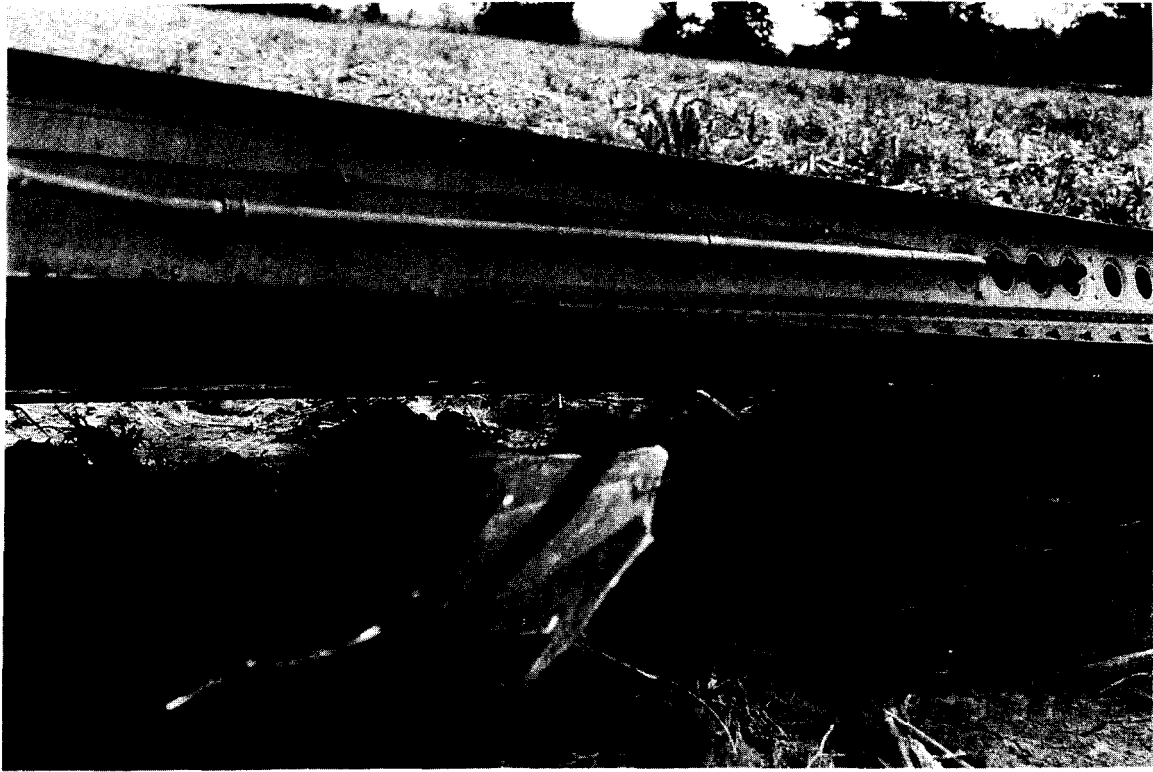
The lower attachment screws remained installed, but the leading edge assembly had separated from the stabilizer, with the exception of a small portion of composite structure remaining below the two farthest inboard screw heads. The spar cap on the lower left side of the horizontal stabilizer showed evidence of being pulled down so that it would project into the wind stream along with the leading edge. This pulling damage is consistent with the left side leading edge assembly having been ripped down and away from the lower attaching screws as it separated from the horizontal stabilizer. This evidence was consistent with screws missing on the top side of the left leading edge assembly, and the lower attaching screws holding fast, pulling down the frame (spar cap) on the lower side of the stabilizer, and thereby forming the lip.

Figure 1c.--Front frame of left side of horizontal stabilizer with lower screw attaching area angled downward.

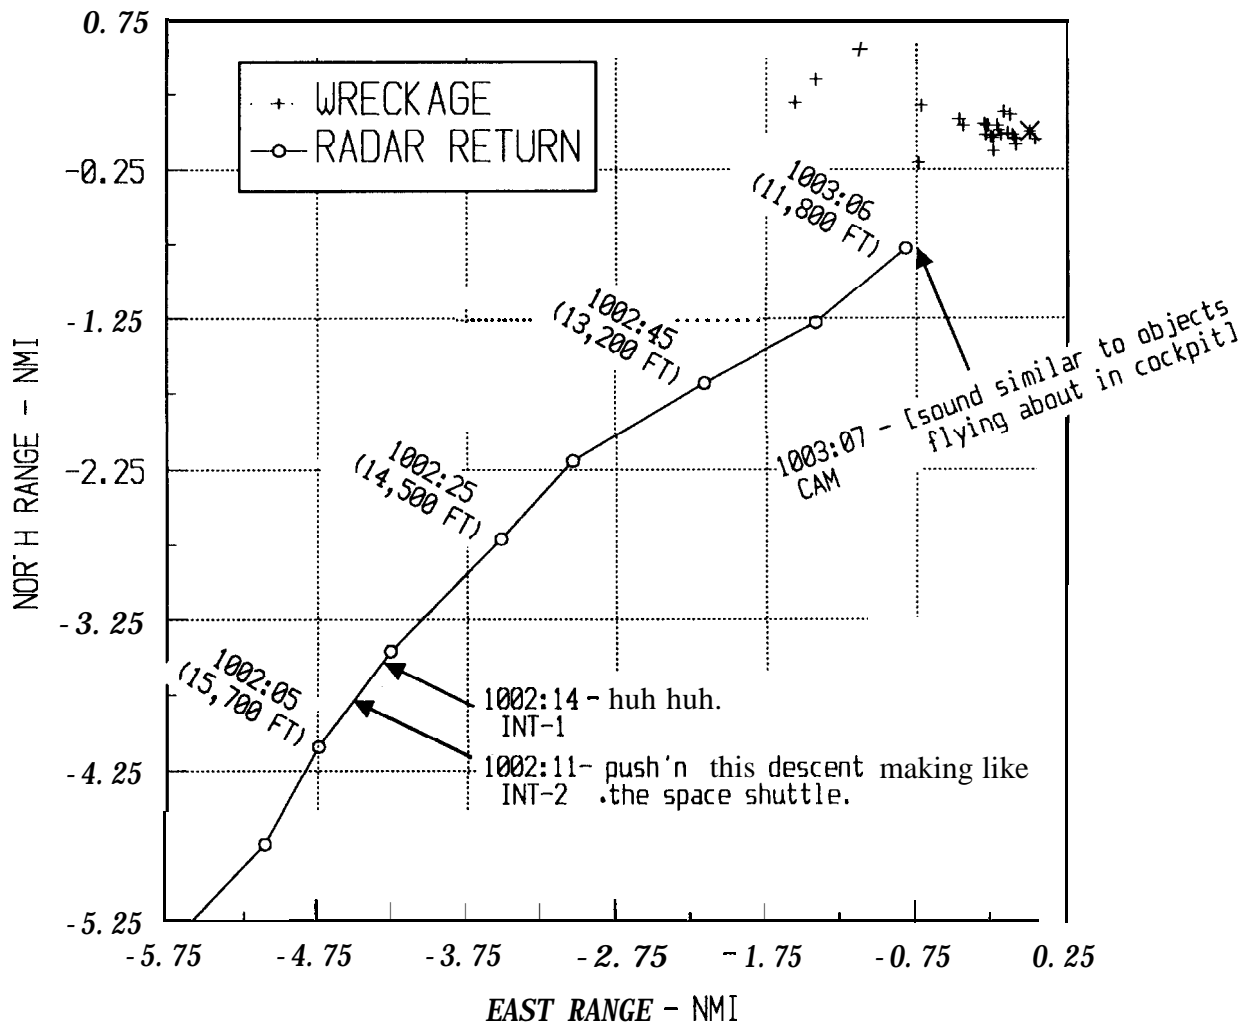
Figure 2.--Radar-derived ground track, CVR sounds, and wreckage distribution.

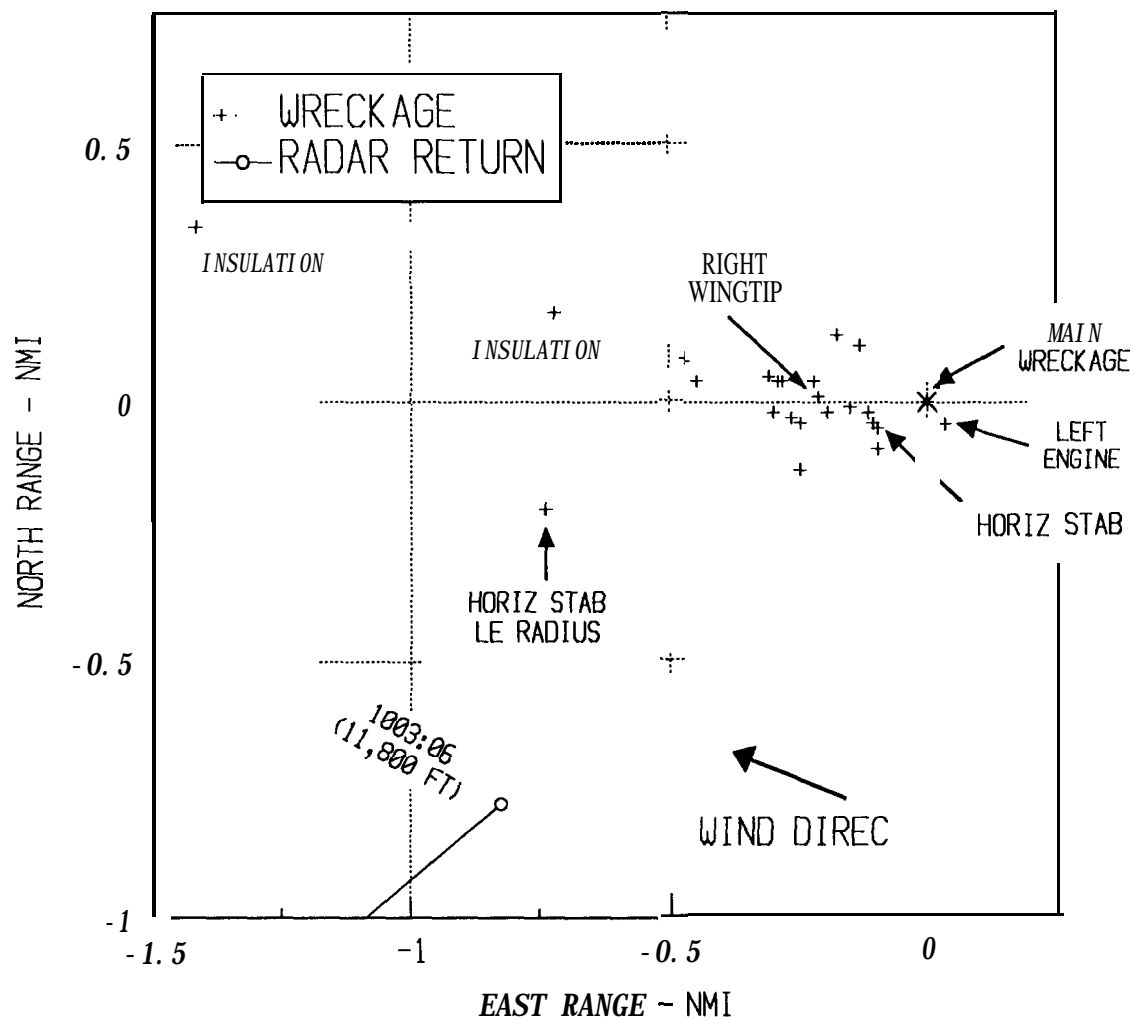
Figure 3 provides a closeup view of part of the ground track and wreckage distribution. The piece of airplane structure farthest from the main wreckage was the left side leading edge (LE) of the horizontal stabilizer. The LE

Figure 3.--Closeup view of part of ground track and wreckage distribution.

was the first piece of structure along the flight's northeasterly ground track, preceding the next piece by roughly 1/2 of a nautical mile.

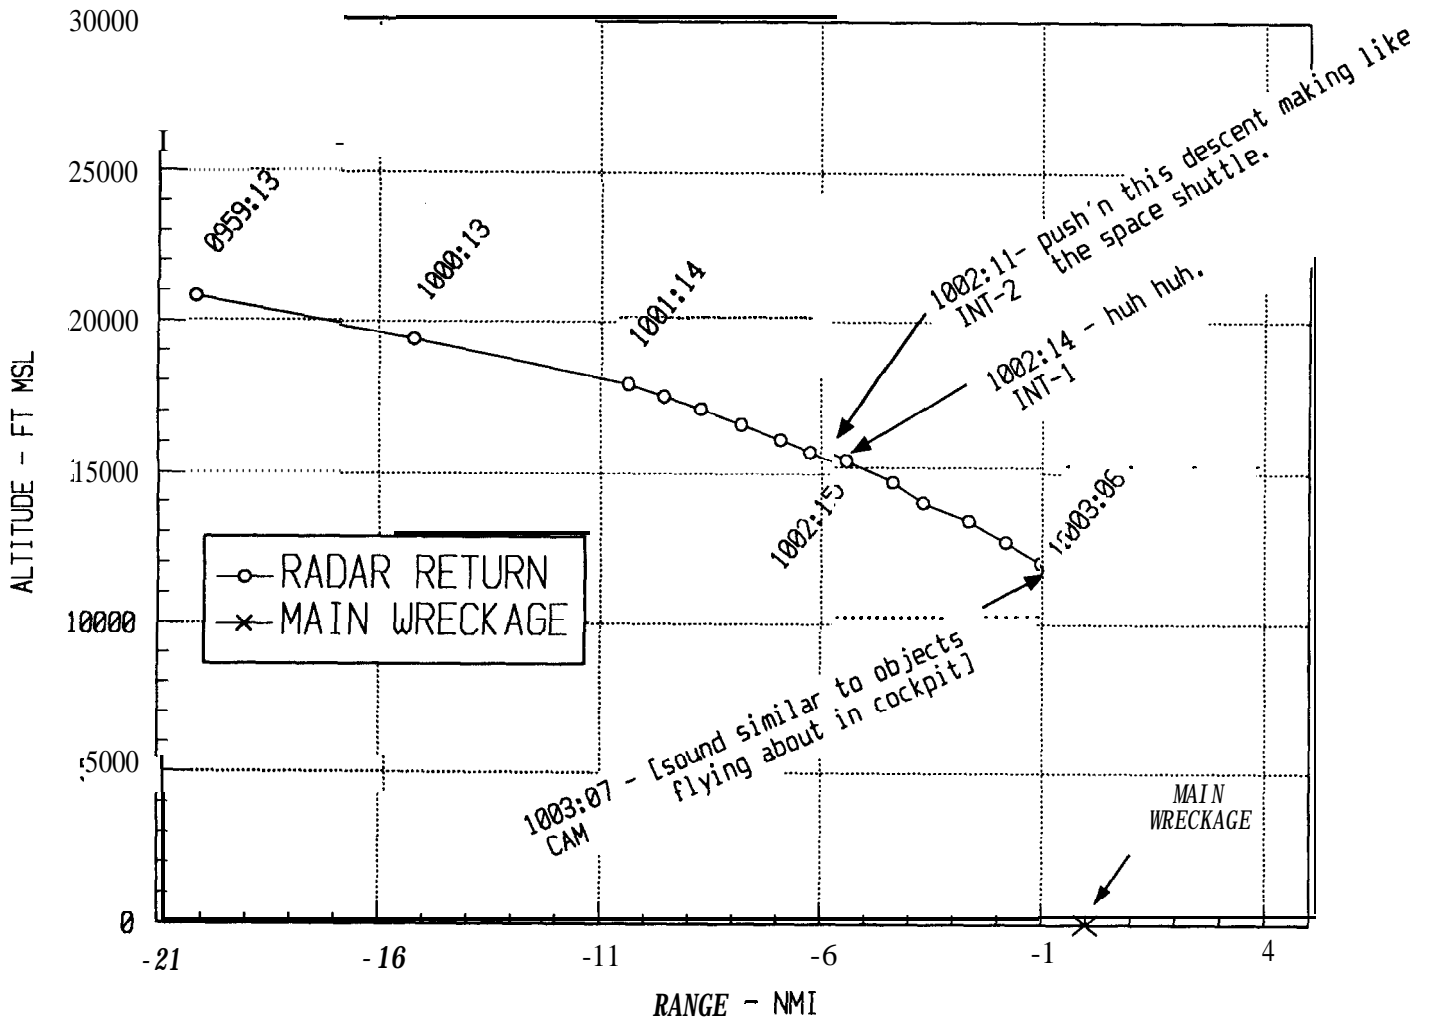
Figure 4.--Radar-derived descent profile.

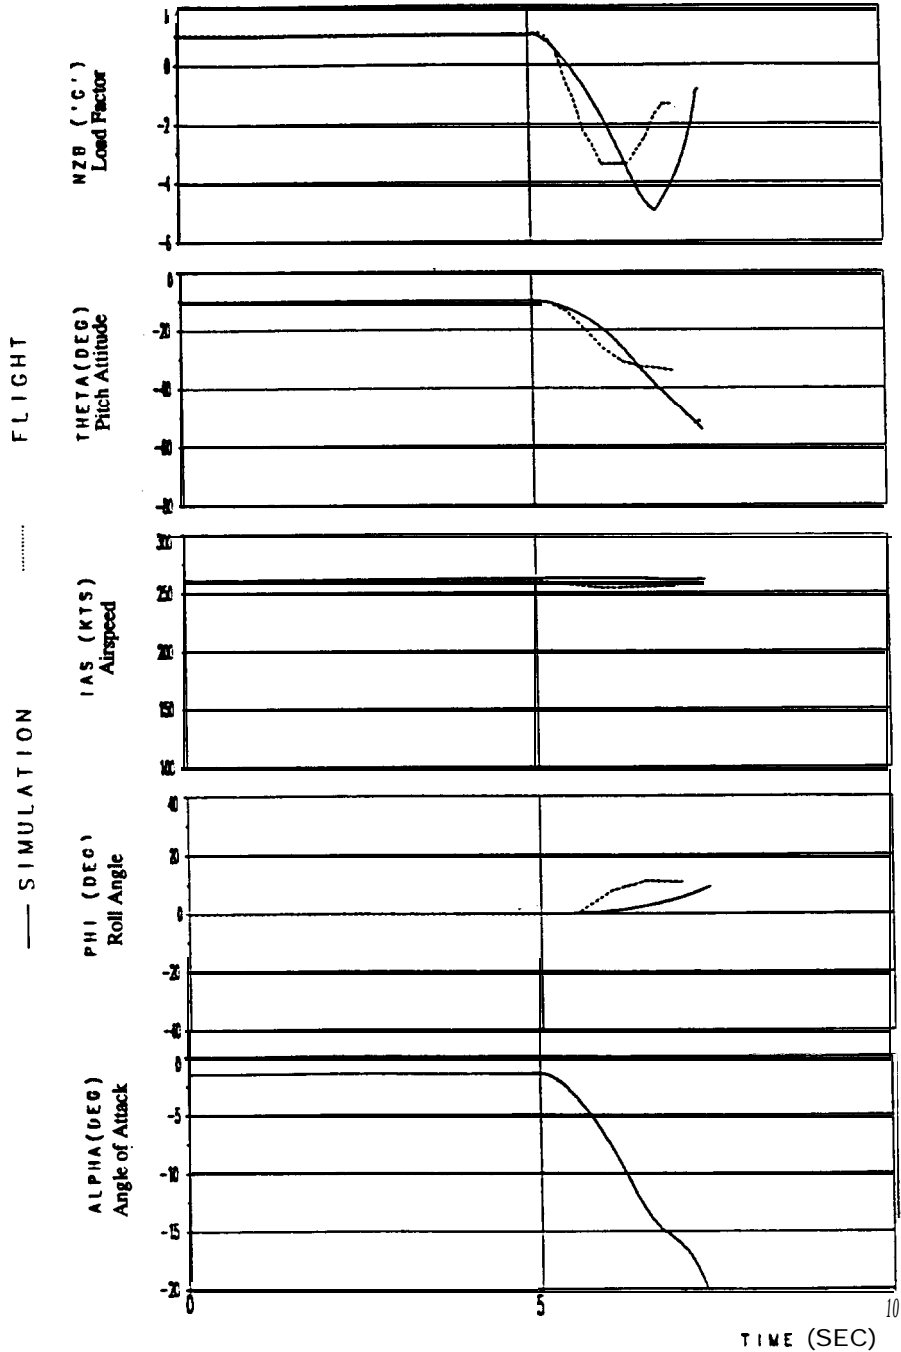
Loss of Left Horizontal Stabilizer Leading Edge

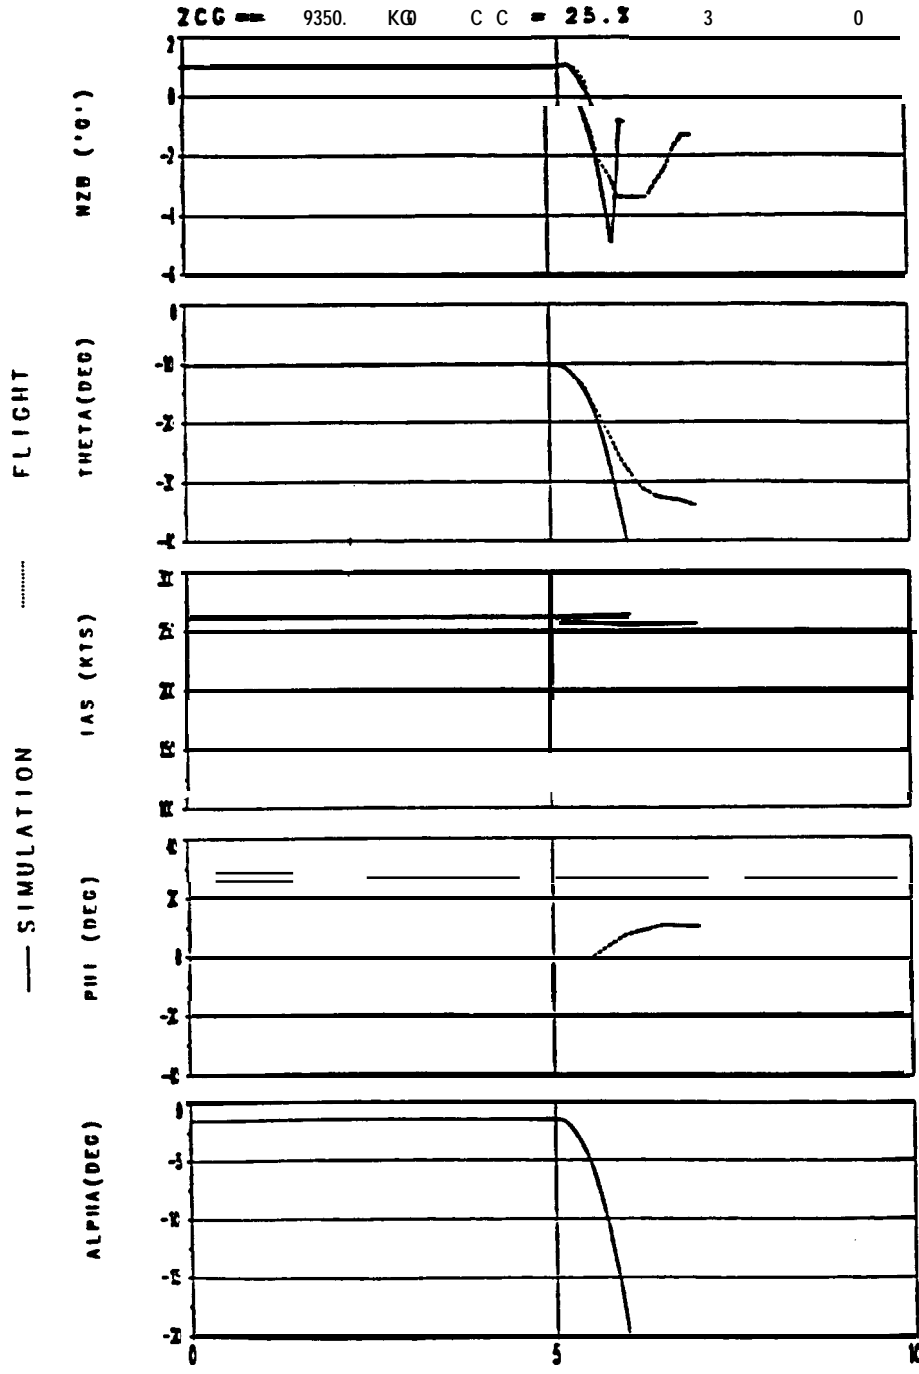
Loss of Entire Horizontal Stabilizer
