PB92-910406
NTSB/AAR-92/05

AIRCRAFT ACCIDENT REPORT

AIR TRANSPORT INTERNATIONAL, INC., FLIGHT 805
DOUGLAS DC-8-63, N794AL
LOSS OF CONTROL AND CRASH
SWANTON, OHIO
FEBRUARY 15, 1992

**Adopted: November 19, 1992
Notation 5718B**

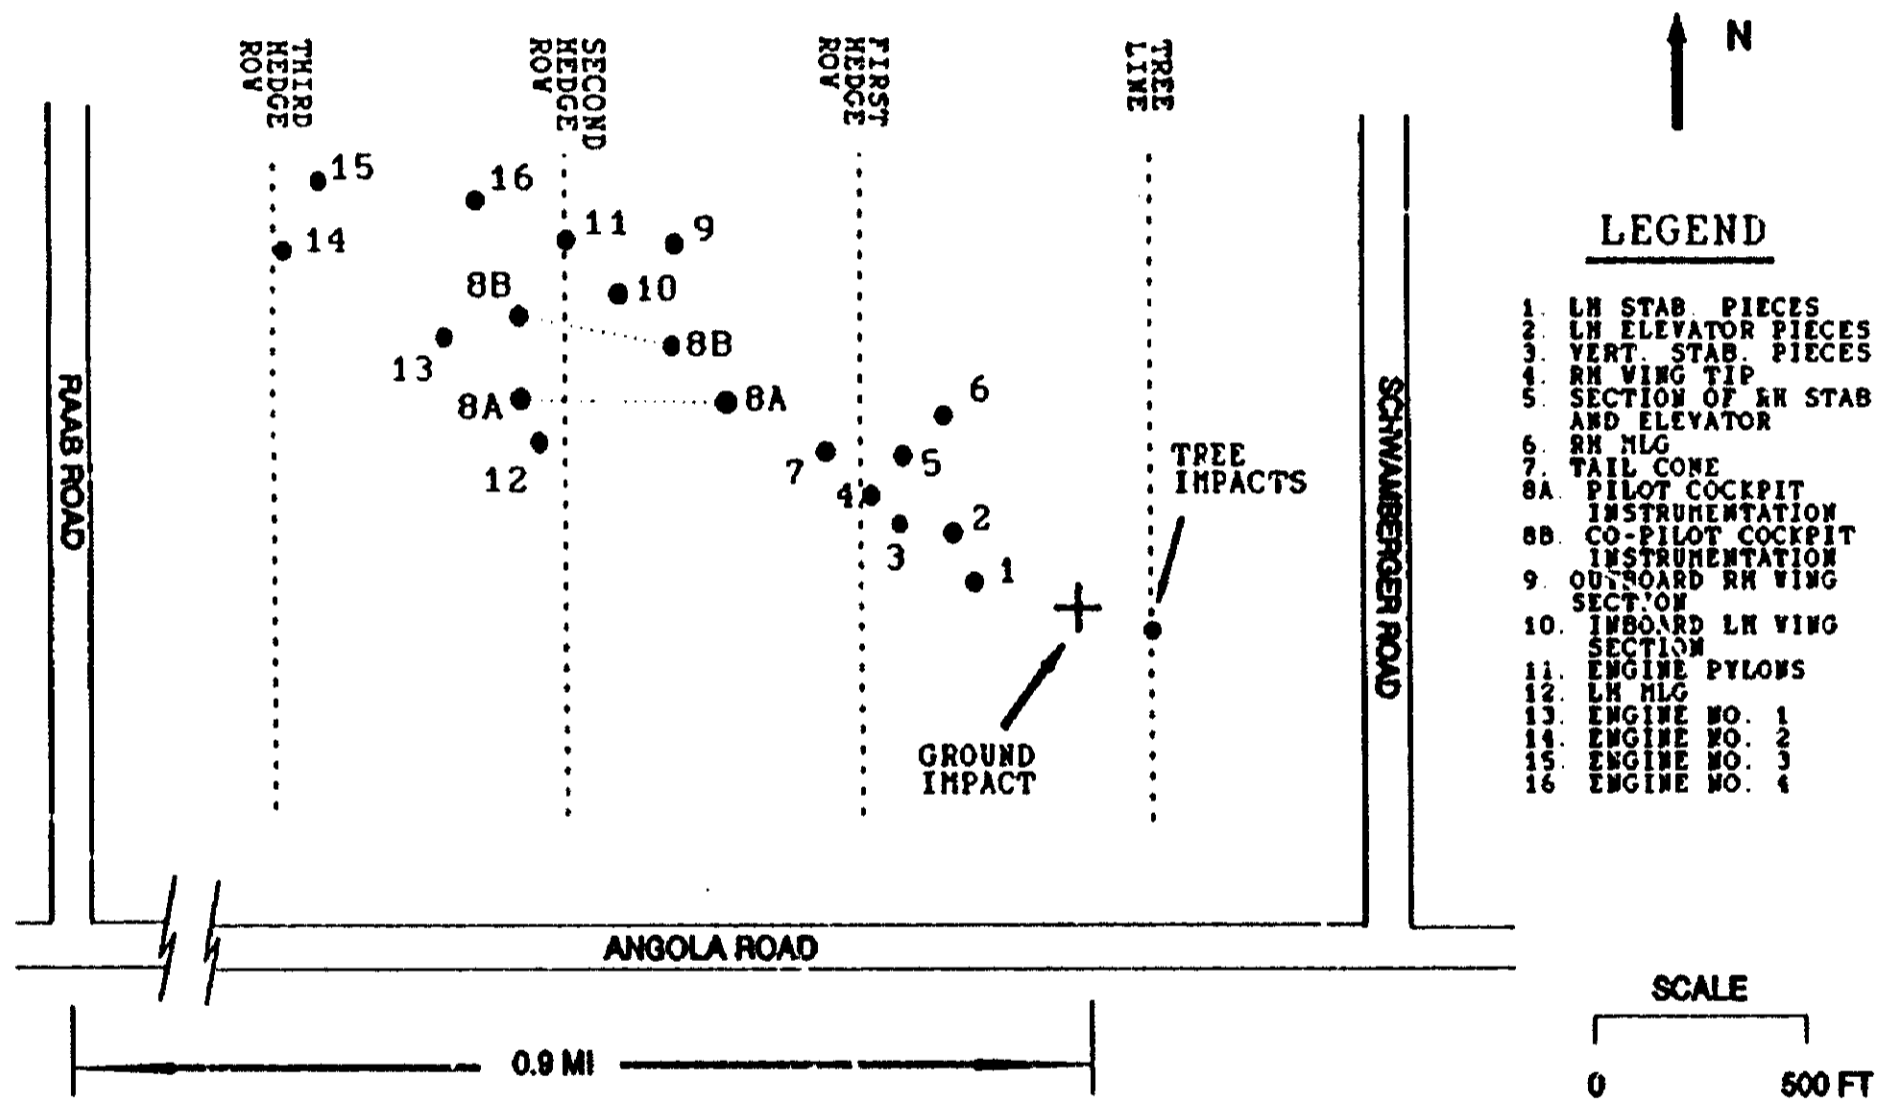
Figure 3.--Wreckage distribution diagram.

Several tree strikes were documented near the location of the initial ground impact site. In the area of the tree impacts, only a few small pieces of wing skin and engine cowling were found. A piece of one of the trees measuring 2 feet in length was found toward the west end of the debris field and was imbedded with several pieces of thick wing skin.

At the initial ground impact site, several ground scars were observed that were consistent with the size and spacing of the left wing tip, No. 1 engine, No. 2 engine, fuselage, No. 3 engine, and No. 4 engine. No initial ground scars were observed outboard of the No. 4 engine indentation. Based on the tree strikes, ground scars, and airplane dimensions, the flightpath angle was estimated at 17 degrees down, and the airplane roll was approximately 15 degrees left wing down.

The tail cone was found approximately 600 feet from the initial ground impact site. The bottom was not crushed and the tail light and lens, which are located on the bottom of the tail cone, were intact.

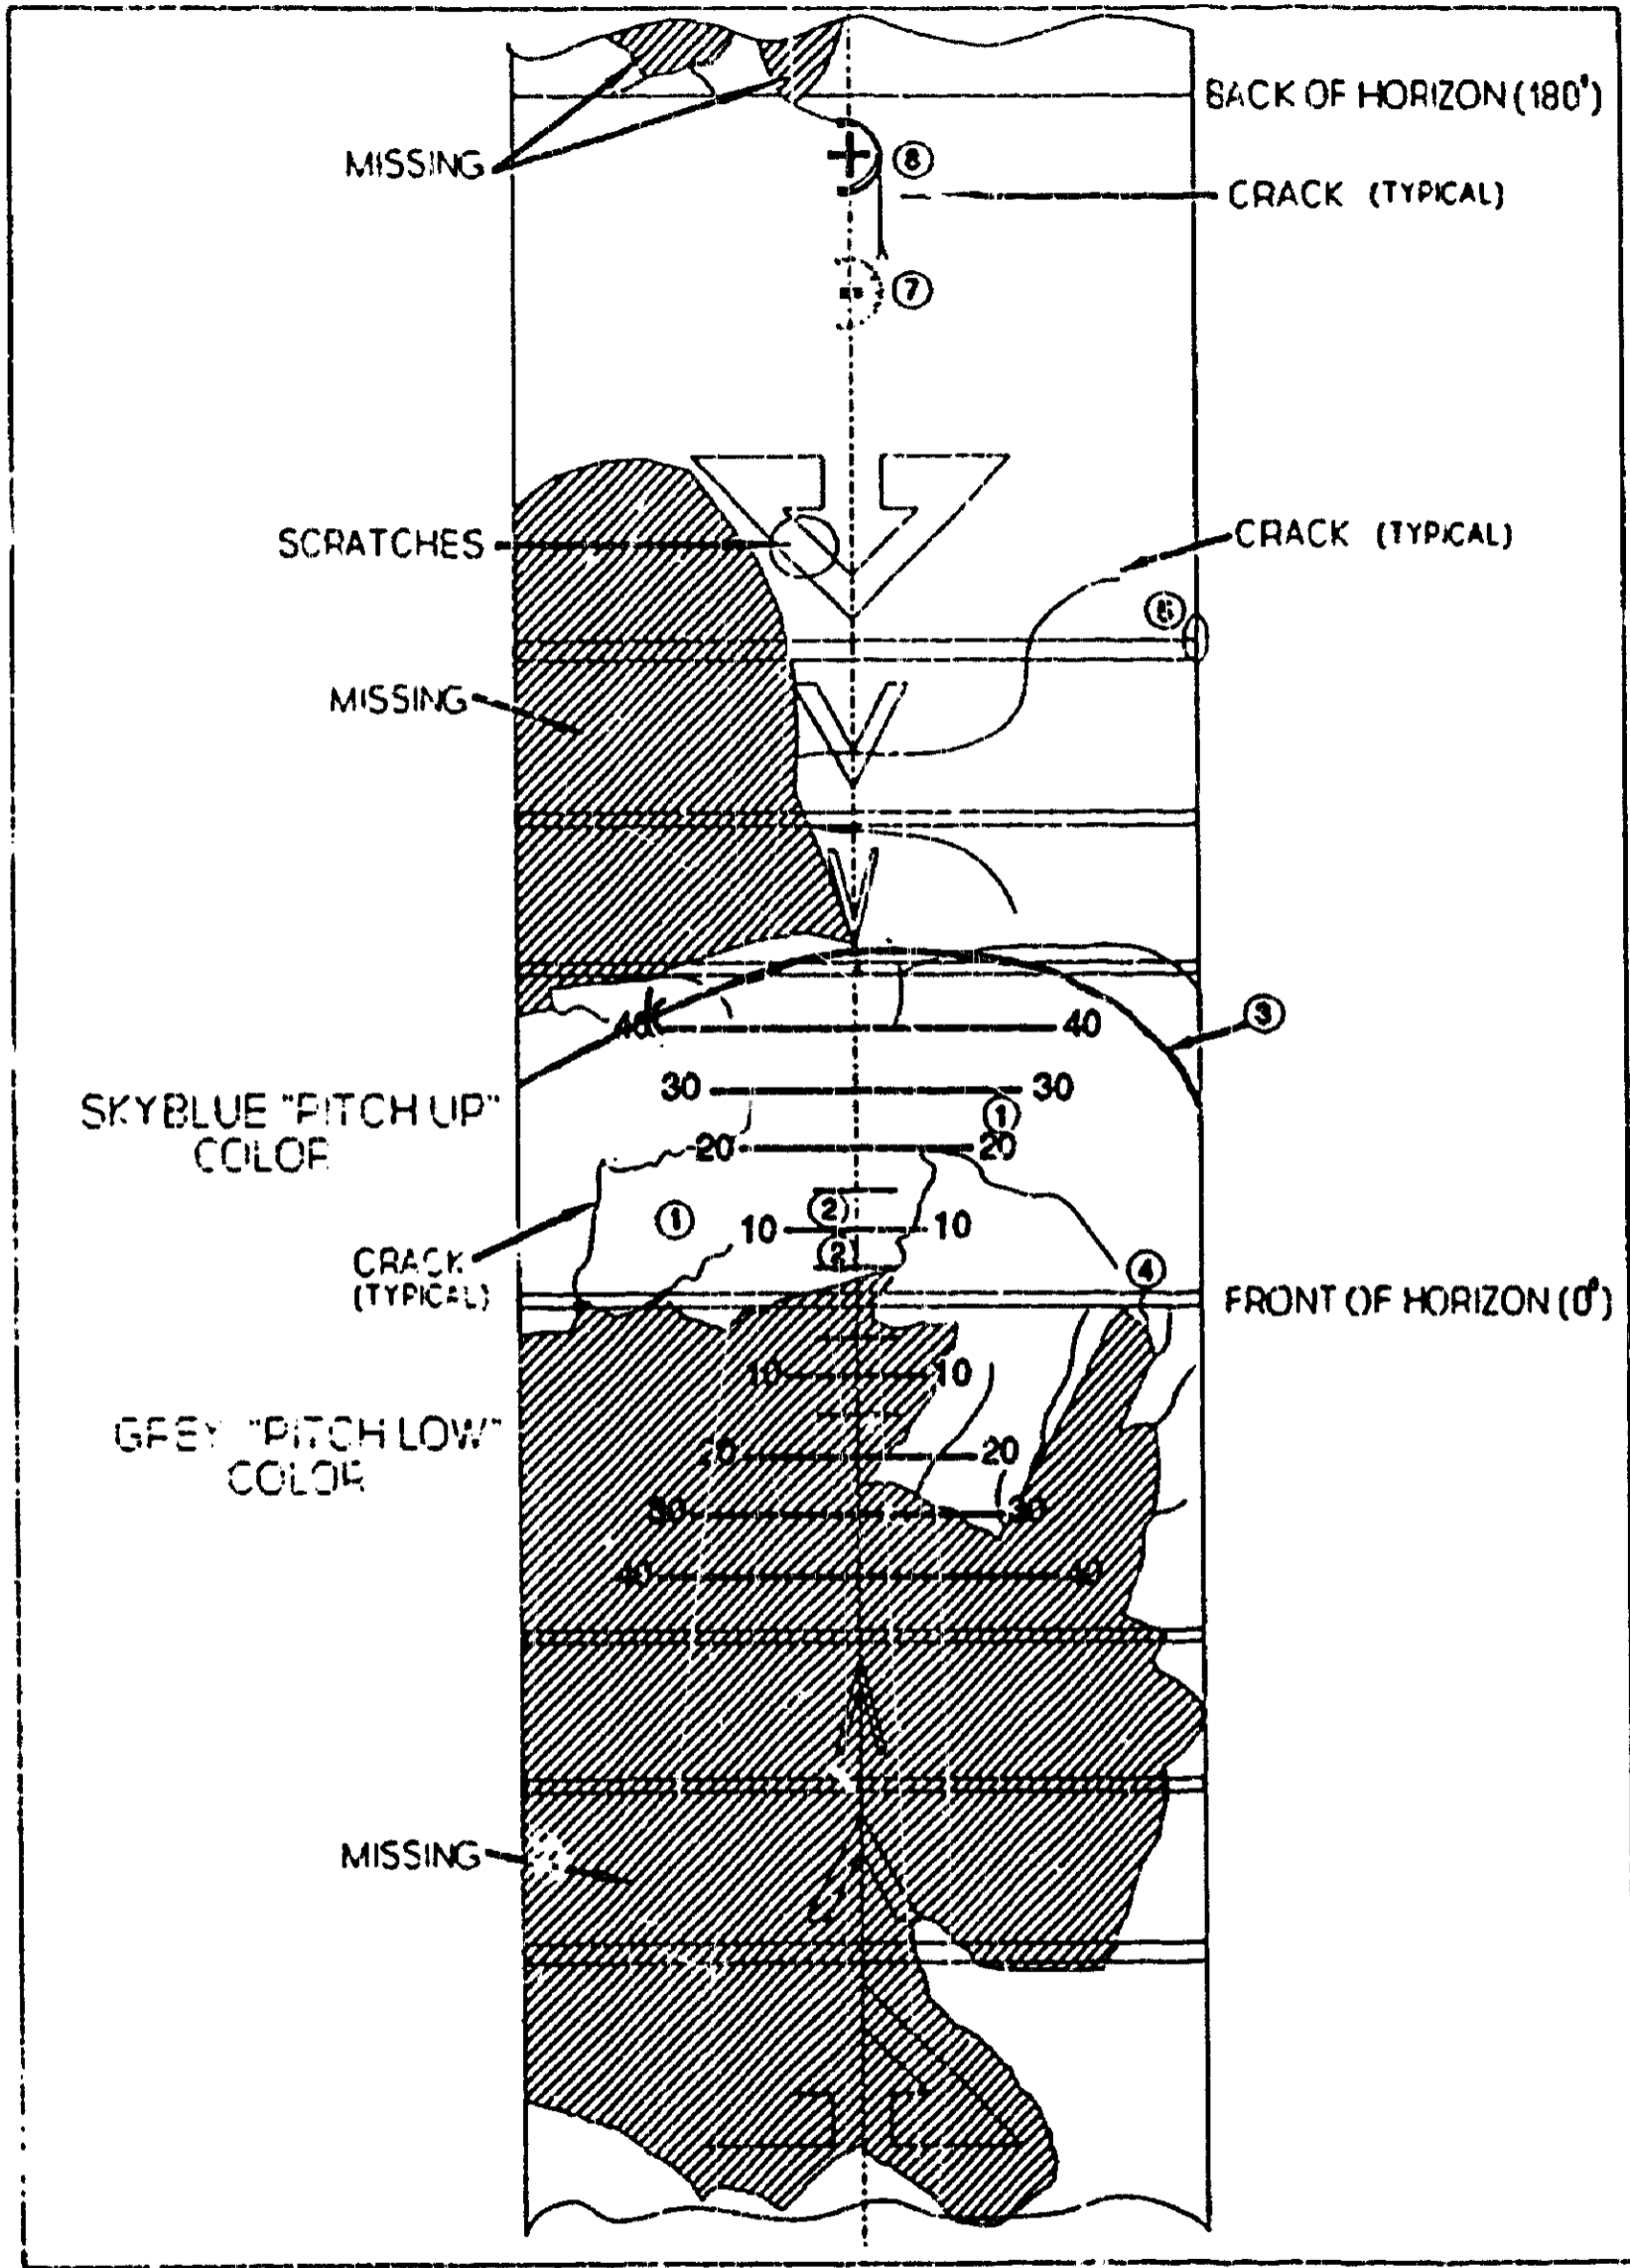
ADI HORIZON BALL MARKINGS AND DAMAGE
(AS UNWRAPPED FROM BALL SURFACE)

12. (Not shown in illustrations) Douglas documents show that the airplane uses internal resolvers within each ADI to compare pitch data. The March 4, 1992, group recorded the resolver position as seized at 53 degrees, 29 minutes A.N.D., which was noted by that group as placing the resolver 90 degrees out of phase with a 36 degree 71 minute A.N.D. electrical position. At the September 9, 1992 meeting, Honeywell personnel stated that in subsequent review, it was realized that the measurement should have been described by the inverse phase, therefore, an indication of 26 degrees, 31 minutes A.N.D. was given as the correct measurement.

Note: Two remaining instrument light filaments were fused to the glass and exhibited massive stretching of individual coils and of the general coil.
