# NATIONAL TRANSPORTATION SAFETY BOARD

TAKEOFF STALL IN ICING CONDITIONS  
USAIR FLIGHT 405  
FOKKER F-28, N485US  
LAGUARDIA AIRPORT  
FLUSHING, NEW YORK  
MARCH 22, 1992

**Adopted: February 17, 1993  
Notation 5732A**

**(NTSB/AAR-93/02 PB93-910402)**

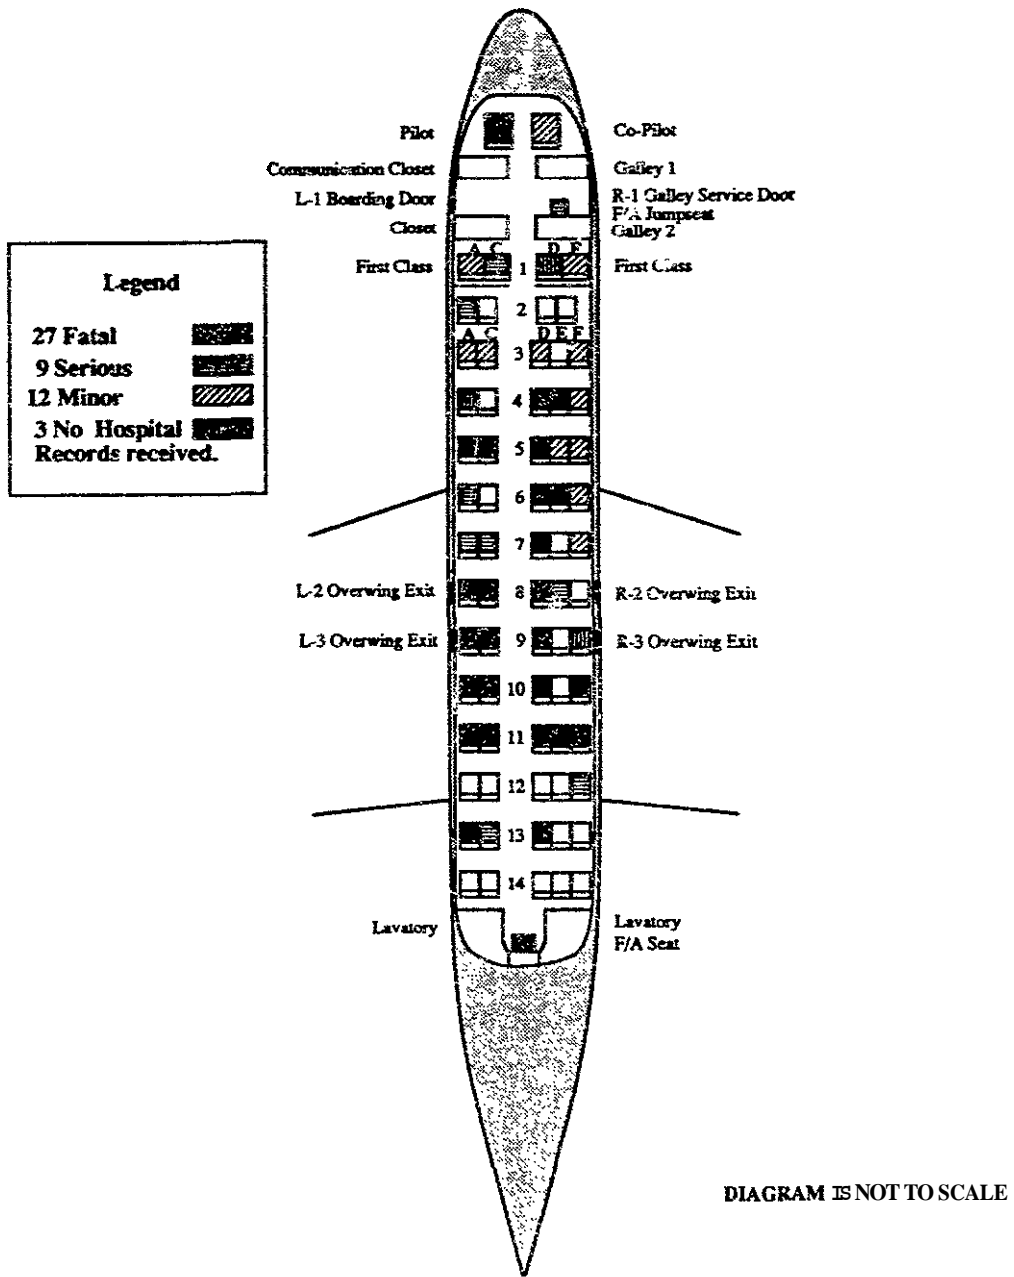
Figure 2.--Cabin diagram and injury information.

The cockpit was of the standard captain and first officer configuration. The cabin was configured into two sections. (See figure 2). The first class section had a forward-facing double occupancy seat unit on the left side labeled 1A, C and one forward-facing double occupancy seat unit on the right side labeled 1D, F, for a total of four seats.

The airplane was equipped with 28 double and triple occupancy seats, 14 on each side of the center aisle for a total of 68 passenger seats; 28 seats were on the left side of the cabin and 40 were on the right side. Nineteen of the 28 seats had separated from the cabin floor and were scattered throughout the wreckage, and 6 of them were fire damaged. The remaining nine seats were not recovered. Of these 19 seats, 10 were from the right side of the cabin and 9 were from the left side. Only one first class seat unit at row 1D, F remained partially attached to the floor.
