AIRCRAFT ACCIDENT REPORT

CONTROLLED COLLISION WITH TERRAIN
GP EXPRESS AIRLINES, INC., FLIGHT 861
A BEECHCRAFT C99, N118GP
ANNISTON, ALABAMA
JUNE 8, 1992

**Adopted: March 2, 1993
Notation 5806A**

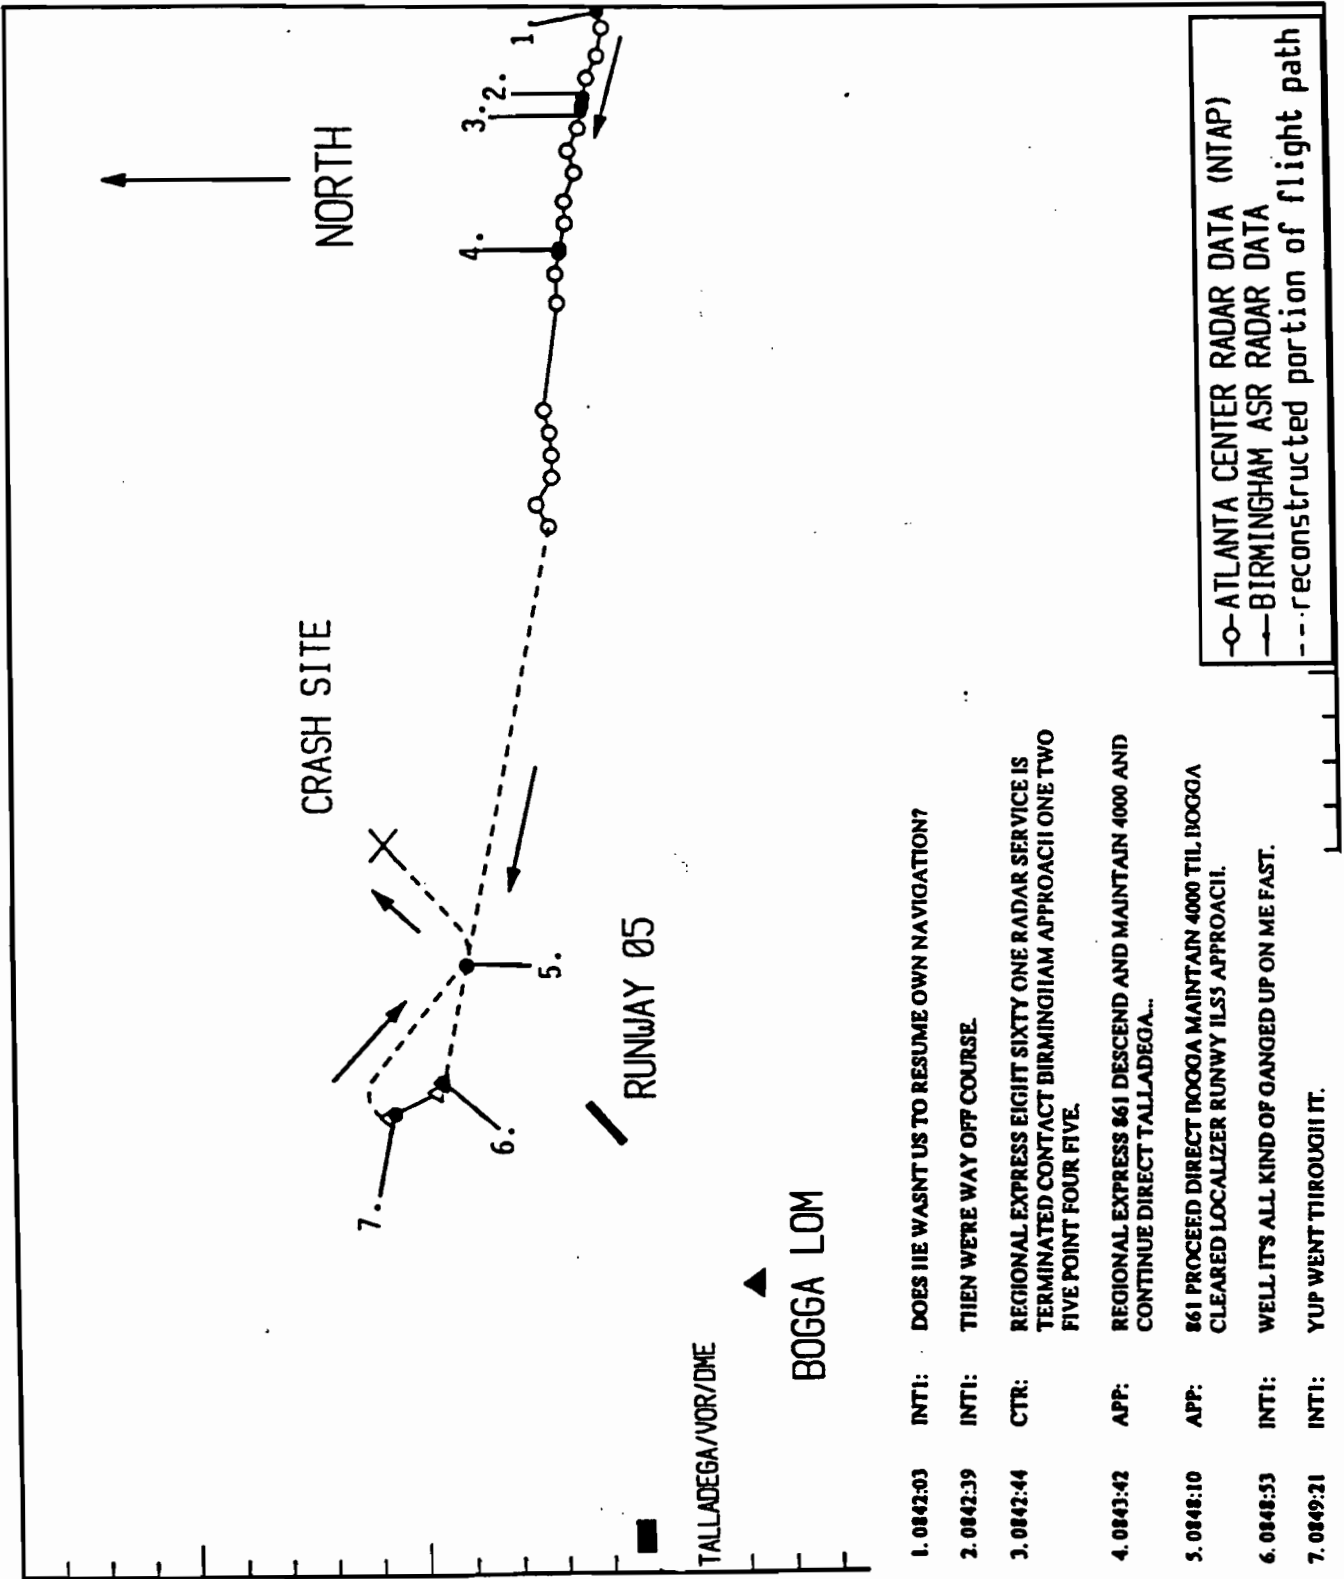
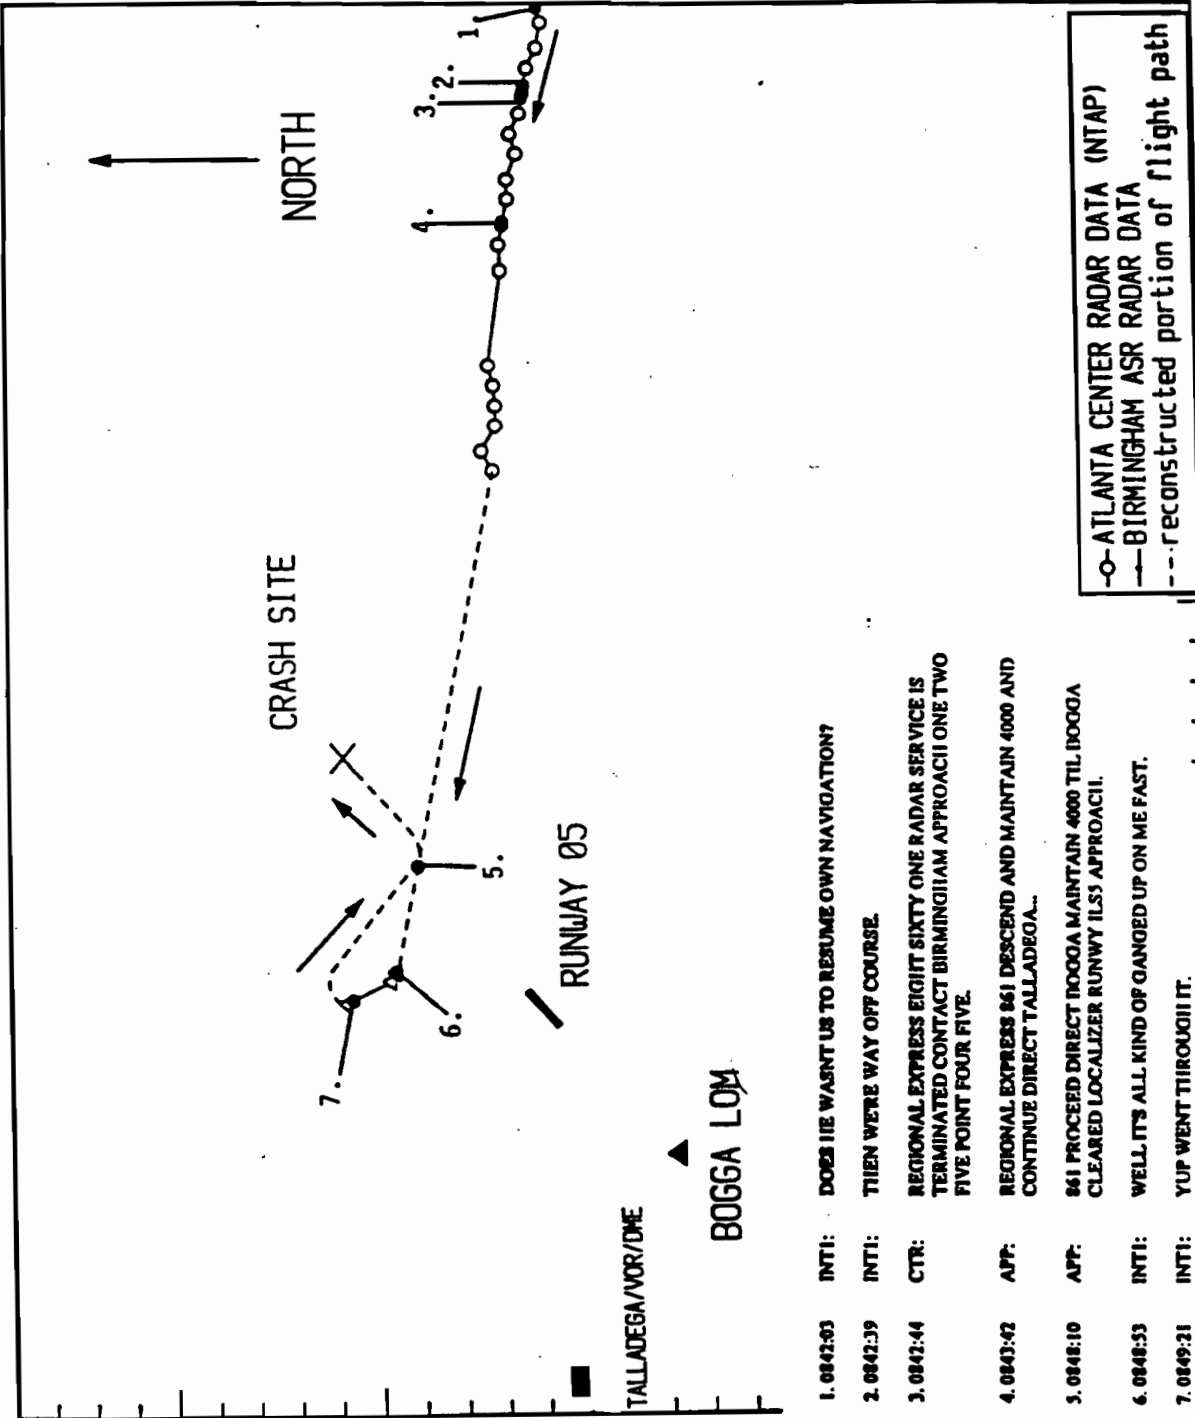
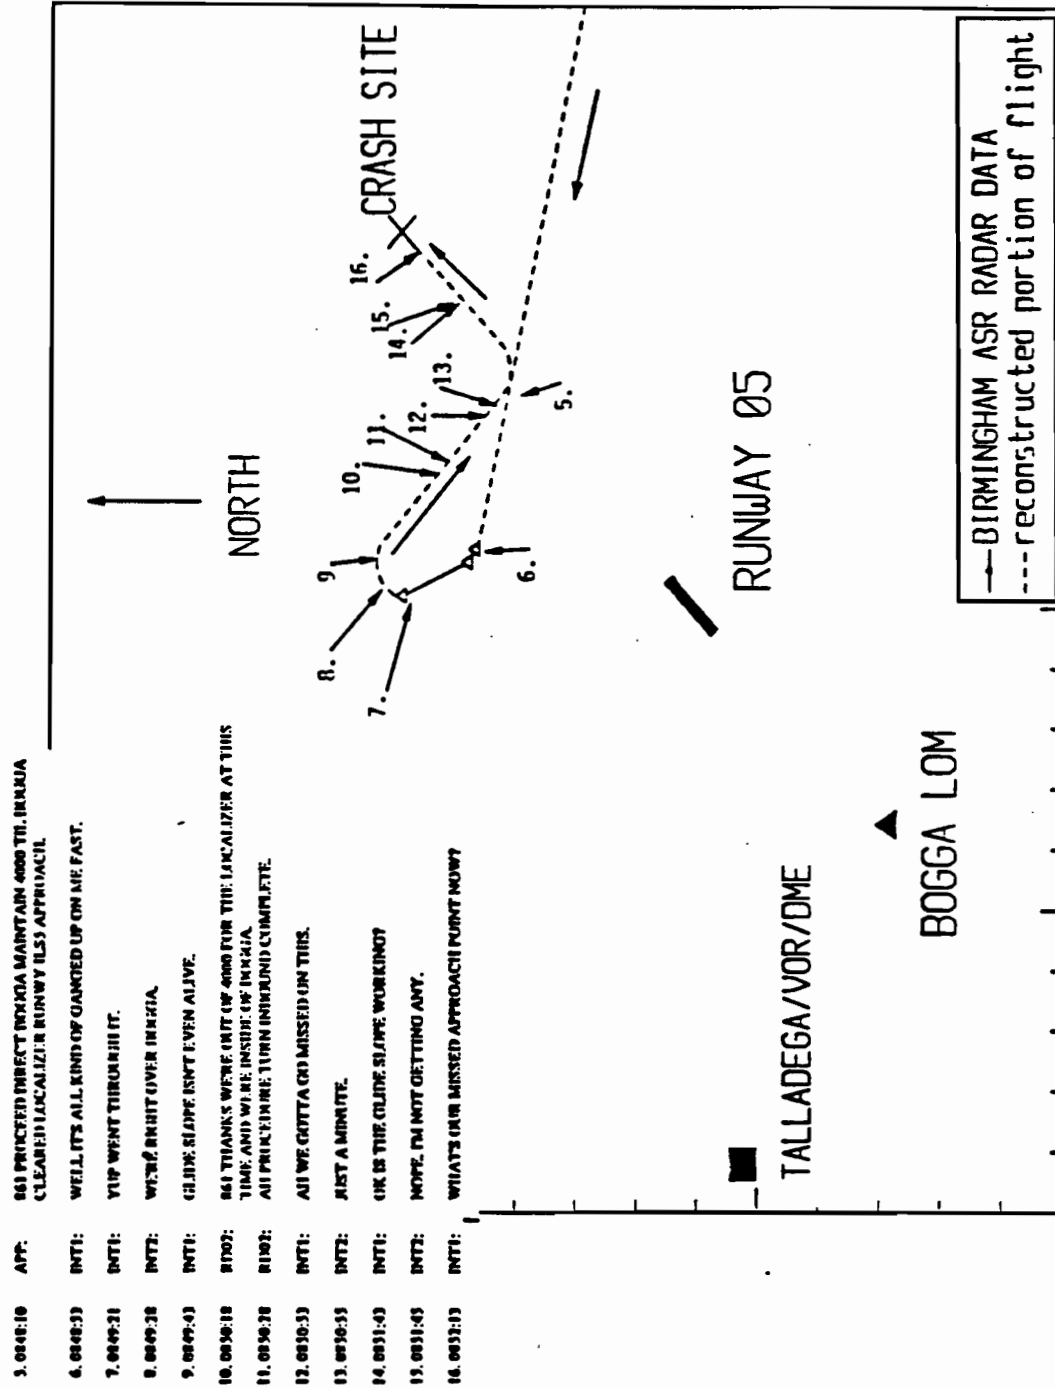
Figure 2a.--Composite ground track of flight 861 with CVR information.

Figure 2b.--Composite ground track of flight 861 with CVR information.
(expanded continuation)

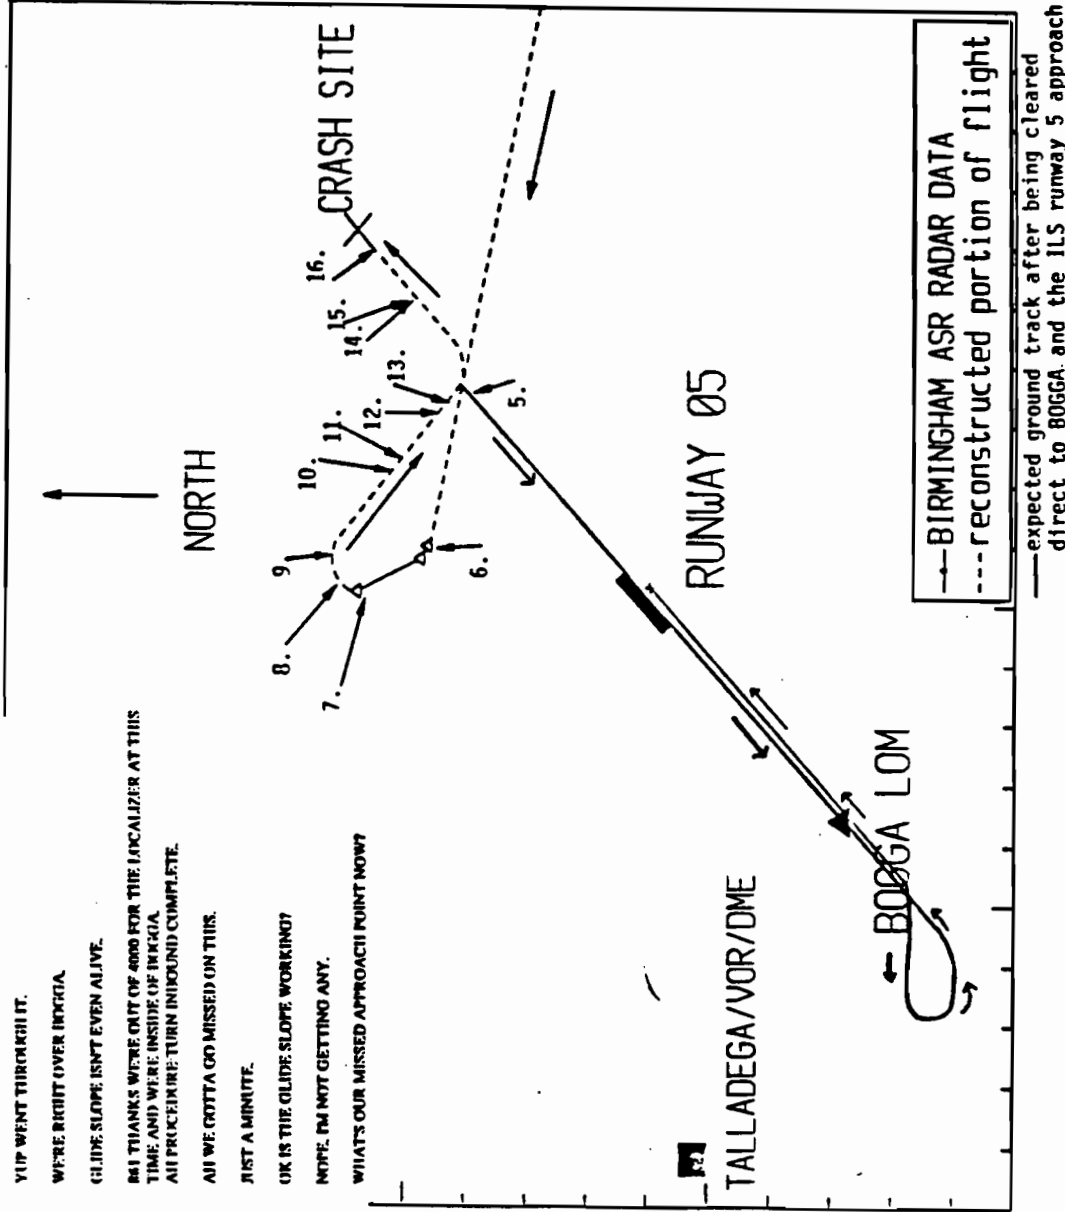
Figure 3.--Expected ground track of flight 861 for the ILS approach.
