NATIONAL TRANSPORTATION SAFETY BOARD

AIRCRAFT ACCIDENT REPORT

**ABORTED TAKEOFF SHORTLY AFTER LIFTOFF
TRANS WORLD AIRLINES FLIGHT 843
LOCKHEED E-1011, N11002
JOHN F. KENNEDY INTERNATIONAL AIRPORT
JAMAICA, NEW YORK
JULY 30, 1992**

**Adopted: March 31, 1993
Notation 5868B**

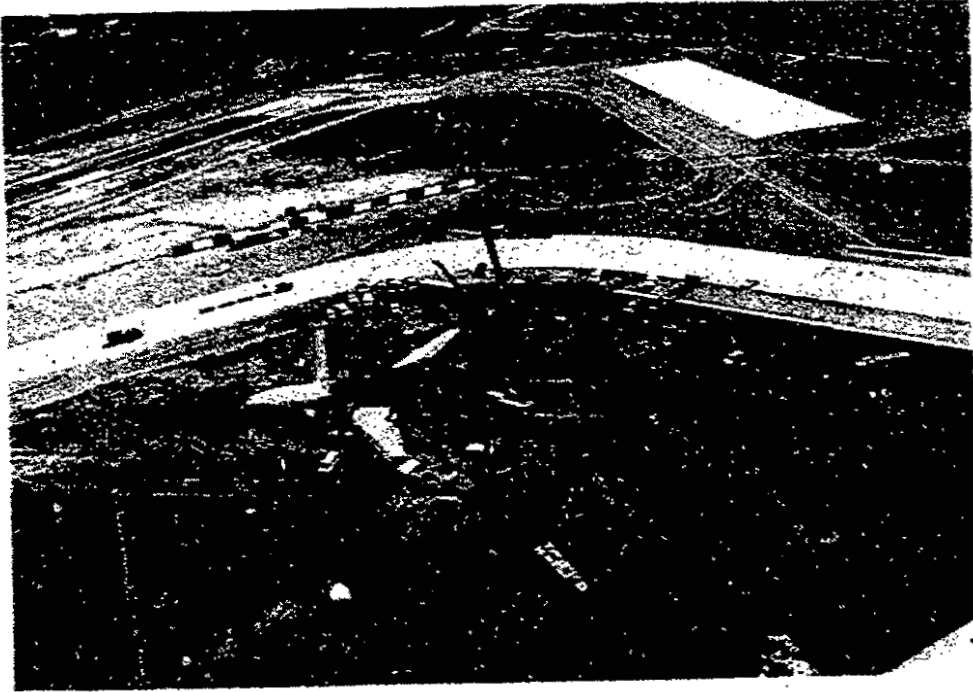
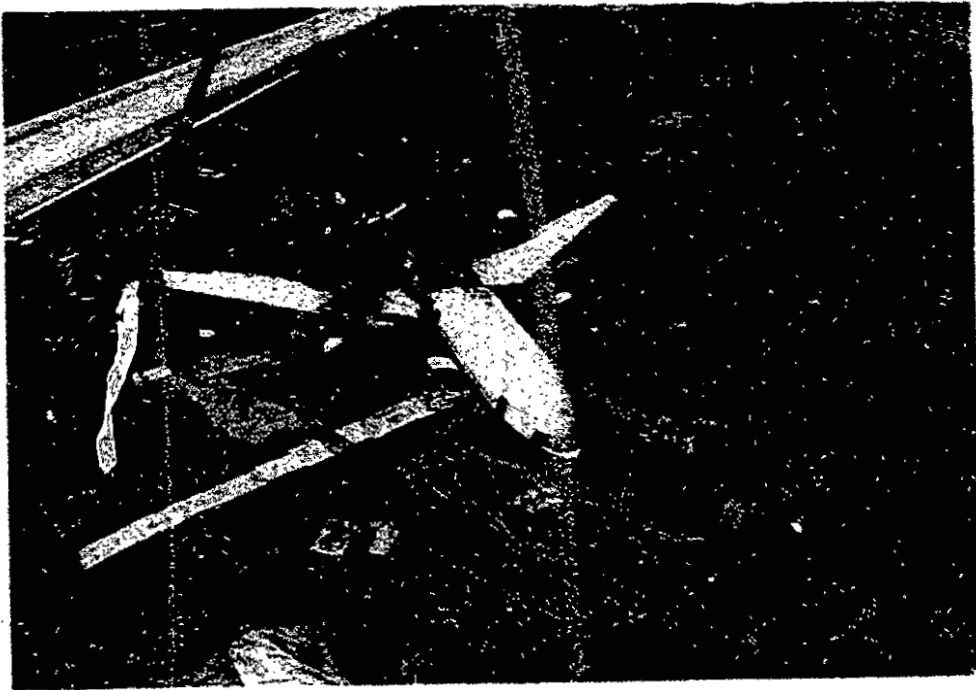
Figure 3.--Airplane wreckage.

Within 2 minutes of the time the airplane came to rest, airport rescue and fire fighting (ARFF) trucks arrived at the site. However, the airplane continued to burn. Before the fire could be extinguished, it consumed the entire aft fuselage, in the area behind the wings and above the cabin floor. The fire also burned through the lower fuselage in two places, so that two sections fell separately to the ground. After the fire was extinguished, the airplane rested on the wheels from the two main landing gear and the structure and skin beneath the forward cockpit and nose. Figures 3 and 4 are photographs of the wreckage.

The airplane was destroyed by fire; however, there was little damage to the fuselage forward of the wing's rear spars. The fire damage was severe in the cabin area, beginning aft of the wing's rear spars.

Intense fire damage existed throughout the empennage. Aft of the forward bulkhead for the coach section, the cabin was substantially burned away. Fuselage skin, frames and stringers were either melted or remained as ash residue, and cabin seats and extensive sections of cabin floor were significantly melted by the fire, leaving a residue of globules of aluminum and ash mixed with the remaining seat and cabin structure. Although the interior of the passenger cabin in the coach class was destroyed, seats forward of the bulkhead between the coach and business class sections were not fire damaged.

After the fire was extinguished, the fuselage remained upright in three large sections. The forward section extended aft to about midway back in the cabin, with this section resting on the wheels of the main landing gear; the second section consisted of the fuselage, from about midway back in the cabin to just before the rear bulkhead; and the third section was comprised of the aft fuselage and empennage, including the rearmost portion of the cabin, as well as the No. 2 engine and engine inlet cowling. The rearmost structure dropped to the ground and rested on the partially burned horizontal stabilizers and underside of the No. 2 engine.

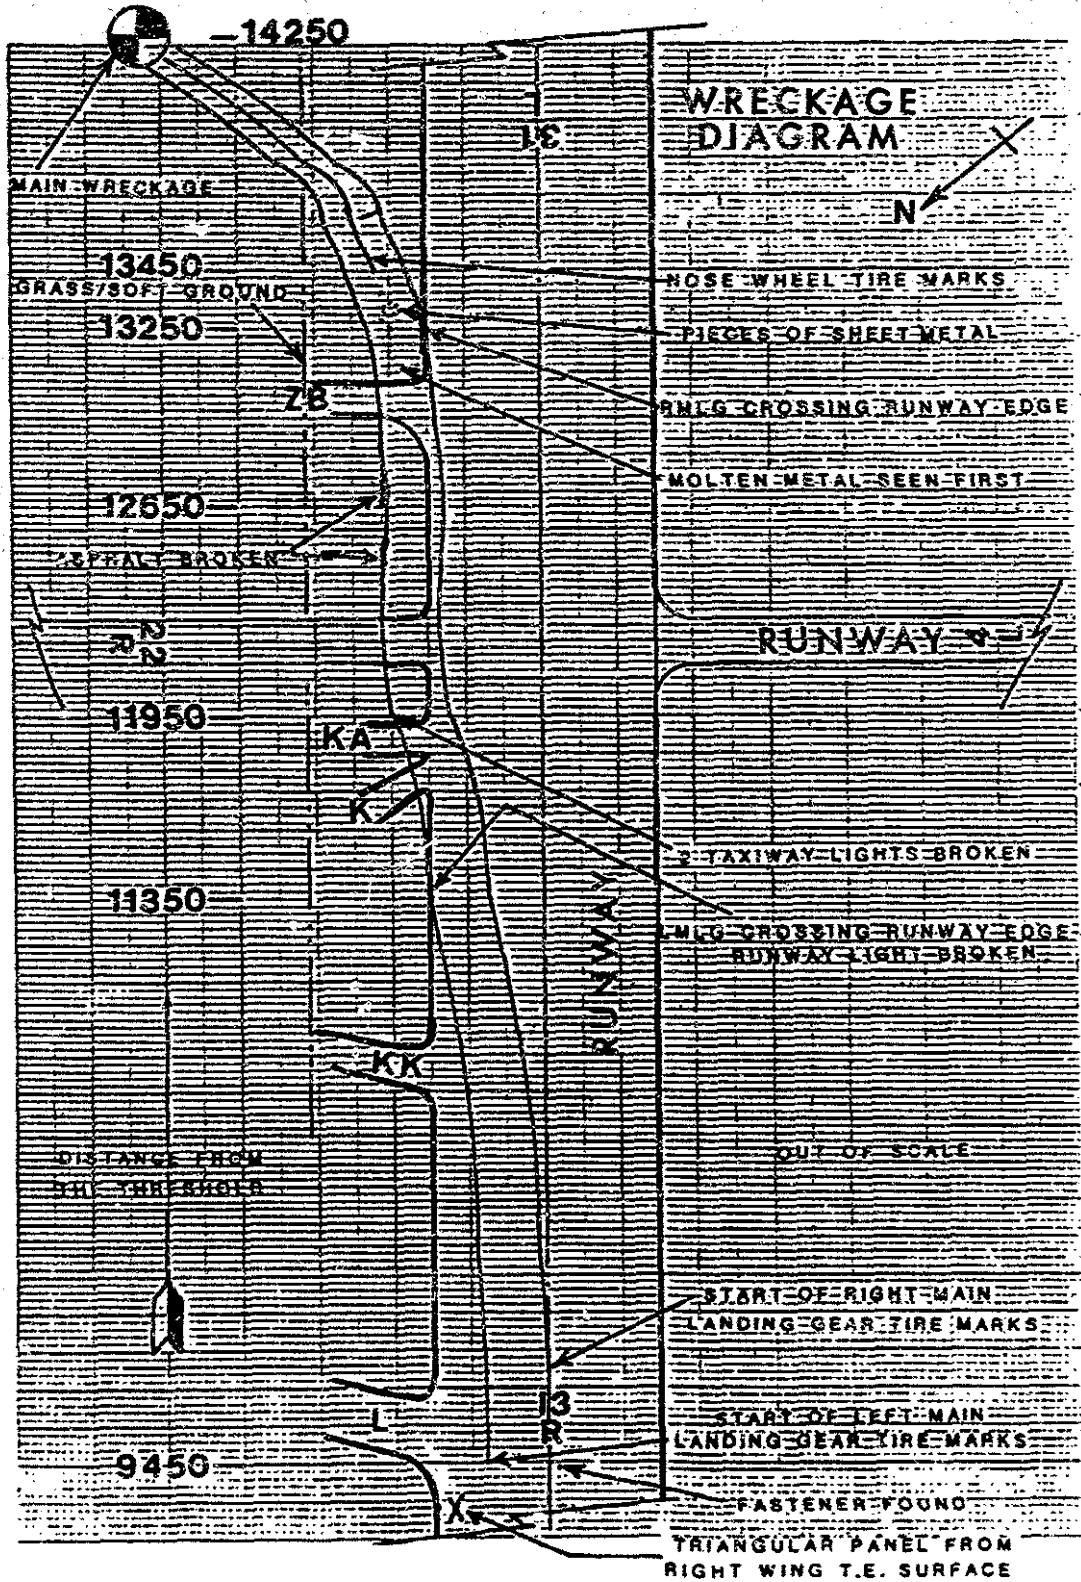
Figure 5.--Wreckage diagram.

Initial contact marks found on runway 13R were a pair of tire marks from the left main landing gear, starting about 9,418 feet from the beginning of the takeoff runway. (See figure 5). They started about 39 feet to the left of the runway centerline and ran approximately parallel to the centerline and later angled off the left shoulder of the runway.

A 24- by 10-inch triangular-shaped piece of skin panel was found about 9,350 feet from the beginning of takeoff runway 13R, or about 70 feet prior to the first set of tire marks. The skin panel, which was found about 10 feet to the left of the runway centerline, was matched to the structure on the bottom inboard side of the right wing of the accident airplane.

A fastener, with an aluminum nut and rubber sealant material attached, was found at approximately the 9,500-foot mark of the takeoff runway. It was immediately to the right of the runway centerline. The fastener was later matched with the fasteners in the rear spar of the right inboard wing.

A large darkened area on the runway, which progressively widened, was found beginning about 13,250 feet from the threshold of takeoff runway 13R. The right main landing gear skid marks ran through the darkened area. These marks increased in intensity and width until they departed the shoulder on the left side of the runway. The darkened area continued to where the airplane came to rest.

Aluminum splatters were found on the takeoff runway, about 13,000 feet from the threshold and 75 feet to the left of runway centerline. Pieces of sheet metal and bits of rubber were found in the blackened area about where the right main landing gear tire marks departed the left side of the runway.

The main gear tire marks departed the asphalt on the left side of the m way at 13,918 and 14,068 feet, respectively, from the beginning of the runway. The ruts continued to where the airplane came to rest. The main wreckage came to rest, burning, 14,368 feet from the beginning of runway 13R, about 296 feet to the left of the centerline at the departure end of the m way.

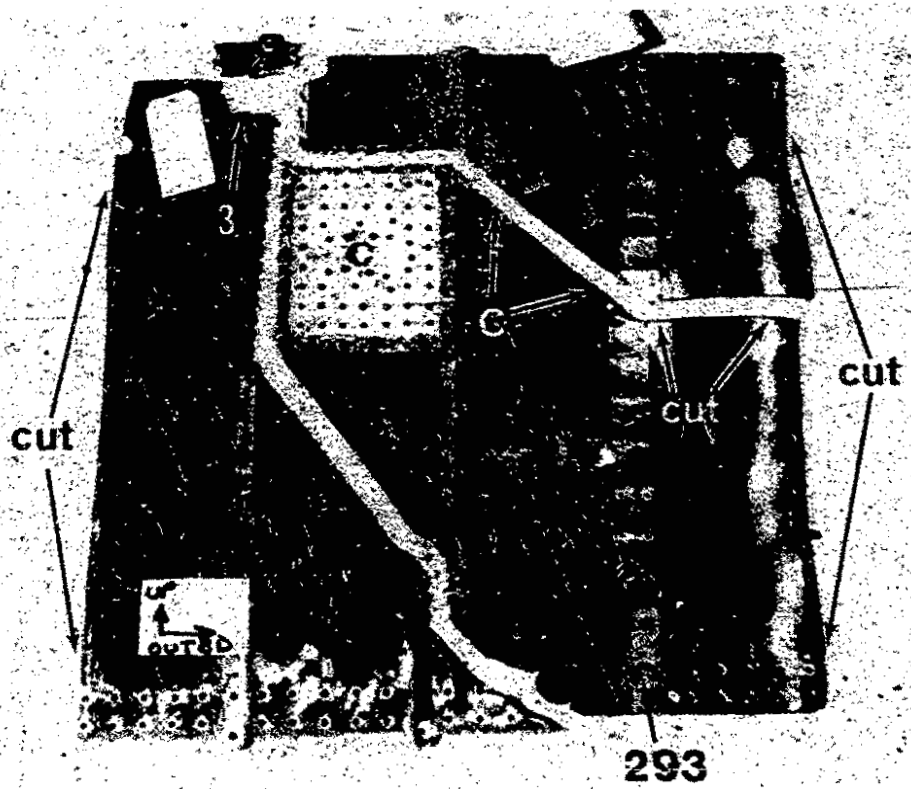
Figure 6.--Right wing spar damage.

The right inboard wing rear spar, which also formed part of the fuel cell wall, was fractured between the right side of the fuselage and the right main landing gear. (See figure.6). Mer the fire was extinguished, fuel continued to drip out of this fracture. The fractures in the right wing rear spar were examined in the field by structural engineers and metallurgists; portions of the spar web were brought to the Safety Board's Materials Laboratory in Washington, D.C., for detailed metallurgical examinations.²

The detailed examinations of the right wing rear spar revealed no evidence of preexisting fatigue damage. All fractures were found to be caused by overstress forces. There Was no fatigue cracking or progressive failure found in the spar web fracture, or in any other fracture in the structure of the right wing, including stiffeners, upper and lower spar caps, stringers, and skin. Hardness and conductivity measurements of the fractured web material produced results consistent with the specified material.

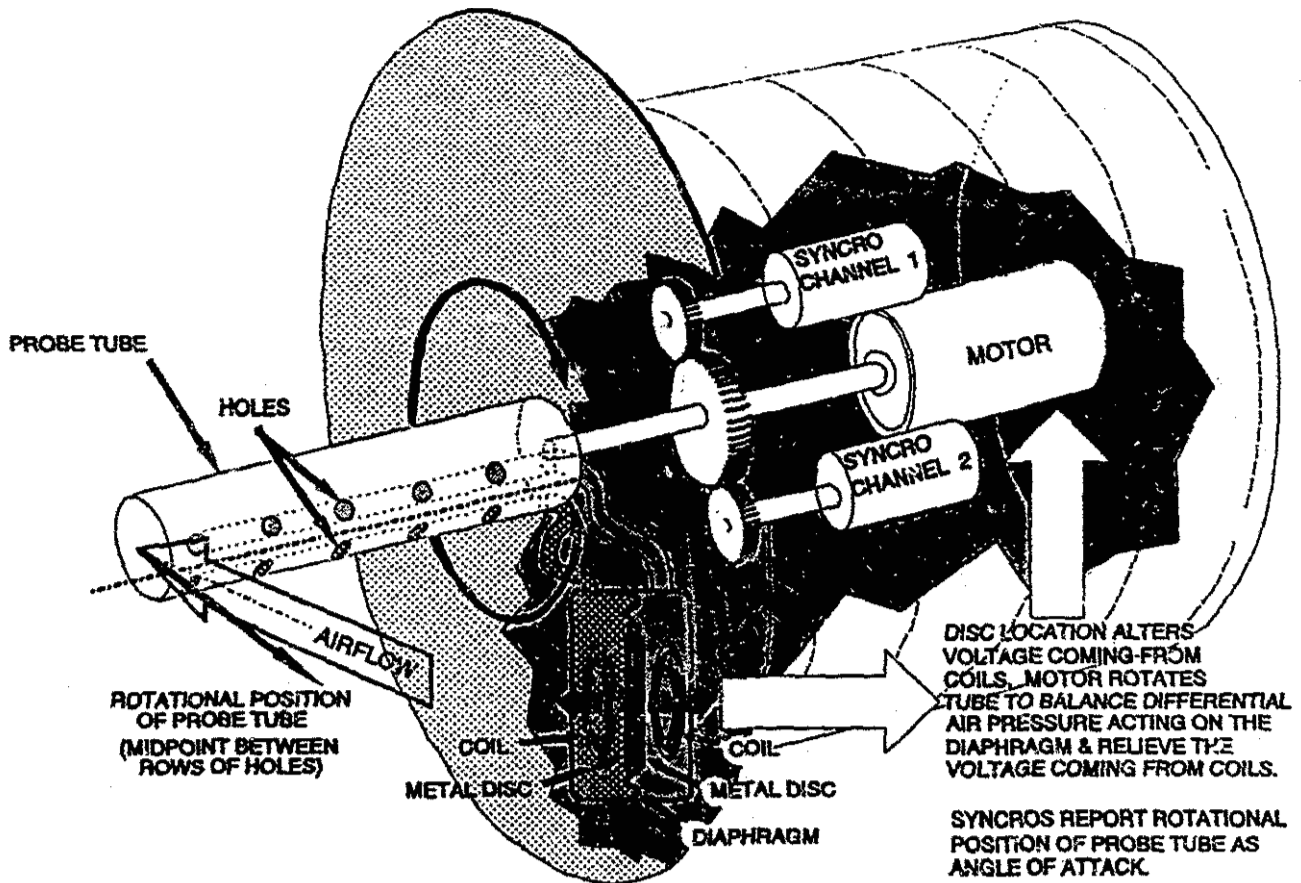
Figure 7.--Angle of attack probe basic components.

The stall warning system components were removed from **N 11002** and tested at the **TWA** maintenance facility. The right **AOA** sensor was also tested at **Sundstrand Data Control**. The left **AOA** sensor was found lightly sooted. The Pitot-static holes were clear, and the electrical pins were straight and clean. All bench tests were passed successfully, except the probe range of travel, which was out of tolerance at the extreme limit.

The right **AQA** sensor was also lightly sooted. All Pitot-static holes were clear, the electrical pins were straight and clean, and there was no evidence of bud strike damage to the right sensor. The probe rotated within maintenance manual tolerances. There was no binding in the probe rotate drive assembly.

The right sensor **was** also bench tested. The sensor **stopped** movement on four **different** occasions and **errors** were recorded at four different **angles**. Although the errors in AOA **position** were found in **two** FDR recordings and in **two** ground tests, the accident **flight** had the only error sufficient to reach the documented stickshaker limits.

When power was first applied to the right sensor, the **AOA signal** changed rapidly and a failure was **indicated** after **10** seconds. Power was then cycled **off** and **on**. The sensor again **indicated** a failure after **10** seconds. When **electrical** power was cycled again, the probe **operated** normally without another failure indication. Attempts to **induce** a failure by gently **moving** the internal **wiring** were unsuccessful. The probe successfully passed **all** tests after the **initial** failures.

Upon further evaluation at Sundstrand, it was found that **tapping** on the **internal** pressure transducer could **cause** an **intermittently false** value of **AOA**. Subsequent taps on **this** transducer caused the unit **to** report the correct AOA. The observed failure created a **4-degree** error in the reported **AOA** but not the sticking at 24.1 degrees, **as** seen in the accident **FDR data**. The investigation concluded that the "failure **was** due to **intermittencies** in **coil** of pickoff."
