# RAAD VOOR DE LUCHTVAART

AIRCRAFT ACCIDENT REPORT  
93-01

PALAIR FLIGHT PMK301,  
FOKKER 100, PH-KXL,  
SKOPJE, REPUBLIC OF MACEDONIA  
MARCH 5, 1993

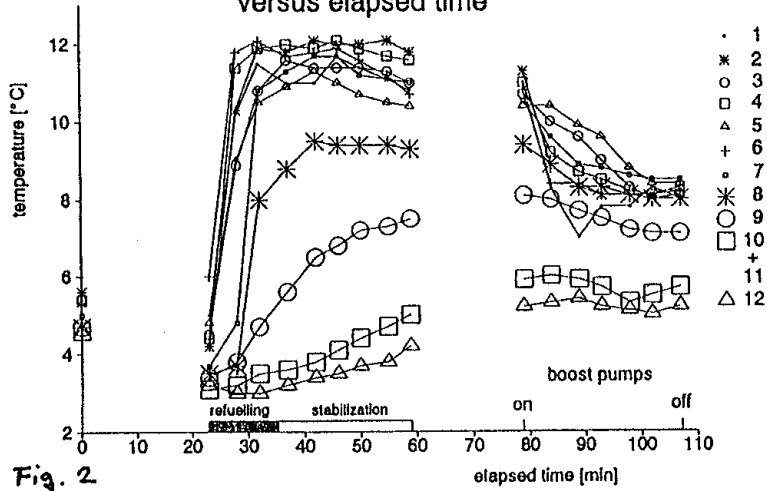
Fig. 2

It appears that immediately after start of refuelling, the locally measured wing skin temperatures of the CT and MT1 increase rapidly. Not only the skin attached to the hollow stringers - through which fuel is passing - shows a temperature increase, but also the skin attached to the "leaky" plugged stringer channels. The probes on MT2 respond also, but slower and to a lower temperature. Of the probes on MT3 only the probe next to rib WS 8200 shows some response. This indicates that the warming effect of the added fuel does not extend significantly into MT3. The probes on the CT and MT1 reach a maximum temperature during the refuelling and these temperatures remain fairly stable for quite some time. The maximum recorded skin temperatures remain below the "bowser" temperature in this test.

A significant effect can be seen to occur after switching the booster pumps on. Due to the mixing of the fuel in the CT with that from MT1, the upper skin temperatures drop again rapidly to approximately the ideally mixed temperature level. There is again little effect on the skin temperatures of MT3. Another significant detail is that temperatures recorded at the drain valves indicate that there can be significant temperature difference between a tank top and bottom.

### RH wing skin temp. distribution versus elapsed time

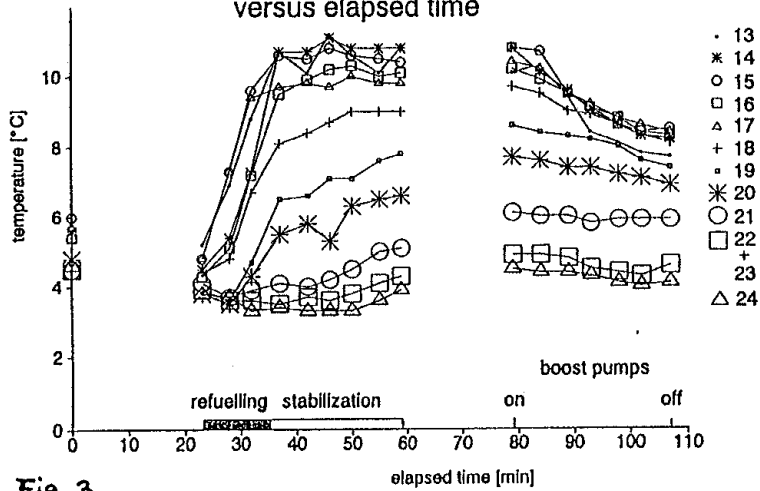
Fig. 3

### LH wing skin temp. distribution versus elapsed time

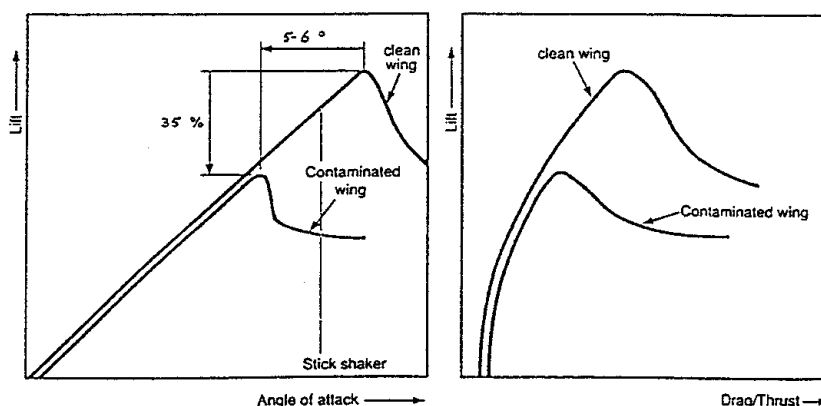
The aerodynamic effects represented in the simulation test on the Engineering Flight Simulator are summarized below (See also figure 5 below):

- Reduced  $C_{Lmax}$  relative to the clean wing.
- Reduced  $\alpha$  at the moment of maximum lift relative to the clean wing.
- Significant decrease of  $C_L$  with increasing  $\alpha$ , just prior to reaching  $C_{Lmax}$ .
- Significant increase in drag at an  $\alpha$  higher then the  $\alpha$  for  $C_{Lmax}$ .
- Change in the aircraft aerodynamic moments (pitch, roll and yaw).
- Effects on the elevator hingemoments and elevator effectiveness (Related to contamination on the horizontal stabilizer).

Fig. 5 Typical effect of wing contamination on aircraft lift and drag

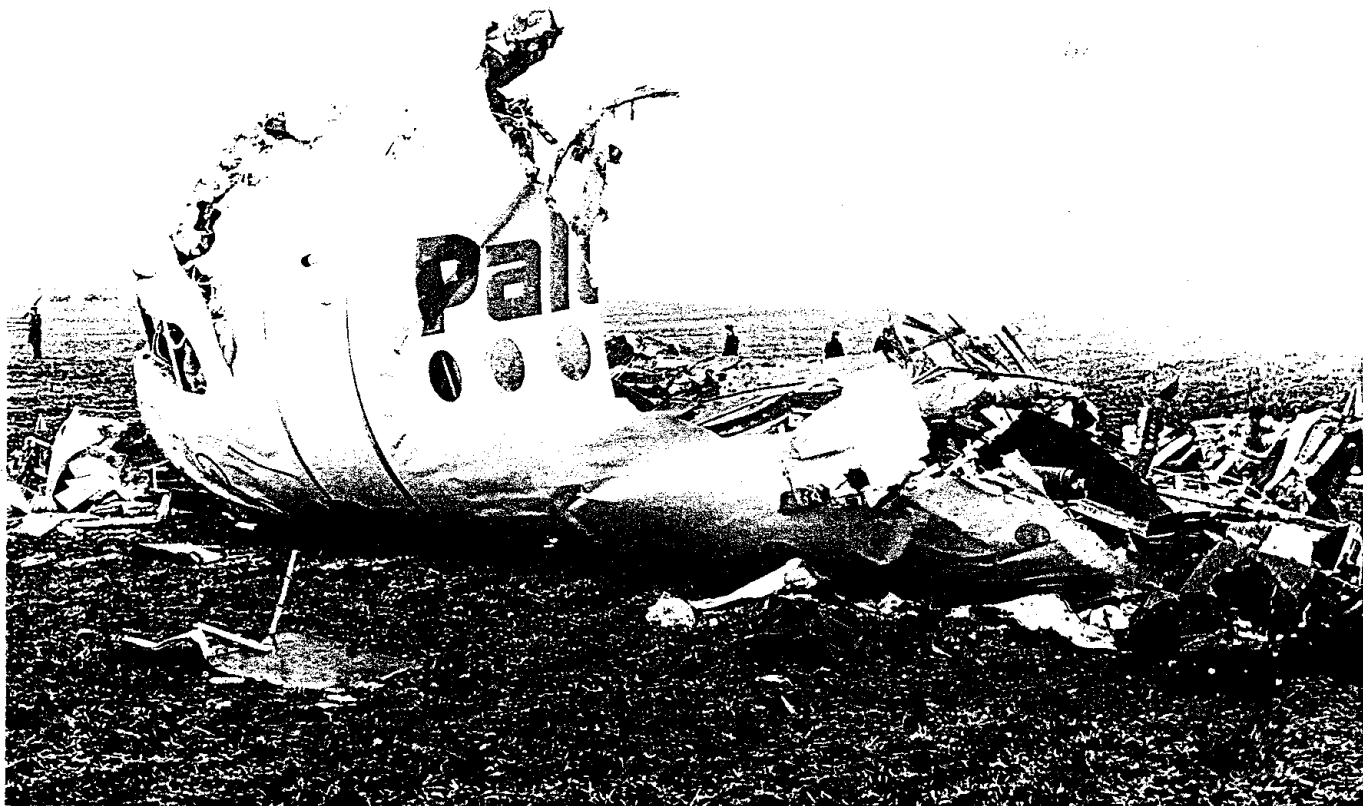
Cockpit and forward cabin section

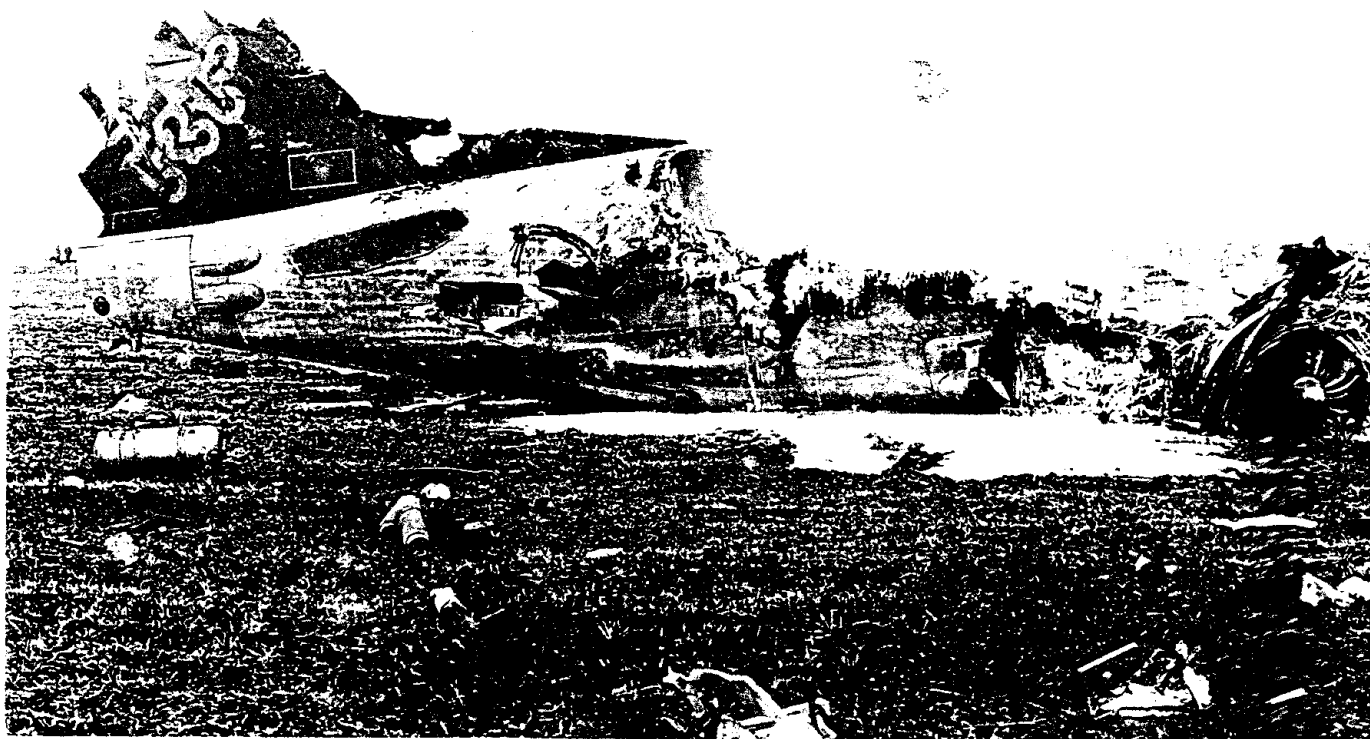
Tail and aft cabin section

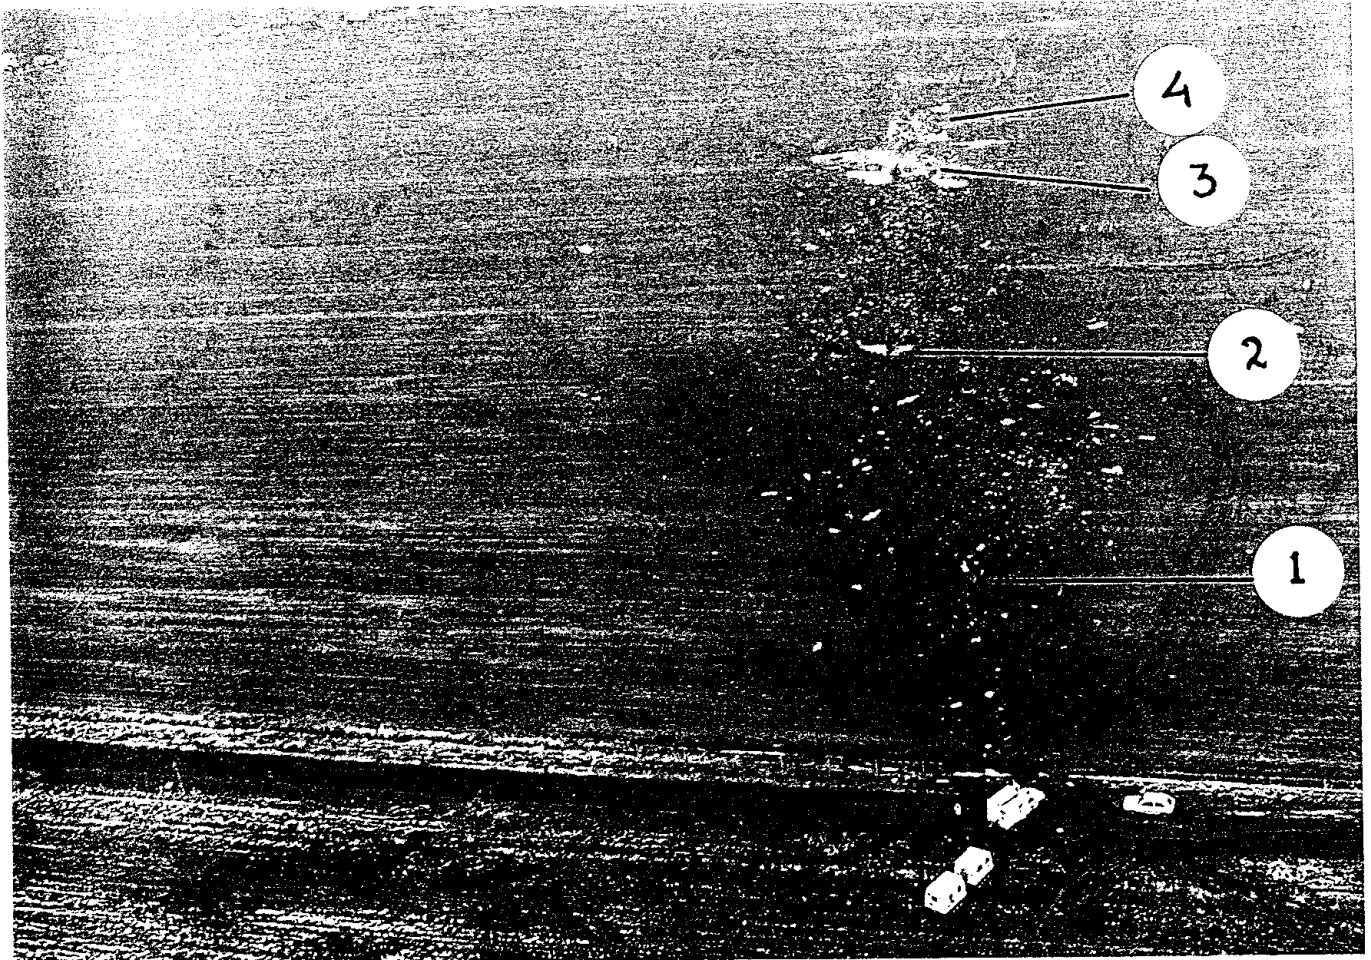
PHOTOGRAPHS

Appendix 1 contains some photographs of the wreckage. The wreckage was primarily distributed over an area with a length of 220 meters and a width of 40 meters. The fuselage was broken in three major parts, i.e. the cockpit and a part of the fuselage, a mid part ending before the wing, and the aft fuselage. Of the cockpit and mid-fuselage parts, the right side had disappeared. Of the aft fuselage, the cabin part was destroyed by fire.

1. Main impact area
2. Stabilizer and top of fin
3. Tail and aft cabin section
4. Cockpit and forward cabin section

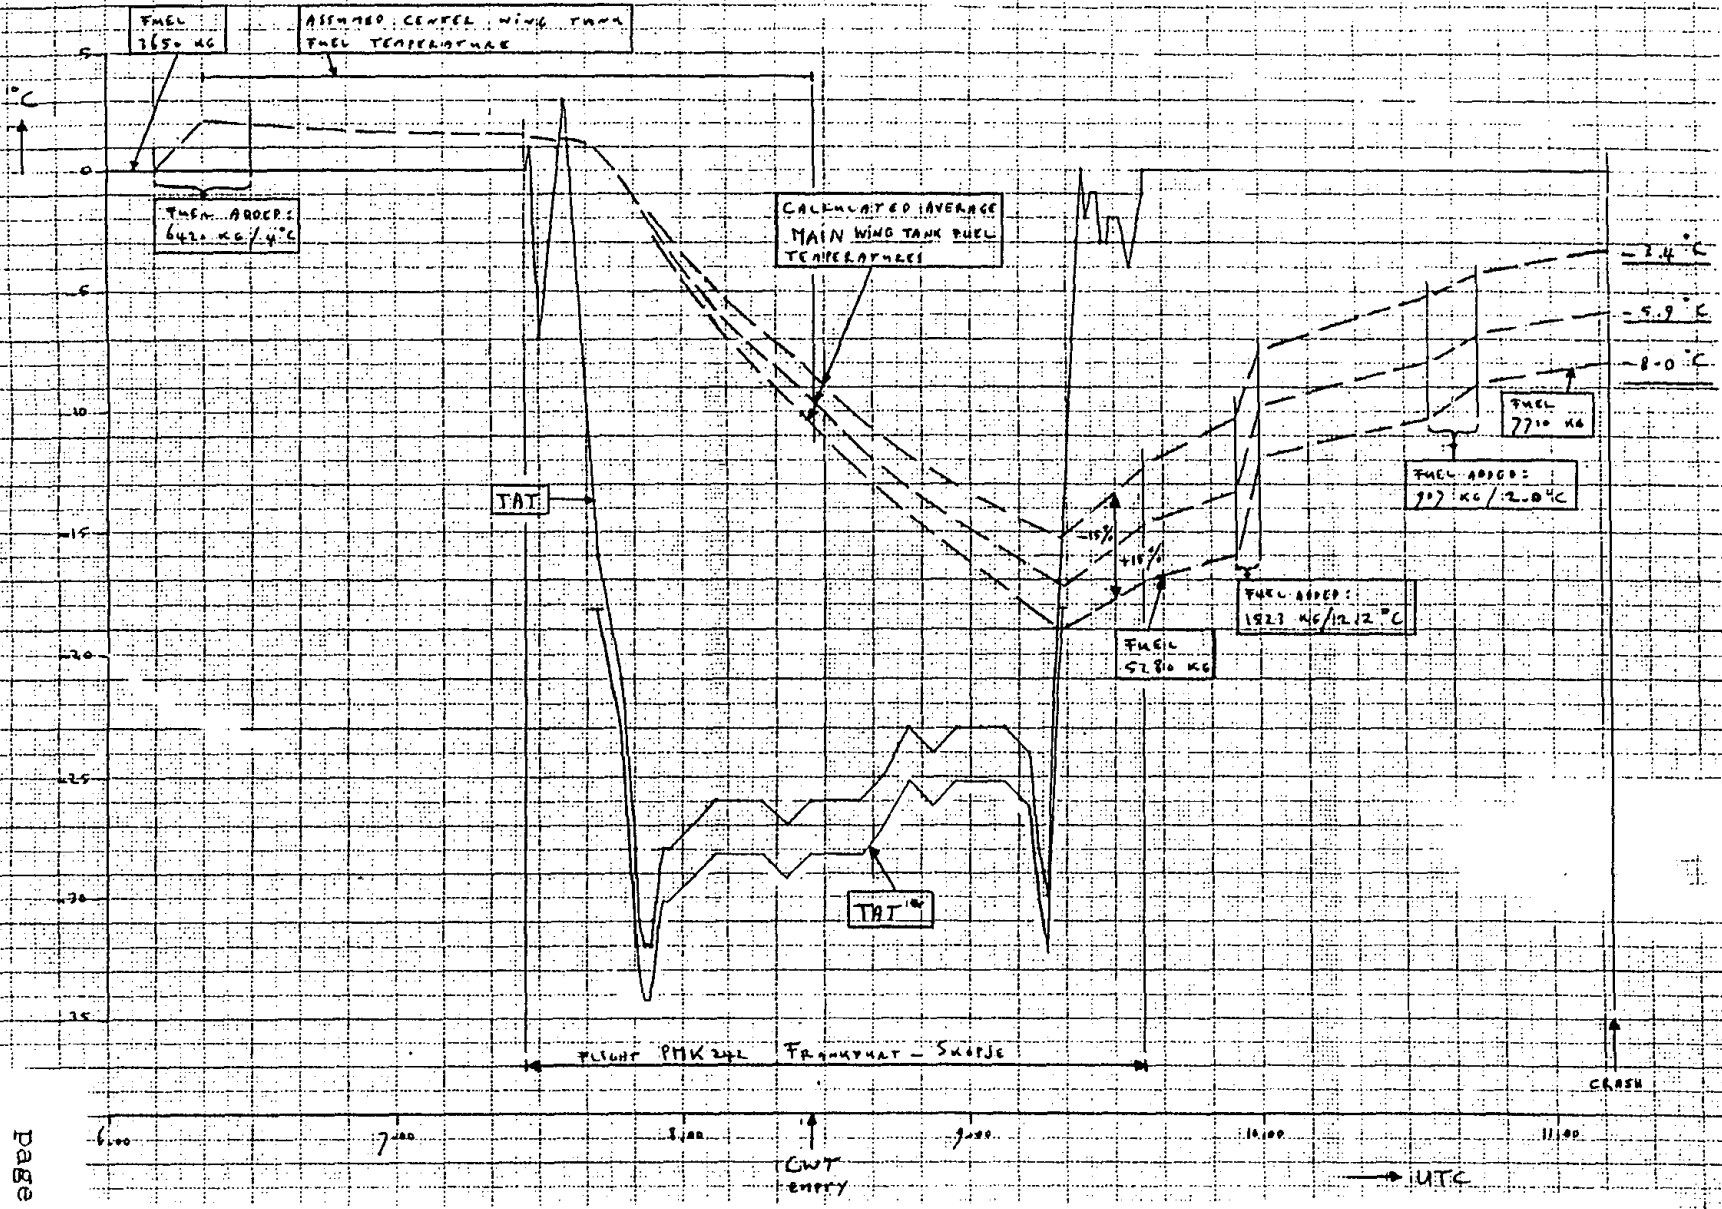
Figure 3 - Calculated fuel temperature changes in the hours prior to the crash
