NATIONAL TRANSPORTATION SAFETY BOARD

AIRCRAFT ACCIDENT REPORT

IN-FLIGHT ENGINE SEPARATION
JAPAN AIRLINES, INC., FLIGHT 46E
BOEING 747-121, N473EV
ANCHORAGE, ALASKA
MARCH 31, 1993

**Adopted: October 13, 1993
Notation 6081A**

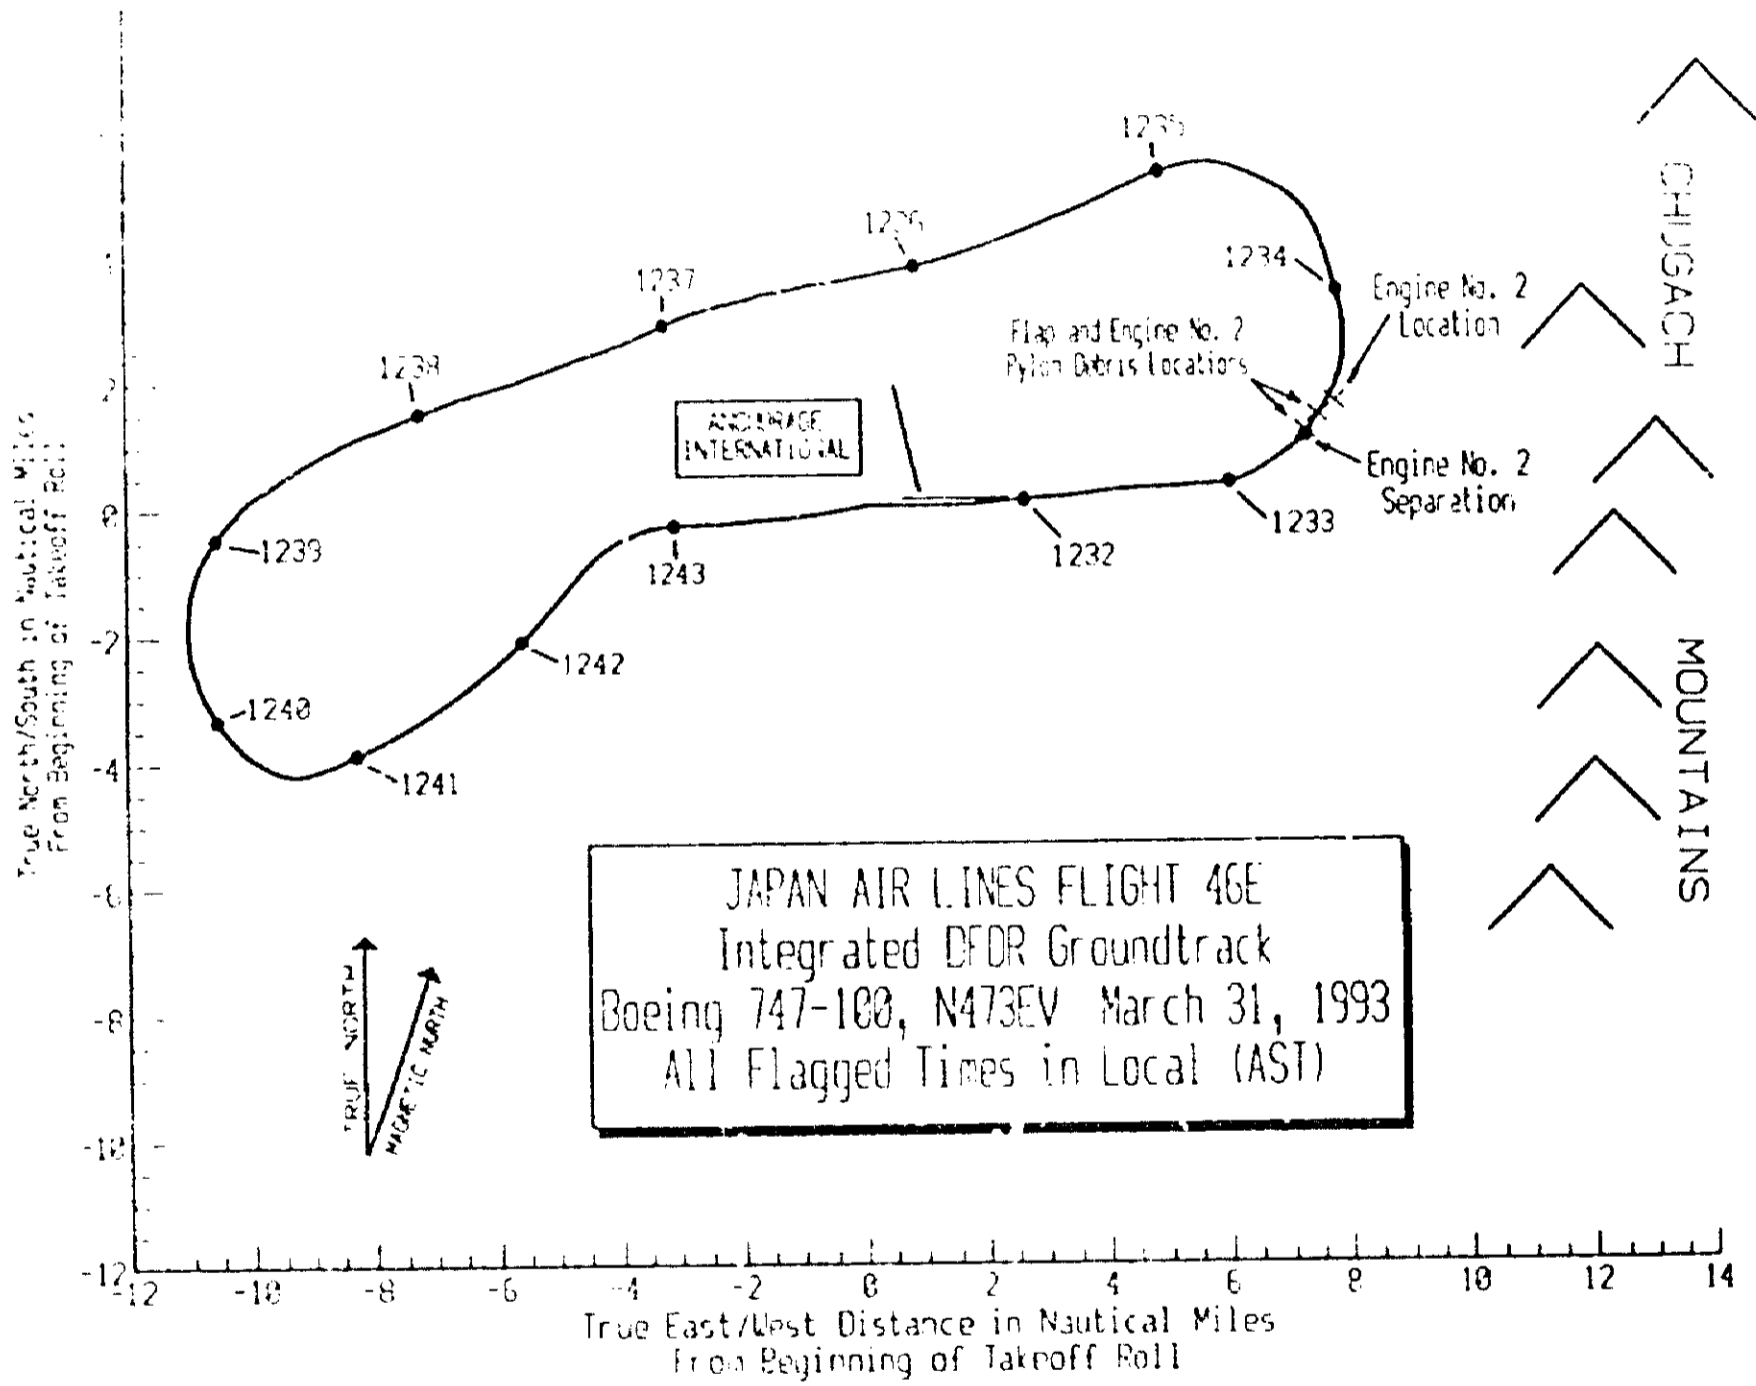
Figure 1.--Flightpath and wreckage location.

Several private dwellings, automobiles, and landscaping were damaged by the impact of the No. 2 engine and various parts of the engine pylon and wing LEDs. Figure 1 is a diagram of the airplane's flightpath and the wreckage location.

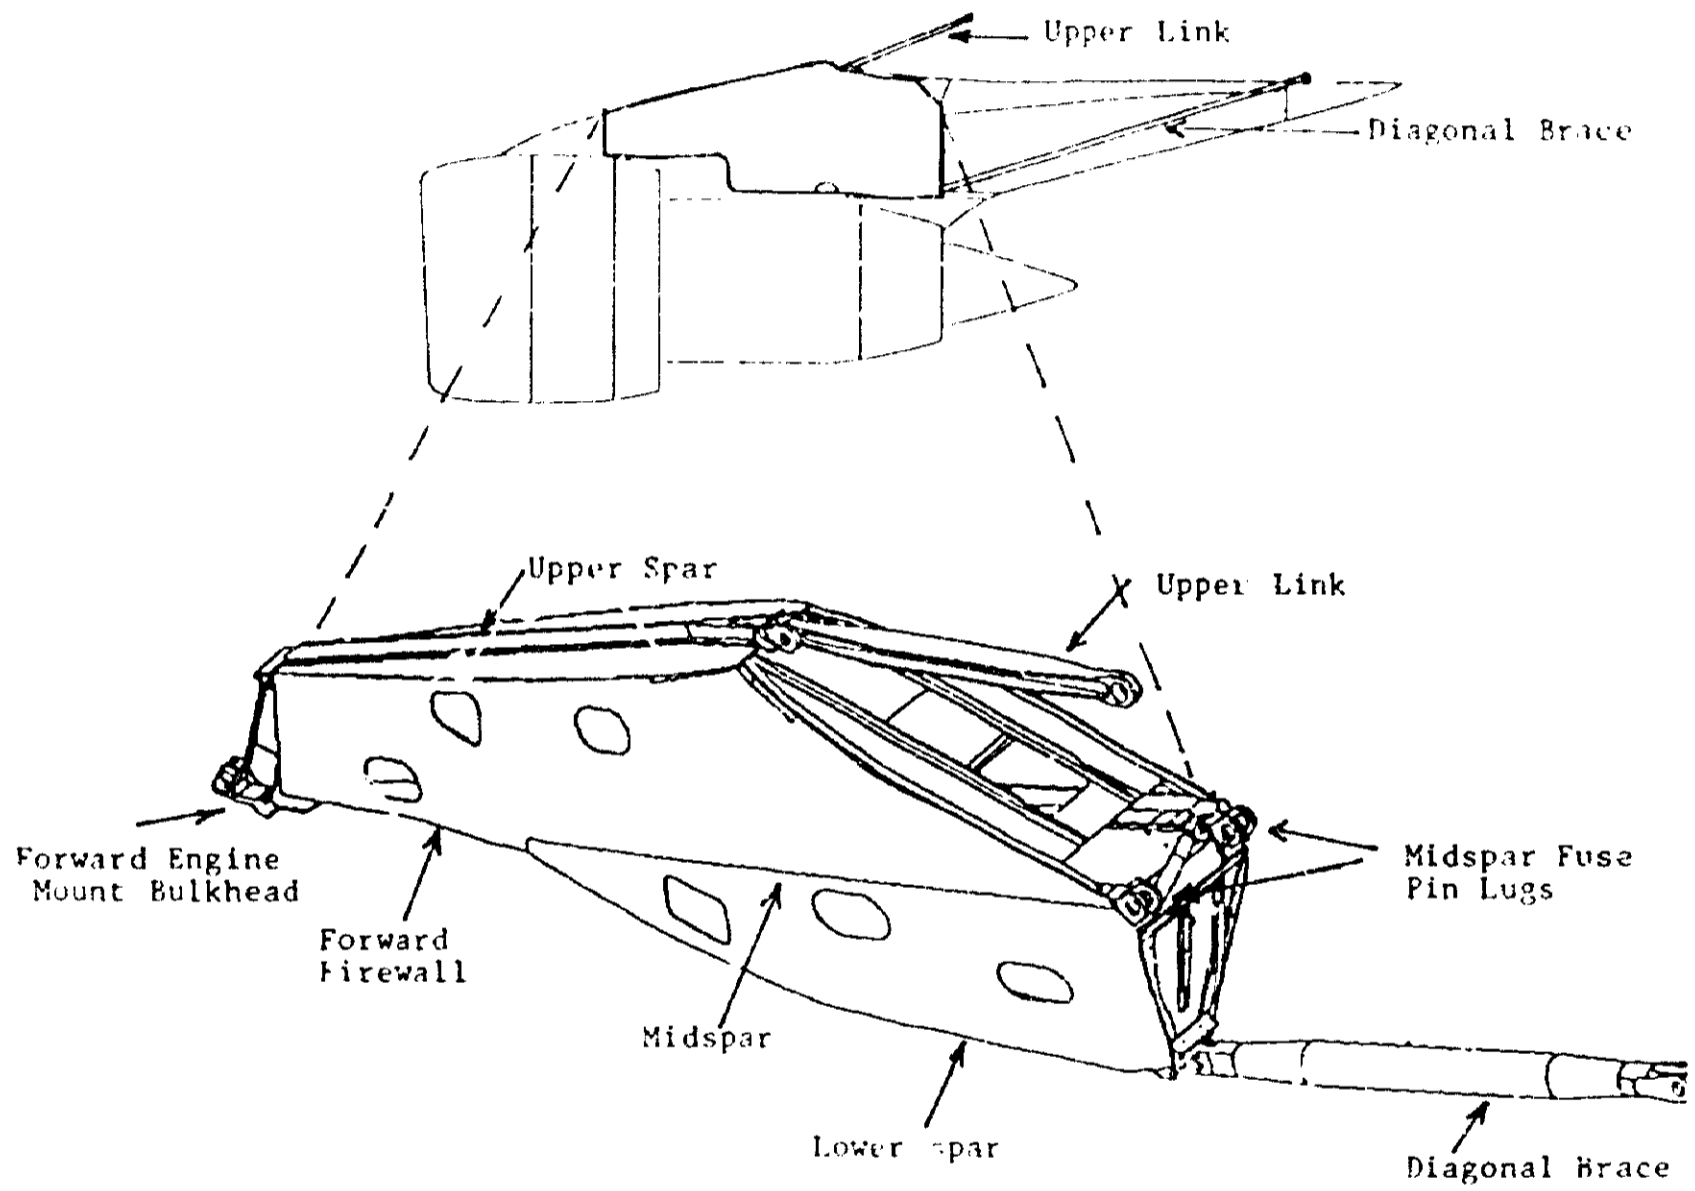
Figure 2.--Pylon structure.

The No. 2 engine pylon was separated into four pieces as a result of three principal fracture areas. These fractures were located just aft of the forward engine mount bulkhead, along a jagged vertical plane aft of the rear engine mount bulkhead, and around the inboard midspar fuse pin fitting. The two forward pieces of the pylon remained attached to the engine through the forward and rear engine mounts. Examination of the fractures around the perimeter of the break aft of the forward engine mount bulkhead revealed features typical of overstress separations, with the exception of a small, flat fracture region in the firewall web.

The flat fracture area was approximately in the middle of the web, on the outboard side of the web centerline. The fracture was a lateral fracture about 2 inches long through the thickness of the web and was aft of the third transverse stiffener behind the forward engine mount bulkhead. The location of this fracture area is indicated in figure 3. Investigators cut the flat fracture area from the remainder of the firewall and examined it in detail with a bench binocular microscope and a scanning electron microscope. The mating fracture faces had been heavily rubbed. Despite the rubbing, isolated areas of fatigue striations, indicative of through-the-thickness propagation, were noted. Compression buckling of the firewall web extended from the fatigue crack area forward to the outboard side of the pylon at the second transverse stiffener. Inspection of the other three pylons on the airplane found no similar cracks.

The pylon piece that remained with the portion of the pylon that was attached to the wing had a 3-inch-long fatigue crack in the midspar web. The fatigue crack area was not on the fracture surface that separated the web into two pieces, but was on a crack that extended into the web where it was held between the jaws of the inboard midspar fitting. Nearly all of this fatigue crack was on a portion of the web that was sandwiched between other structure. The plane of cracking in the fatigue area was oriented 45° to the fore-and-aft direction, consistent with propagation under shear loading of the web.

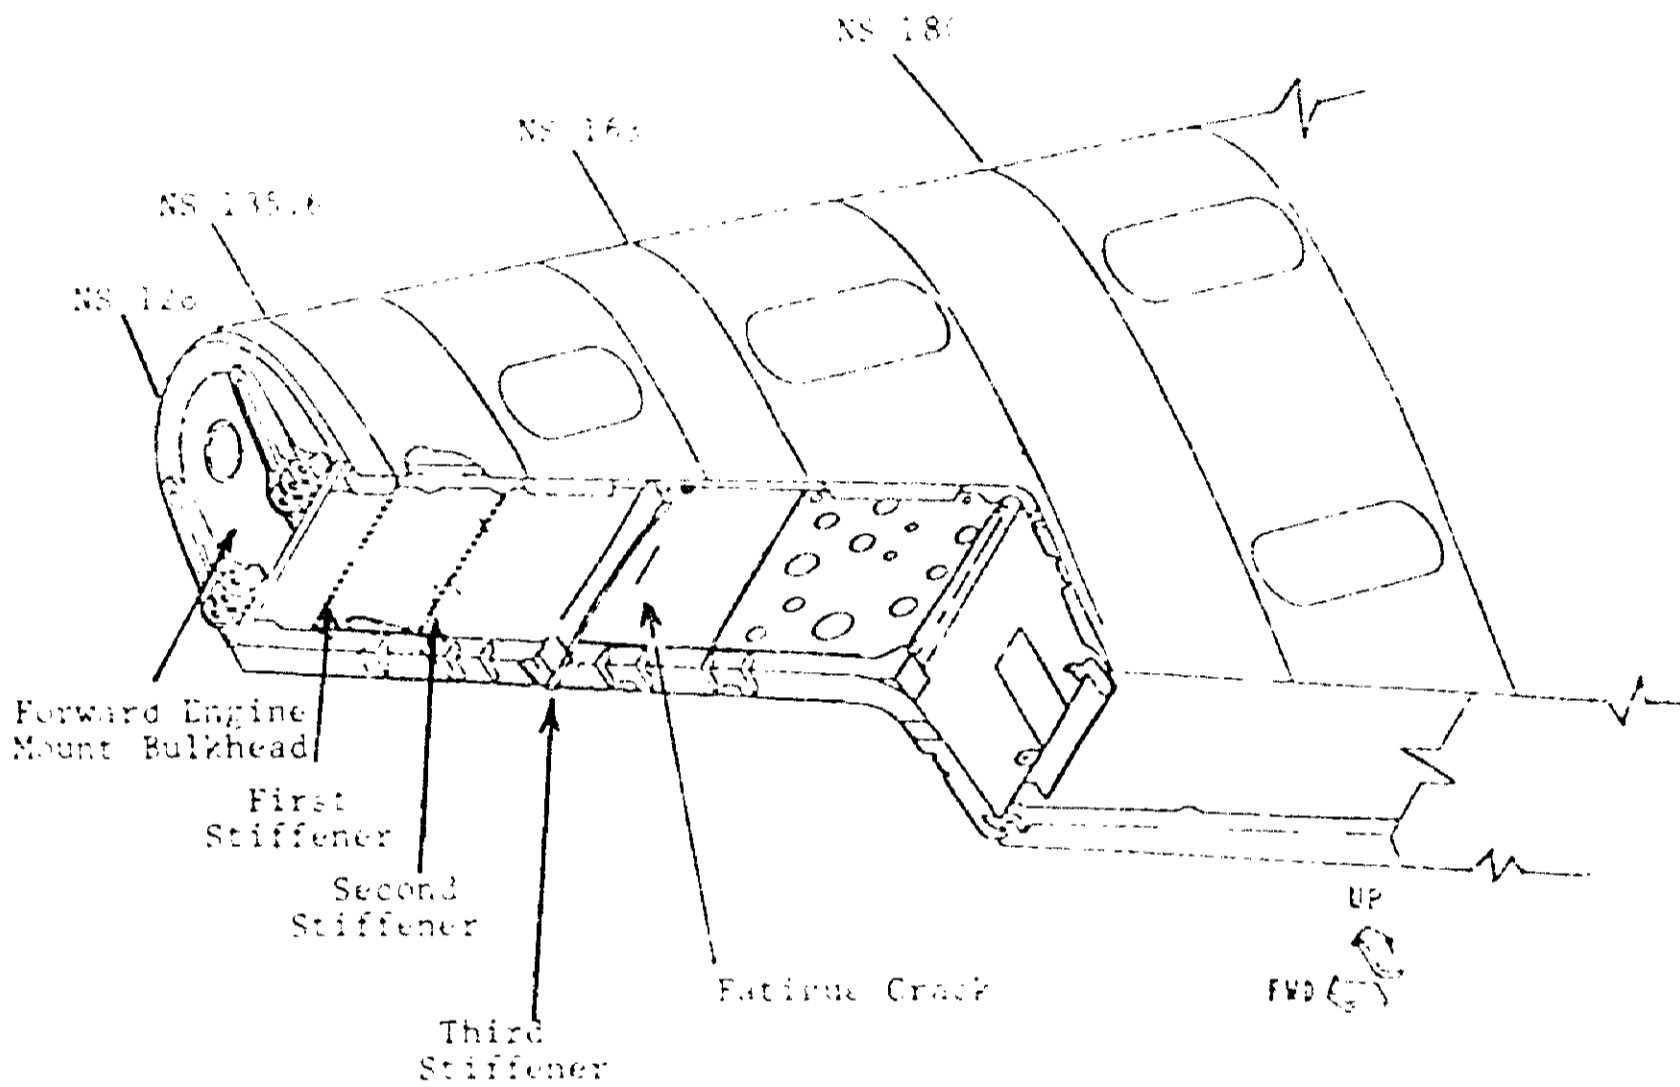
Figure 3.-Flat fracture area.

The two fatigue cracks that were found in the No. 2 engine pylon structure were subjected to metallurgical examinations. One of the fatigue cracks was a lateral fracture about 2 inches long and was in the web of the pylon forward firewall, just aft of the third transverse stiffener behind the forward engine mount bulkhead. This fatigue crack was lateral to the web. Although most of the features of this crack had been obliterated by rubbing, a few isolated areas of fatigue striations were found. The orientation of the striations indicated that the cracking propagated through the thickness of the web. The web material (nickel alloy) and construction appeared to comply with specification requirements. There was no evidence of damage or defects that may have contributed to initiation of the fatigue cracking.
