AIRCRAFT ACCIDENT REPORT

IN-FLIGHT ENGINE SEPARATION
JAPAN AIRLINES, INC., FLIGHT 46E
BOEING 747-121, N473EV
ANCHORAGE, ALASKA
MARCH 31, 1993

**Adopted: October 13, 1993
Notation 6081A**

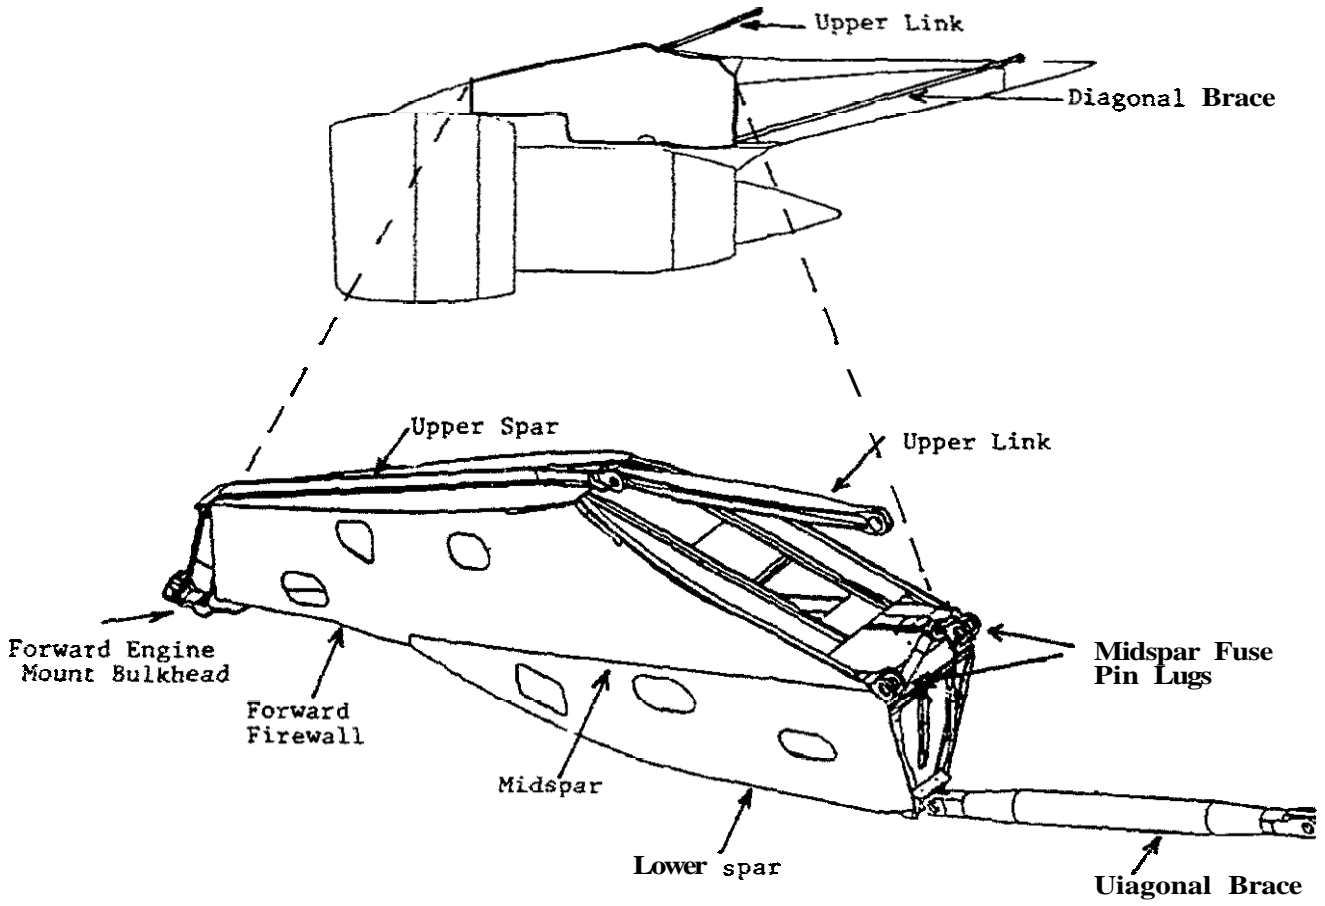
Figure 2.--Pylon structure.

The No. 2 engine pylon was separated into four pieces as a result of three principal fracture areas. These fractures were located just aft of the forward engine mount bulkhead, along a jagged vertical plane aft of the rear engine mount bulkhead, and around the inboard midspar fuse pin fitting. The two forward pieces of the pylon remained attached to the engine through the forward and rear engine mounts. Examination of the fractures around the perimeter of the break aft of the forward engine mount bulkhead revealed features typical of overstress separations, with the exception of a small, flat fracture region in the firewall web.

The flat fracture area was approximately in the middle of the web, on the outboard side of the web centerline. The fracture was a lateral fracture about 2 inches long through the thickness of the web and was aft of the third transverse stiffener behind the forward engine mount bulkhead. The location of this fracture area is indicated in figure 3. Investigators cut the flat fracture area from the remainder of the firewall and examined it in detail with a bench binocular microscope and a scanning electron microscope. The mating fracture faces had been heavily rubbed. Despite the rubbing, isolated areas of fatigue striations, indicative of through-the-thickness propagation, were noted. Compression buckling of the firewall web extended from the fatigue crack area forward to the outboard side of the pylon at the second transverse stiffener. Inspection of the other three pylons on the airplane found no similar cracks.

The pylon piece that remained with the portion of the pylon that was attached to the wing had a 3-inch-long fatigue crack in the midspar web. The fatigue crack area was not on the fracture surface that separated the web into two pieces, but was on a crack that extended into the web where it was held between the jaws of the inboard midspar fitting. Nearly all of this fatigue crack was on a portion of the web that was sandwiched between other structure. The plane of cracking in the fatigue area was oriented 45° to the fore-and-aft direction, consistent with propagation under shear loading of the web.

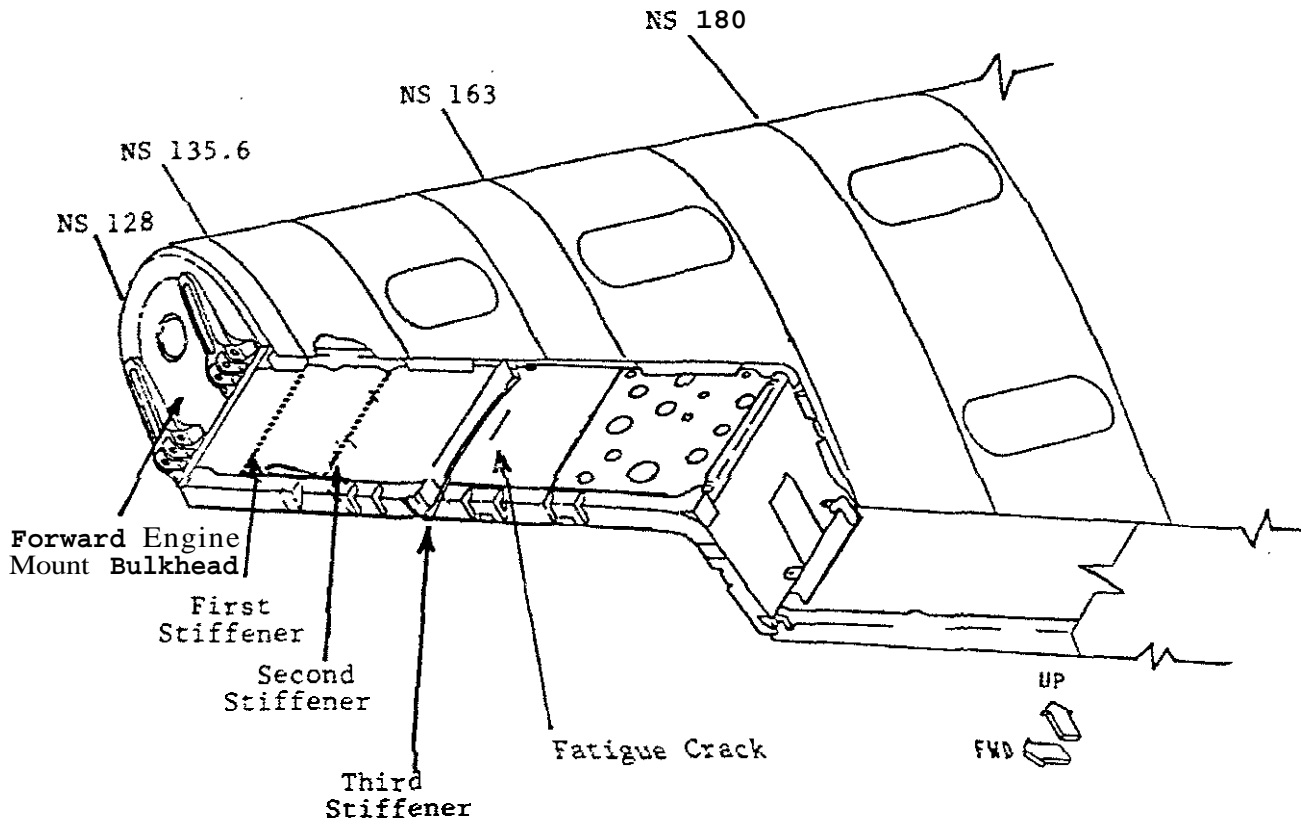
Figure 3.--Flat fracture area.

The two fatigue cracks that were found in the No. 2 engine pylon structure were subjected to metallurgical examinations. One of the fatigue cracks was a lateral fracture about 2 inches long and was in the web of the pylon forward firewall, just aft of the third transverse stiffener behind the forward engine mount bulkhead. This fatigue crack was lateral to the web. Although most of the features of this crack had been obliterated by rubbing, a few isolated areas of fatigue striations were found. The orientation of the striations indicated that the cracking propagated through the thickness of the web. The web material (nickel alloy) and construction appeared to comply with specification requirements. There was no evidence of damage or defects that may have contributed to initiation of the fatigue cracking.

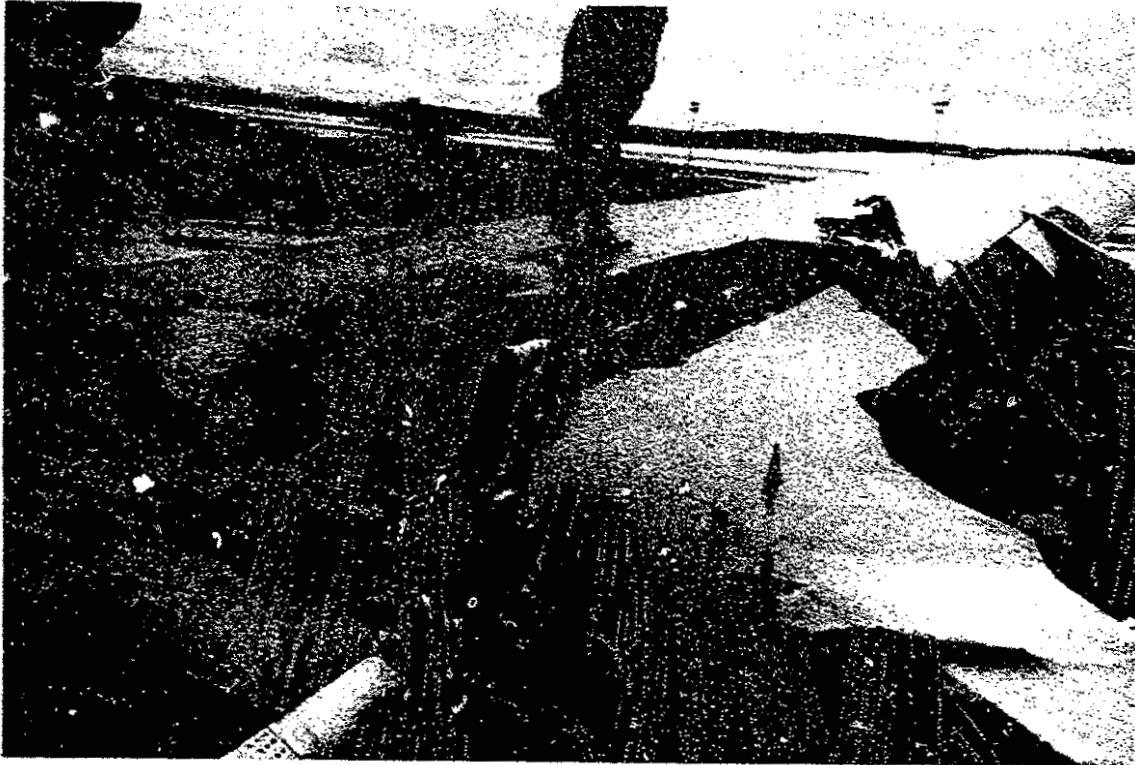
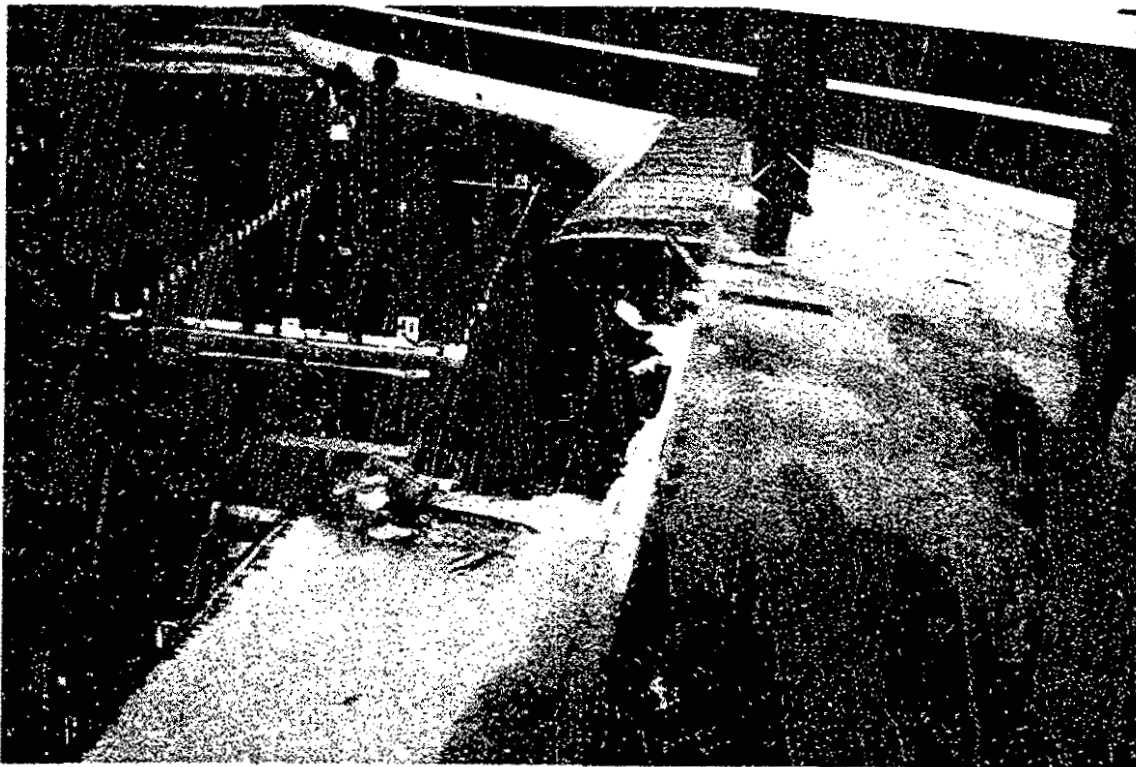
Figure 4.--Left wing damage.

Ail of the entire upper surface fixed leading edge panels from approximately inboard leading edge station (**ILES**) 695 **to** **ILES** 930 on the **left** wing were missing (see **figure 4**). The wing leading edge "D" beam and thermal anti-ice duct from ILES 695 to ILES 930 on the left wing were missing. The leading edge variable camber (**VC**) flaps **Nos.** 7, 8, 9, and 10, including their drive motors, torque tubes, and 50 percent of all the linkage had been torn from the wing. Additionally, all of the leading edge **flap** support ribs were either missing or partially missing in this area.

The pneumatic duct was pushed against the wing front spar and was crushed and separated in three places. The lower fixed leading edge panels were intact; however, their forward edges were bent upward over most of the span between the No. 1 and No. 2 engines.

The D beam and thermal anti-ice duct portions, as well as many of the VC flap folding nose sections, were crushed and appear to have been struck by a large, heavy object. The recovered VC flap portions were split in the spanwise direction. The leading edge flap support ribs were broken near the front spar's upper chord attachment and the rib post lug tension tube attachment. The appearance of these fractures and the position of the rib portions that were still attached to the front spar were consistent with an upward and outboard motion of the object that impacted the structure. The VC flap linkage parts that were recovered exhibited compression and torsion damage that was also consistent with this motion. Some parts of the wing's upper surface fixed leading edge honeycomb panels smelled of fuel. A puncture in the No. 4 spoiler was consistent with an object that entered on the upper surface and exited on the lower surface, when the spoiler was deployed. The remaining punctures, gouges, and dents were typical of impact with small objects.

Other damage was found on the wing's trailing edge outboard fore, mid, and aft flaps, inboard aft flap outboard corner, spoiler No. 4, the lower fixed trailing edge panel aft of the "sailboat" fairing, and the left side of the lower rudder. This damage consisted of punctures and tears. Dents, scrapes, and scratches were found on the left wing upper and lower skin panels as well as on the left stabilizer leading edge. Figure 4 shows the damage to the leading edge of the wing.
