NATIONAL TRANSPORTATION SAFETY BOARD

AIRCRAFT ACCIDENT REPORT

RUNWAY DEPARTURE FOLLOWING LANDING
AMERICAN AIRLINES FLIGHT 102
McDONNELL DOUGLAS DC-10-30, N139AA
DALLAS/FORT WORTH INTERNATIONAL AIRPORT, TEXAS
APRIL 14, 1993

Abstract: This report explains the runway departure of American Airlines flight 102, a DC-10-30, after landing at Dallas/Fort Worth International Airport, Texas, on April 14, 1993. The safety issues discussed in the report include weather conditions affecting the flight, flightcrew and air traffic control training and procedures, airplane emergency evacuation lighting, and runway maintenance. Recommendations concerning these issues were made to the Federal Aviation Administration, Dallas/Fort Worth International Airport, and American Airlines, Inc.

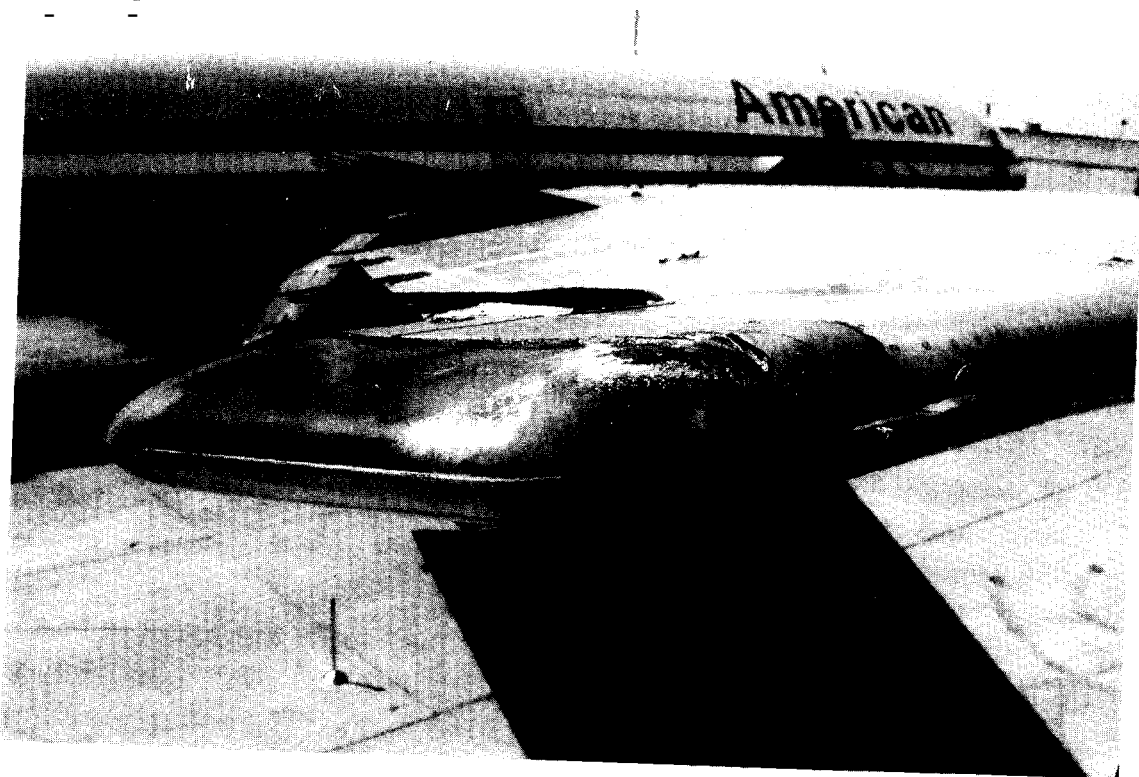
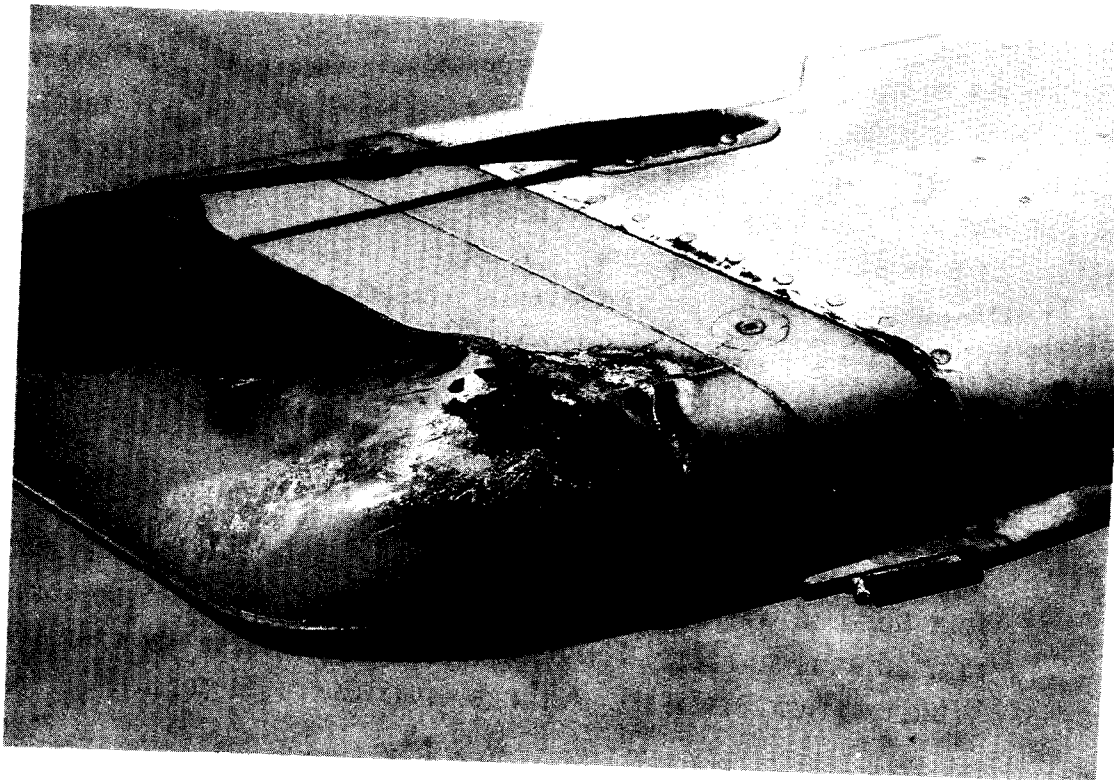
Figures 1a and 1b.--Lightning damage to right wing tip.

A lightning strike was reported to maintenance personnel by the crew of American Airlines Flight 73, on April 11, 1993. An inspection of the airplane, in accordance with maintenance manual procedures, found no damage from the lightning strike. There was, however, a lightning strike noted by the flightcrew, cabincrew, and passengers, occurring as the accident flight was inbound to DFW, about 17 minutes prior to landing. Examination, as part of the Safety Board's investigation following the accident, found evidence of a lightning strike at the top of the right wing tip.

The top of the light lens on the right wing tip trailing edge exhibited melting and discoloration characteristic of a lightning strike. Melting and discoloration were also observed along the boundary of the lens and on the static discharger located outboard and adjacent to the lens. Only the retainer portion of the static discharger was found. No similar damage was observed on the remaining static dischargers on the airplane. However, three other dischargers were found broken--one each on the right wing trailing edge, left wing trailing edge, and left wing tip.

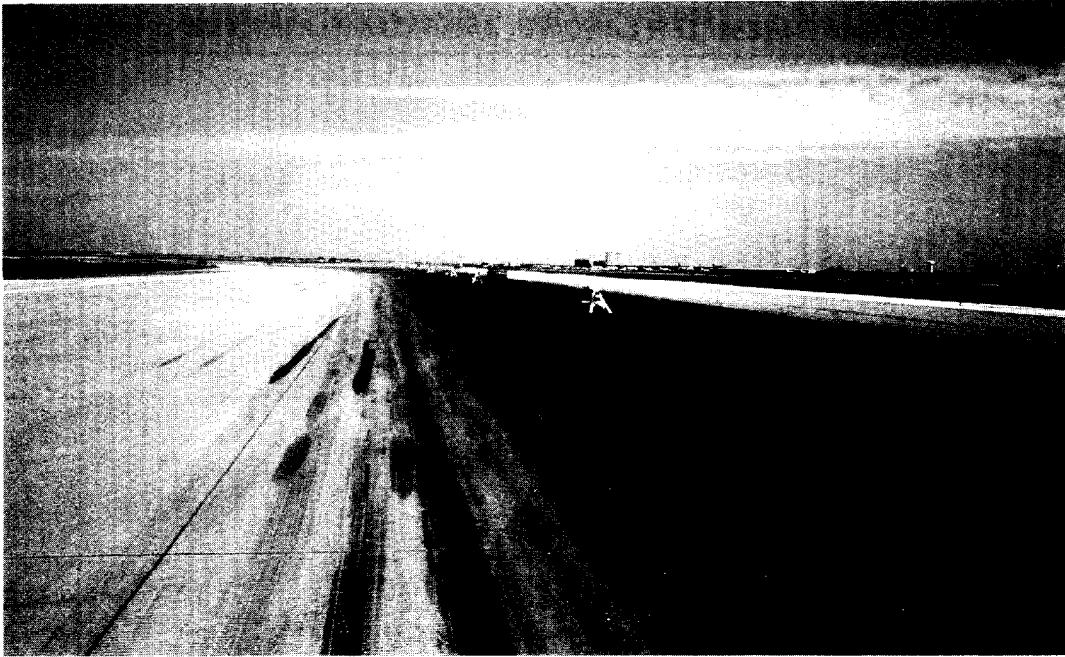
The first tire marks found on the runway were traced to the left and right main landing gear, and started at 4,303 feet from the beginning of the runway. The tracks approximately paralleled the runway centerline for about 1,700 feet, then turned gradually to the right until they departed the runway.

Figure 3a.--Tire marks on landing runway 17L (looking north).

Investigators examined the landing runway after the accident and found **traces** lighter than the surrounding runway surface, or white tire traces from the left, center, and right main landing gears, starting at 4,303 feet from the beginning of the runway, or with 7,085 feet remaining. The center gear tire marks were 4 feet to the right side of the runway centerline. There were no marks of any kind before this point on the runway that could be linked to the accident airplane.

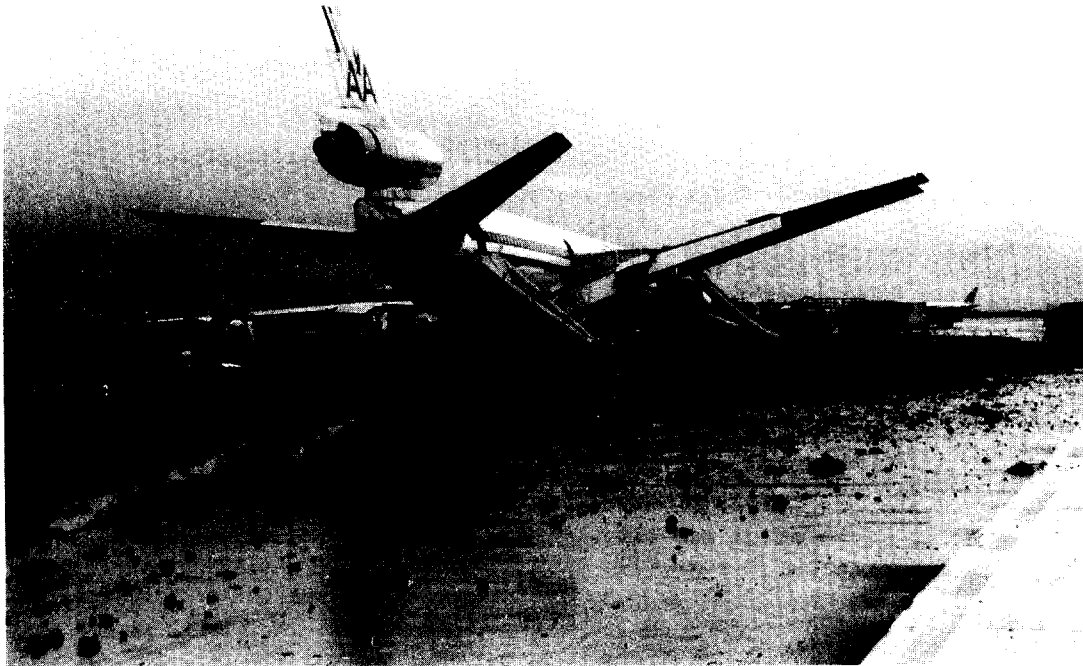
Investigators examined the landing runway after the accident and found three long sets of lightly shaded tire traces that paralleled the centerline but then angled to the right and departed the runway. The tracks from the right main landing gear continued as furrows in the soil.

Figure 3b.--Tire marks on high speed taxiway 3S, and trenches in the soil leading to the final resting position of the airplane.

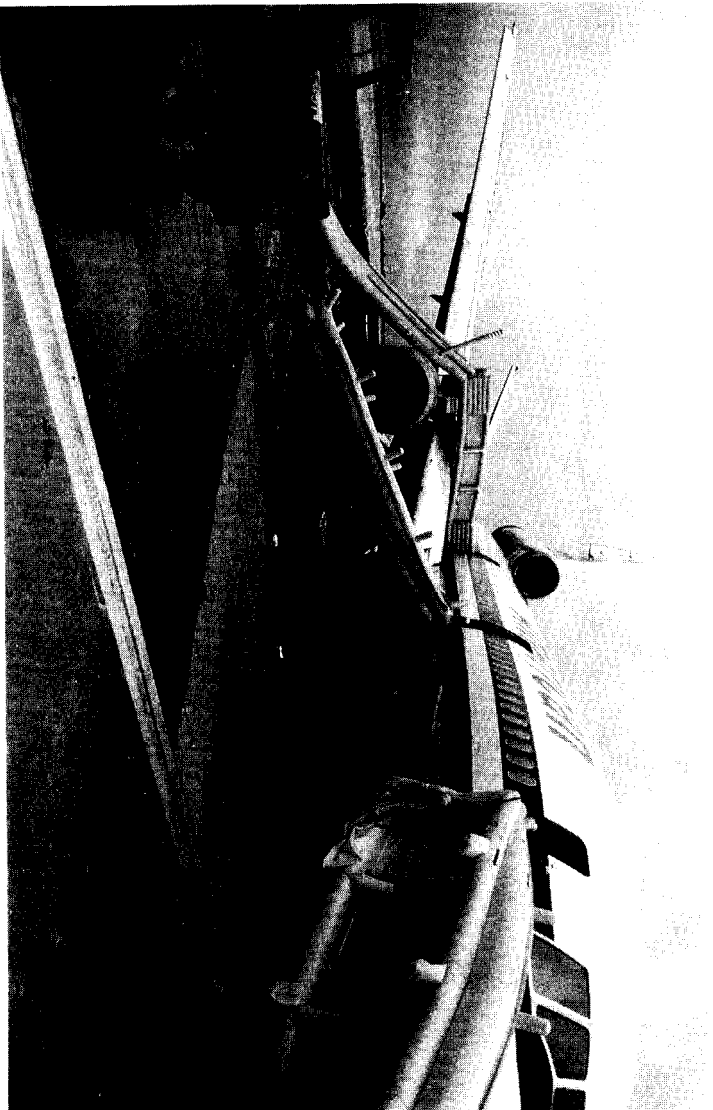
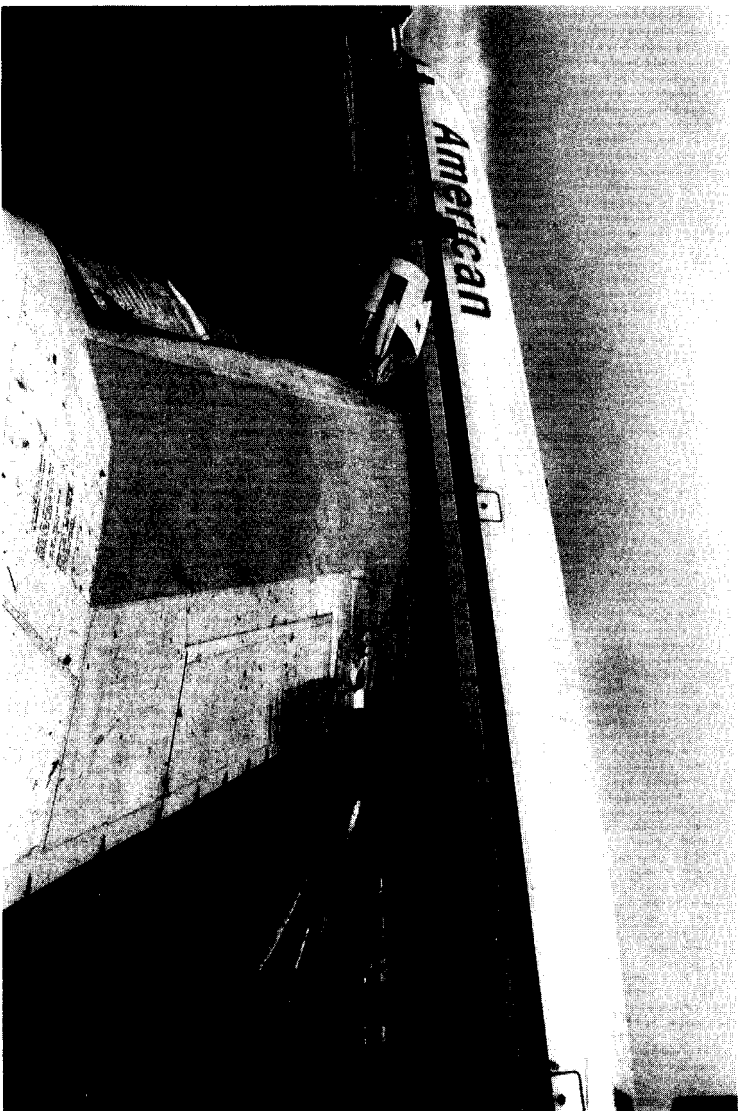
Figures 4a and 4b.--Airplane resting attitude and location.

The airplane came to rest supported by the forward fuselage, the center and right main landing gear, and the left wing and No. 1 engine. The left main gear strut was fractured and the nose gear strut was folded aft. The airplane came to rest slightly nose low and about 10 degrees left wing low. In its final resting position, the left wing and forward fuselage, as well as the right main and center gear, provided support and areas of ground contact.

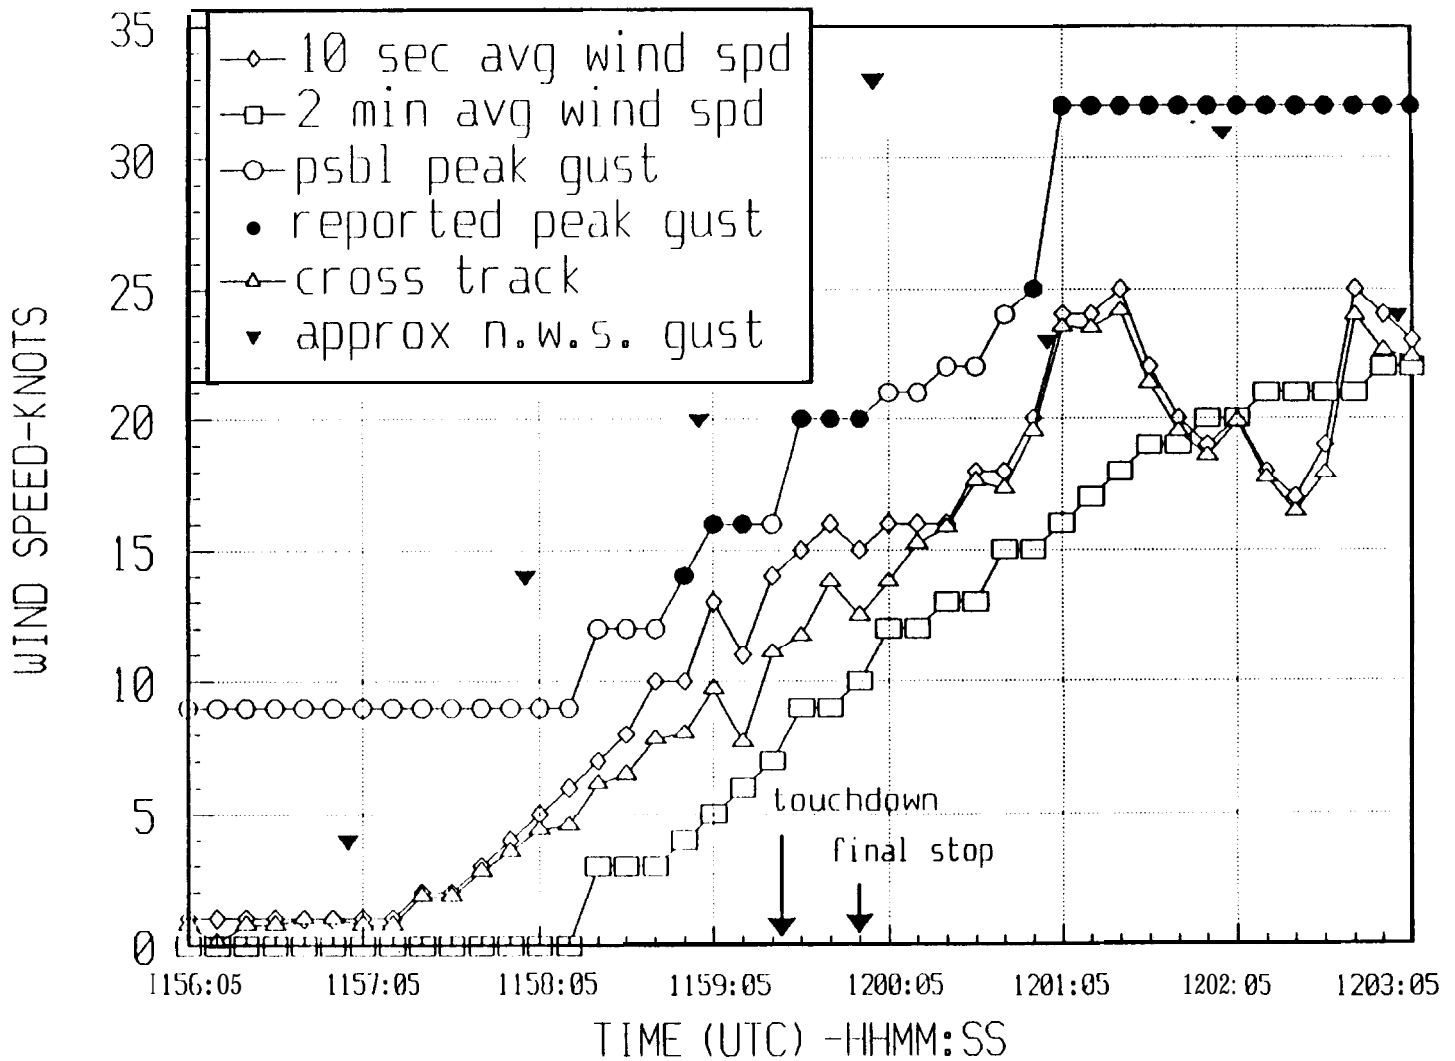
Figure 5.--LLWAS data.

all six sensors. The northwest, west, and center field sensors were found to be out of tolerance. The three anemometers were shipped to the manufacturer and under direction of the Safety Boards Investigation Weather Group Chairman, the “out of tolerance” anemometers were further evaluated. The sensor from the center field was found to be within manufacturer’s tolerances. The generator output from the sensor from the northwest DFW field position was found stable, and tested root mean square errors were found only slightly out of tolerance. The sensor from the west field station at DFW failed potentiometer tests in nearly every direction, with high root mean square errors.

Belfort Instrument, the manufacturer of the sensors, concluded that the northwest and center field sensors were unlikely to have contributed to significant LLWAS errors. Considering the large magnitude of error in the west sensor’s potentiometer, the manufacturer surmised that the potentiometer may have been damaged by an electrical transient.
