In-flight Breakup Over the Atlantic Ocean
Trans World Airlines Flight 800
Boeing 747-131, N93119
Near East Moriches, New York
July 17, 1996

**NTSB/AAR-00/03
DCA96MA070
PB2000-910403
Notation 6788G
Adopted August 23, 2000**

The National Transportation Safety Board determines that the probable cause of the TWA flight 800 accident was an explosion of the center wing fuel tank (CWT), resulting from ignition of the flammable fuel/air mixture in the tank. The source of ignition energy for the explosion could not be determined with certainty, but, of the sources evaluated by the investigation, the most likely was a short circuit outside of the CWT that allowed excessive voltage to enter it through electrical wiring associated with the fuel quantity indication system.

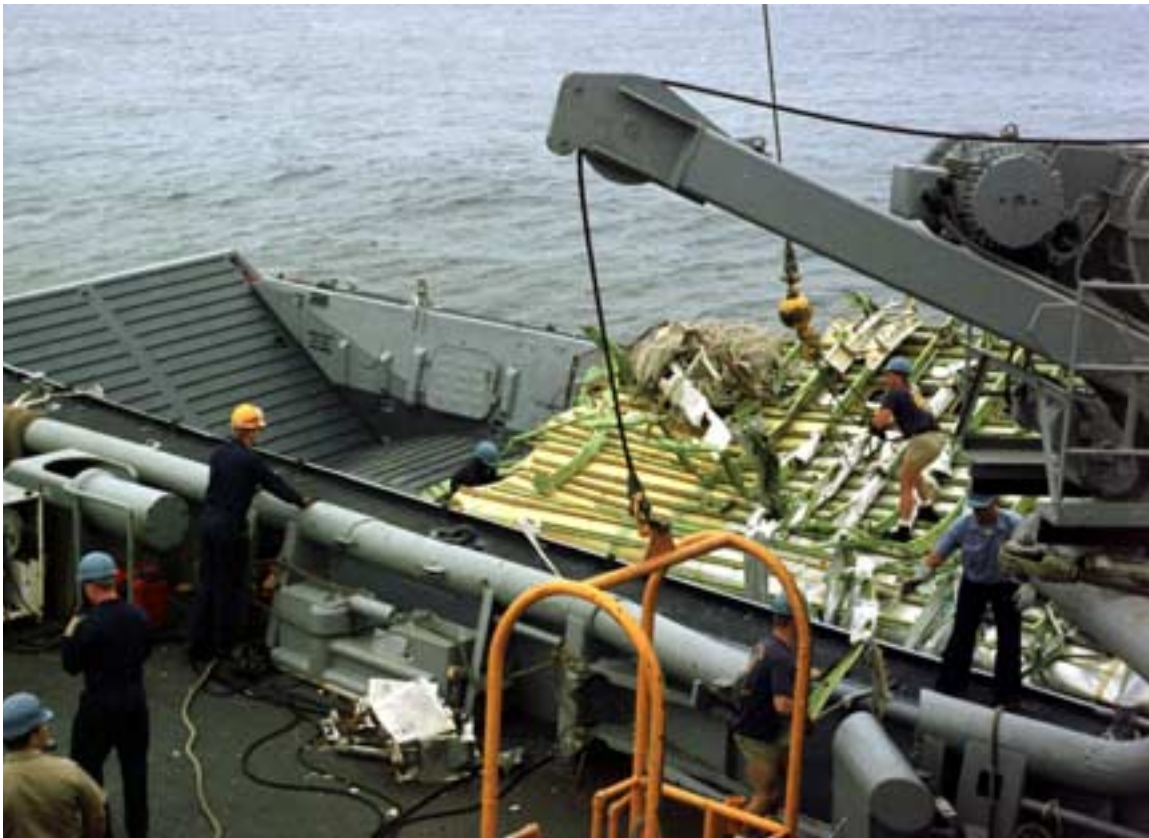
Figure 24. A photograph showing wreckage recovered with tangled and damaged wires attached.

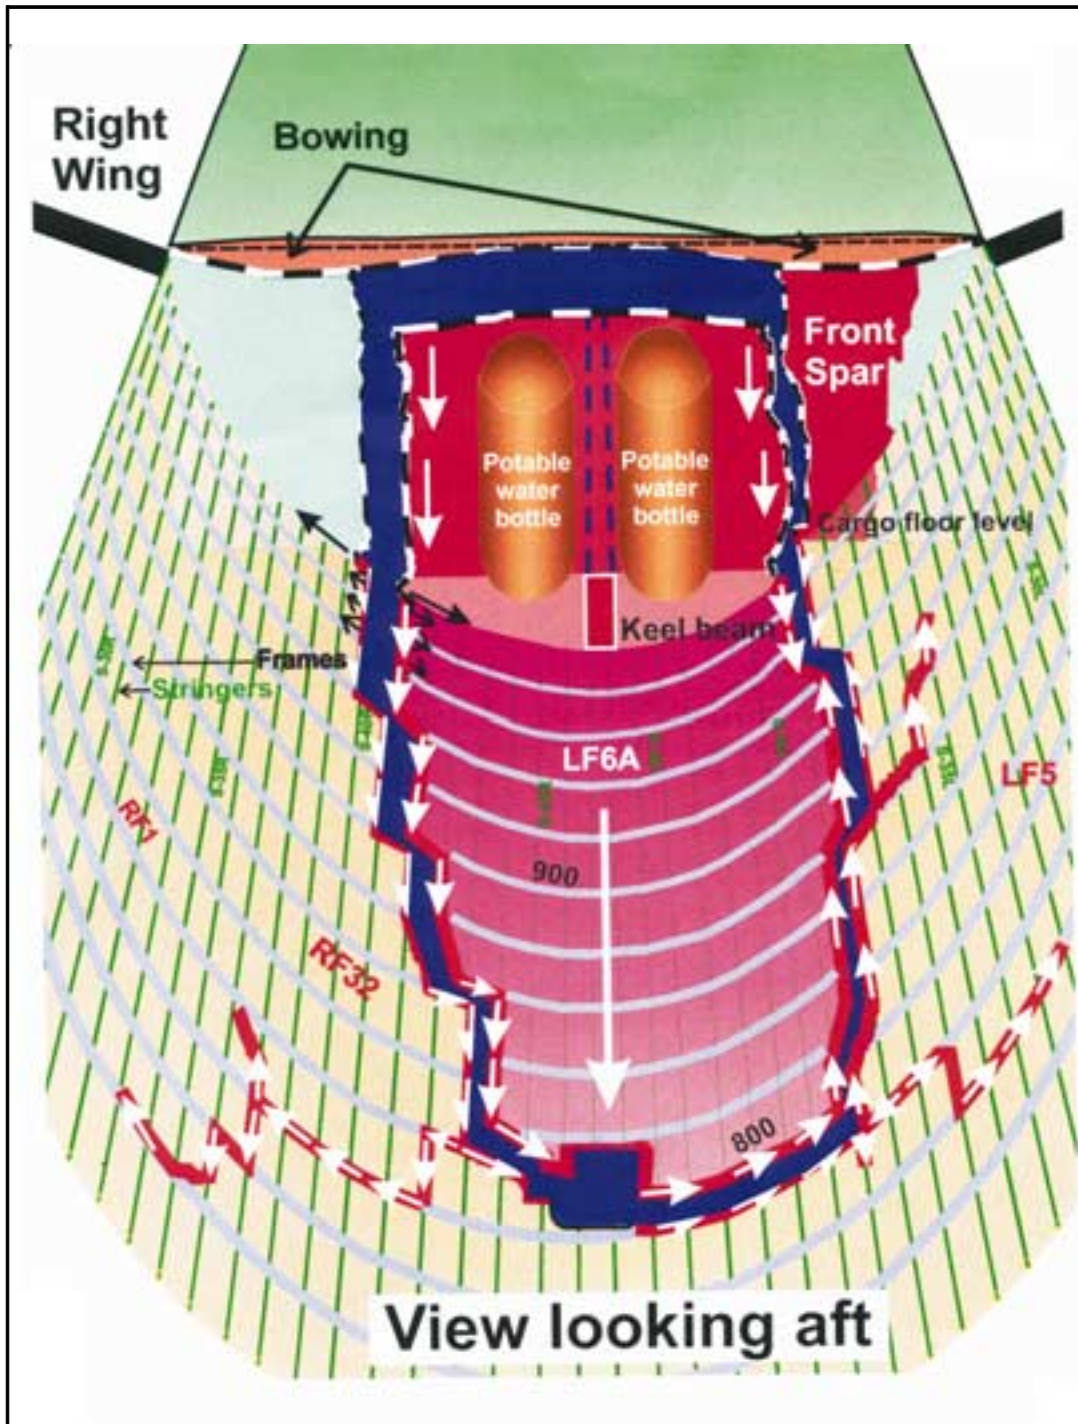
Figure 30. A schematic drawing of the lower portion of the fuselage skin in the area

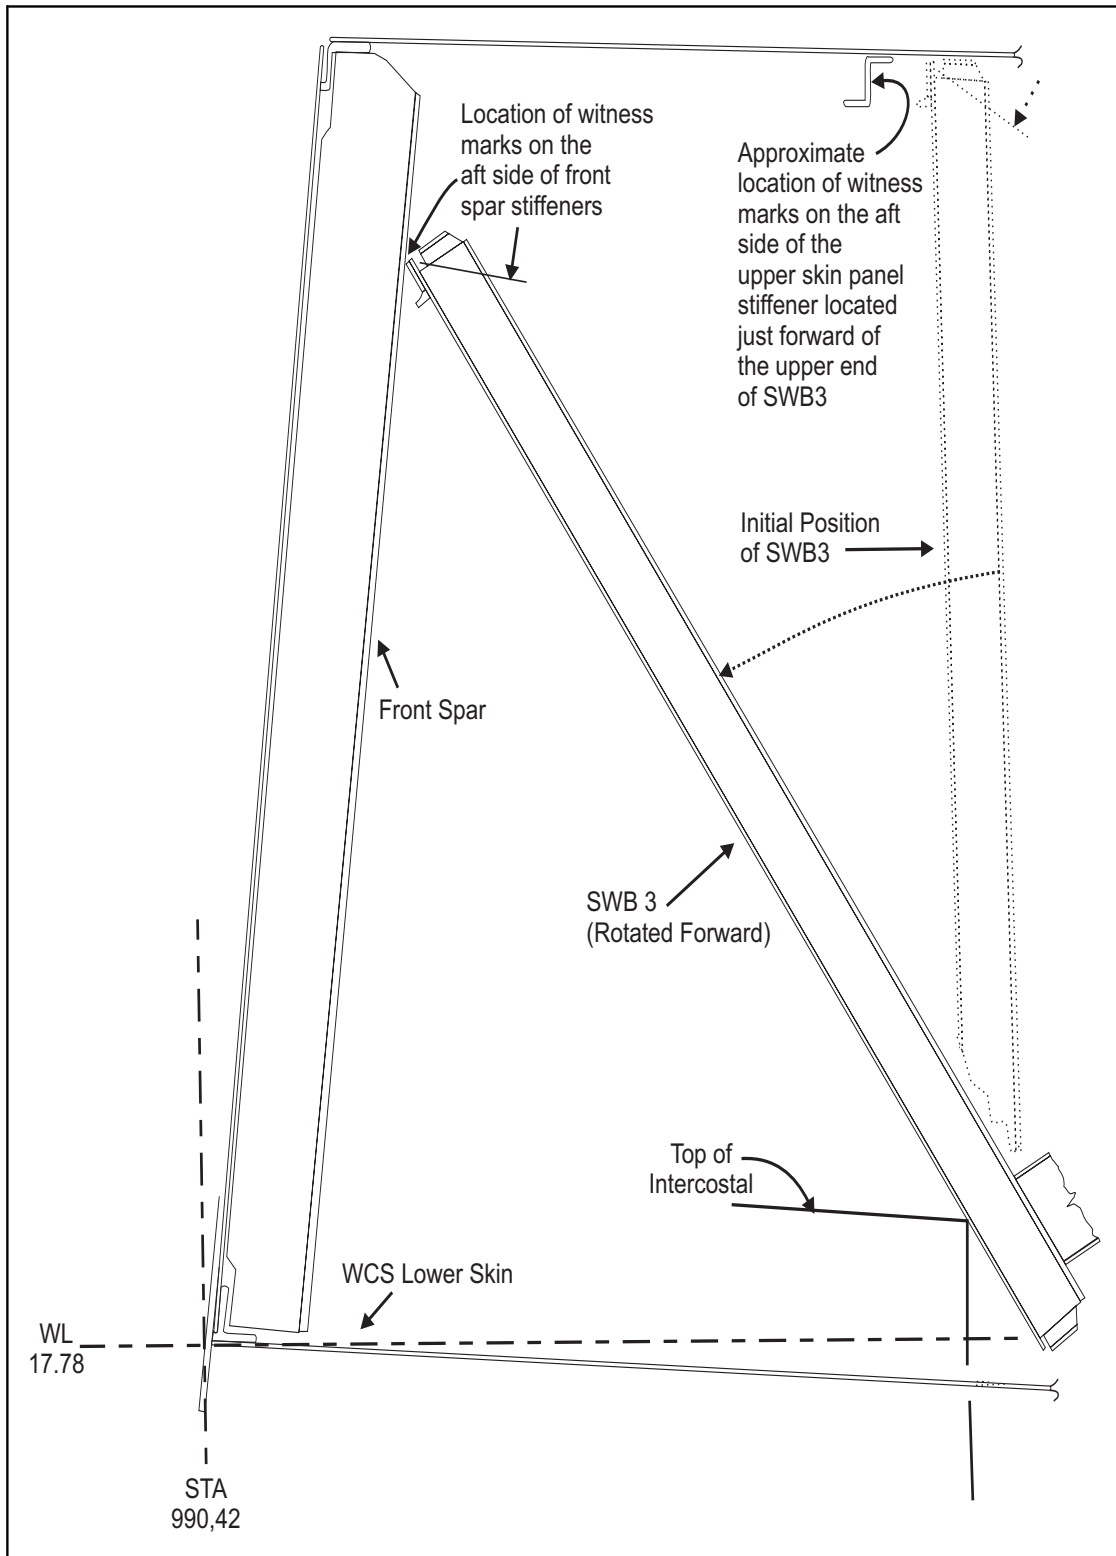
Figure 31. Diagram showing the approximate shape of the upper skin panel stiffener and its location before being struck by SWB3 as the beam rotated forward.
