5. Appendixes

Transcript of a Fairchild Model A-100 Cockpit Voice Recorder S/N UNK which was removed from a Trans World Airlines, Inc., Boeing Commercial Aircraft Co. B747-100 N93119, which was involved in an inflight accident on July 17, 1996 approximately 10 miles south of East Moriches, New York.

Appendix F

Sooting and Fracture Diagrams

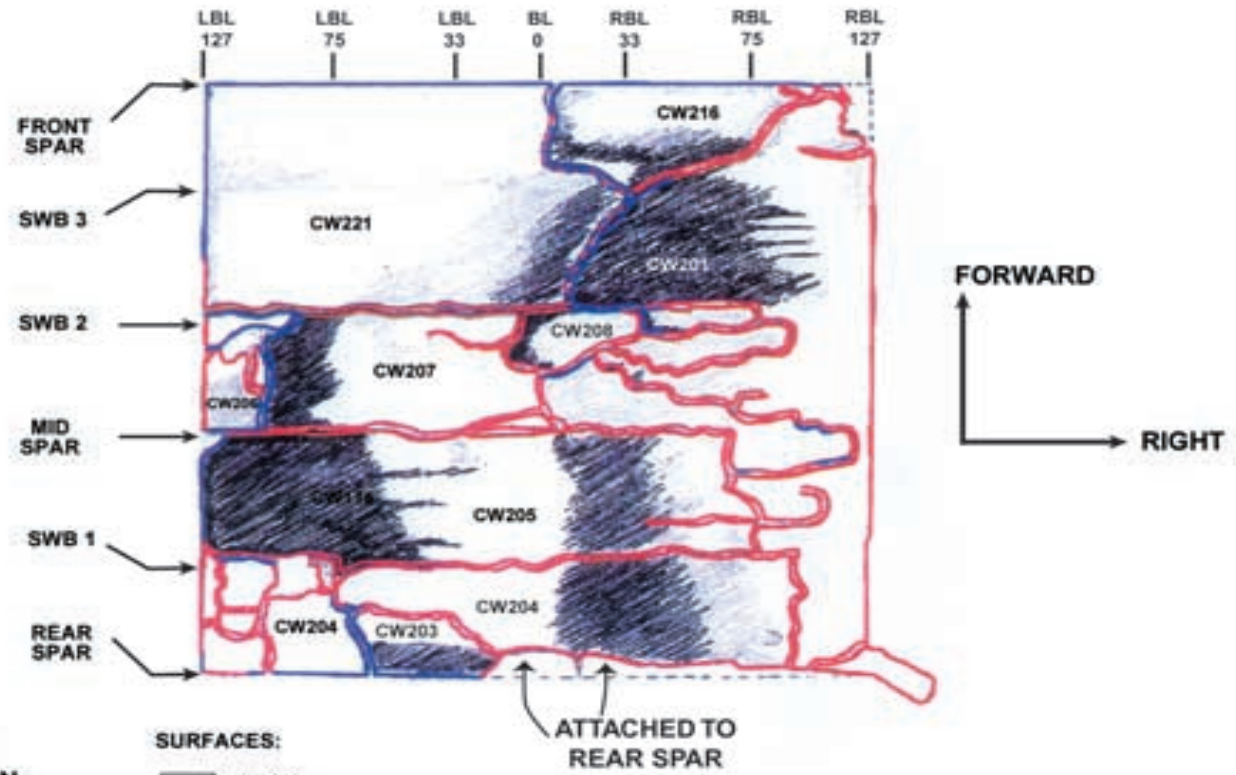
**CENTER WING TANK SOOTING PATTERN DIAGRAM
LOWER SKIN - UPPER SURFACE**

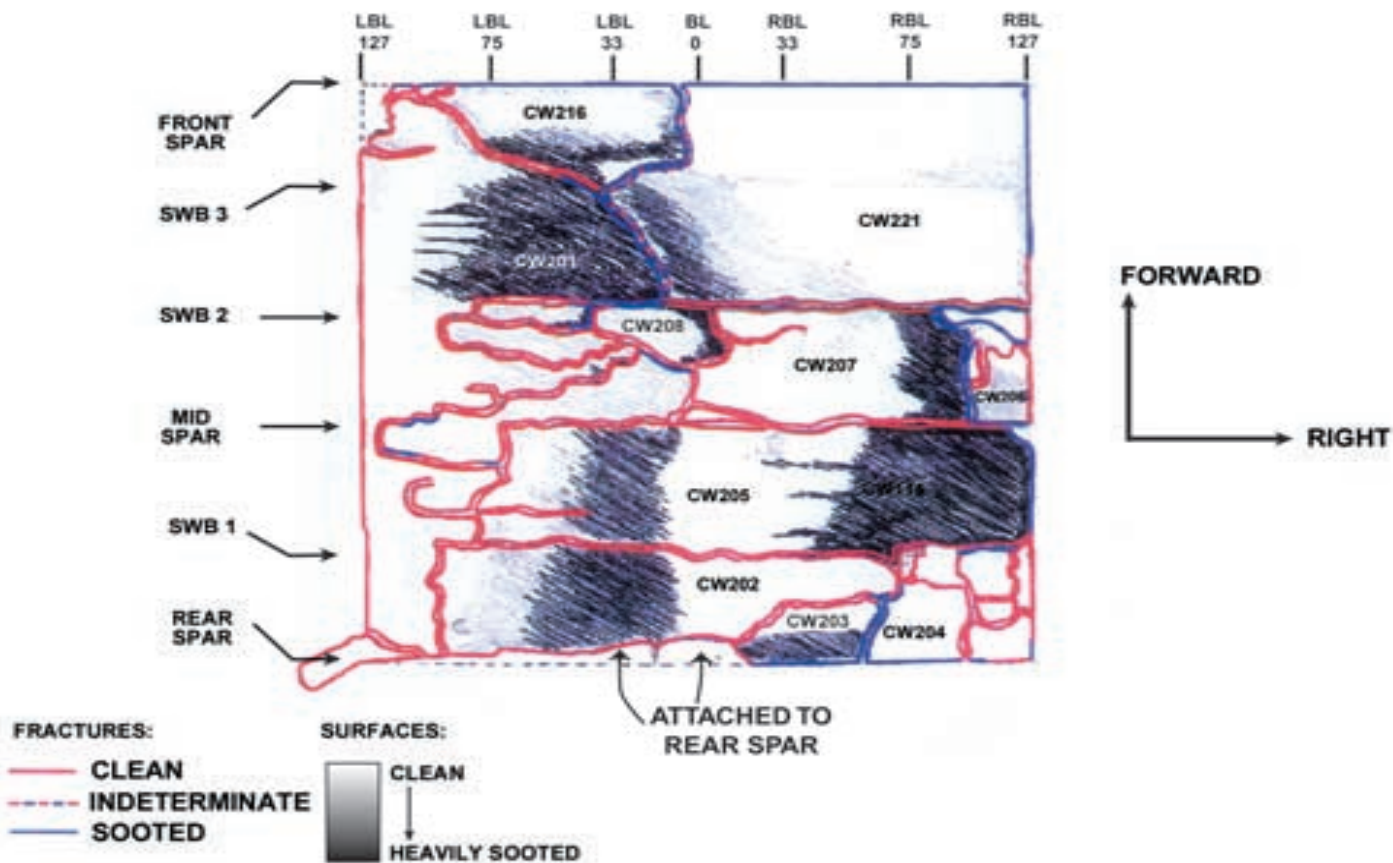
CENTER WING TANK SOOTING PATTERN DIAGRAM

LOWER SKIN - LOWER SURFACE

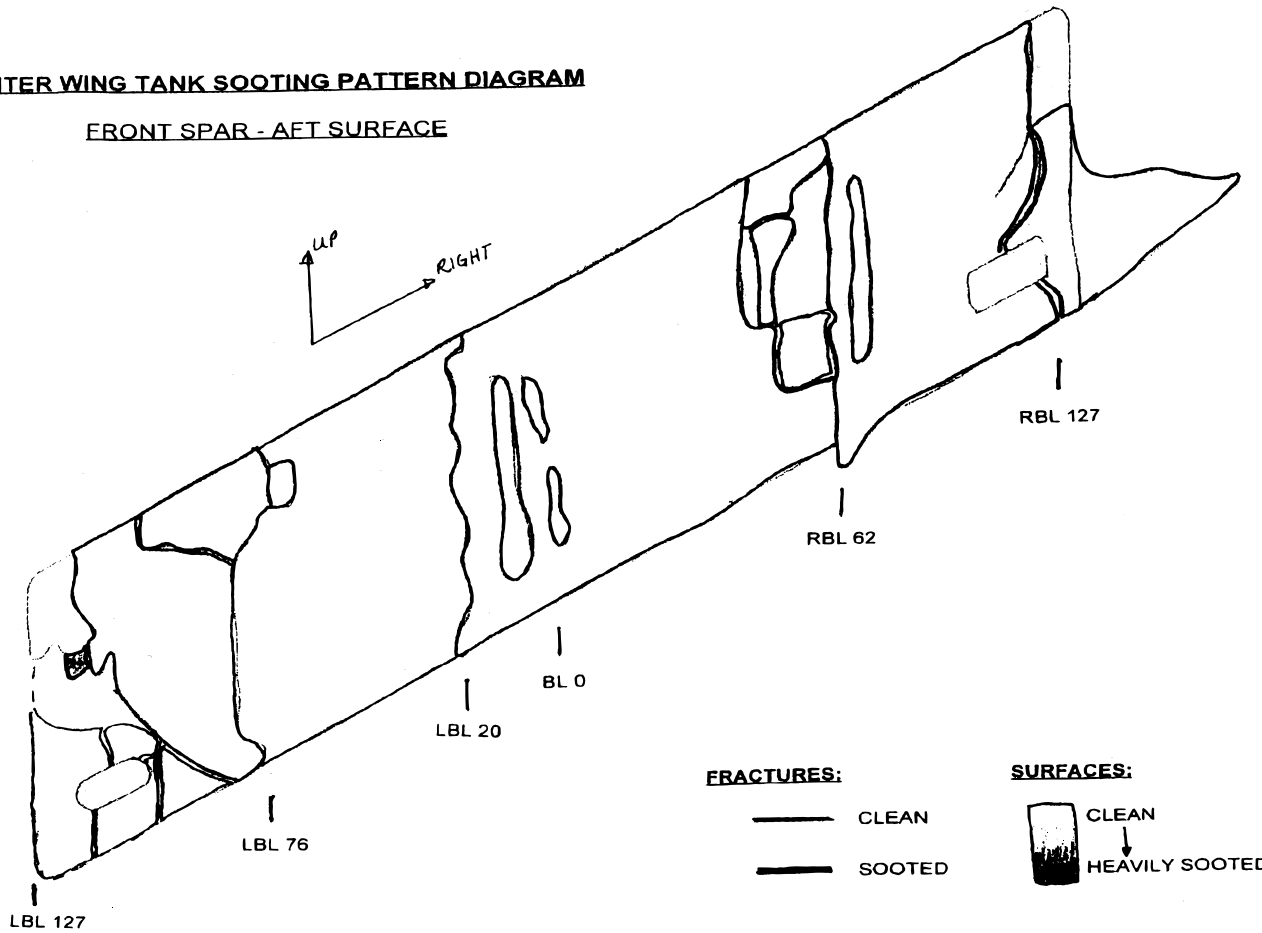
CENTER WING TANK SOOTING PATTERN DIAGRAM

FRONT SPAR - AFT SURFACE

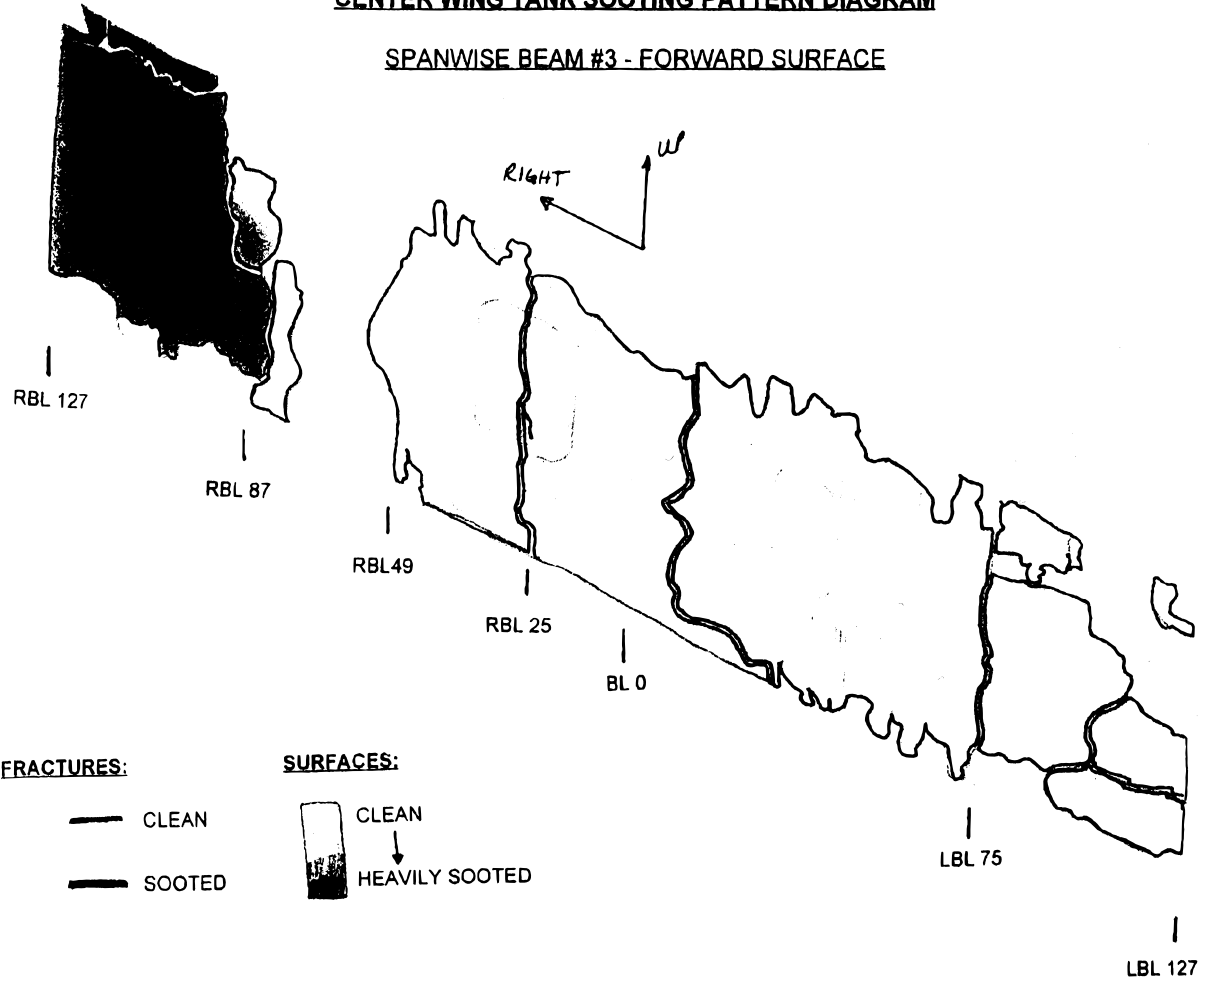
CENTER WING TANK SOOTING PATTERN DIAGRAM

SPANWISE BEAM #3 - FORWARD SURFACE

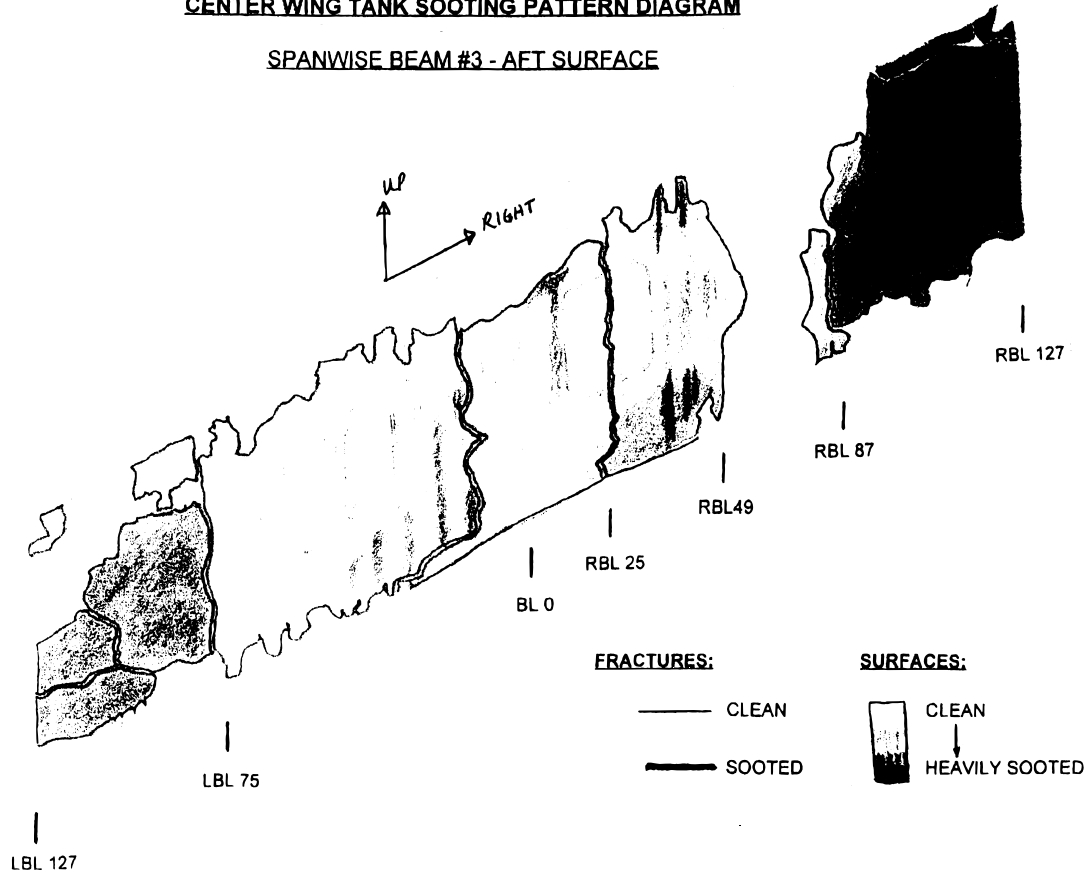
CENTER WING TANK SOOTING PATTERN DIAGRAM

SPANWISE BEAM #3 - AFT SURFACE

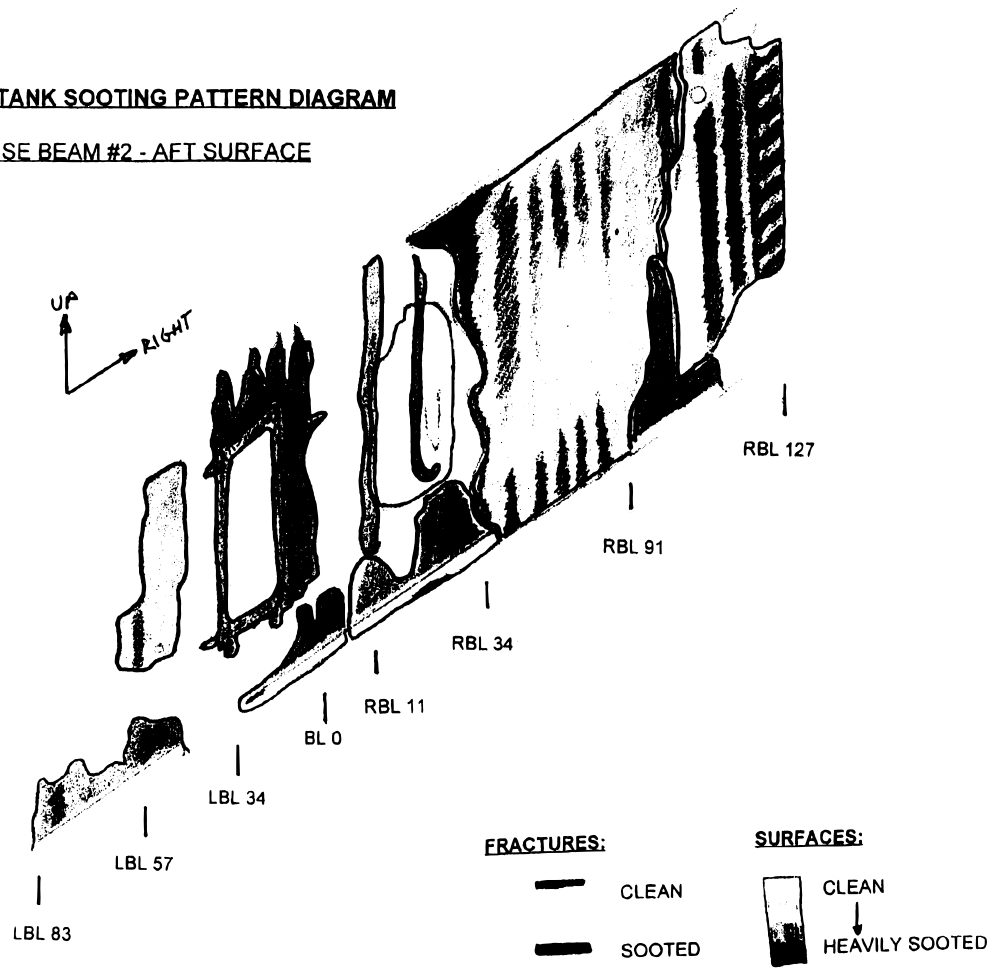
CENTER WING TANK SOOTING PATTERN DIAGRAM

SPANWISE BEAM #2 - AFT SURFACE

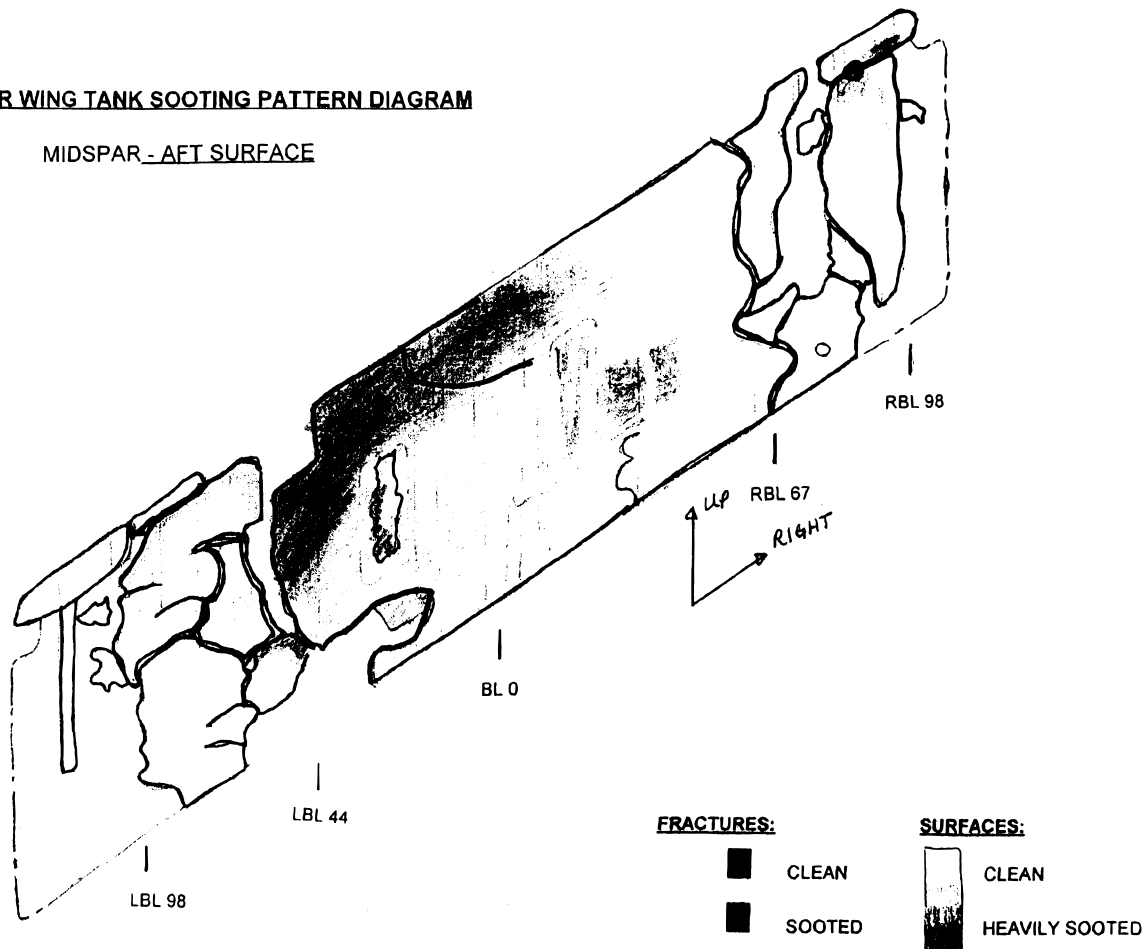
CENTER WING TANK SOOTING PATTERN DIAGRAM

MIDSPAR - AFT SURFACE

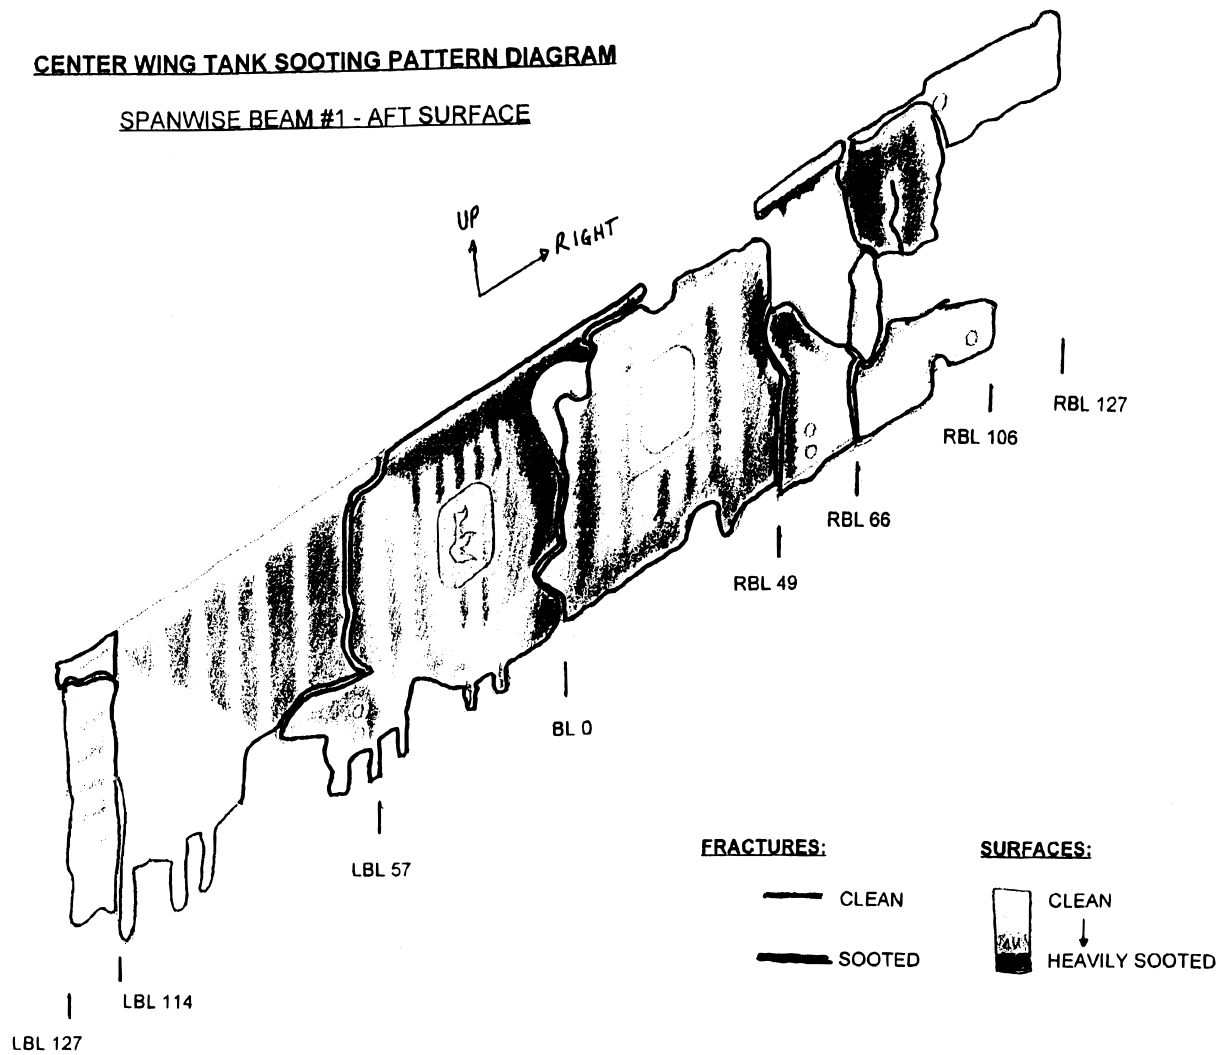
CENTER WING TANK SOOTING PATTERN DIAGRAM

SPANWISE BEAM #1 - AFT SURFACE

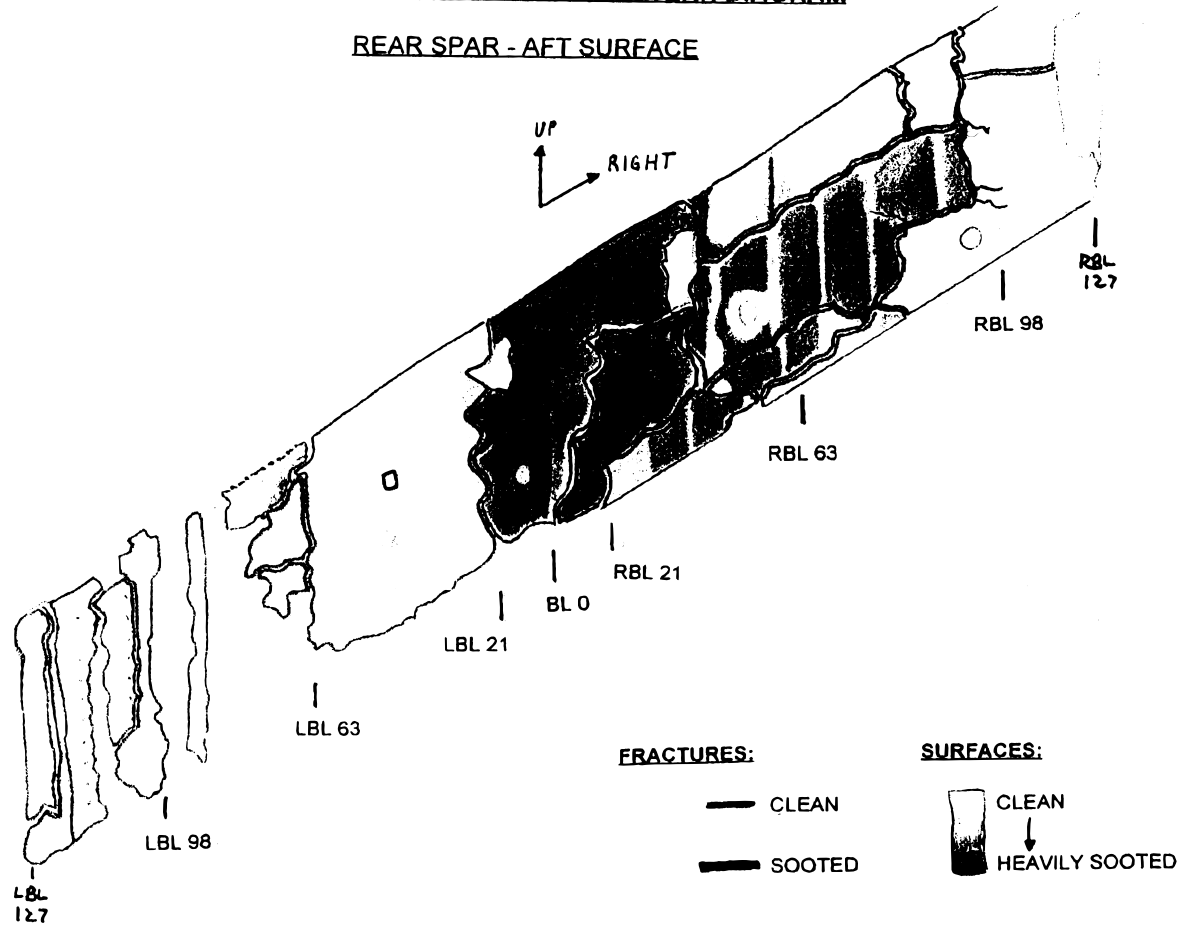
CENTER WING TANK SOOTING PATTERN DIAGRAM

REAR SPAR - AFT SURFACE

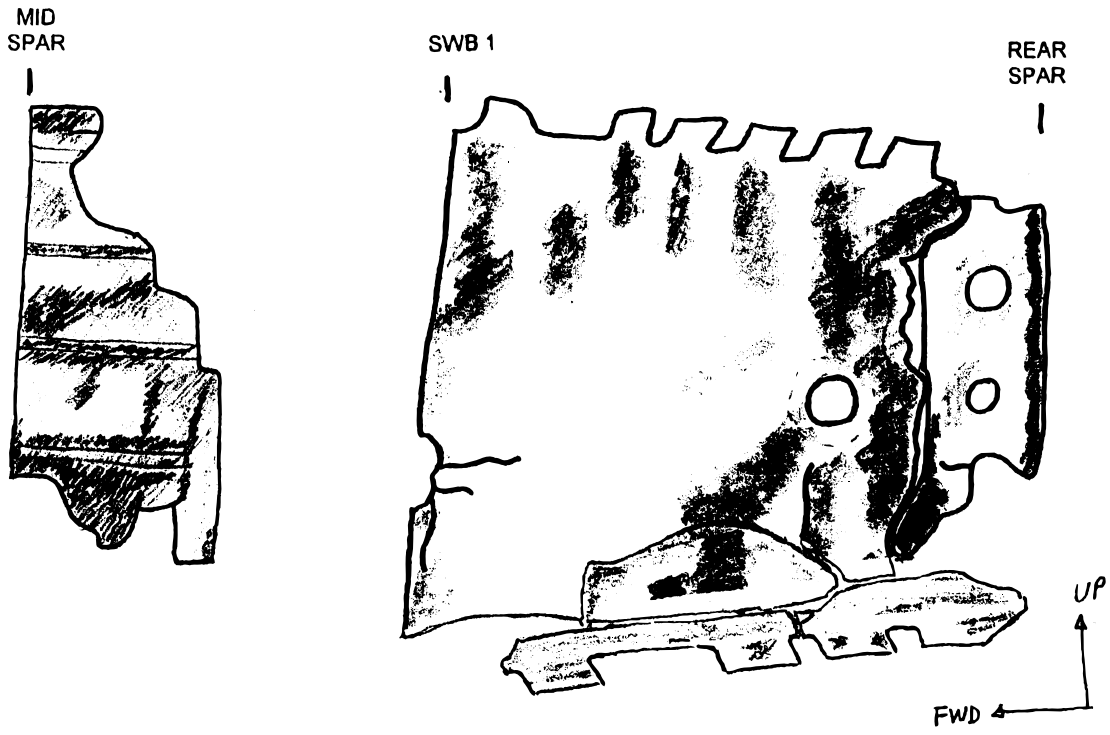
CENTER WING TANK SOOTING PATTERN DIAGRAM

BL 0 RIB - LEFT SURFACE

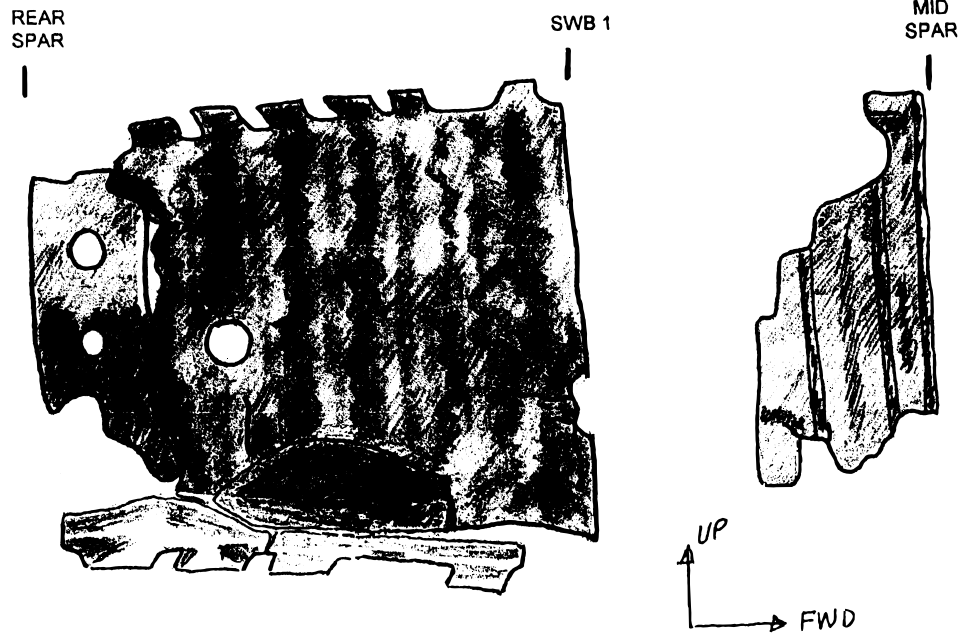
CENTER WING TANK SOOTING PATTERN DIAGRAM

BL 0 RIB - RIGHT SURFACE

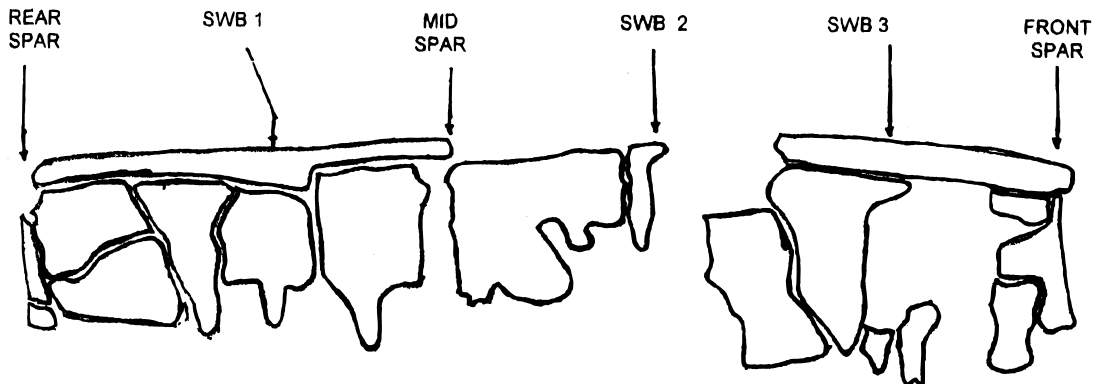
CENTER WING TANK SOOTING PATTERN DIAGRAM

RIGHTHAND SIDE OF BODY RIB - OUTBOARD SURFACE

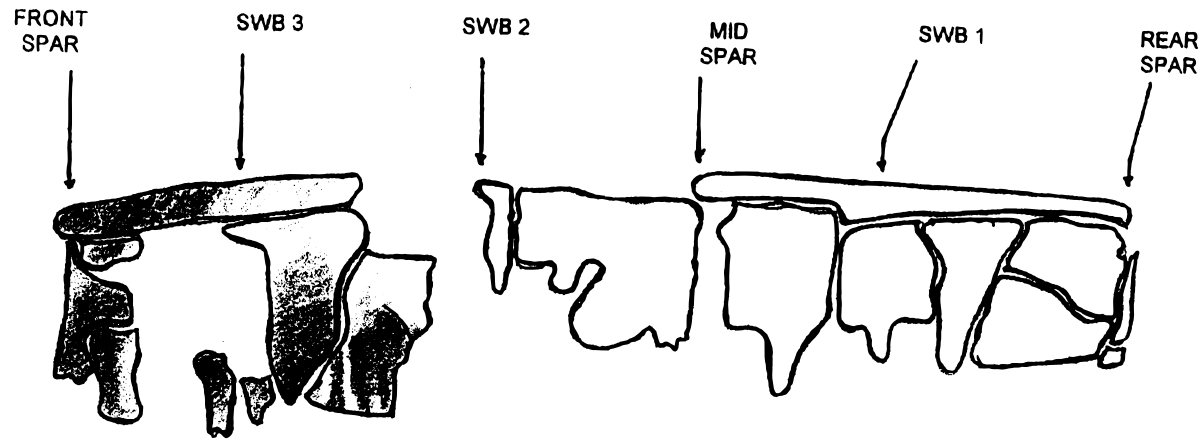
CENTER WING TANK SOOTING PATTERN DIAGRAM
RIGHTHAND SIDE OF BODY RIB - INBOARD SURFACE

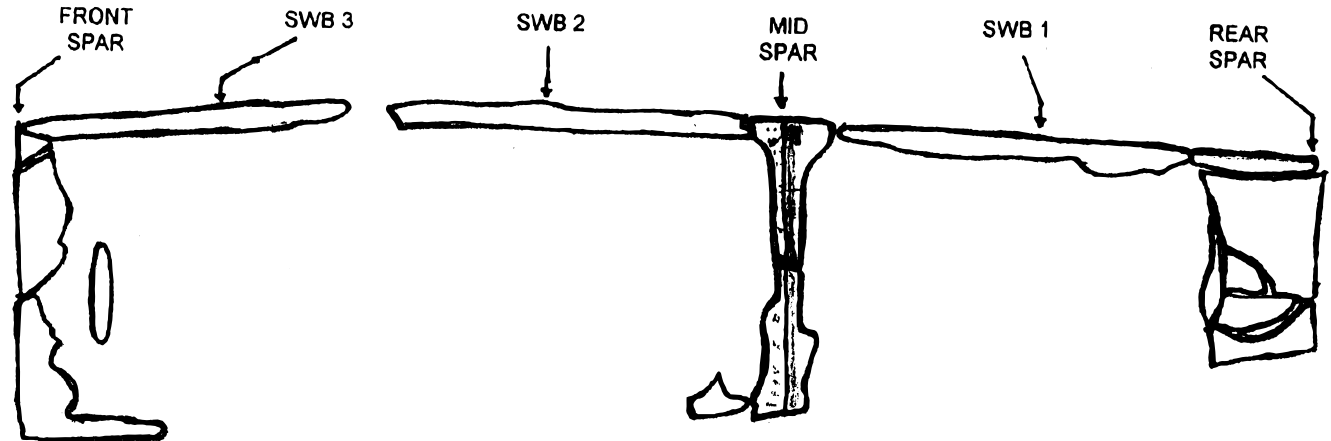
CENTER WING TANK SOOTING PATTERN DIAGRAM
LEFTHAND SIDE OF BODY RIB - OUTBOARD SURFACE

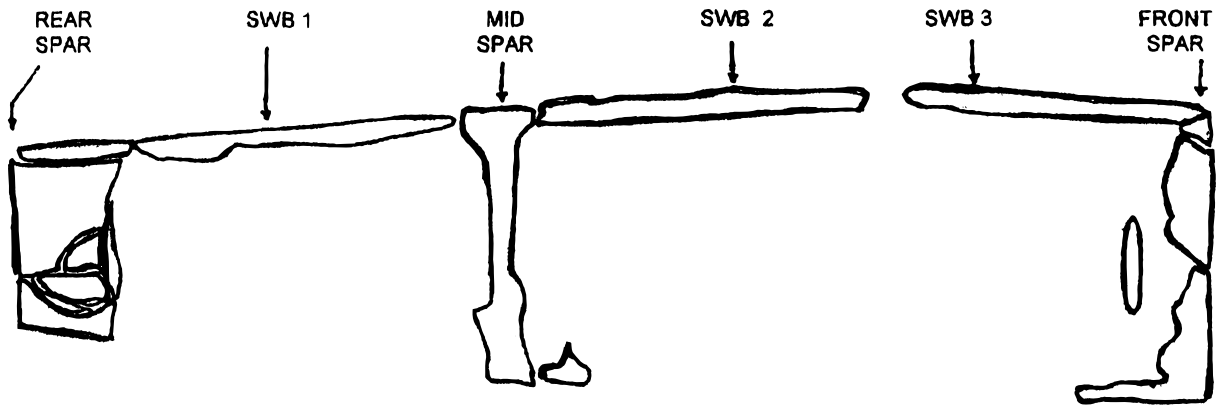
CENTER WING TANK SOOTING PATTERN DIAGRAM
LEFTHAND SIDE OF BODY RIB - INBOARD SURFACE

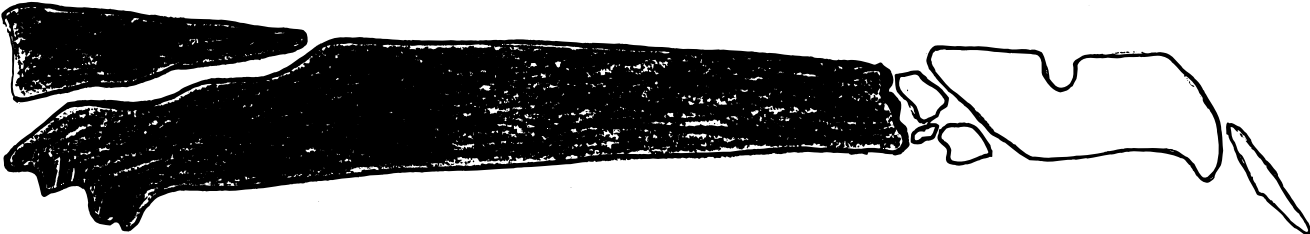
RIGHT WING SOOTING PATTERN DIAGRAM

UPPER SKIN - EXTERNAL SURFACE

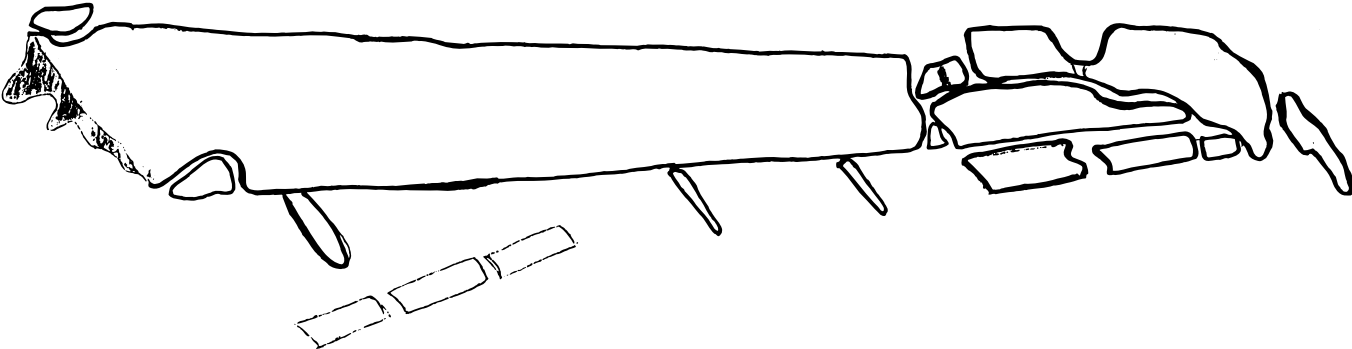
LOWER SKIN - EXTERNAL SURFACE

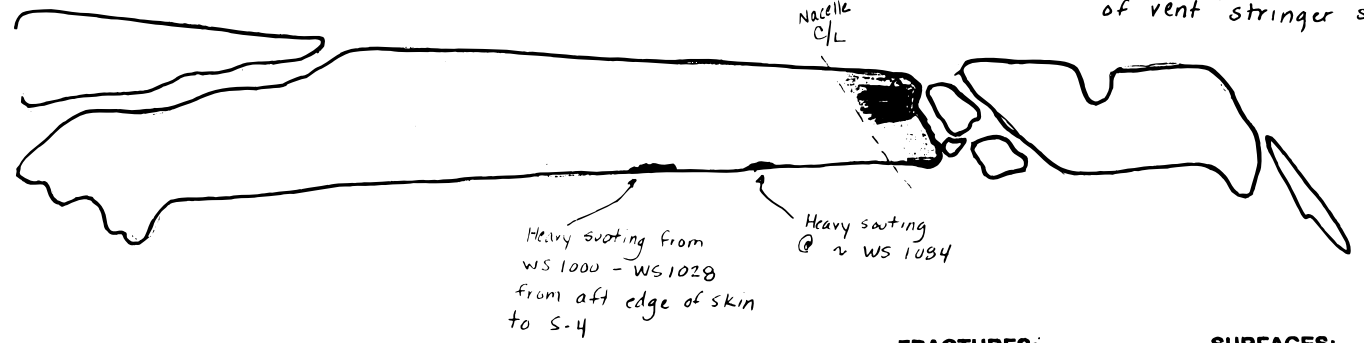
RIGHT WING SOOTING PATTERN DIAGRAM

UPPER SKIN - INTERNAL SURFACE

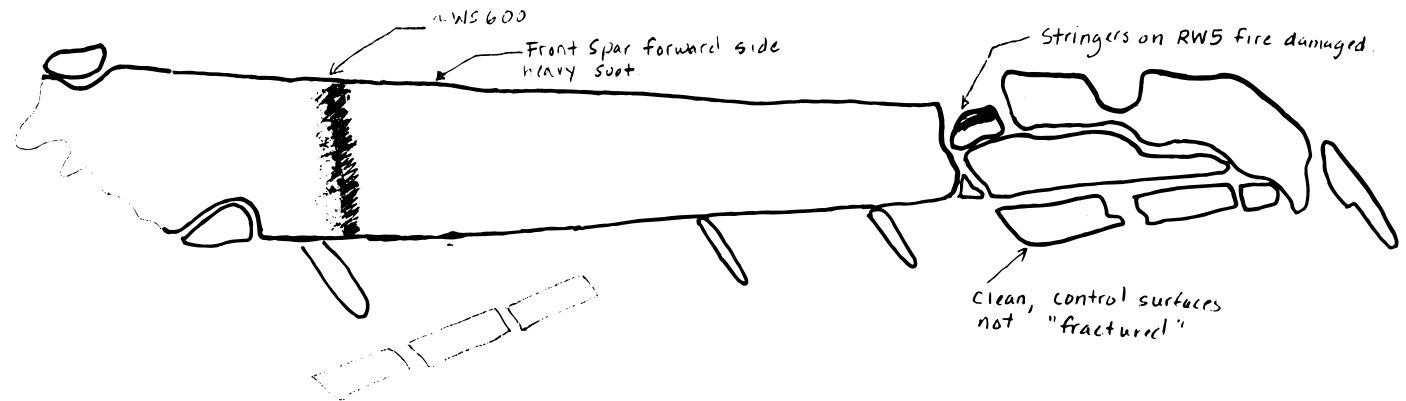
LOWER SKIN - INTERNAL SURFACE

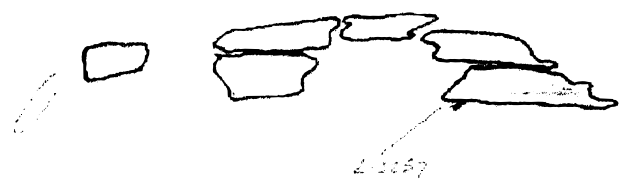
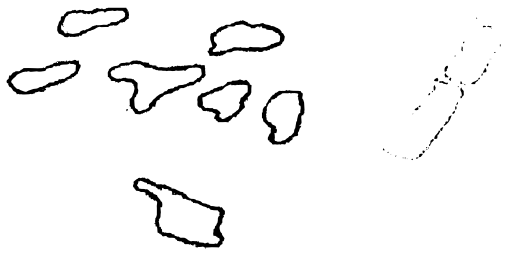
UPPER SKIN - EXTERNAL SURFACE

NOTE: With the exception of the piece noted, the external surface of the upper skin is clean. The control surfaces do show sooting and Arc damage to the composite parts.

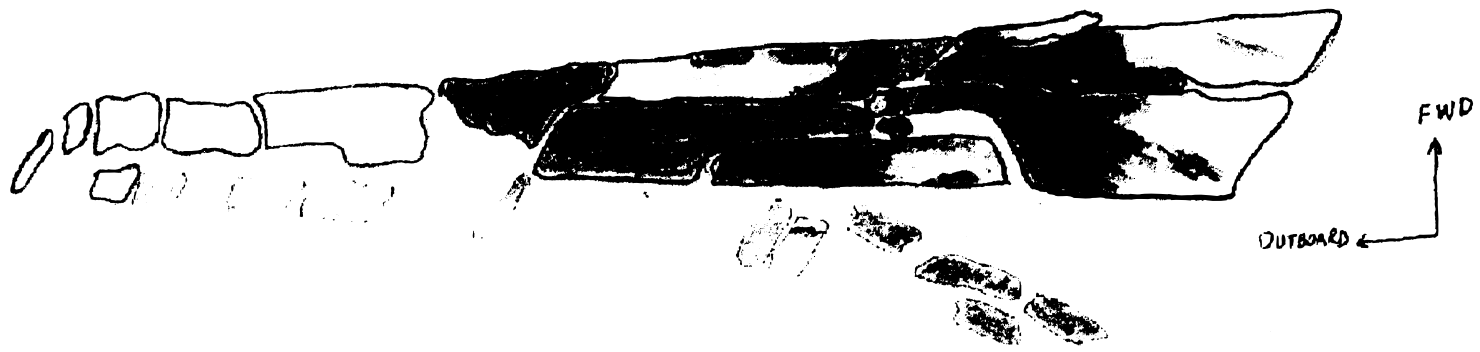
LOWER SKIN - EXTERNAL SURFACE

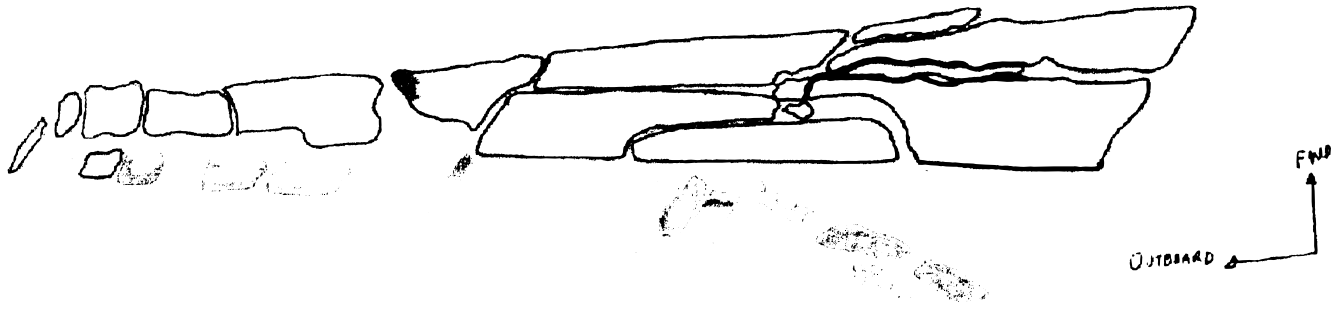
LEFT WING SOOTING PATTERN DIAGRAM

NOTE: With the exception of the piece noted, the internal surface of the upper skin is clean. The control surfaces do show sooting and fire damage to the composite parts.

LOWER SKIN - INTERNAL SURFACE

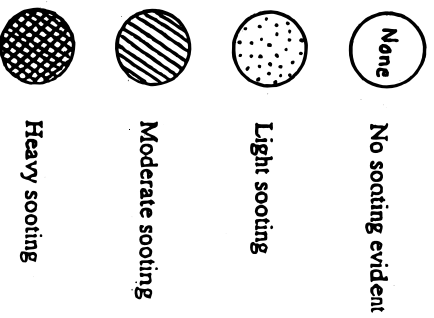
Fuselage sooting diagrams

Surveyed panels are all recovered from the Green debris field and are located from approximately STA 910 to STA 1600. Aft of STA 1600, no sooting is evident internally. On the exterior, there is light to moderate sooting extending aft along the entire length of the fuselage from approximately the main deck window belt on the RHS to approximately S-8 on the LHS

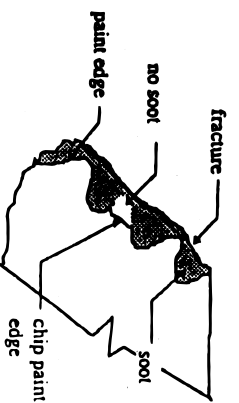
Determination primarily made by examining external paint failures near the fracture edge. Soot deposits remain on underlying paint when the top layer peels near fracture.

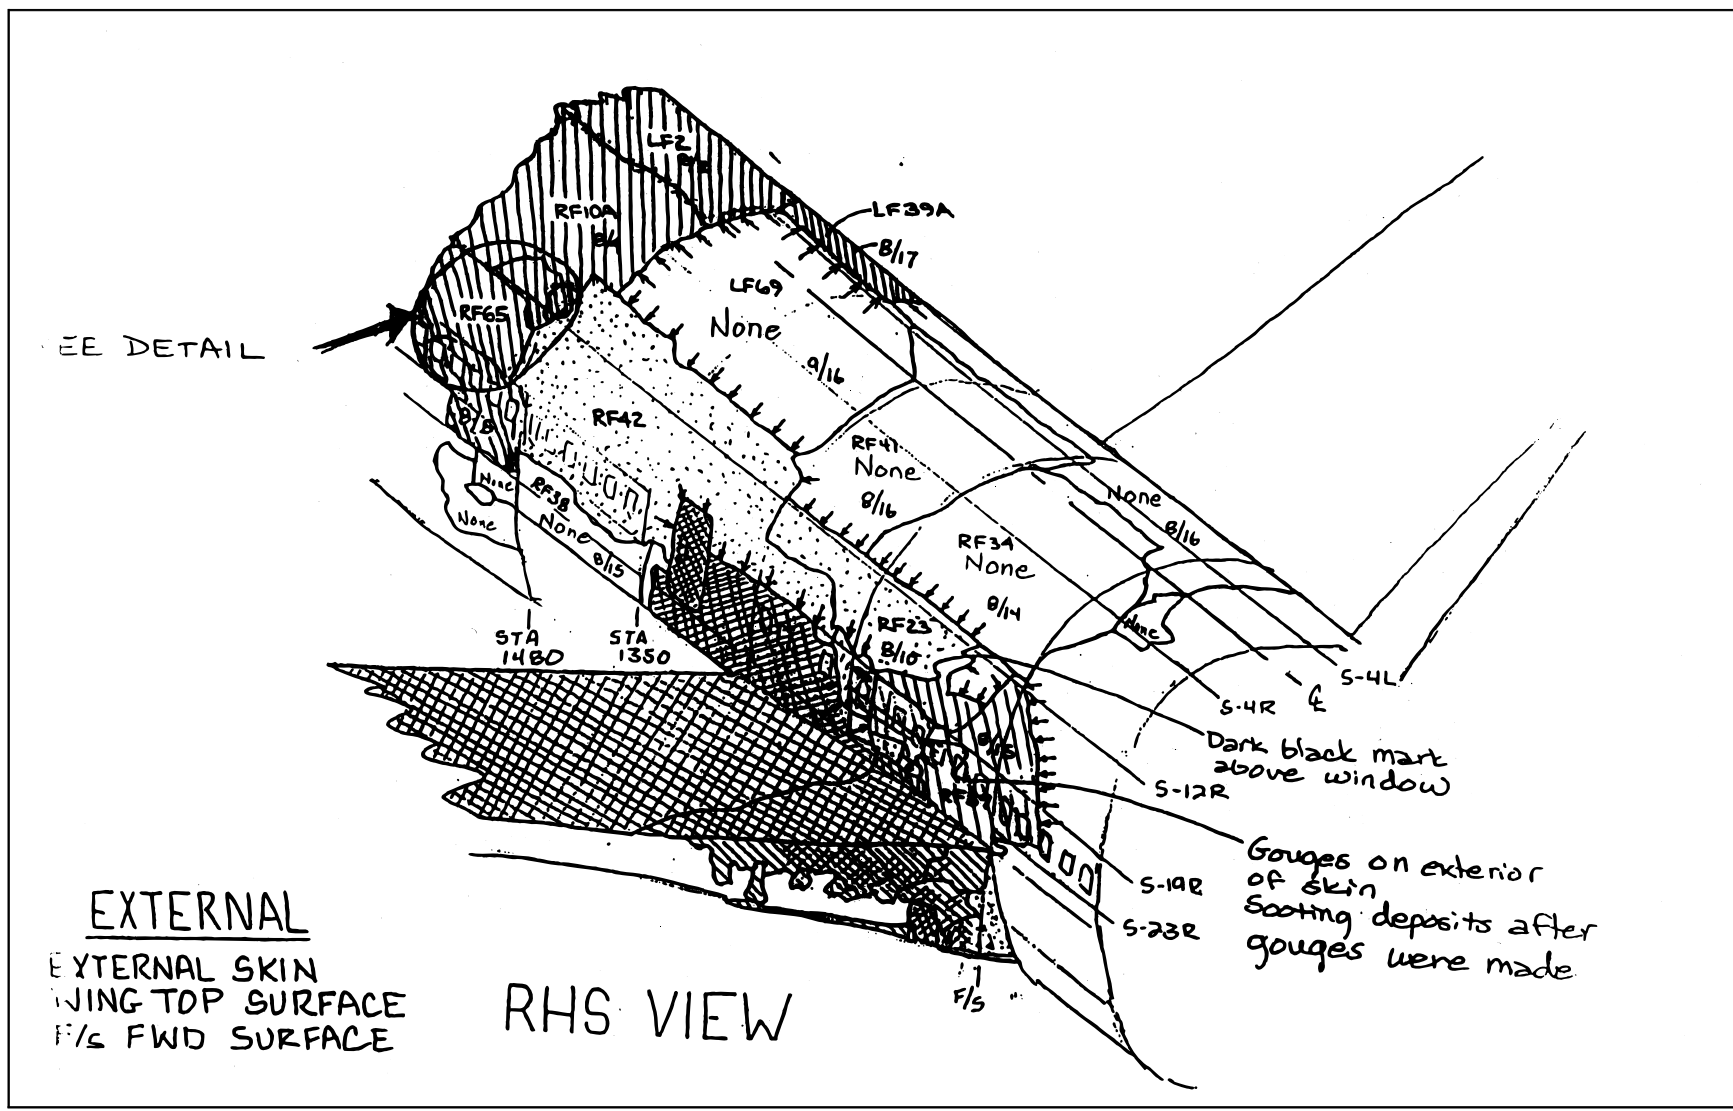
Dark black mark
above window

Gauges on exterior
of skin
sooting deposits after
gauges were made
