Ereignisablauf in beiden Cockpits

AX 001-1-2/02 BFU Flight Recorders

Anlage 7
AX001-1-2/02

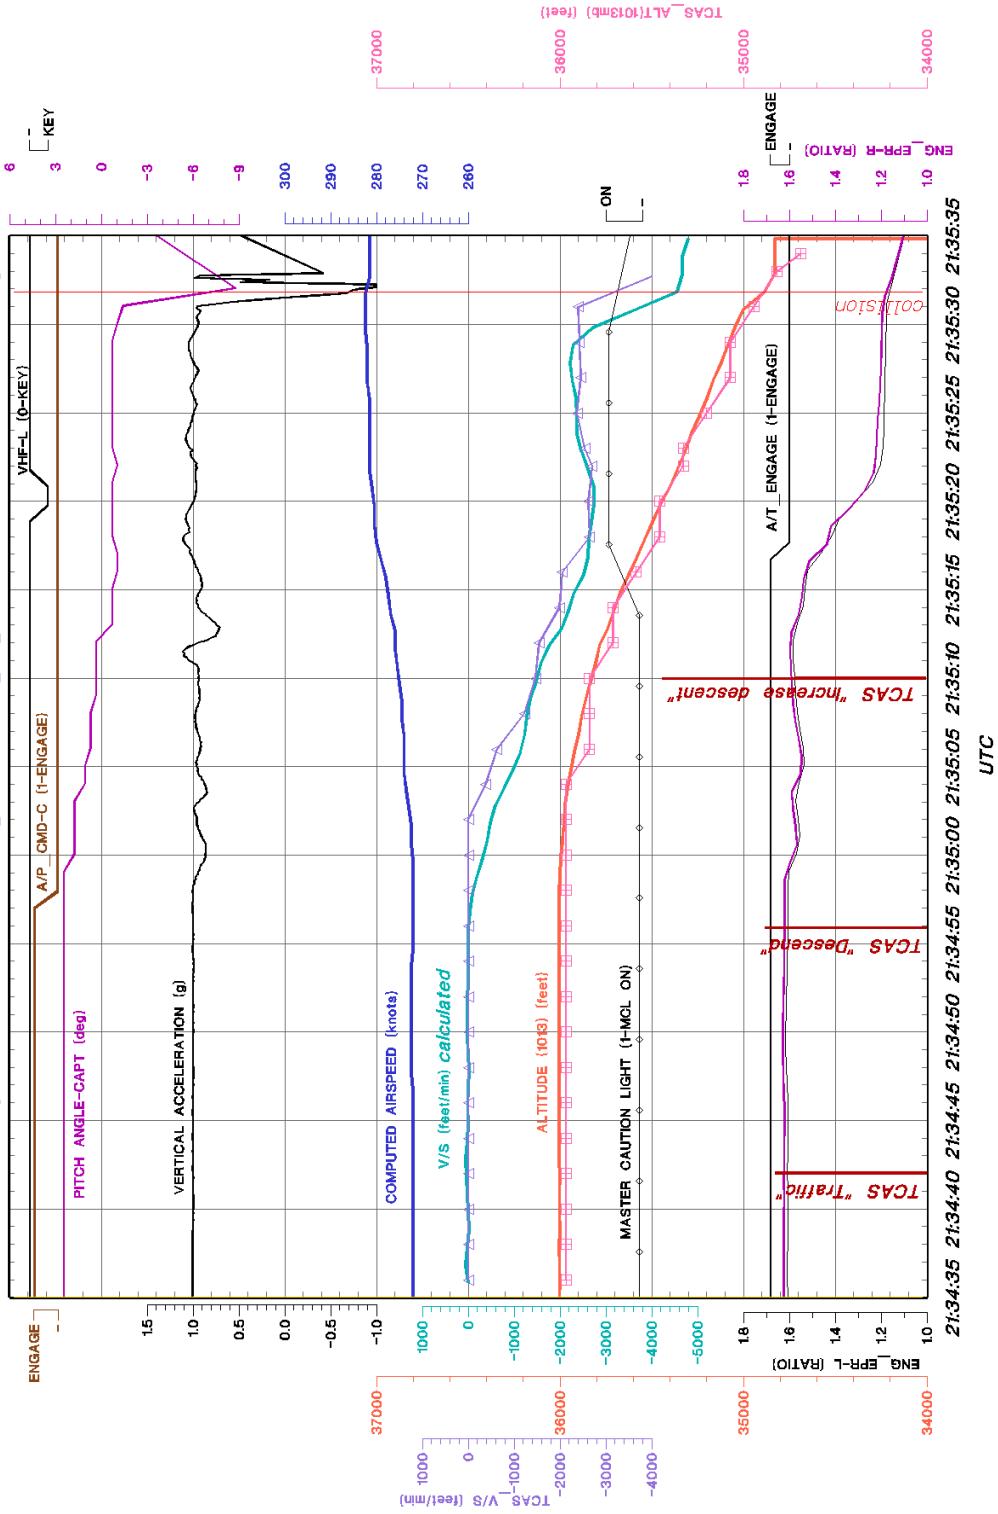
Flugschreiberdaten (Auszüge) der B757-200 (letzte Minute)

21:35:24	0:08		Die Crew erhält vom TCAS das Kommando den Steigflug zu verstärken („increase climb“).
21:35:32	0:00	Kollision mit TU154M in 34 890 ft	Kollision mit B757-200 in 34 890 ft

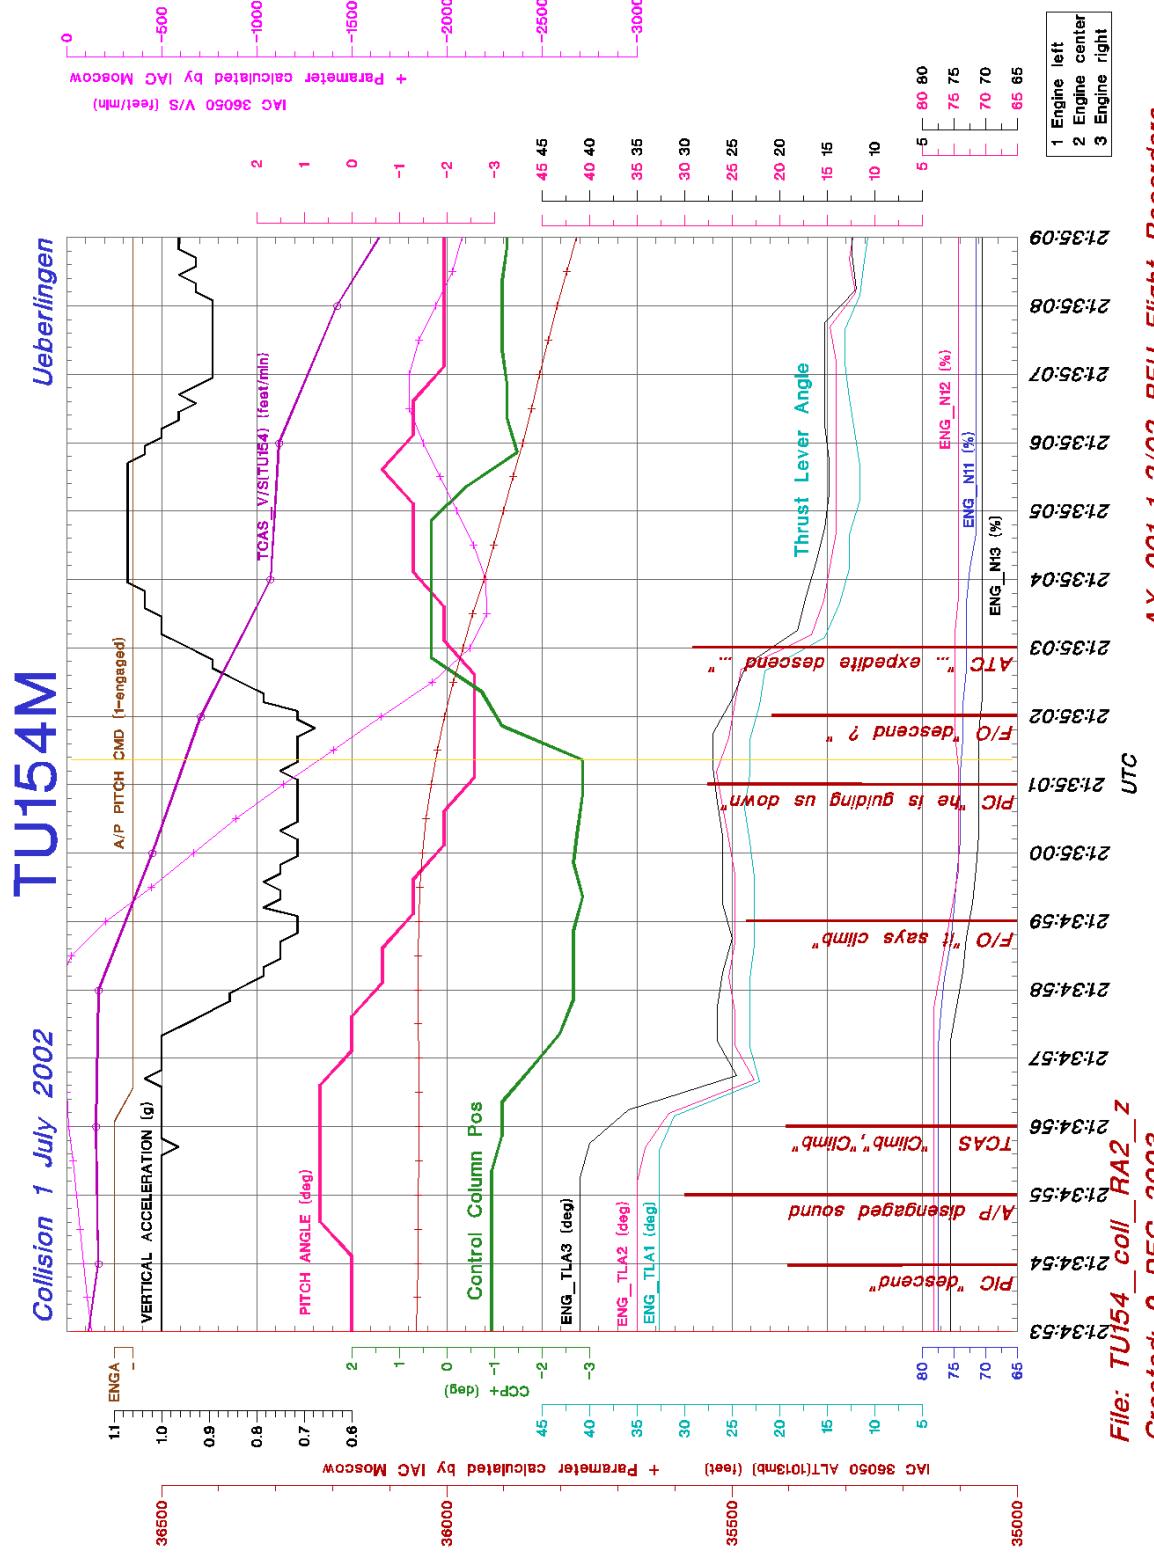
Flugschreiberdaten (Auszüge) der TU154M (Reaktionen auf TCAS-RA)

- *The TU154M crew followed the ATC instruction to descend and continued to do so even after TCAS advised them to climb. This manoeuvre was performed contradictory to the generated TCAS RA. The crew was unable to follow TCAS RA as by that time they were at 35 500 feet and the controller informed them about conflicting traffic above, at FL 360. The false ATCO’s information on the direction towards the conflicting traffic (2 o’clock instead of actual 10 o’clock) and contradictory ATCO and TCAS instructions did not contribute to the correct decision of the crew as well.*

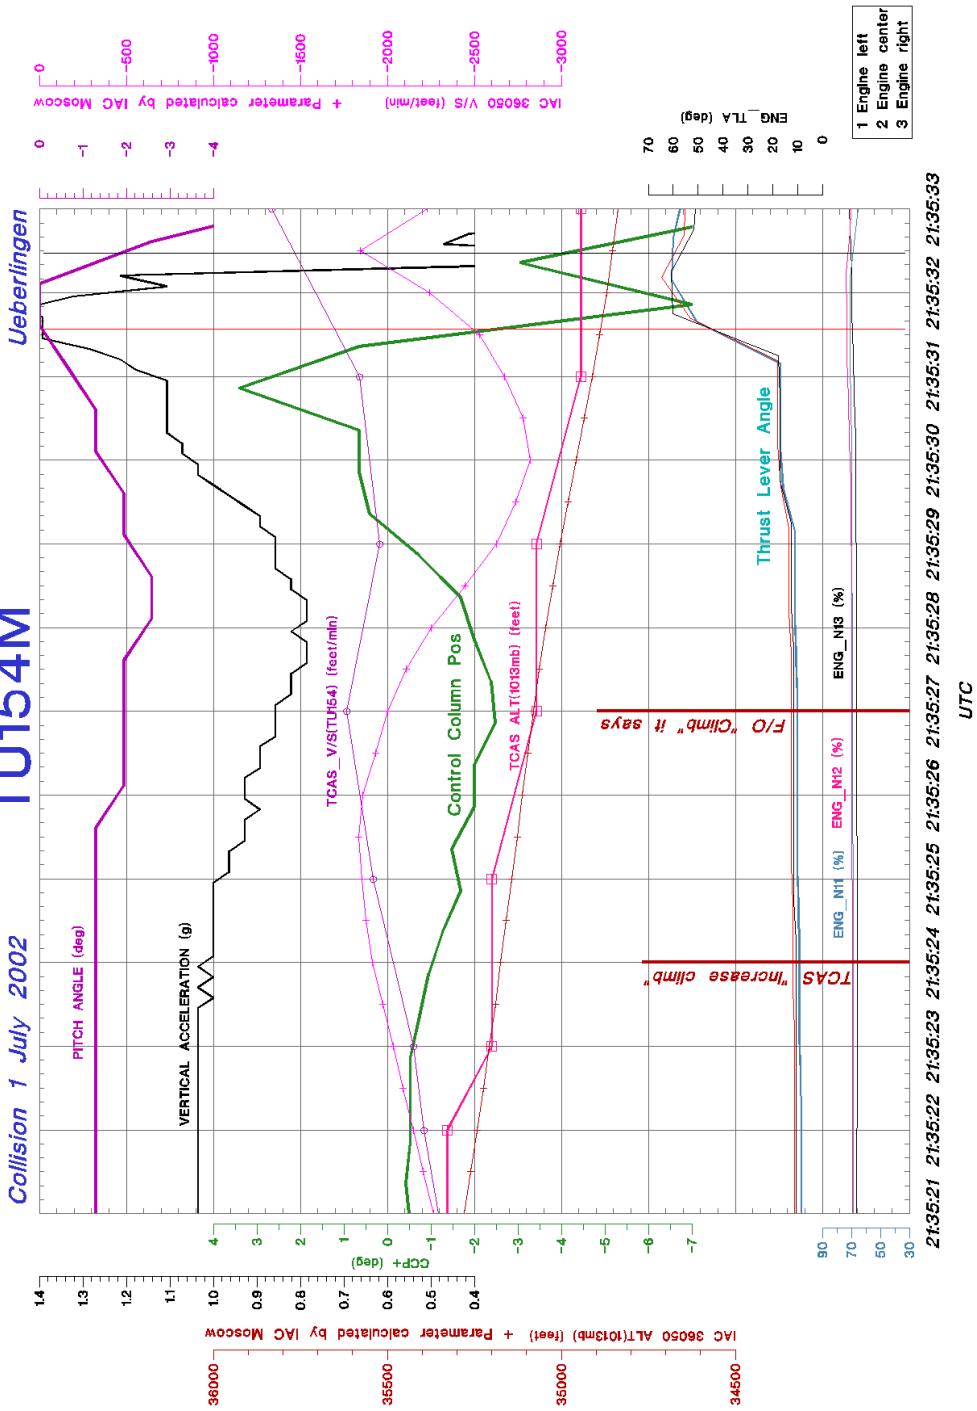
Flugschreiberdaten (Auszüge) der TU154M (Sinkflug und Annäherung auf FL 350)

- *Als die TU154M entgegen der Anweisung der Flugverkehrskontrollstelle unter die zugewiesene Flugfläche 350 sank, betrug ihre Sinkrate ca. 1900 ft/min.*

- *Beim Erreichen der Flugfläche 350 betrug die Sinkrate der TU154M noch ca. 1900 ft/min. In der Folge sank die Crew der TU154M entgegen der Anweisung der Flugverkehrskontrollstelle unter die zugewiesene Flugfläche.*

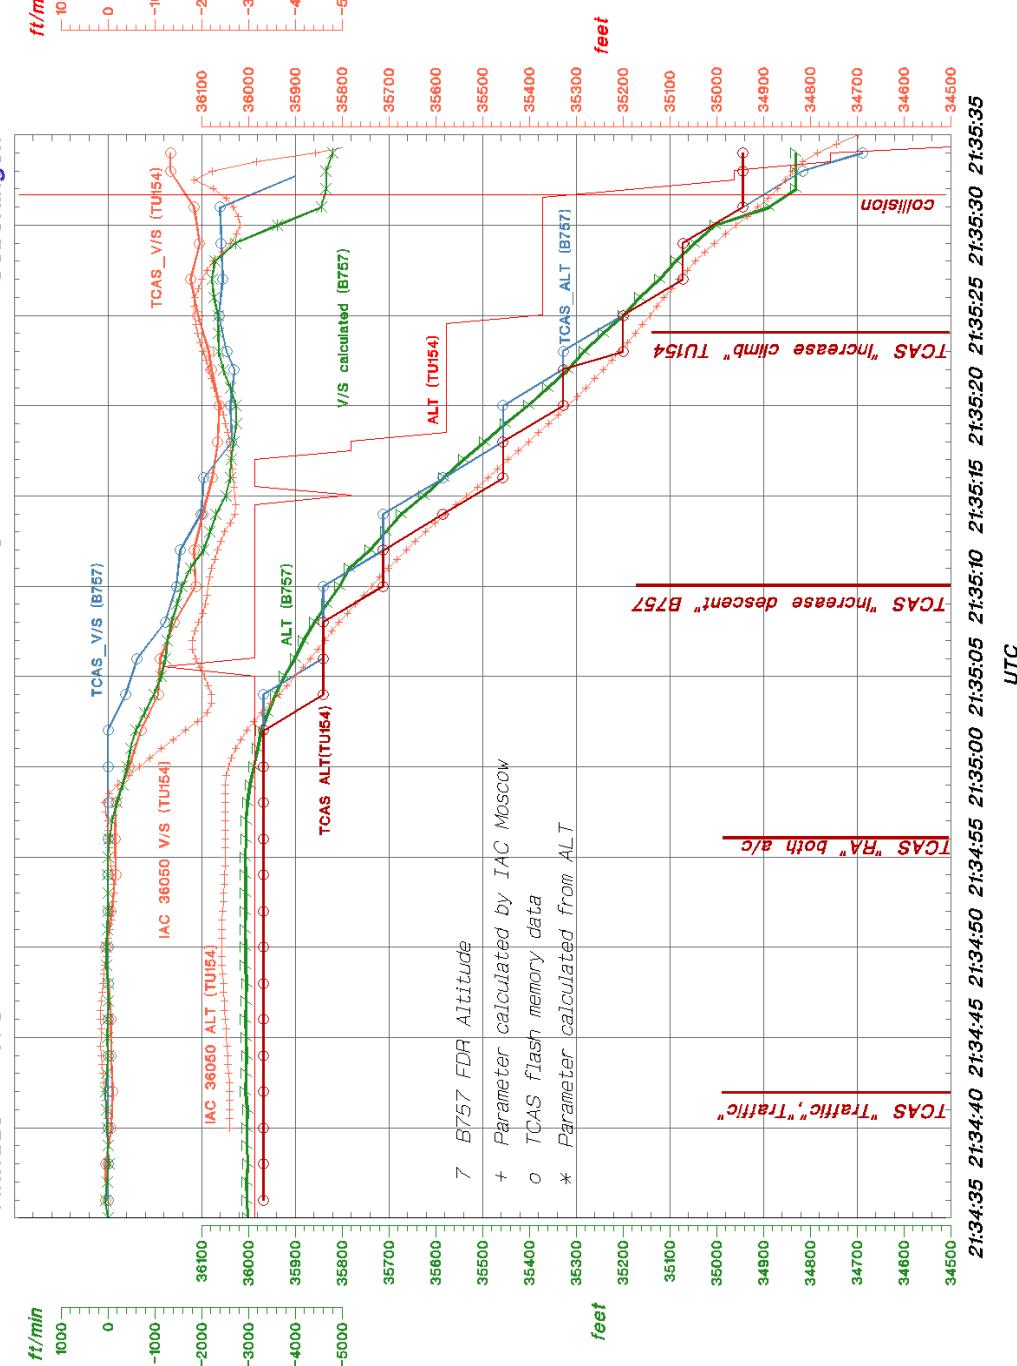
TCAS und FDR-Daten (Auszüge) der B757-200 und TU154M

- *Die Simulation und die Analyse der Anzeigesequenzen zeigten, dass die anfänglichen RA’s eine sichere vertikale Staffelung beider Flugzeuge gewährleistet hätten, wenn sie von beiden Flugbesatzungen genau befolgt worden wären.*
