INTERSTATE COMMERCE COMMISSION
WASHINGTON

REPORT OF THE DIRECTOR
BUREAU OF SAFETY

ACCIDENT ON THE
NEW YORK CENTRAL RAILROAD

APRIL 19, 1940

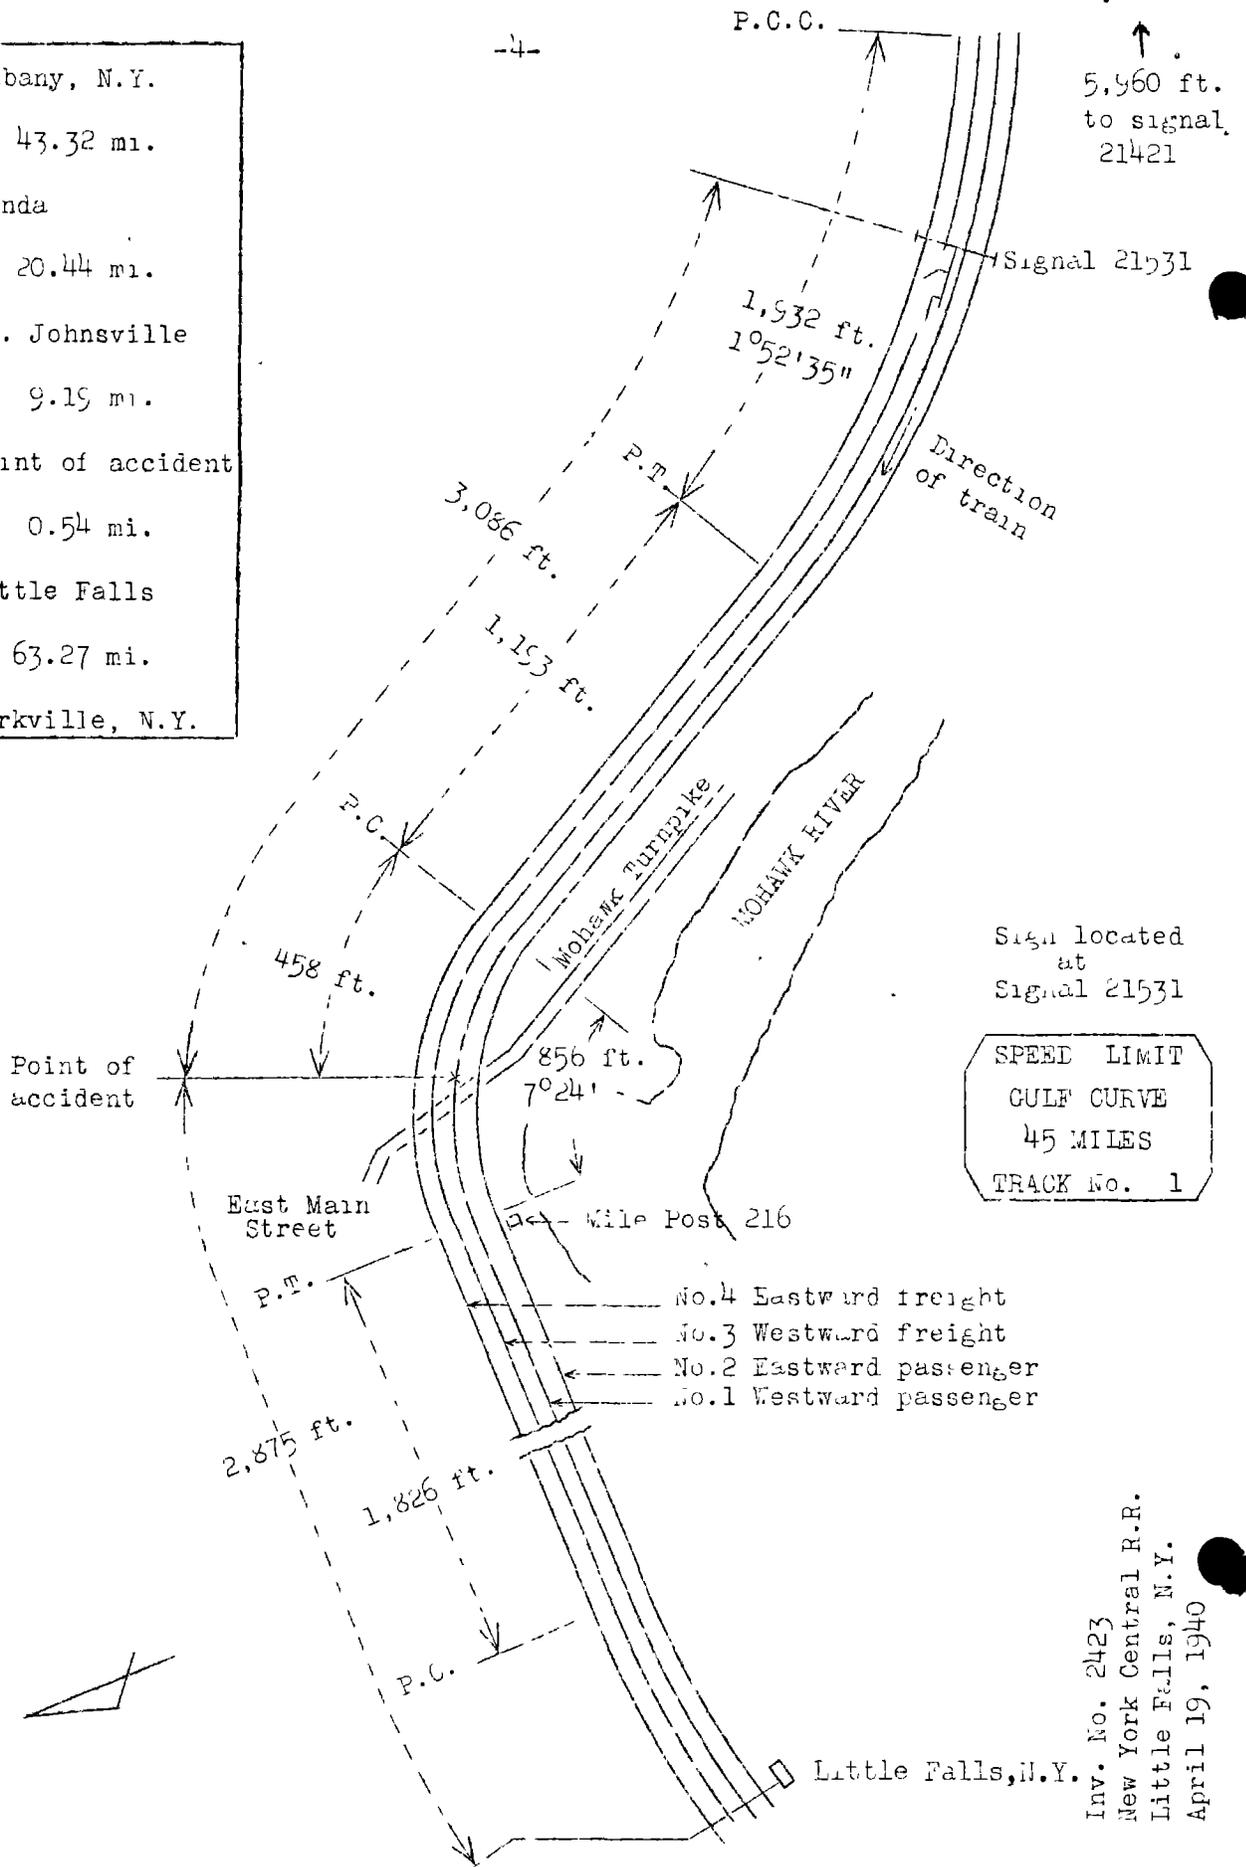
Sign located
at
Signal 21531

SPEED LIMIT
GULF CURVE
45 MILES
TRACK No. 1
