**INTERSTATE AVIATION COMMITTEE
AIR ACCIDENT INVESTIGATION COMMISSION**

**INTERIM REPORT
(PRELIMINARY REFERENCE INFORMATION)
ON ACCIDENT INVESTIGATION**

Type of occurrence	Accident
Type of aircraft	RRJ-95 (RRJ-95B)
Registration	RA-89098
Owner	JSC «VEB-Leasing»
Operator	«Aeroflot » PJSC
Aviation authority	Federal Air Transport Agency (Rosaviatsiya)
Place of occurrence	Russia, Moscow region, Sheremetyevo airport, coordinates: 55°58'06.20" N, 37°24'07.20" E.
Date and time of occurrence	05.05.2019, 18:30 local time (15:30 UTC), daytime

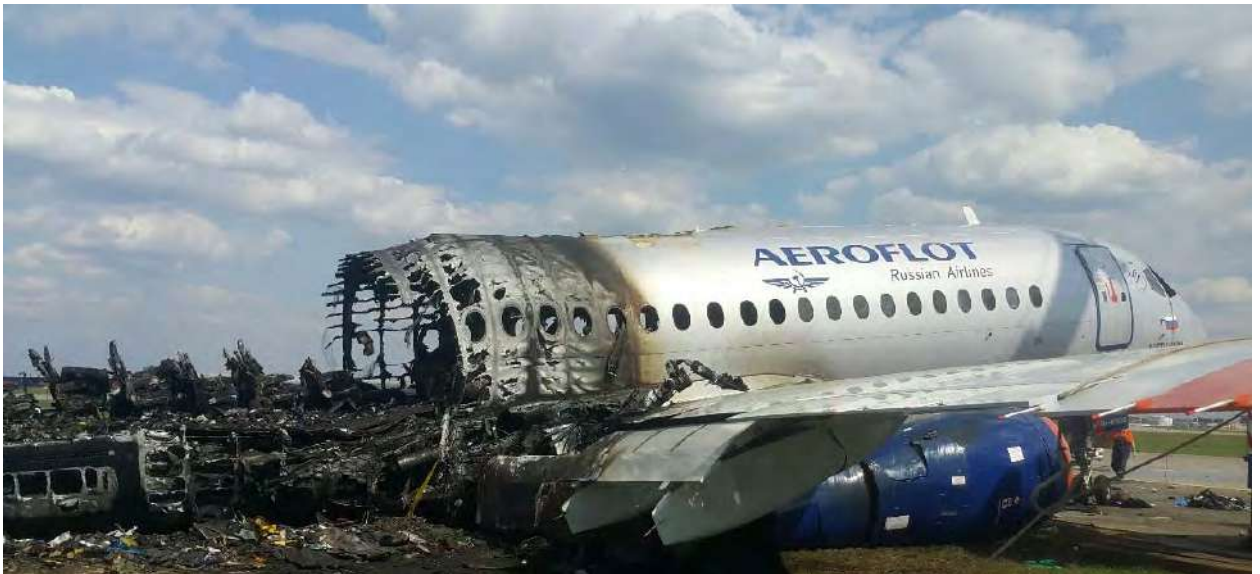
Fig. 10. External view of the fuselage front part after the accident

Fuselage sections F1, F2 (ribs 1-24) do not have external structural damage (Fig. 10)..

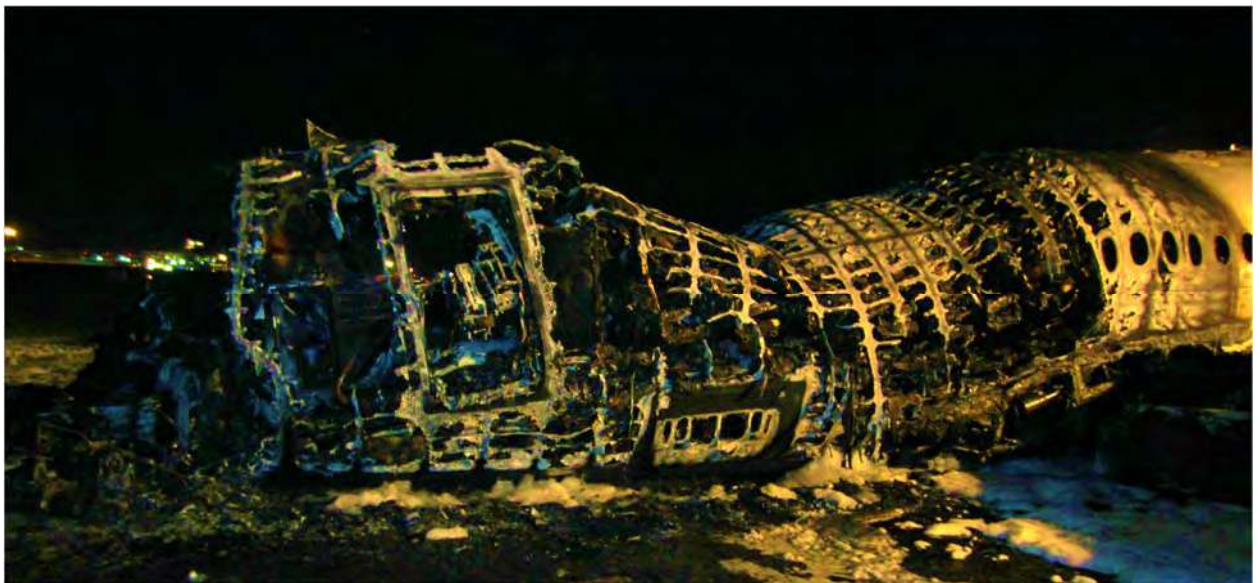
Fig. 11. External view of the middle and rear part of the fuselage after the accident

F3 and F4 (ribs 24-51) burned up completely after rib 29 from the floor level and have substantial skin burnout below the floor level (Fig. 11).

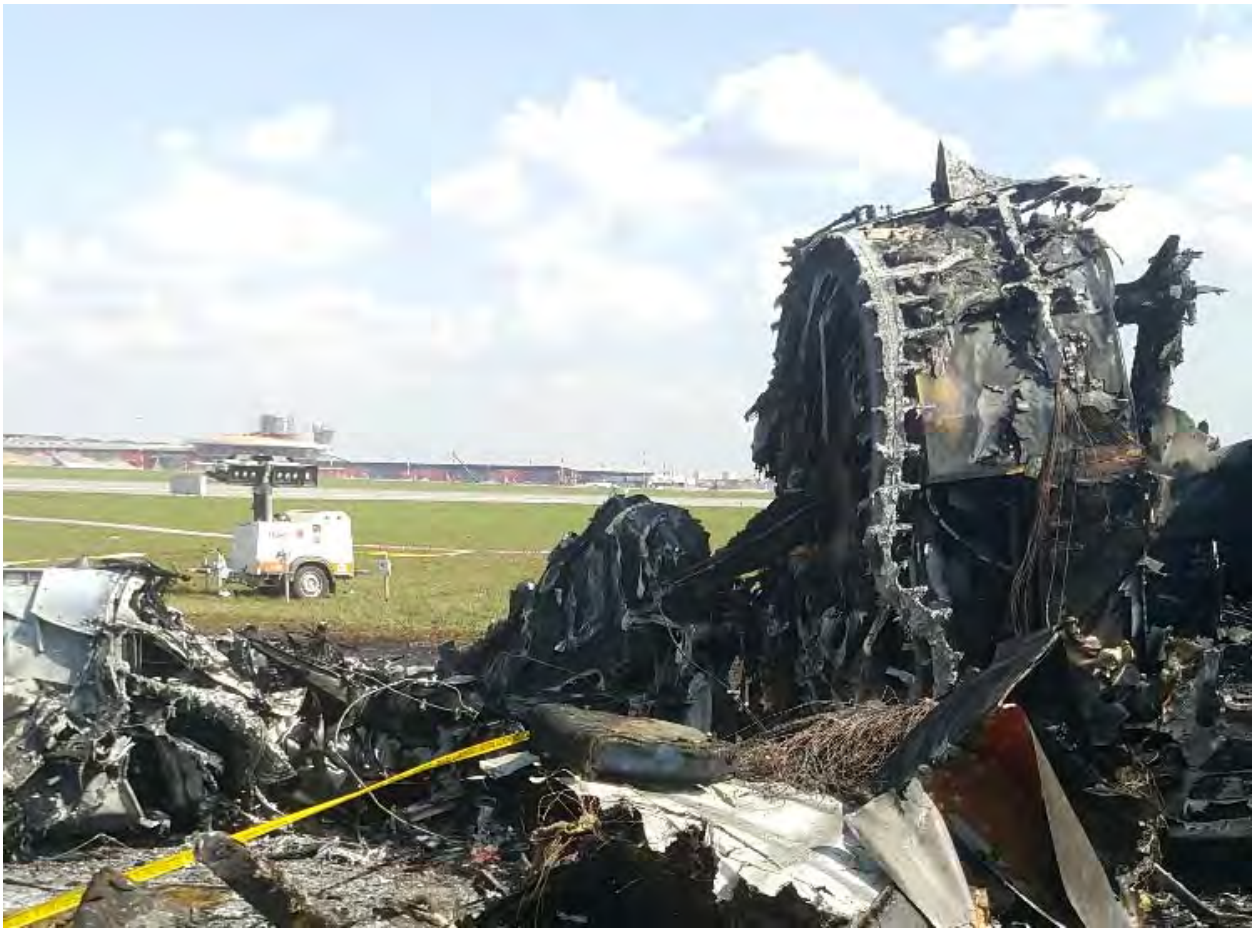
Fig. 12. External view of the F5 section

F5 burned out completely, framework and components fragments situated on the floor and around rib 51 on the ground (Fig. 12).

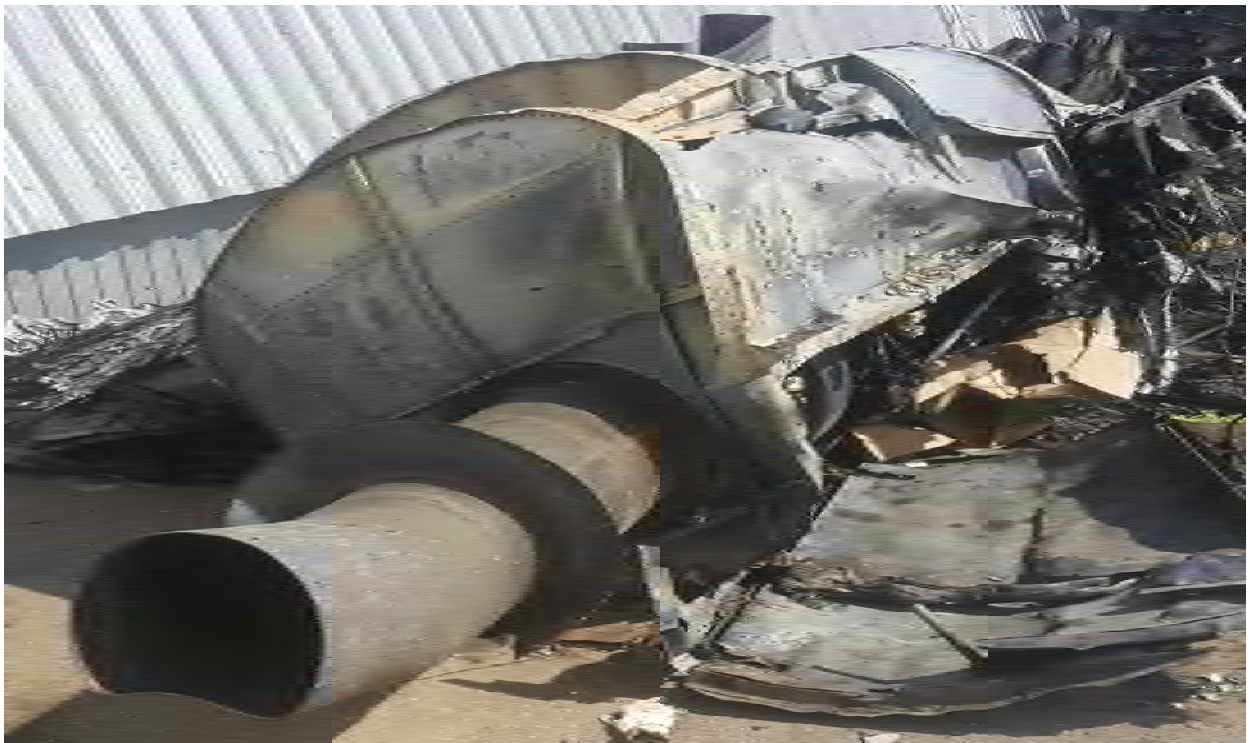
Fig. 13. External view of the F6 section

F6 burned despite the details made of steel and Ti-alloys (Fig. 13), framework and components fragments situated on the floor and on the ground.

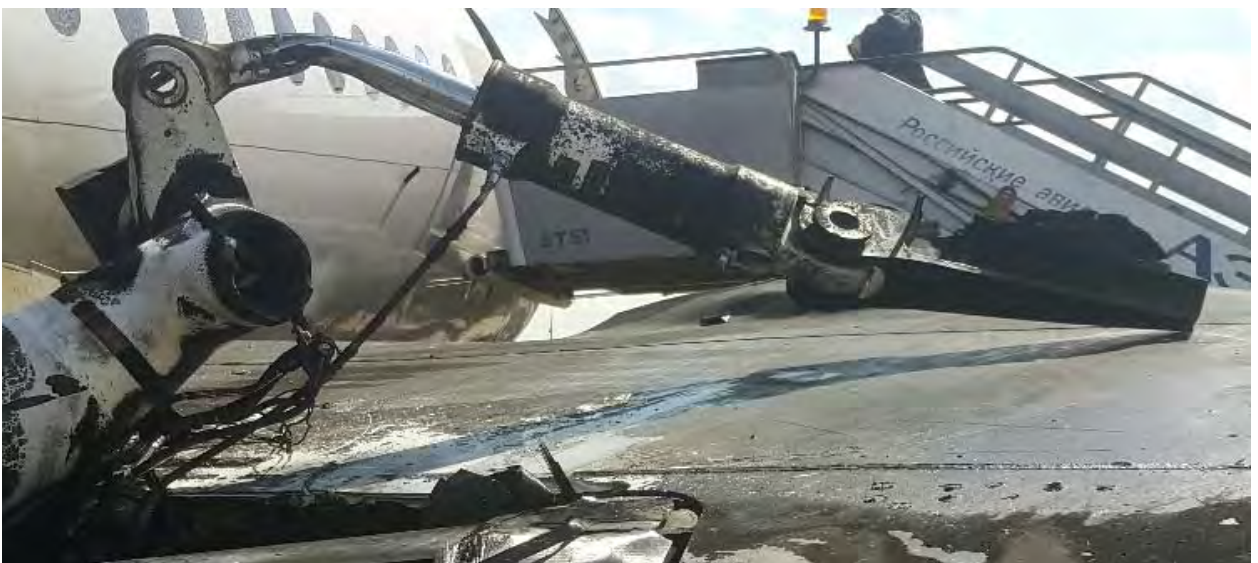
- lower panels of the right-side wing burned out apart from the root segment;
- rear pylon fairing of the right-side wing burnt, flap fairing burned out;
- cylinder bracket of the right main landing gear separated from the rear spar and is situated under the console panel hanging (Fig. 15). After the separation of the cylinder bracket of the right main landing gear there occurred a hole in the spar web, and the fuel spilled through it from the fuel tank of the right-side wing (Fig. 16);

Fig. 15. External view of the cylinder of the right main landing gear

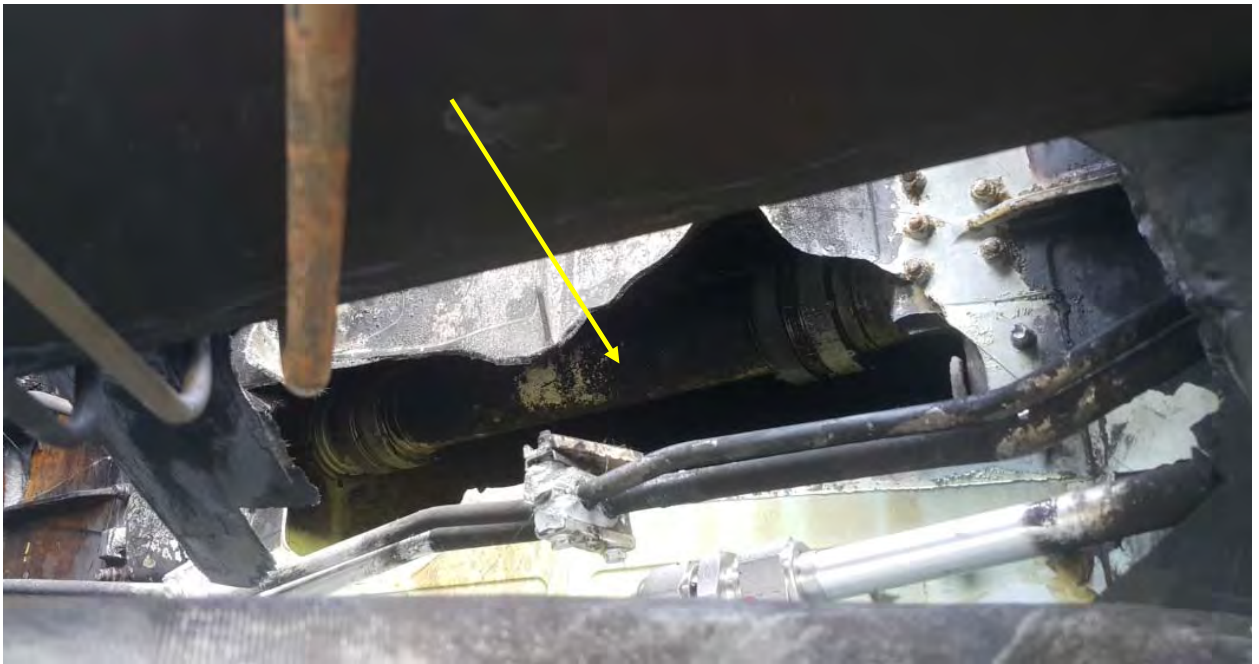
Fig. 16. The hole in the right-side wing spar web (pointed with an arrow)

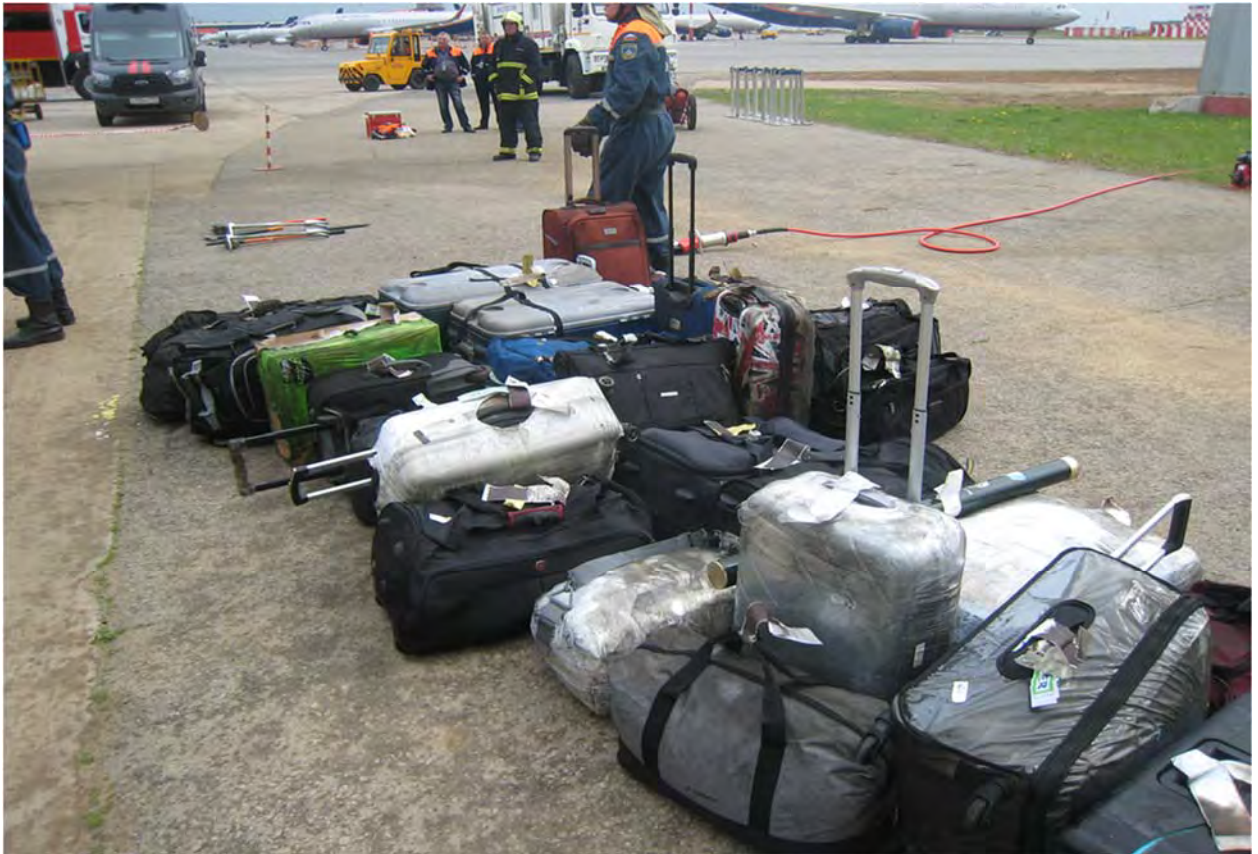
Fig. 18. Passenger baggage from the rear baggage compartment after the accident

Rear baggage compartment damaged partially, there are no signs of open fire in the compartment. There is soot on the front wall of the compartment and the baggage of the passengers (Fig. 18). The access to the rear baggage compartment after the accident was carried out through the upper hatch with no mechanical damage (Fig. 19).

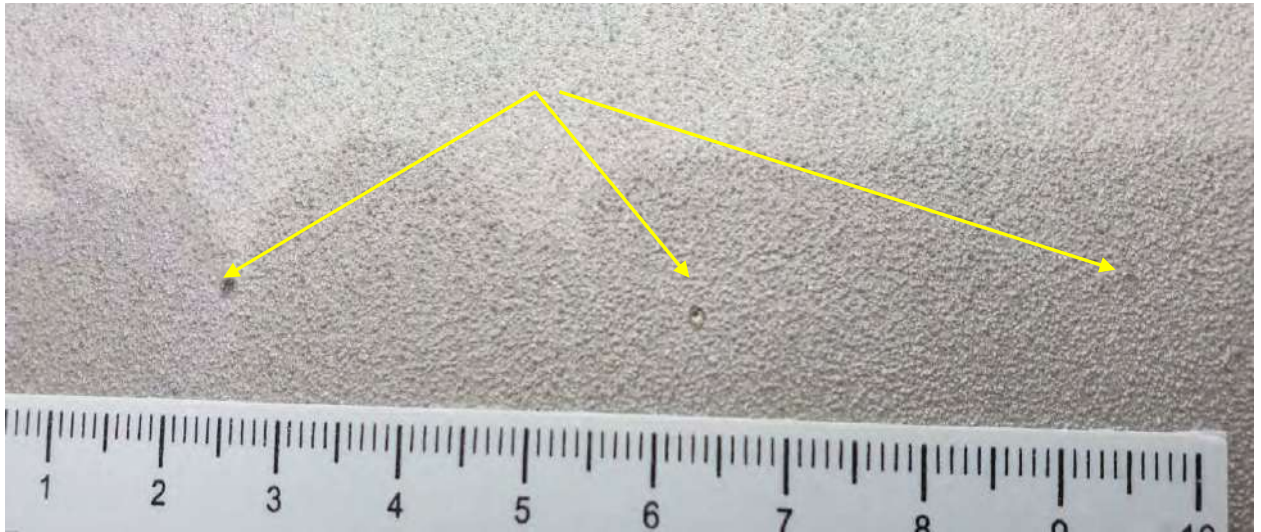
During fuselage examination, including the nose part, after the evaluation of the antennas, transducers (ice detector, temperature probe, angle-of-attack sensor) the exit lights and the cockpit windows there were the traces typical for lightning impact detected (Fig. 23, Fig.24, Fig. 25).

Fig. 23. The external view of the damage caused by the lightning strike to the upper front part of the fuselage

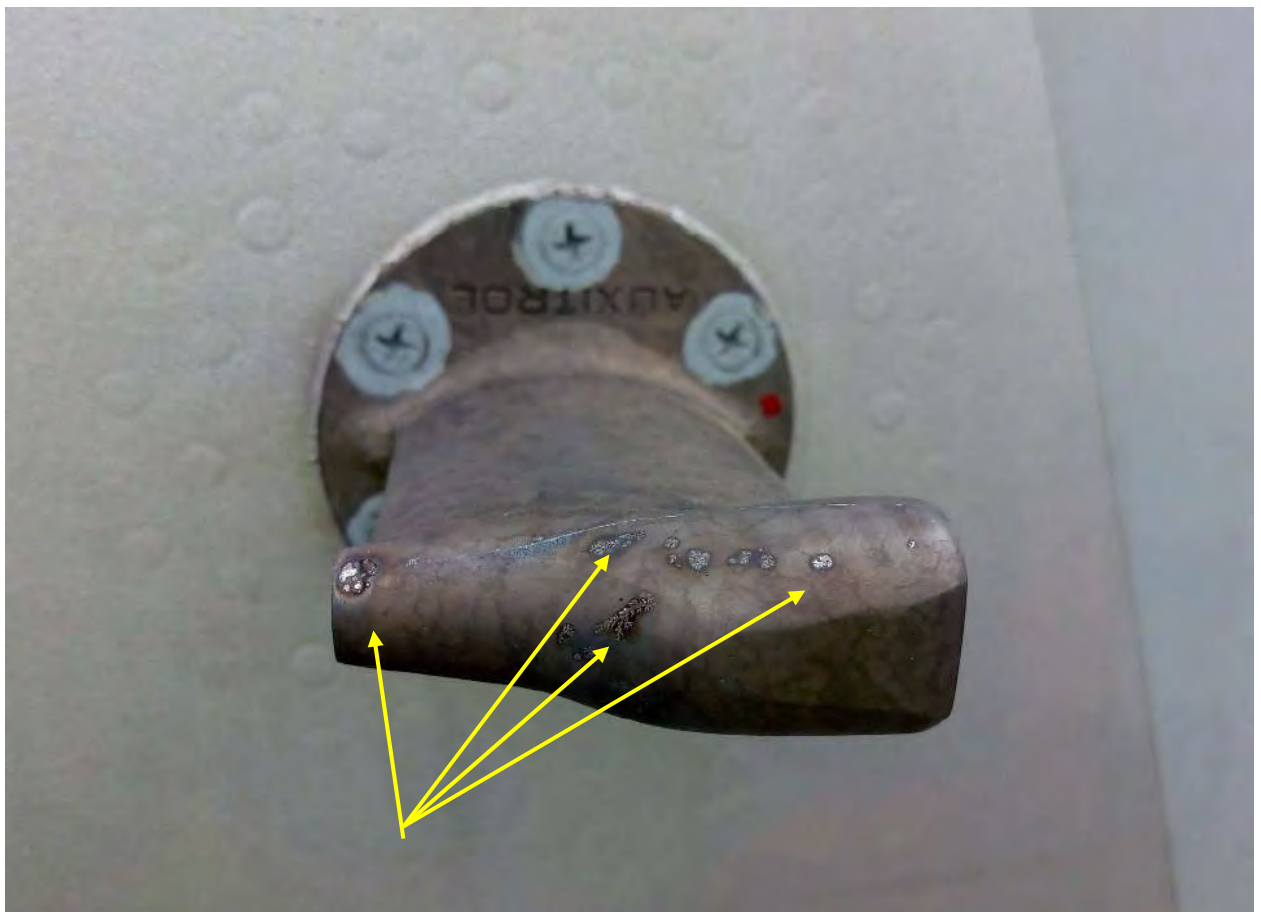
Fig. 24. Lightning strike traces on the right temperature probe

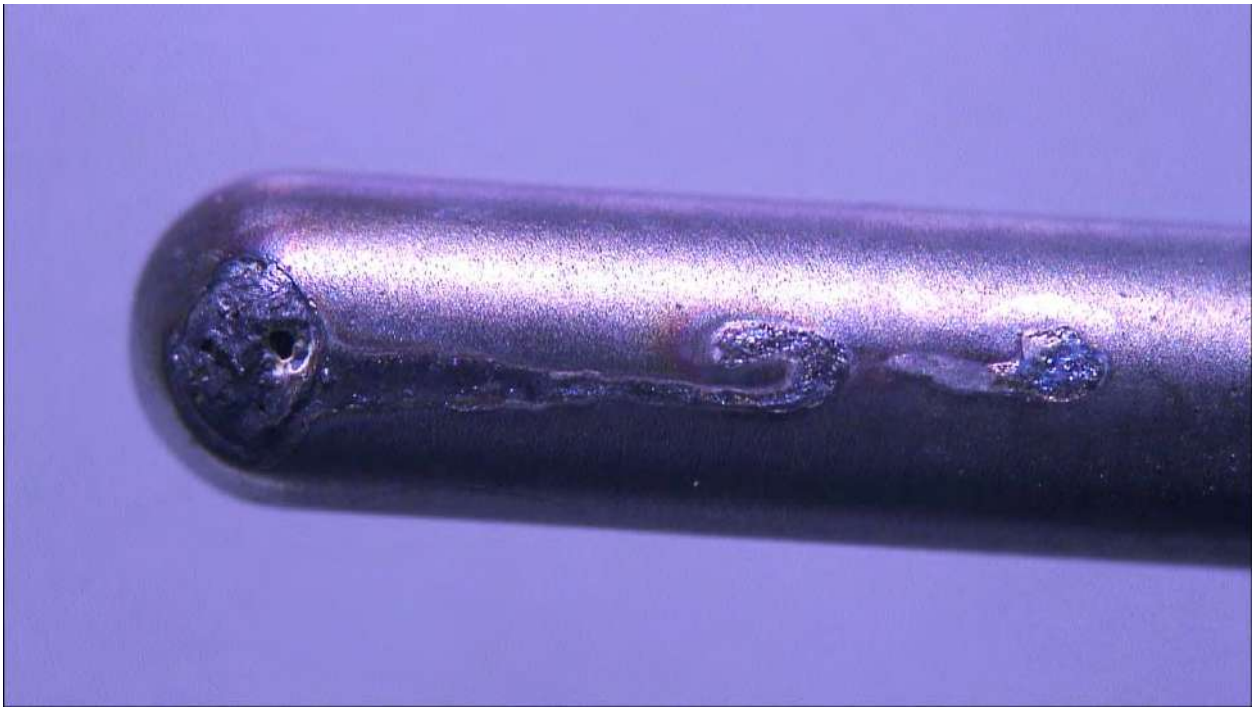
Fig. 25. Lightning strike traces on the right ice detector

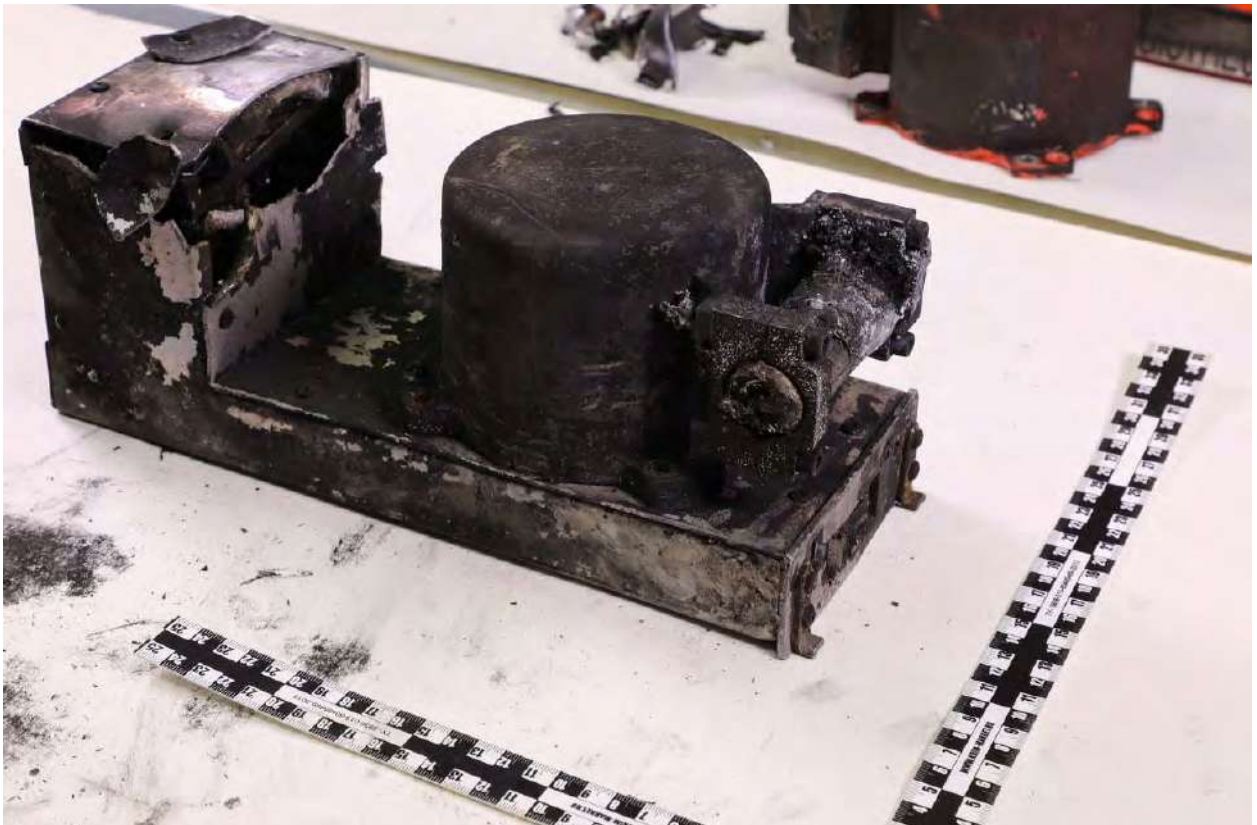
Fig. 30. General view of the FDR L3 FA2100

- FDR L3 FA2100 PNR 2100-2043-12 was damaged, as a result of the heat exposure, the body of the recorder unit was partially destroyed (Fig. 30);

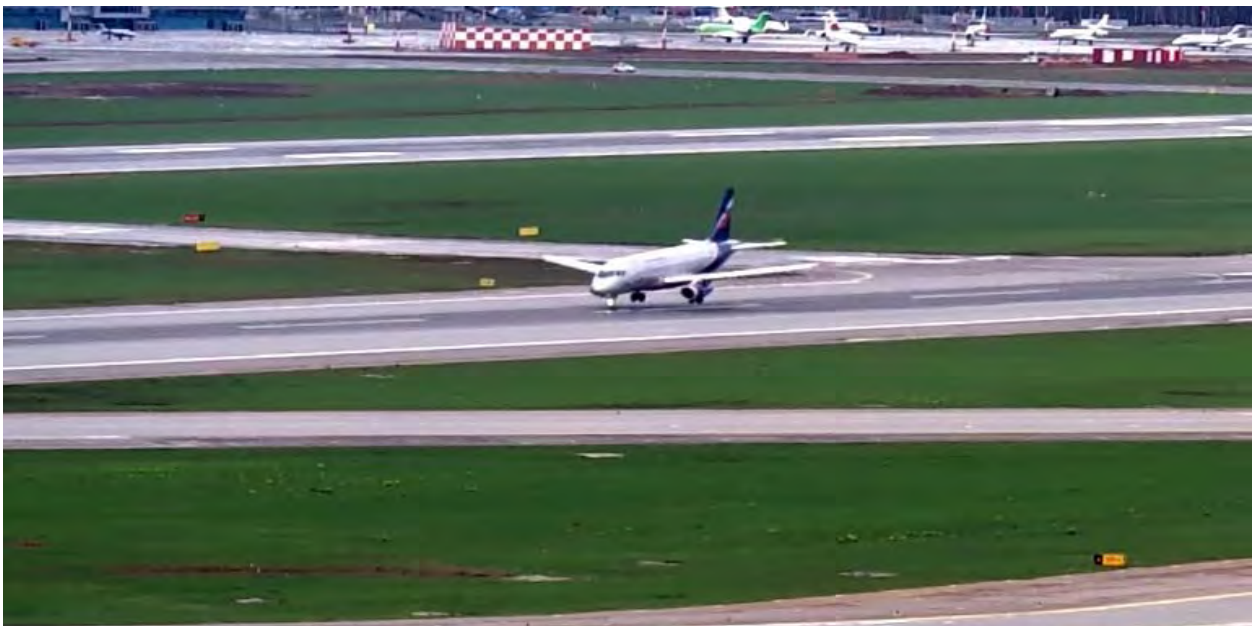
Fig. 35. The place of the second touchdown

The second touchdown occurred at the distance of \approx 1070 m from the RWY 24L threshold, first by the nose gear leg with the further main gear legs impact with the RWY (Fig. 35), another bounce off the RWY occurred afterwards (Fig. 36). At the area of the second impact there were no fuel traces or aircraft fragments found.

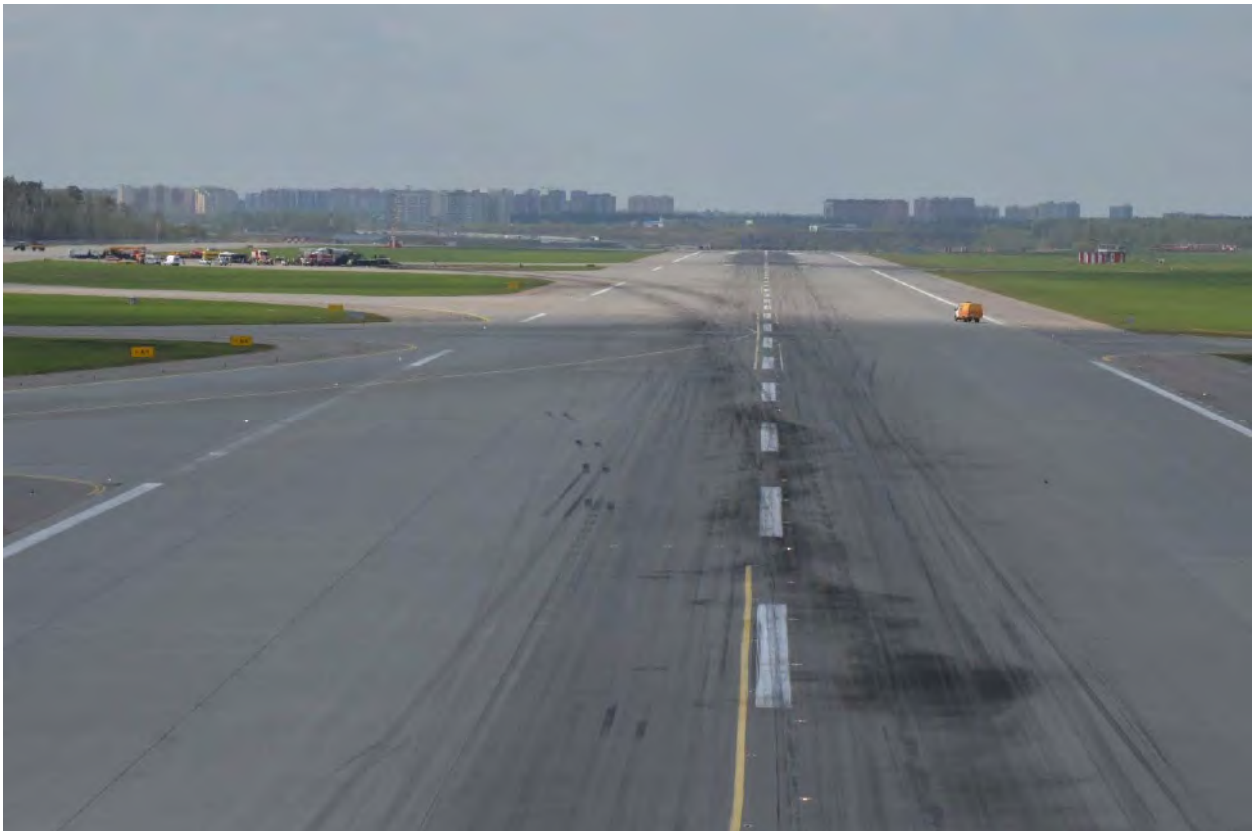
Initially the aircraft moved straightforwardly along the runway centerline on the right side. At the area of TWY A5, the onset of the left shift of the aircraft and its deviation off the RWY centerline was detected (Fig. 38).

Fig. 38. The onset of the left shift traces off the RWY centerline at the area of the A5 TWY

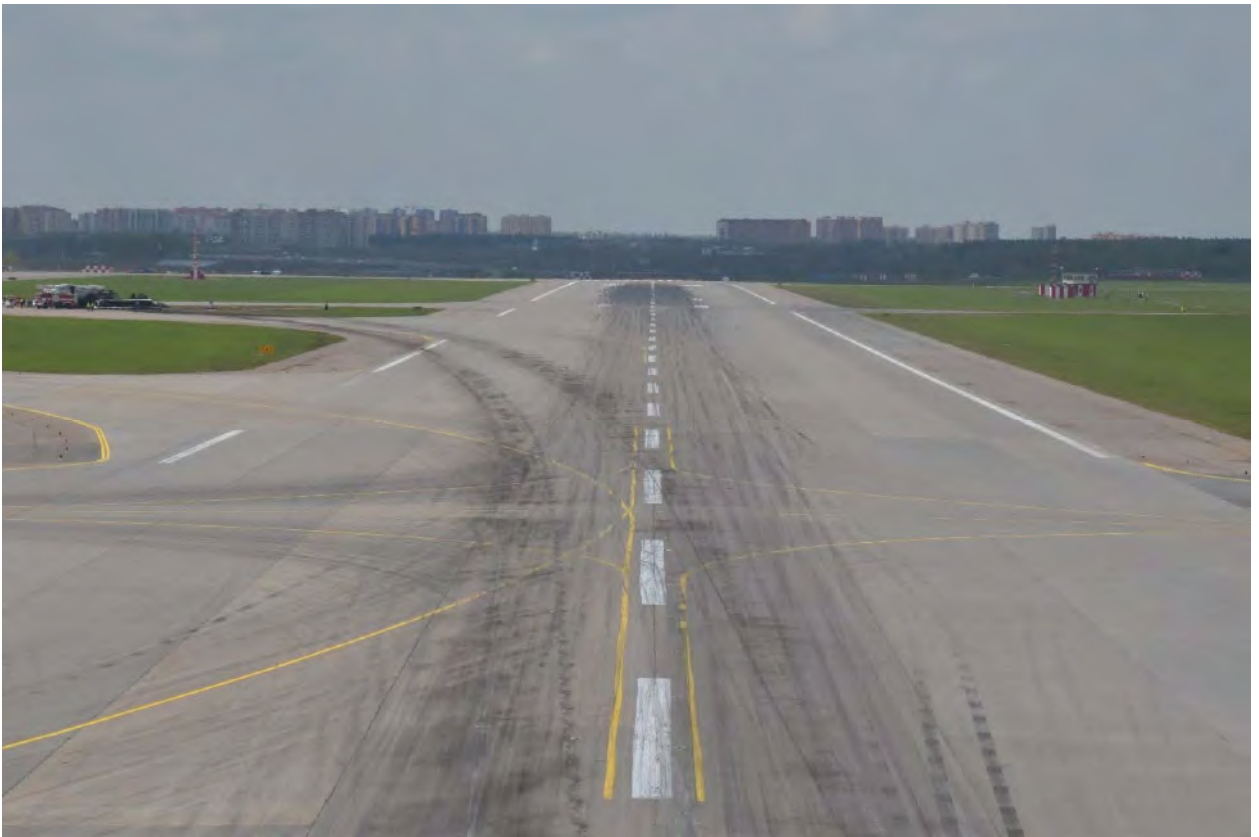
The aircraft excursion of the RWY occurred at the area of the A3 TWY (2460 m off the RWY 24L threshold) (Fig. 39).

Fig. 39. The aircraft motion traces, the point of the RWY excursion at the area of the A3 TWY

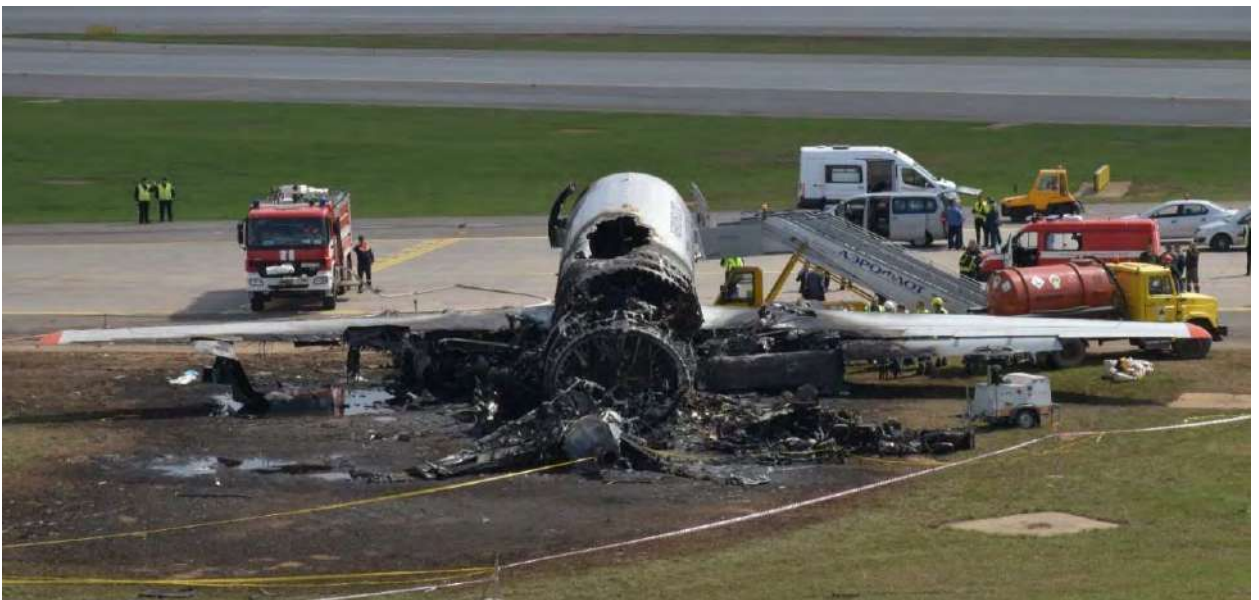
Fig. 40. The RRJ-95B RA-89098 aircraft at the accident site

The AC stopped in between the TWYs \2 and 3, at the $55^{\circ}58'06.20''$ N., $37^{\circ}24'07.20''$ E at the height of 185 m, the true heading of 128° (Fig. 40). The distance from the RWY 24L threshold was ≈ 2720 m, the lateral deviation amounted to about 110 m to the left off the runway centerline.
