# 18 THE F-28 PROGRAM: SPARE PARTS

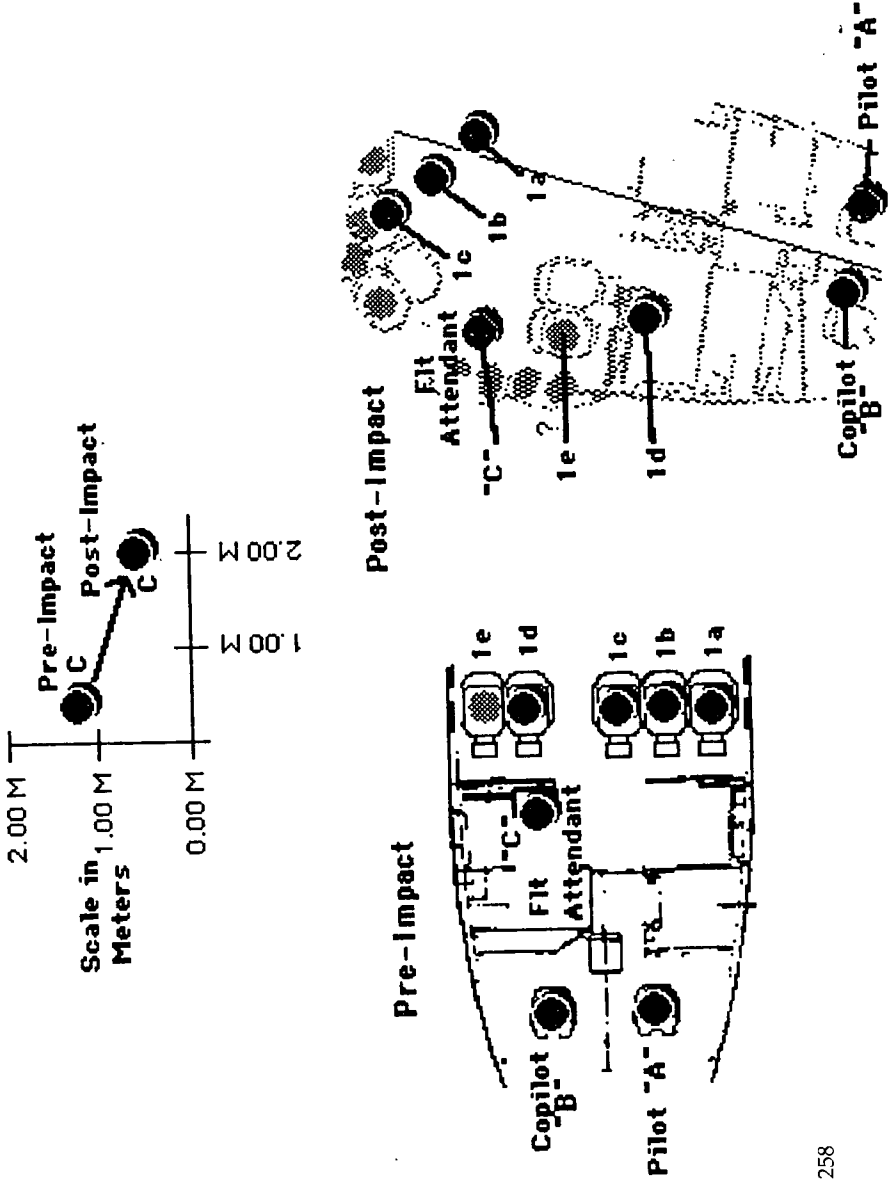
Figure 22-1 Pre- and Post-Accident Locations of Individuals Seated in Forward Positions on Flight 1363

Although other factors may have intervened to cause her head injury during the breakup sequence, it is beyond dispute that, had she been secured by a shoulder harness, her upper body would have been markedly better restrained and protected from injury caused by forward motion on impact. This, after all, is the function of a shoulder harness.
