FINAL REPORT

**ACCIDENT
INVOLVING ATR 72 AIRCRAFT
REGISTRATION MARKS TS-LBB
ditching off the coast of Capo Gallo (Palermo - Sicily)
August 6th, 2005**

AGENZIA NAZIONALE
PER LA SICUREZZA DEL VOLO

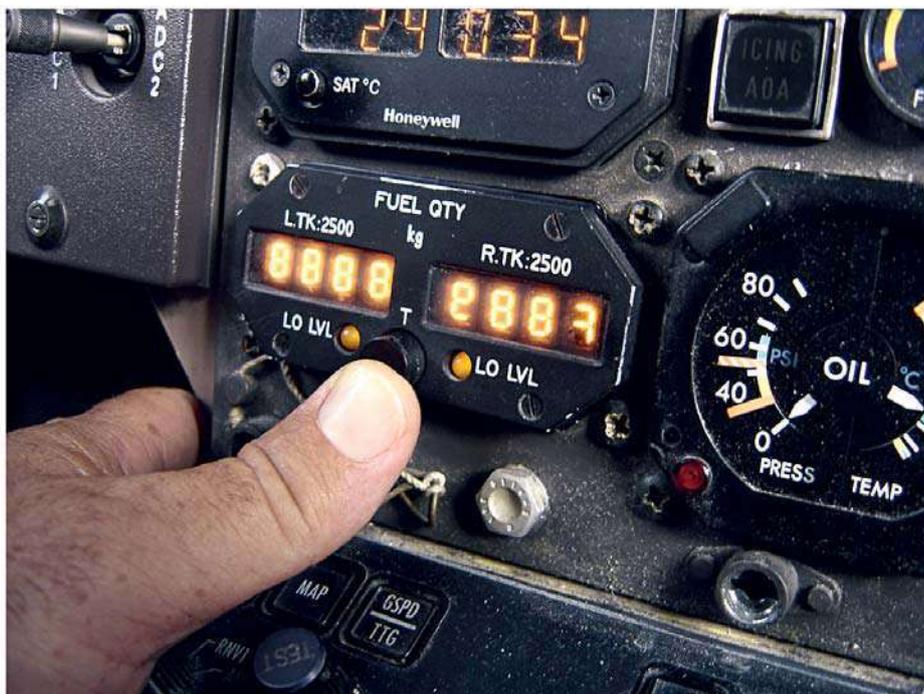
Photo 1: The FQI installed on TS-LBB before replacement.

The same evening the FQI was replaced. In particular, the faulty FQI, P/N 748681-2, S/N 179 was removed and replaced with FQI P/N 749-158, S/N 238, which is however an FQI intended for an ATR 42 type aircraft, and with a mode of operation and characteristics different from the model for the ATR 72 aircraft, although the installation procedure is the same.

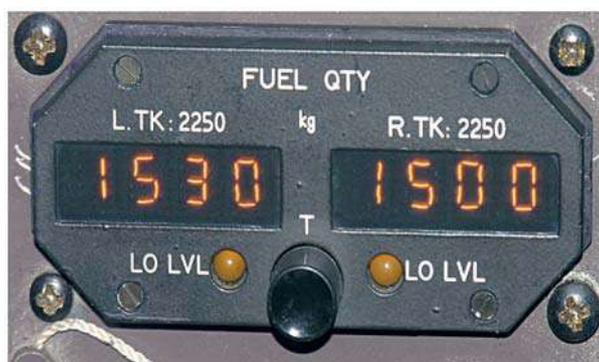
The ATR 42 and ATR 72 type FQIs are identical in their dimension and installation procedure. Therefore an ATR 42 type FQI could be installed by mistake on an ATR 72 aircraft and vice versa. The only difference between the two FQIs, when installed on the aircraft, is white lettering indicating the maximum fuel quantity for each wing fuel tank. This can be found on the front of the instrument and is “2500” for the ATR 72 type FQI and “2250” for the ATR 42 type.

Photo 7: FQI ATR 42.

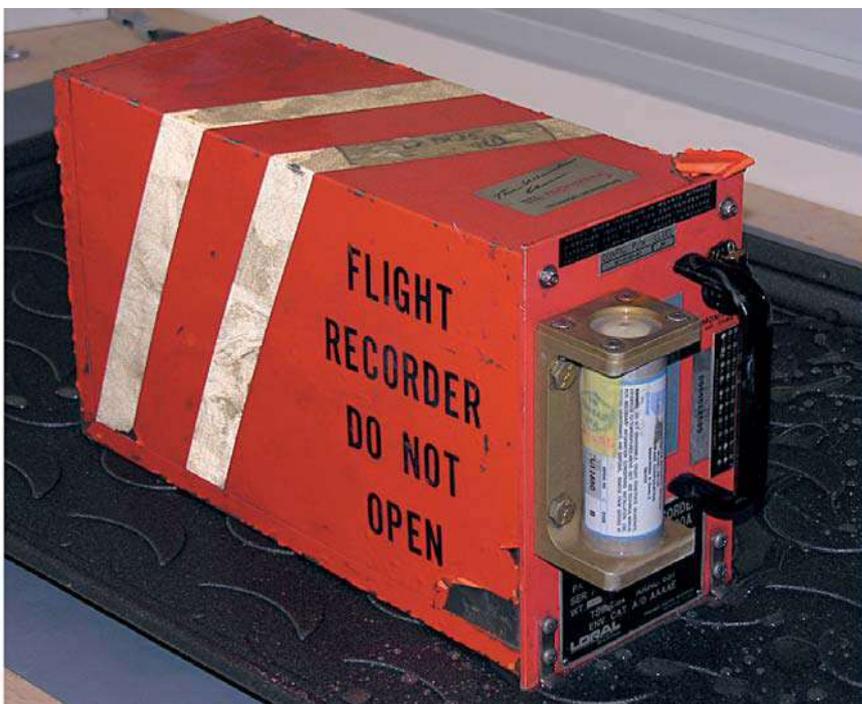
Both units were in reasonable general condition, without evidence of impact or fire damage.

Photo 18: CVR, external condition. ULB in foreground.

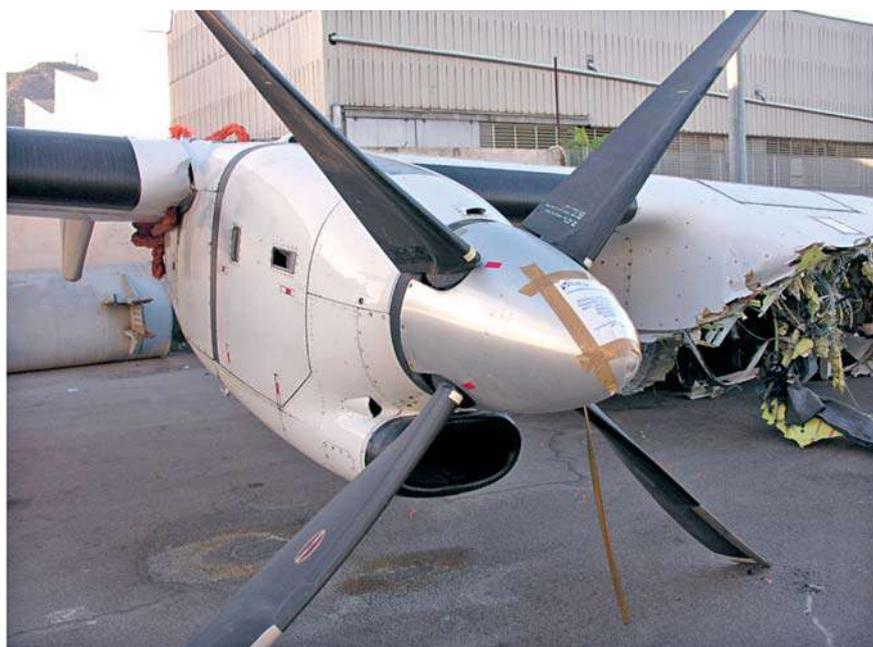
Photo 21: Right engine – note the propellers in the fully feathered position (red line).

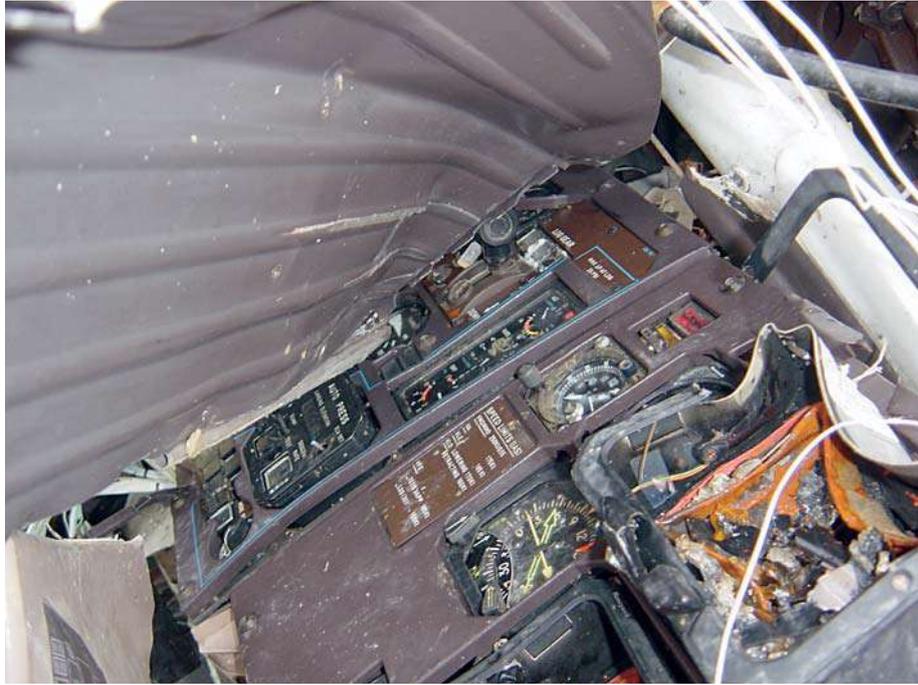
Photo 28, taken immediately after positioning the wreckage on the deck of the ship, shows in fact that the lever of the landing gear was in the UP position. It was also found after removal that the flaps position analogue indicator was showing 30° .

Photo 28: part of the TS-LBB instrument panel after recovery (note the landing gear lever in the “UP” position at the centre of the photo).

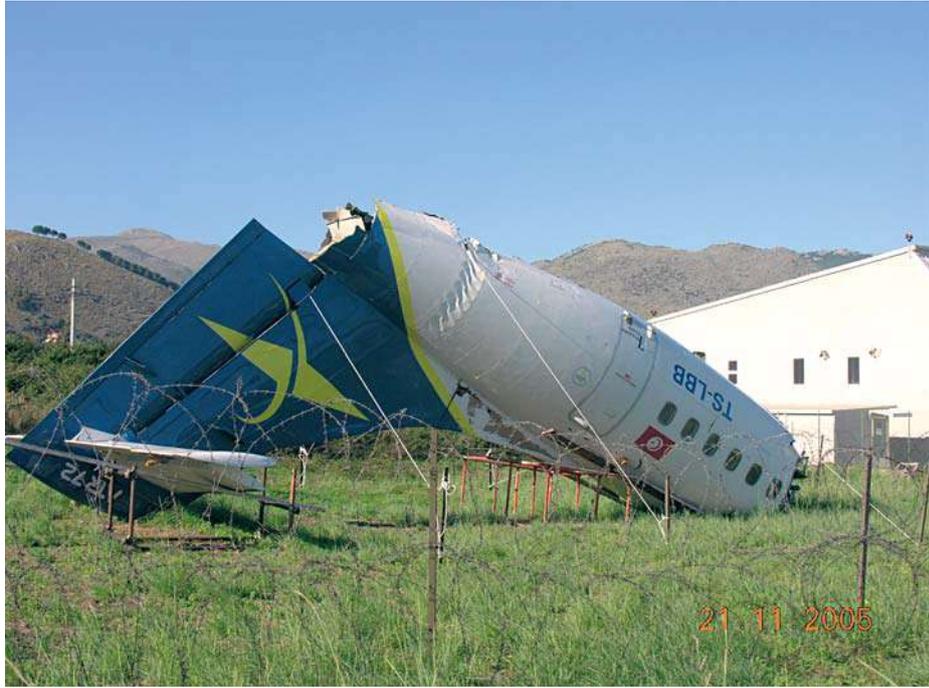
Photo 32: Rear section of the wreckage at Bocca di Falco airport – left-hand view.

The rear of this section showed a great amount of damage and deformation, resulting in the breaking of the pressure bulkhead between the pressurised and the non pressurised zone. This indicates that the impact of the aircraft against the sea surface was very strong. The rear had in fact completely collapsed, while the seating area was virtually intact.

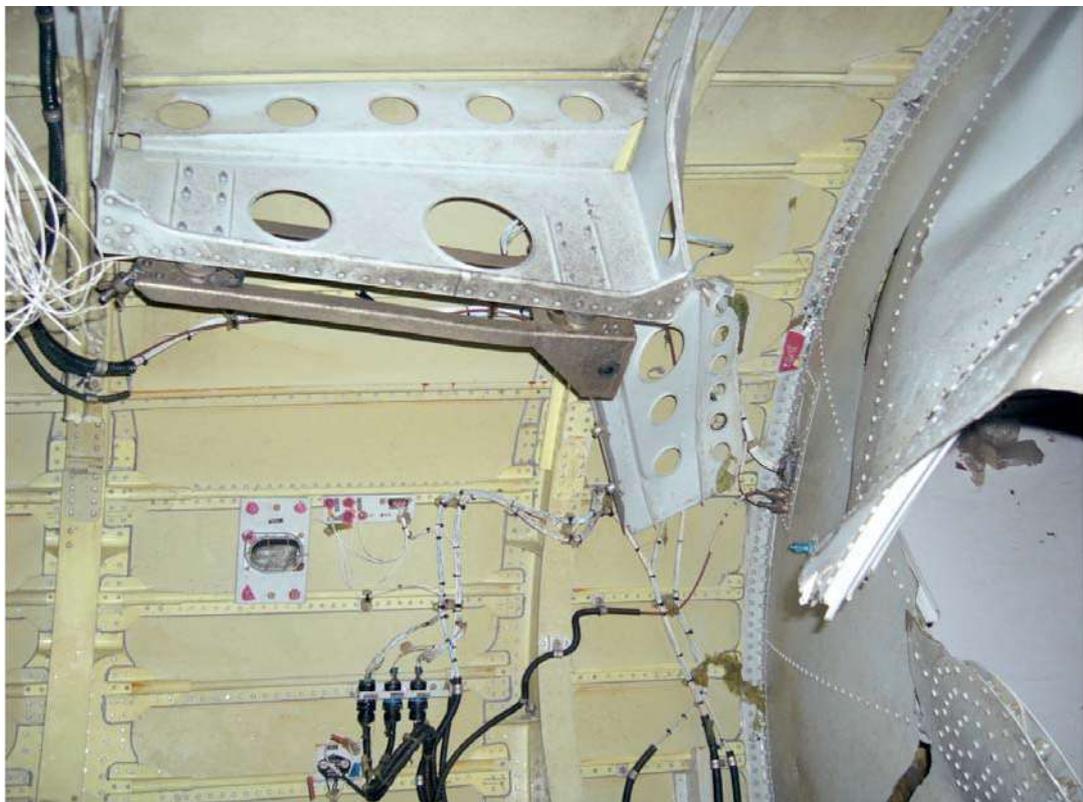
Considerable structural damage was found on the inside. The pressure bulkhead between the cabin pressurized zone and the tail had a large diagonal gash (see photo 34 and 61). The tail assemblies did not show any significant deformation. The CVR was removed from its housing. It was removed, immediately washed with fresh water and then placed in a container full of distilled water. The supports of the FDR housing appeared damaged and the device itself was missing (photo 61).

Photo 61: The damaged FDR housing (note the deformation of the pressure bulkhead, demonstrating the strong impact sustained by the rear section of the aircraft).

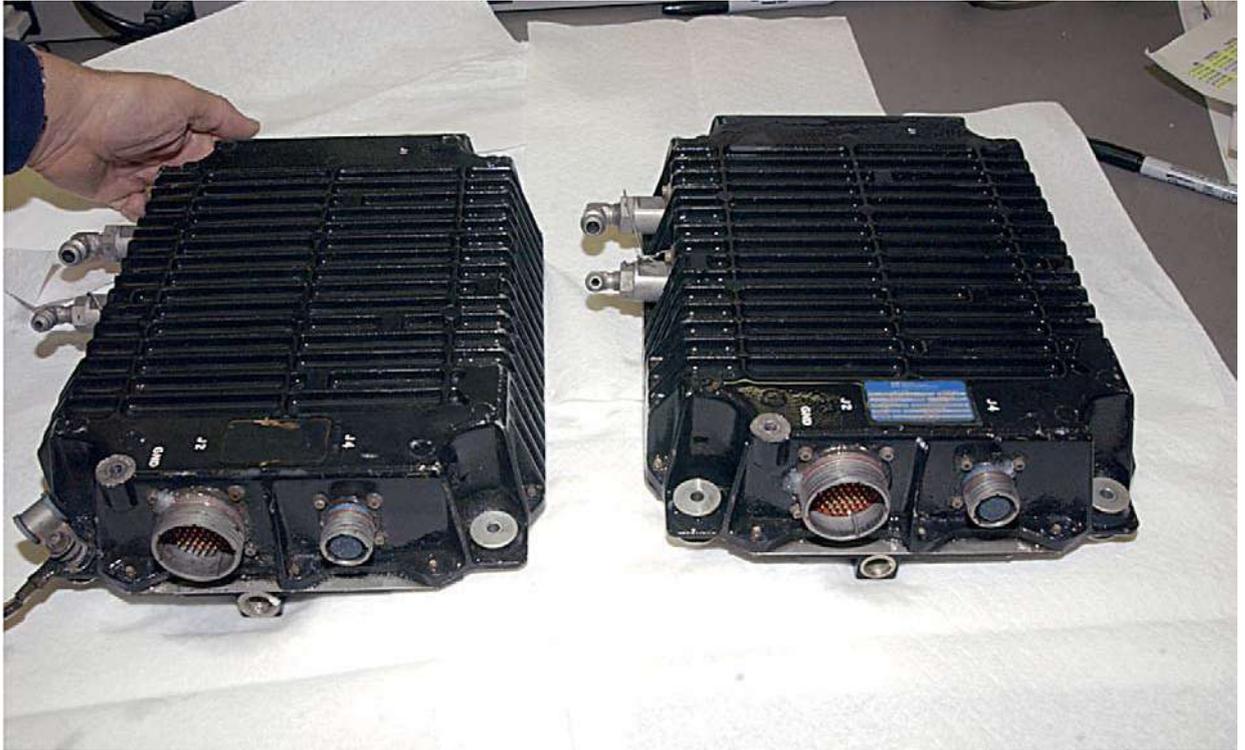
Photo 74: Engine EECs. Note the one on the left, for the right engine, without identification plate.

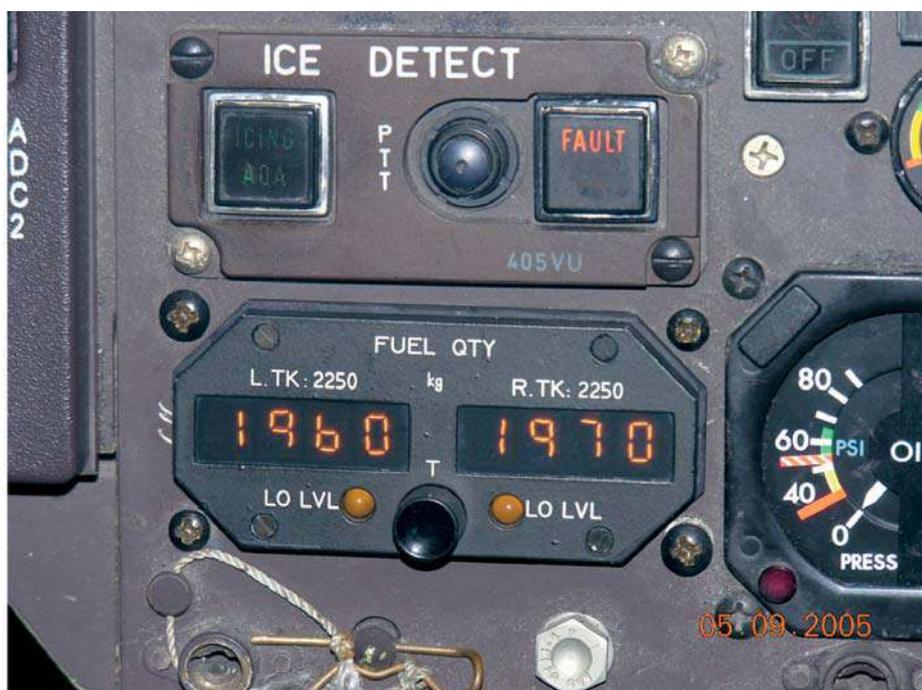
Photo 78: Indication given by an ATR 42 FQI fitted on an ATR 72 with a quantity of 3800 kg of fuel selected.

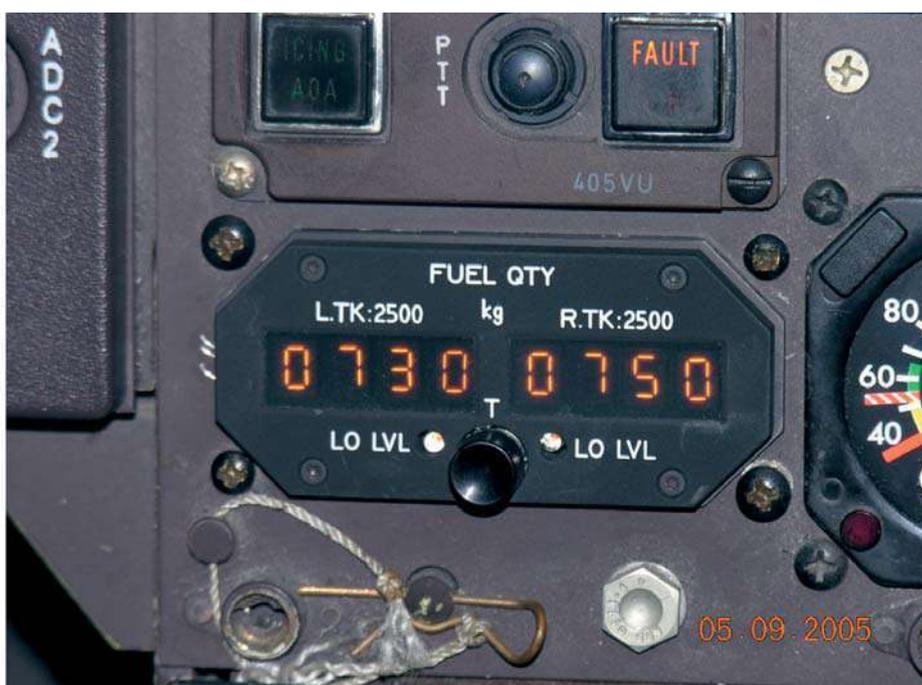
Photo 79: Indication given by the FQI ATR 72 on an ATR 72 with approximately 3800 kg selected (total actually present equals to approximately 1500 kg).

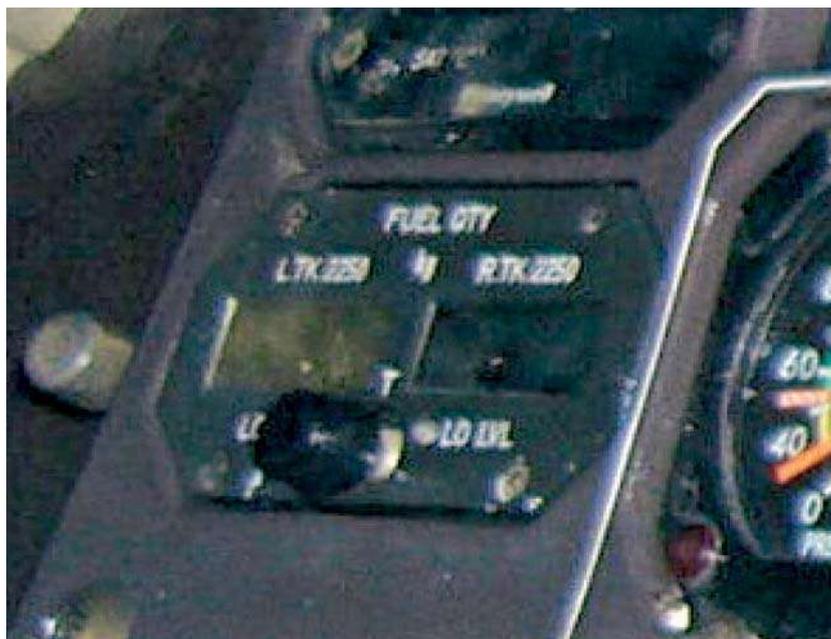
Photo 87: FQI installed onboard TS-LBB, taken immediately after wreckage recovery.
