*Accident
which occurred
on 30 January 2000
in the sea near Abidjan Airport
to the Airbus 310-304
registered 5Y-BEN
operated by Kenya Airways*

REPORT

This report presents the conclusions of the Commission of Inquiry on the circumstances and causes of the accident that occurred on 30 January 2000 in the sea near Abidjan airport to the Airbus 310-304 registered 5Y-BEN operated by KENYA AIRWAYS, which was undertaking the Abidjan - Lagos -Nairobi flight KQ 431.

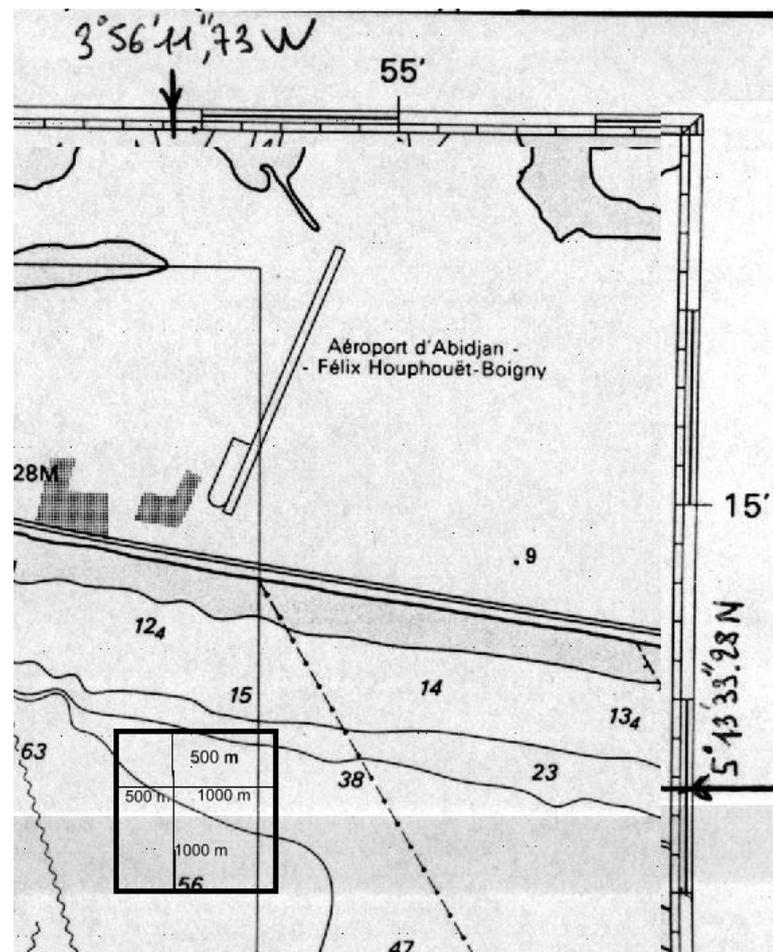
The impact occurred 1.5 NM from the Abidjan runway on the Atlantic Ocean. Debris from the wreckage was spread over an area 150 meters wide (east to west) by 450 meters long (north to south), at depths between 40 and 50 meters. The wreckage came to rest on the sandy seabed and was subject to a sea current from west to east.

The 1.5 square on the site plan above corresponds to the wreckage search area. The inner rectangle delineates the area where most of the debris was found.

The detail on the wreckage distribution map, within the rectangle, gives the dimensions of the debris as identified during the sonar location phase (appendix 8).

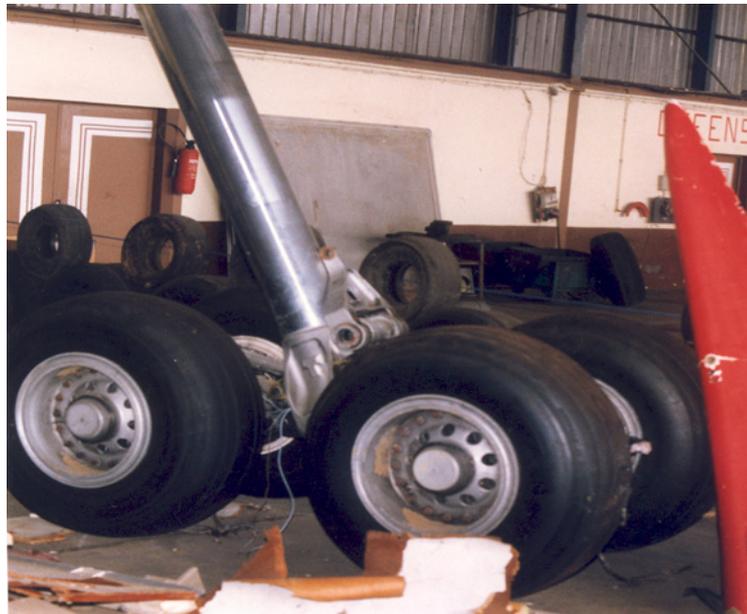
Train d'atterrissage repêché

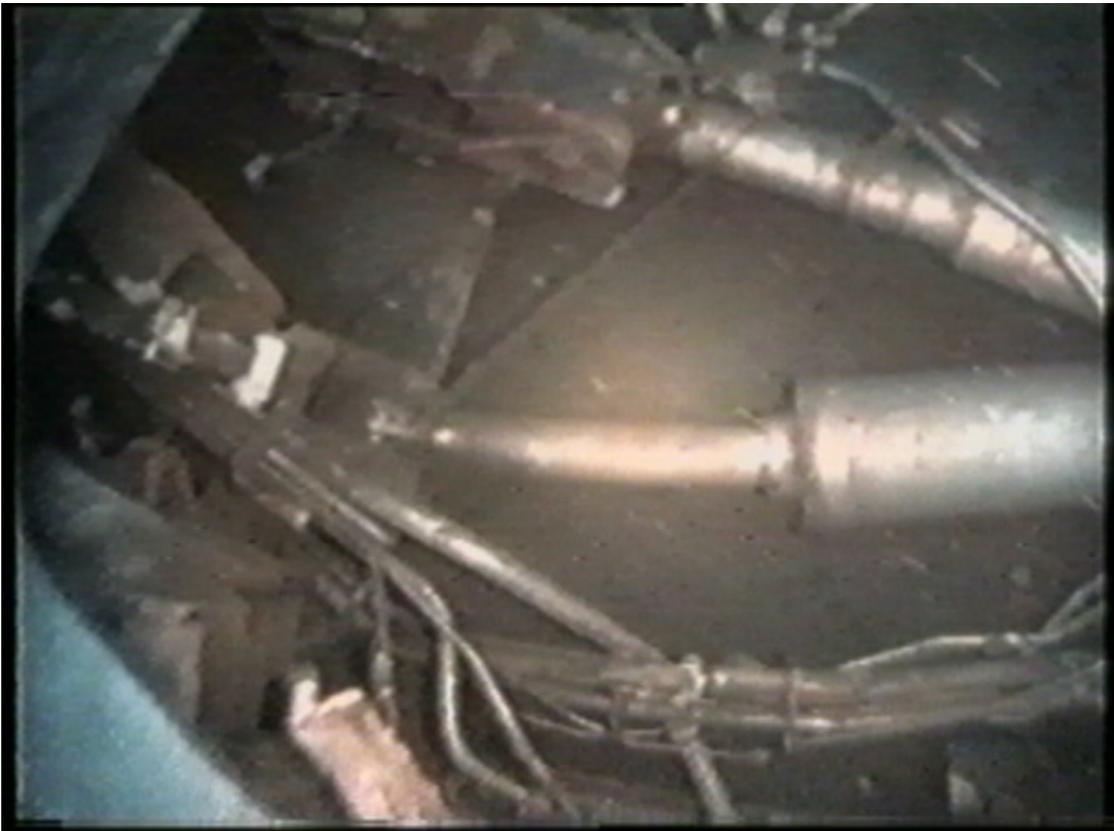
- the landing gear shock absorber that was twisted and in extended position;
- the flap actuator screw jack in the 15° position;
- a slat guide rail broken on the side where it was connected to the wing;
- the elevator actuator screw jack in a 1.2° nose up trim position;
- the fan blades on one engine severely damaged ;
- the second engine observed in two parts;
- on the cockpit center console, spoiler levers in the armed position (raised and locked).

Amortisseur du train d'atterrissage

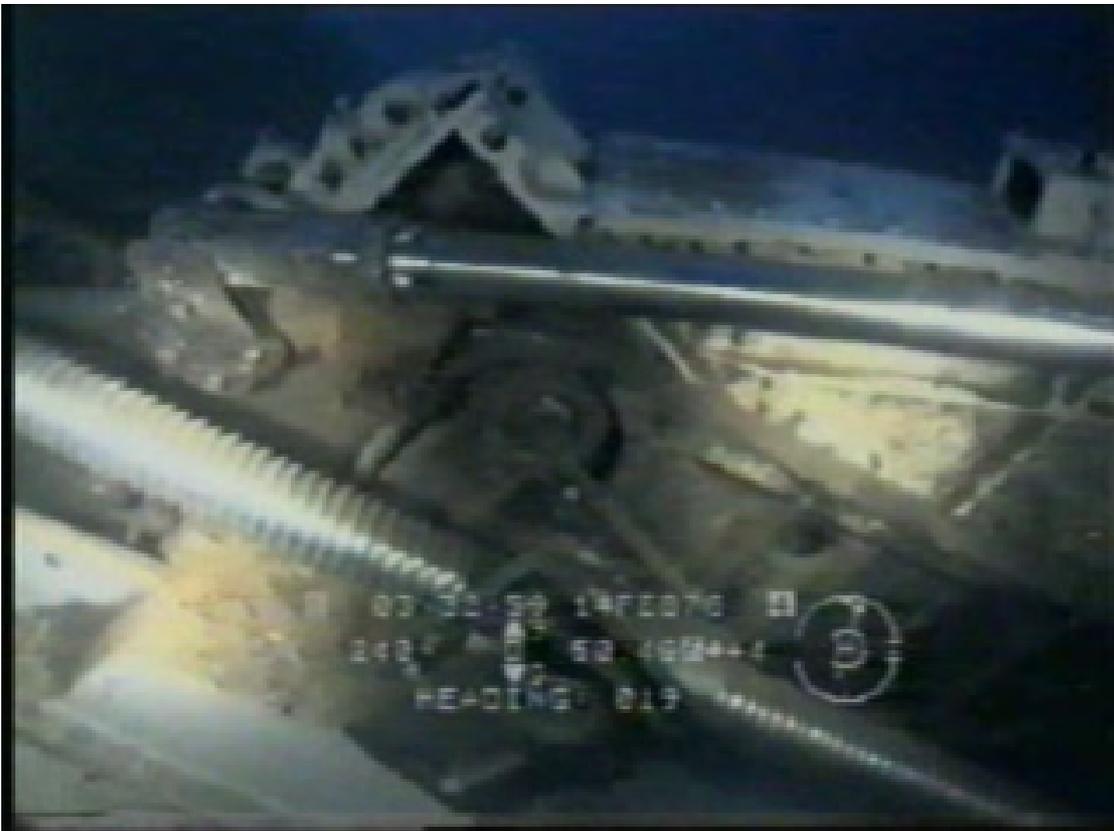
Vis de vérin de volets

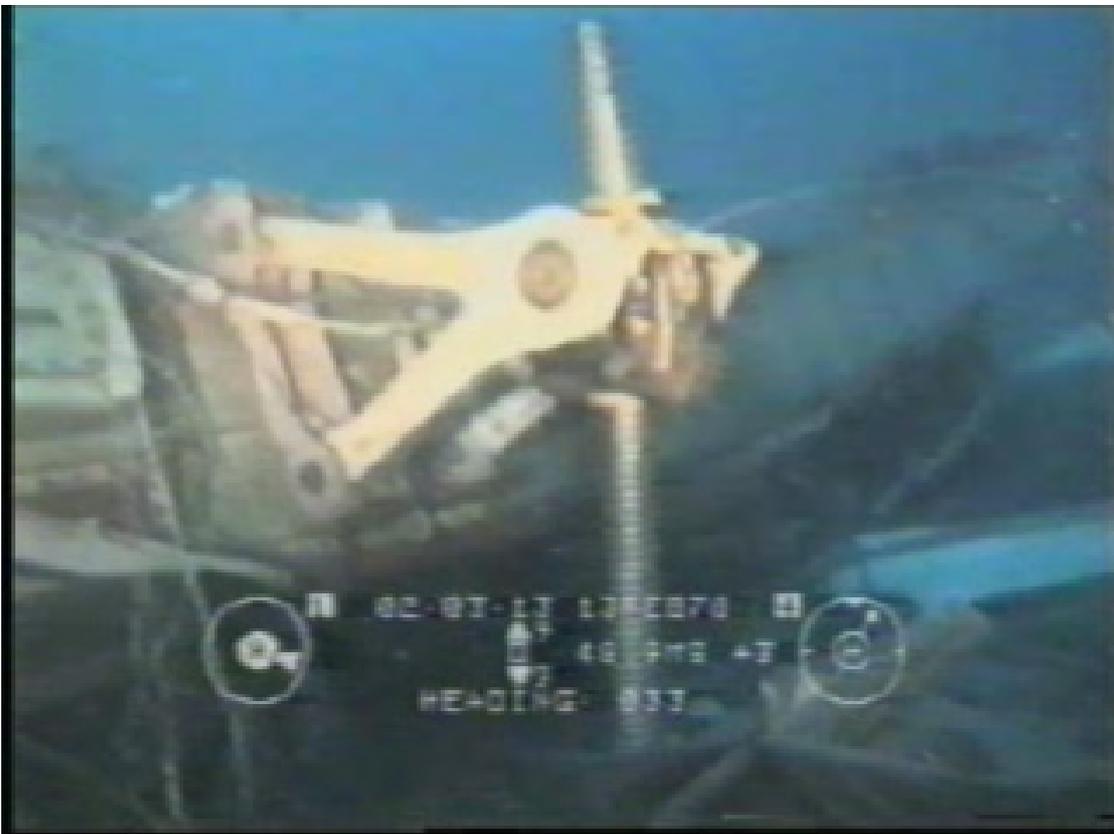
Vis de vérin du plan horizontal réglable

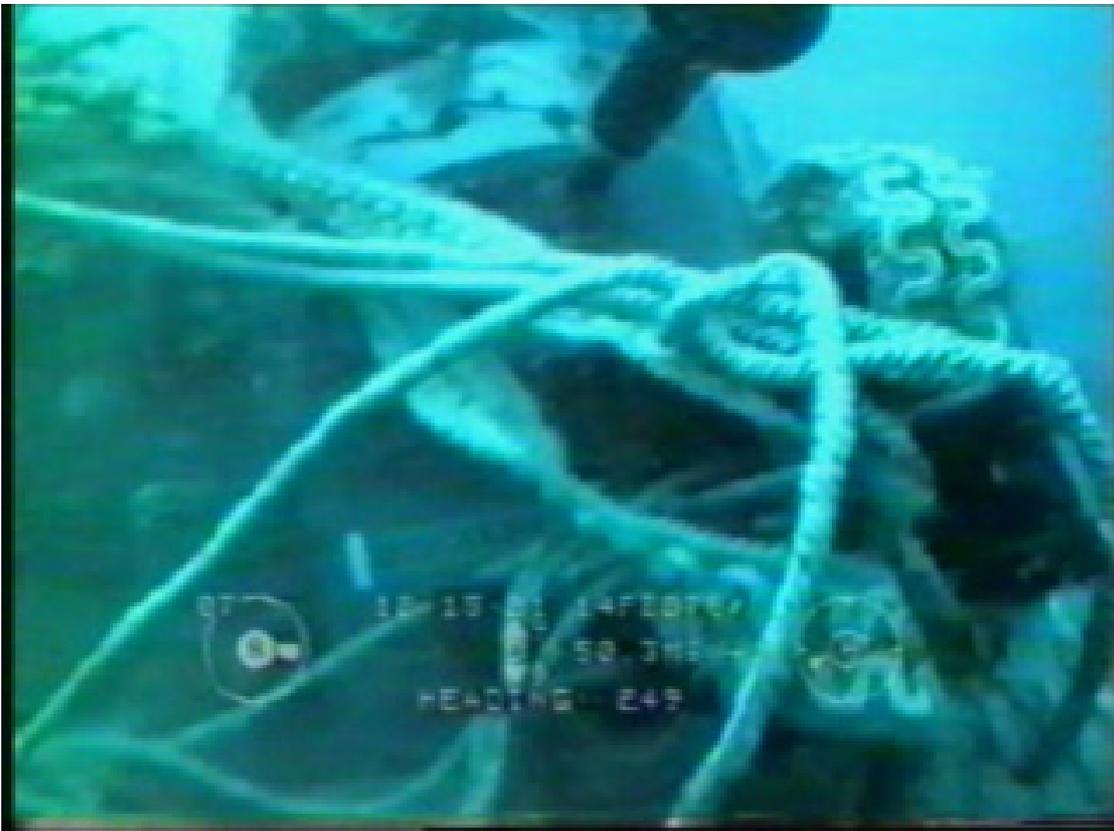
Console centrale du cockpit

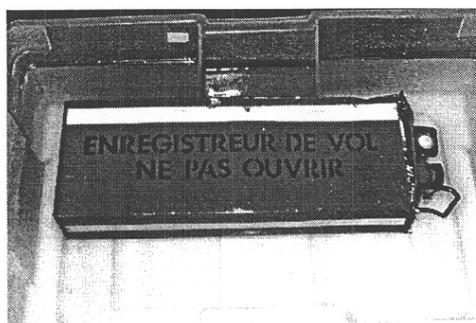
Figure 1: FDR as received

The recorder was transported in water to minimize oxidation. It was found to exhibit slight impact damage to the outer casing and face plate (Figure 1). The recorder was rinsed with fresh water and disassembled in order to remove the tape medium. The internal crash protected memory module and the tape medium were found to be in pristine condition (Figures 2 and 3). There was no corrosion damage to the recording.

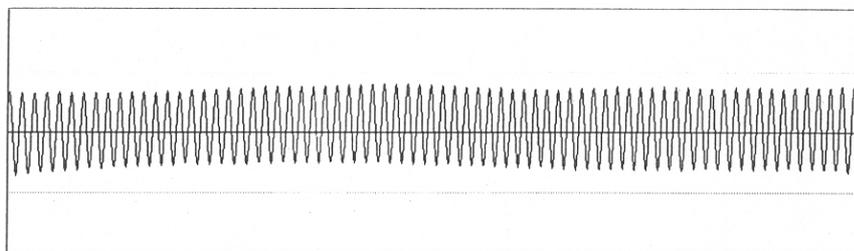
Figure 5: Sample pattern of 'ones' from accident FDR

An examination of the FDR was performed by CTSB at Honeywell, the manufacturer, in order to determine the reason why it did not record the flight data. The XA8 electronic card was tested and found to be operative. The other electronic cards in the FDR were damaged and were inoperative.

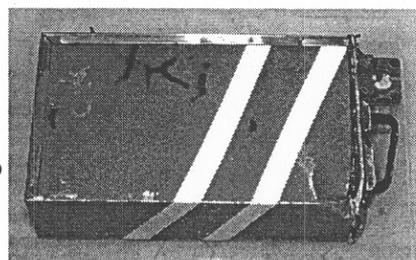
Figure 7: CVR as received

The recorder was transported in water to minimize oxidation. Some impact damage was observed to the outer casing and face plate (Figure 7). The recorder was rinsed with fresh water and disassembled in order to remove the CVR tape. The tape medium was found to be in pristine condition with no corrosion damage. The tape was originally played back on an open reel tape deck at the normal speed of 1 7/8 inches per second using 400 hz AC power. A comparison of the CVR communications with the identical communications recorded on the ATS tape indicated that the original playback speed was too slow, requiring a 1.23% increase in speed. This was considered due to a slight difference between the playback speed

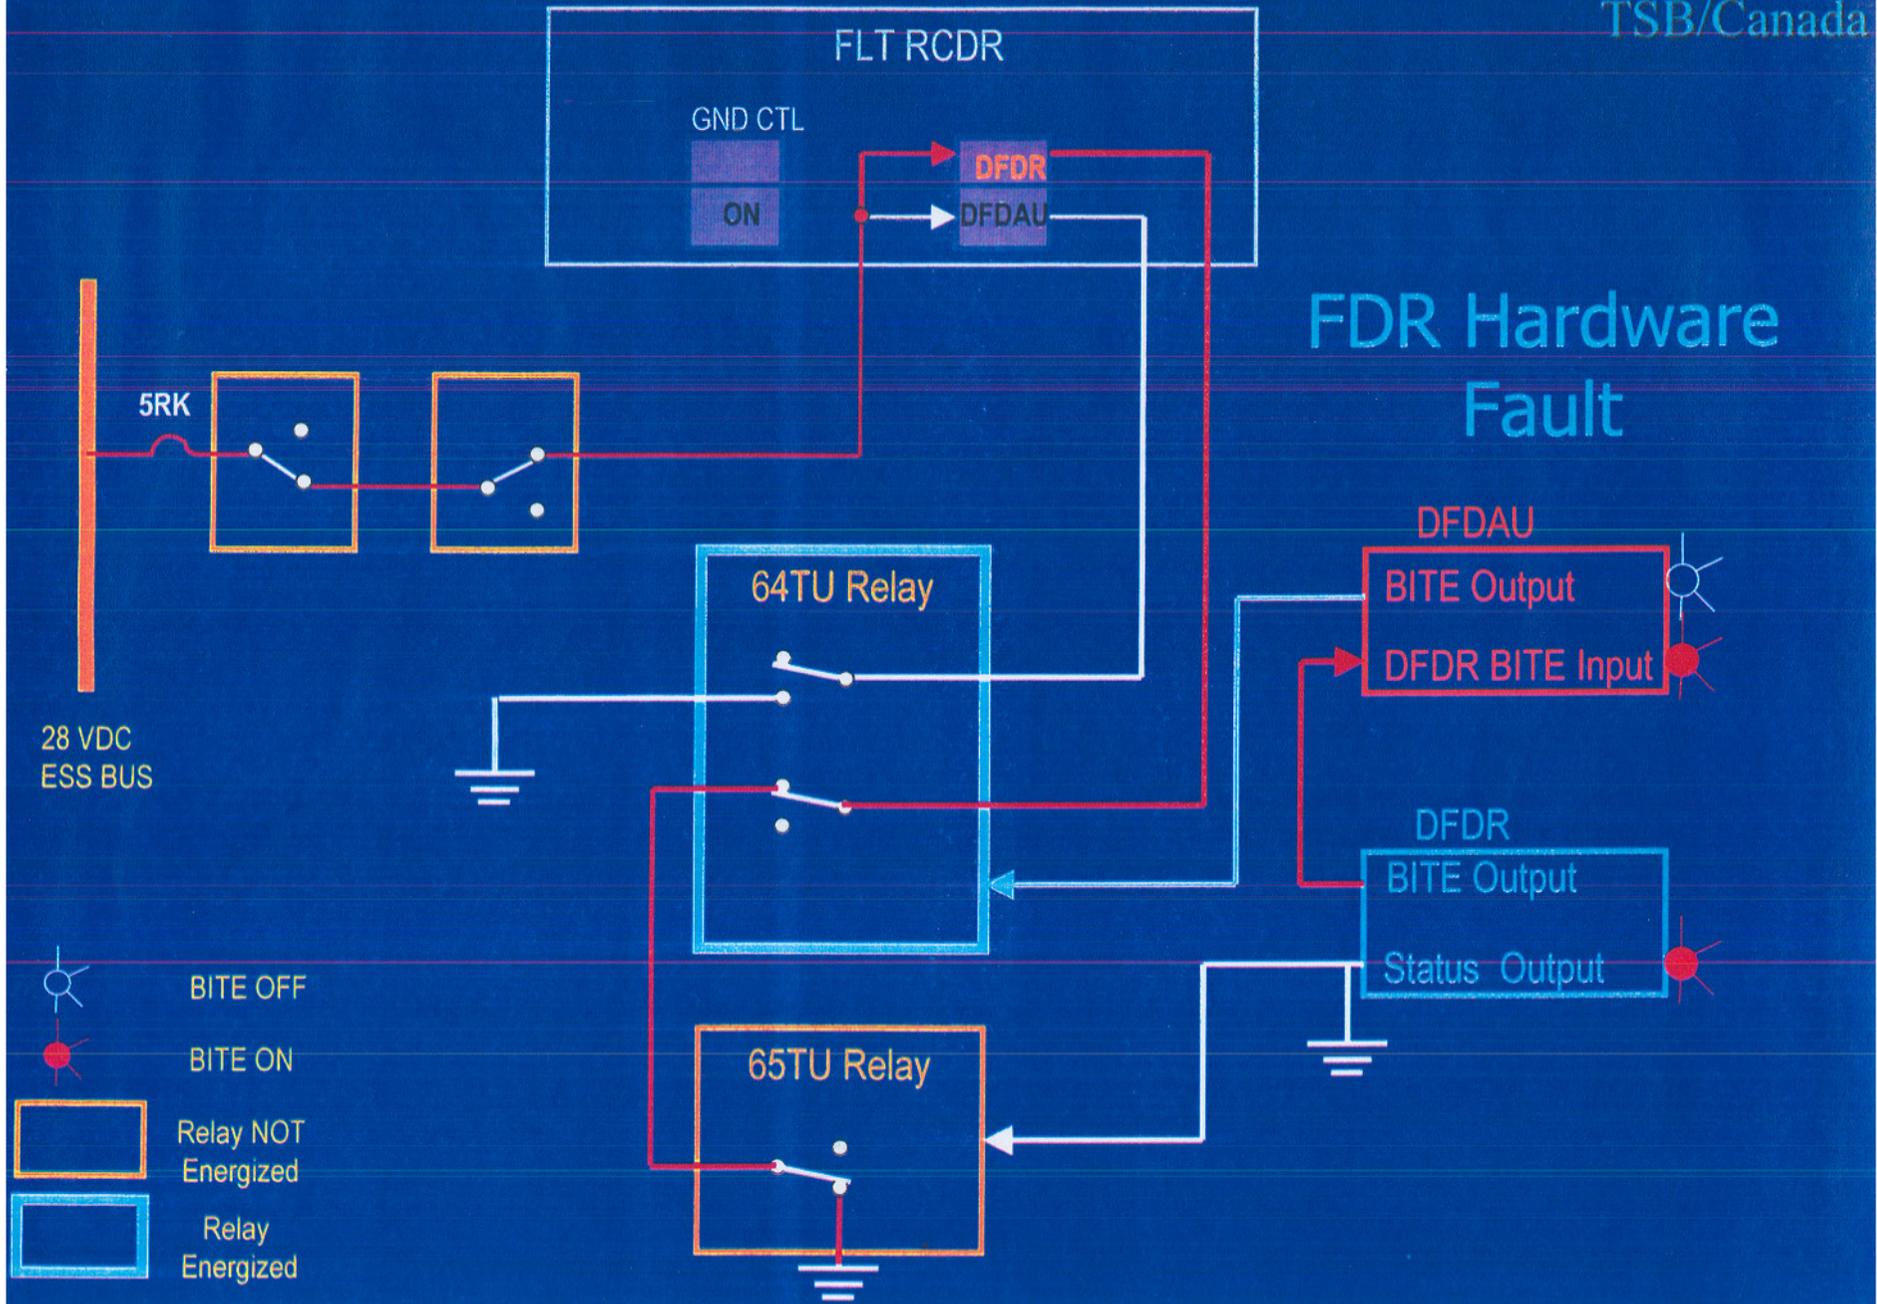
FDR Hardware Fault
