Emergency landing at sea with Britten-Norman  
Islander near Bonaire on 22 October 2009

The Hague, may 2011 (project number 2009090)

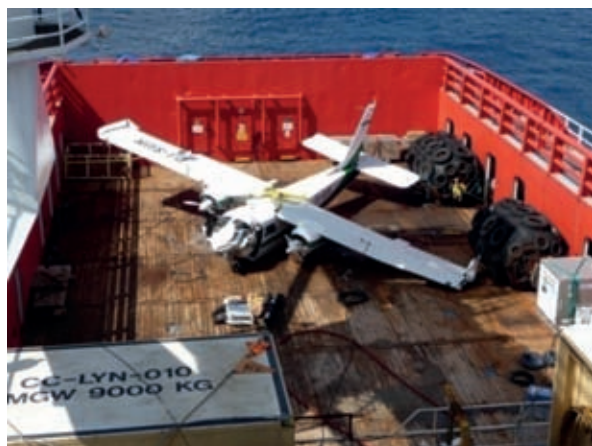
Figure 2: PJ-SUN after it was salvaged

The aircraft suffered extensive damage as a result of the impact with the water. During the impact, the left front door and the left main landing gear broke off from the aircraft and the left propeller shattered. These parts were found floating in the water. The nose and cockpit section of the aircraft were seriously deformed. The aircraft was salvaged on 18 December 2009. The aircraft sustained damage to both wings and to the flap drive mechanism. The damage did not affect the investigation.

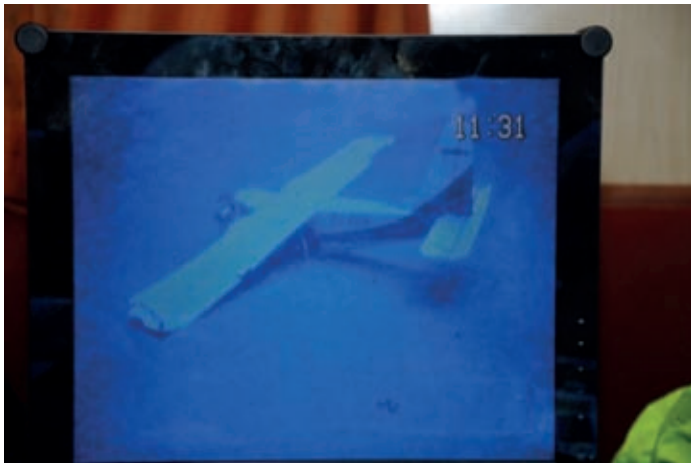
Figure 4: monitor with an image of the PJ-SUN on the seabed

The aircraft wreckage was in a horizontal position on the seabed. The front left door and the back left door were missing. The centre right door was opened. See figure 4.

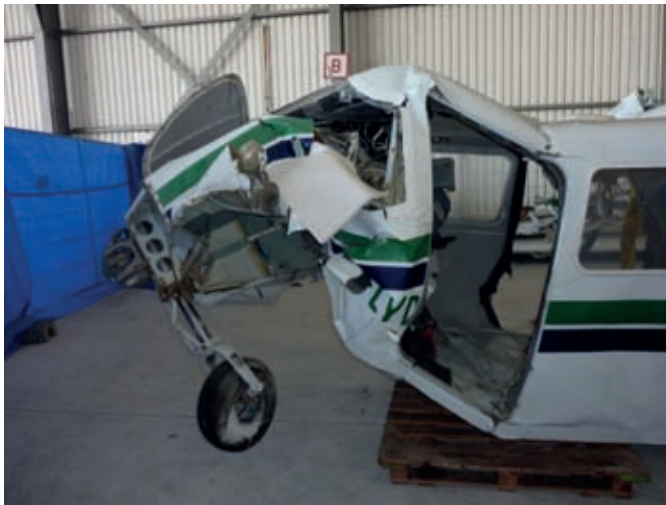
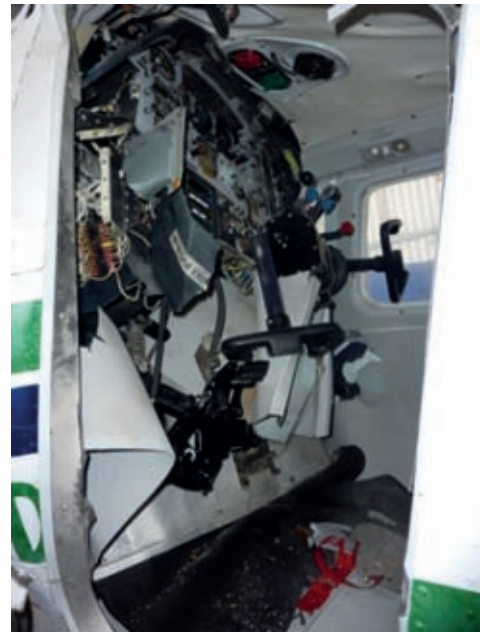
The aircraft wreckage was investigated after it was salvaged. The following was found during the technical investigation: the left main landing gear and wheel was broken off, the left propeller was splintered and the underside of the left engine cowling was damaged. The right propeller was intact and feathered. The nose wheel landing gear was bent backwards and upwards. The aircraft nose and cockpit section and the left wing tip were depressed and twisted upwards. The upper side of the cockpit instrument panel was against the roof. The control column at the pilot's side was broken off. The control column at the passenger's side was slightly bent to the left. See Figures 5 and 6.

The windshield was shattered. The fuselage skin at the underside of the aircraft along the length of the cabin was dented between the stiffeners. The cabin floor was twisted upwards at the aft door frame of each of the three doors. From the front left door, which was found directly after the accident, as from the door centre right the door handle was in the locked position. The locking pin from the locking mechanism from both doors was clearly visible and was intact. The front left door hinges showed signs of overstress fractures. The windows from both doors were missing. Various locations of the aircraft, among others the horizontal empennage and the left wing has various deformations of the supporting structure and fuselage plate. The tailcone was broken off. The flaps were in the upward position.

*Figures 5 and 6: side view of the deformation of the aircraft nose and cockpit (seats removed)  
Left: damage to aircraft nose, cockpit floor twisted upwards. Right: instrument panel against the roof.*

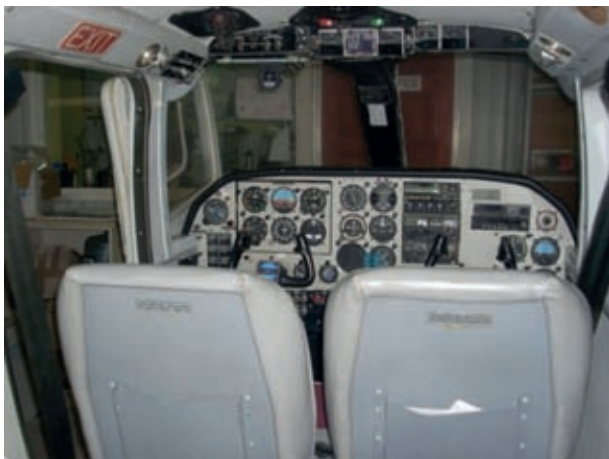
The pilot was seated on the left cockpit seat. The room to move for a person of standard build seated in this seat is limited. The room to move was limited on the left side due to the left front door with a plastic air ventilation duct above. The left front side was bordered by the vertical window and door frame. At the front side it was limited by the instrument panel and the (left) control column and at the front right side by the engine control levers. See figure 7.

Figure 7: cockpit space of a comparable Britten-Norman Islander viewed from the second row

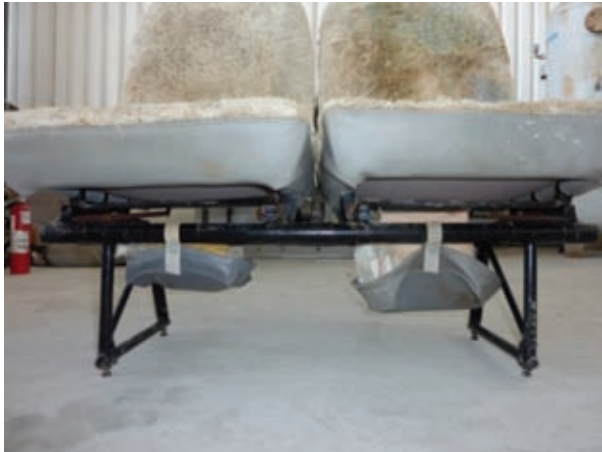
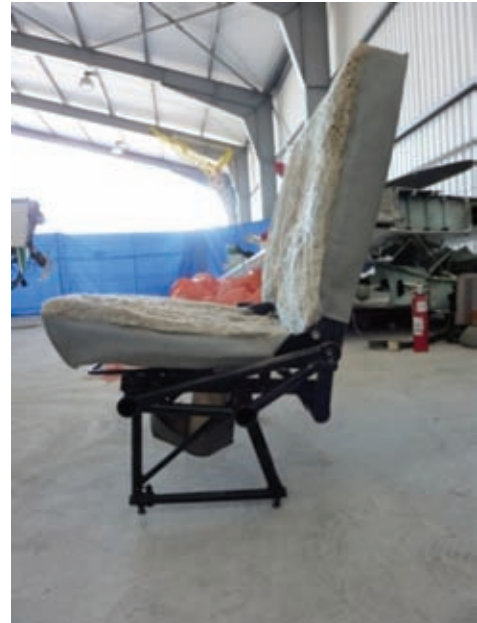
The seats have a metal structure. The backrest has a hinged connection to the frame at the bottom. The seat and rest are covered with padding. The seats and the frame were not deformed. The unused life jackets were in the stowage pouch under both front row seats. By pulling the tab of the press-stud the stowage pouch opens and the life jacket can be taken from it.

*Figures 8 and 9: front and side view of the front row seats with the unused life jackets still in the stowage pouch*

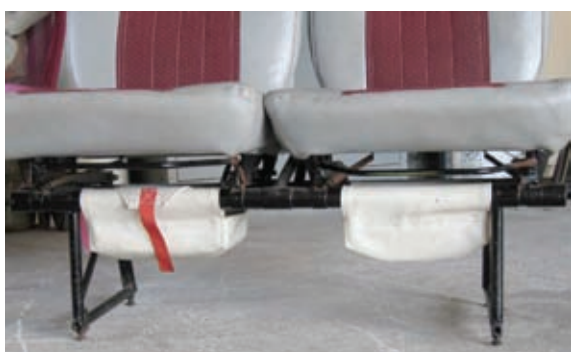
A random check of two other Divi Divi Air Britten-Norman Islander aircraft, of which one aircraft was in the hangar for maintenance, demonstrated that another type of stowage pouch was also used for the life jacket under the seats (under seats three and four, respectively, of the ten seats). This type of pouch used Velcro for the opening. This pouch was opened by pulling the red strap attached to the tab of the pouch. In some cases, however, the red strap had been pushed into the pouch making it inaccessible. In these cases it was difficult to open the pouch and it was not easy to determine how to open it. See figure 10.

Figure 10: removed seats and stowage pouch with an accessible red pulling strap (left) and with an inaccessible pulling strap (right)

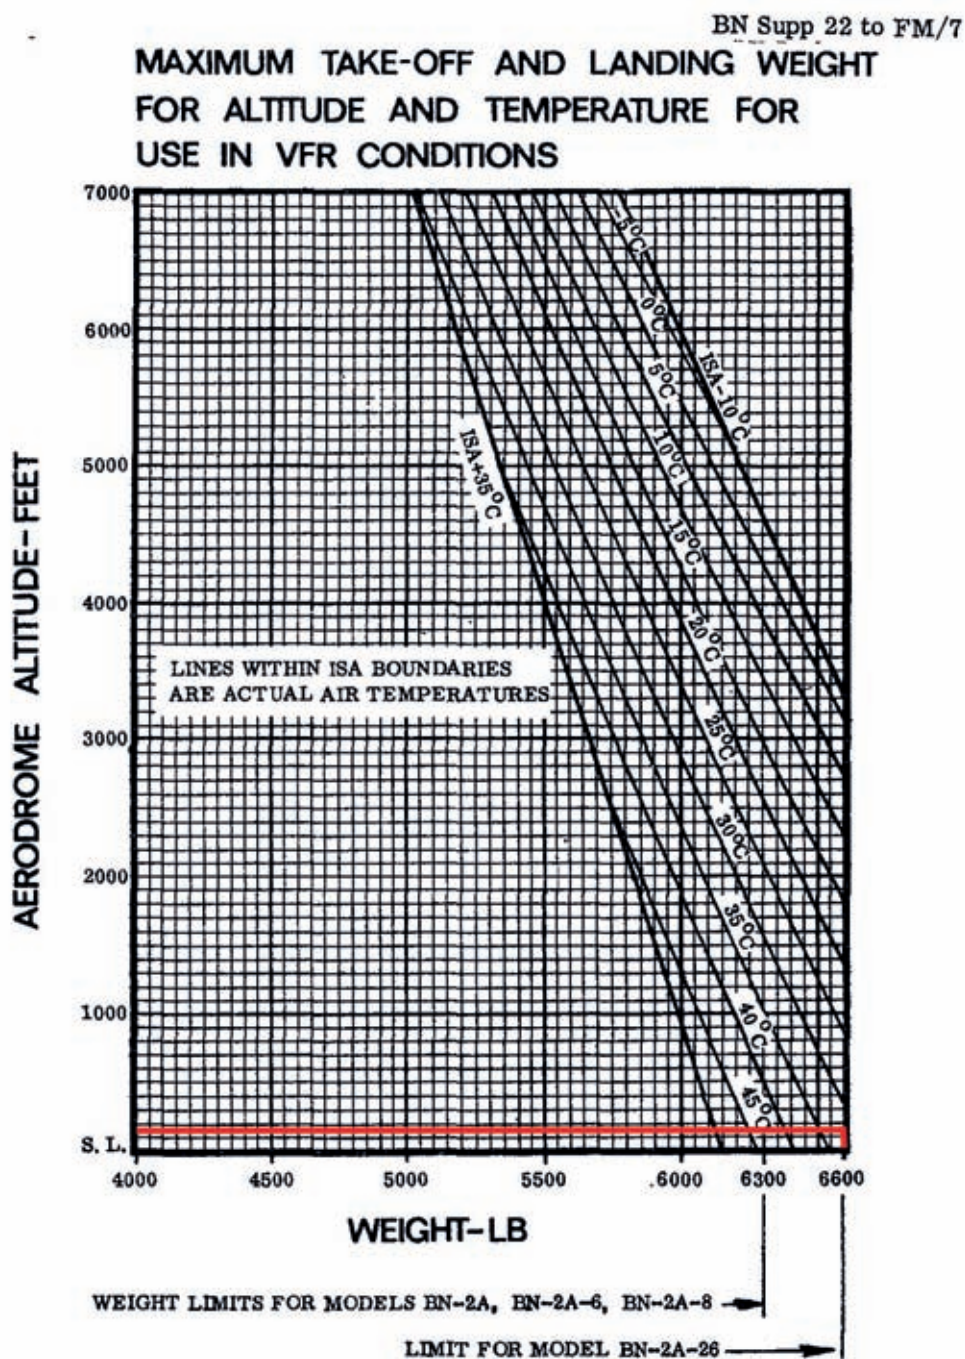
The climb-limited take-off weight according to supplement 22 of the flight manual can be read from the graph below. From this it follows that a take-off weight of 6600 lb is allowed from Hato airport up to about 33 degrees Celsius outside air temperature with the restriction to fly in VFR conditions and with the approval of the Directorate of Civil Aviation.

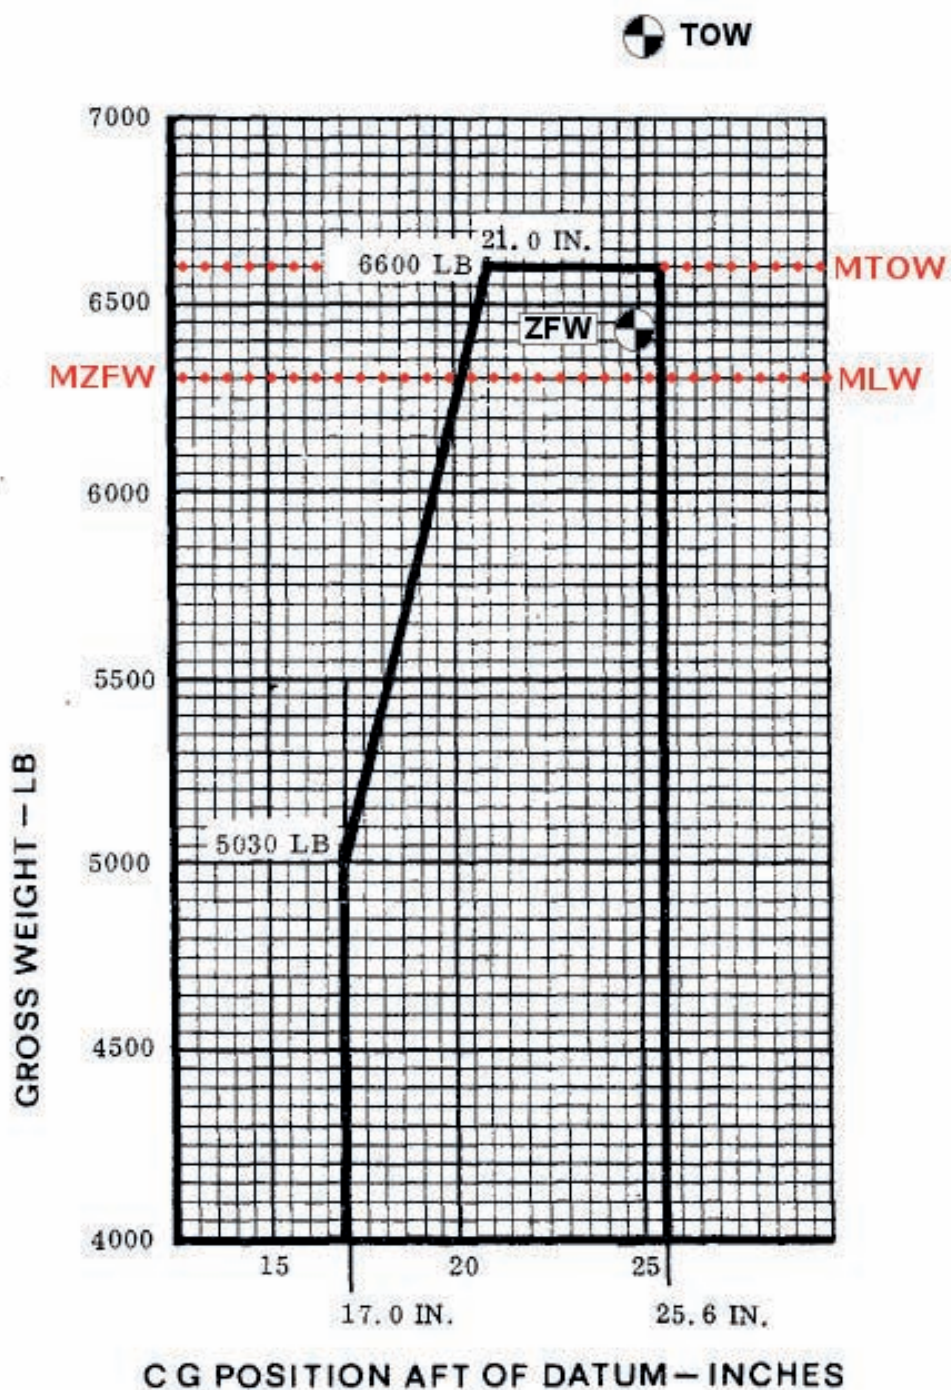
The position of the actual centre of gravity was at 25.1 inch at a take-off weight (TOW) of 7211 lb and is displayed in the diagram below from the flight manual. The position of the actual zero-fuel weight centre of gravity was at 24.9 inches at a zero-fuel weight (ZFW) of 6431 lb.
