Report

Accident on **27 November 2008**
off the coast of Canet-Plage (66)
to the **Airbus A320-232**
registered **D-AXLA**
operated by **XL Airways Germany**

BEA

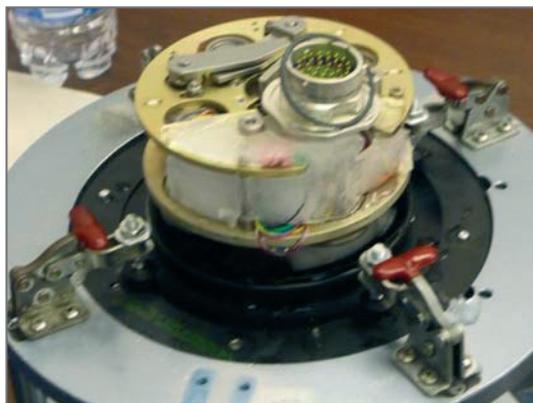
On opening the angle of attack sensor housing, a significant amount of water was revealed (in the form of ice or liquid) likely to block the turning parts (bearings and vane counterweight).

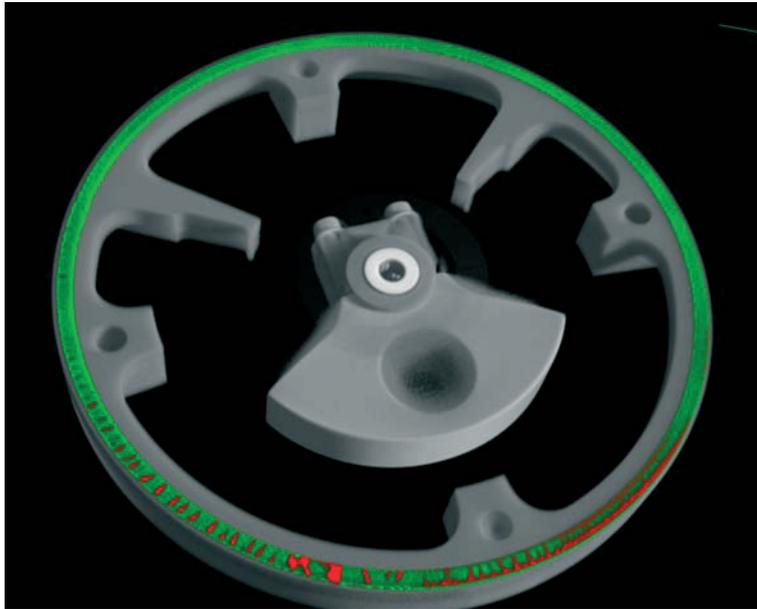
A tomography of this sensor was carried out and revealed damage to the sealing ring between the upper panel and the housing edge.

Sensor tomography
In green, the sealing ring.
Red represents less dense matter

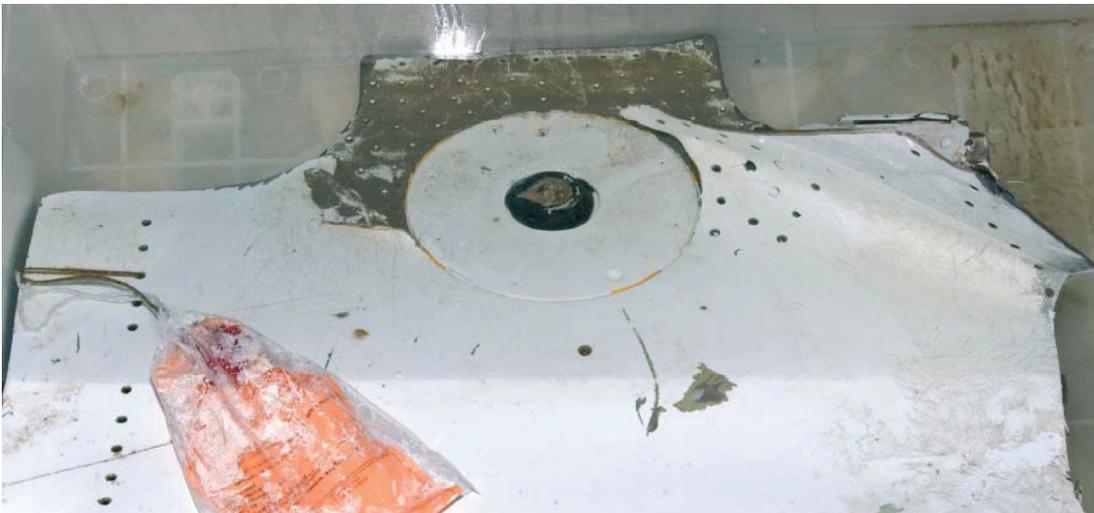
Angle of attack sensor 1 remained attached to the structure of the aeroplane by its attachment plate, painted white, which covered the face of the sensor. The vane was cut off at its base on impact with the water. It was blocked in rotation, stuck at an angle of about 30 degrees (pitch up) in the longitudinal axis of the aeroplane. The two electrical cables from the de-icing and anti-icing heating element were cut off in line with the break in the vane.

Angle of attack sensor attached to the aeroplane structure

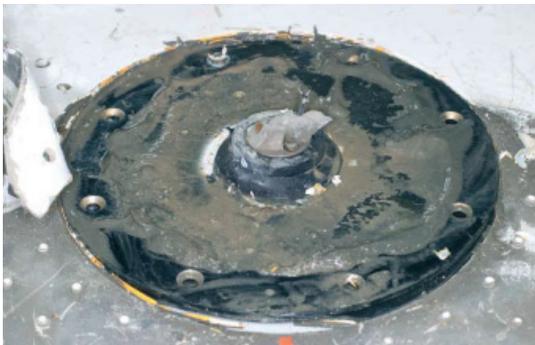
Removal of the attachment plate revealed an accumulation of mud in the free space between this plate and the face of the sensor. Traces of yellow finishing paint under the outer layer of white paint are visible locally on the attachment plate and on the circular surround that this plate was attached to.

*Top of the sensor after removal of the attachment plate
(presence of yellow paint)*

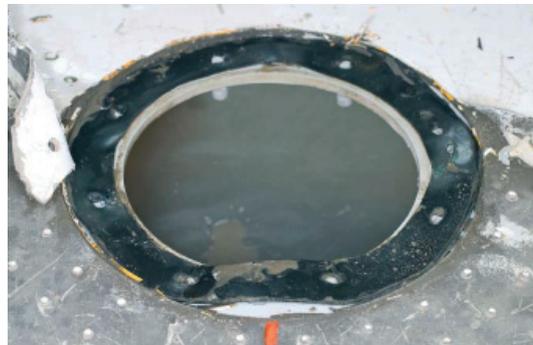
- ❑ The mounting flange of angle of attack sensor 1, which remained attached to the sensor and to the fragment of the panel, showed the presence of the application of a yellow paint underneath the white paint. This yellow paint, which corresponds to one of the aeroplane's previous liveries, was also visible under the white paint of a section of the fuselage framing this mounting flange.

*Position of the sensor on the joint in the aeroplane
structure (presence of yellow paint)*

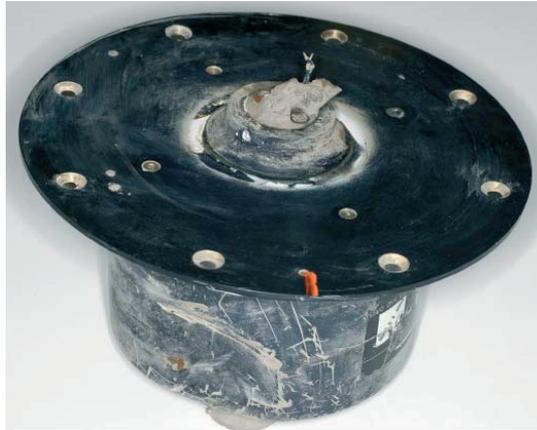
The forward side of the sensor casing was buckled, following the shape of the components inside. The base of the 32-pin connector was slightly crushed with not opening towards the inside.

General view of the sensor
(presence of white paint)

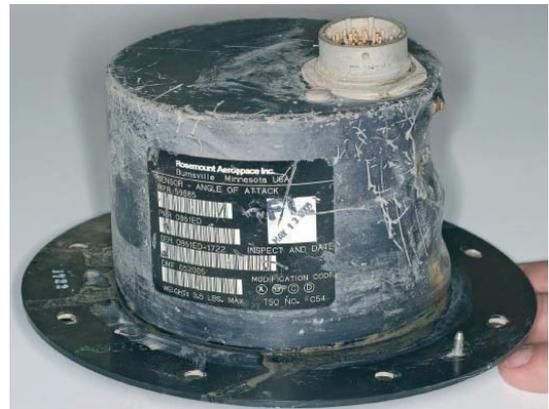
Local damage to the casing

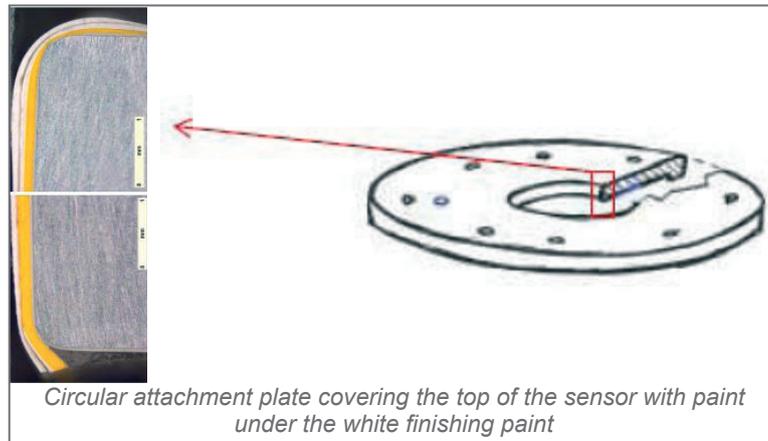
ending at its central hole, revealed the presence of yellow paint in two layers, covered with white paint. This yellow paint was not part of the range of paints applied by EAS Industries.

This yellow paint came from the previous livery of the aeroplane when it was in the colours of Freedom Air Limited (see photo paragraph 1.6.3).

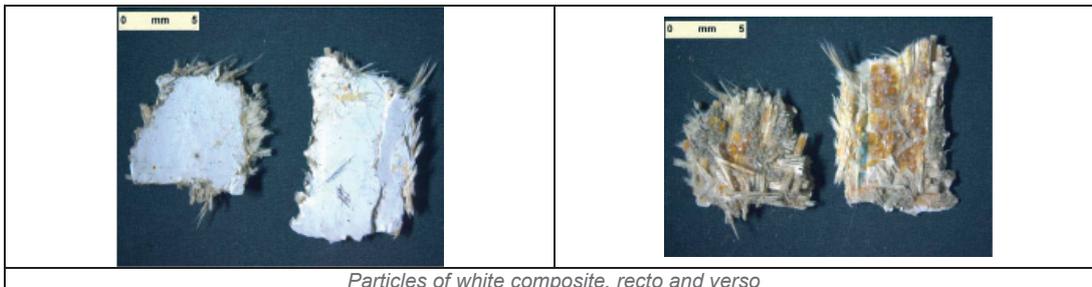
- two fragments of composite (glass fibre and phenolic resin) painted white were stuck under the upper edge of the housing distorted by impact. The white paint was different from the aeroplane's finishing paint;

Particles of white composite, recto and verso

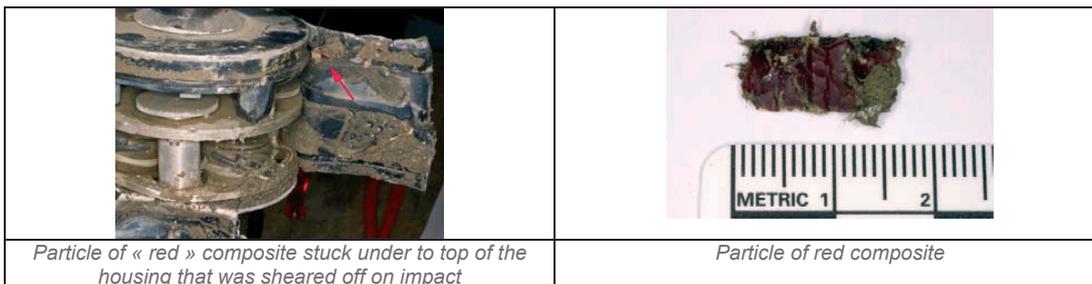
- a fragment of composite (made of kevlar – aramide fibres – and of phenolic resin), dark red in colour and stuck to a fragment of plastic film (terephthalate type plastic) was stuck on the upper part of the housing, near the O seal.

Particle of « red » composite stuck under to top of the housing that was sheared off on impact

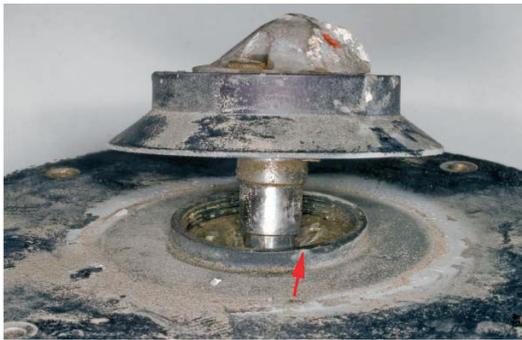
After separation of the vane and its shaft from the sensor, it seems that the ring deposit of white paint on the top of the sensor was limited to the area of the conical base of the vane. The thickness of this ring deposit varied between 0.08 and 0.15 mm. During separation of the vane and its shaft from the sensor, a thin translucent film was found in the sensor recess under the base of the vane.

Flexible film in the sensor recess, under the base of the vane

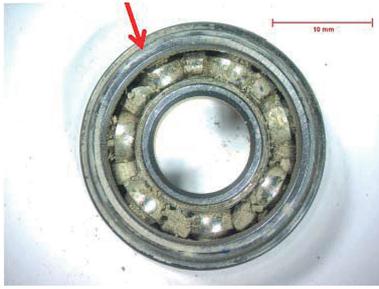
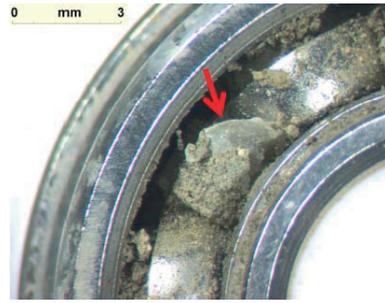
The lower bearing, cleaned with ultra-sound, could be rotated almost normally. Inside the upper bearing, a translucent film similar to that found under the base and also made of polyester, was located between the lower flange and the ball race, in the middle of the mud. After cleaning, the upper bearing turned freely with slight friction points.

Upper bearing after removal of flanges, with 2 mm translucent particle
