# BEA

# INVESTIGATION REPORT

## **Accident to the AIRBUS - AS350 - B registered F-GIBM**

on 07 March 2021  
at Touques (Calvados)

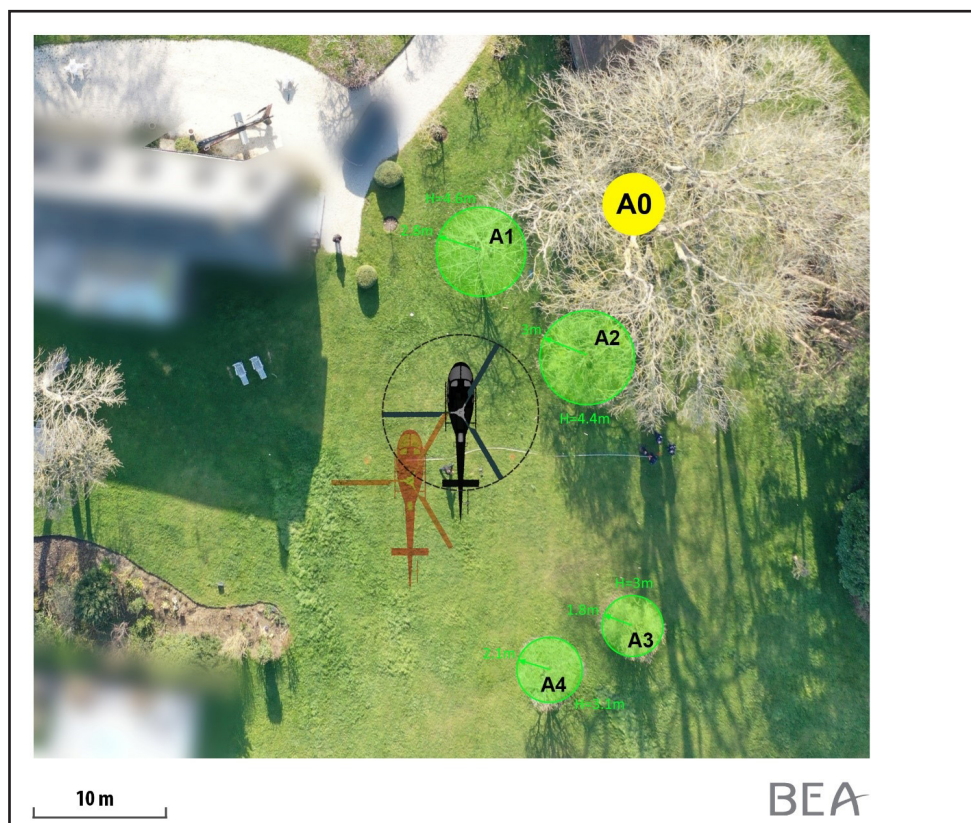
Figure 5: Take-off area and its direct environment, with the position of an aircraft model, shown to scale, at the time of the take-off (black) and where it was usually parked (red).  
The shade from the trees does not correspond to the shade on the day of the accident

The following figures show that the take-off point was situated close to leafless trees of various heights:

- ❑ Ahead of and to the right of the helicopter, two trees of a maximum height of around 4.60 m arbitrarily designated A1 and A2.
- ❑ Ahead of and to the right of the helicopter, beyond the first two trees described above, an ash tree around 23 m tall and the largest in the area concerned, arbitrarily designated A0.
- ❑ Aft of the helicopter, two trees of a maximum height of around 3 m arbitrarily designated A3 and A4.

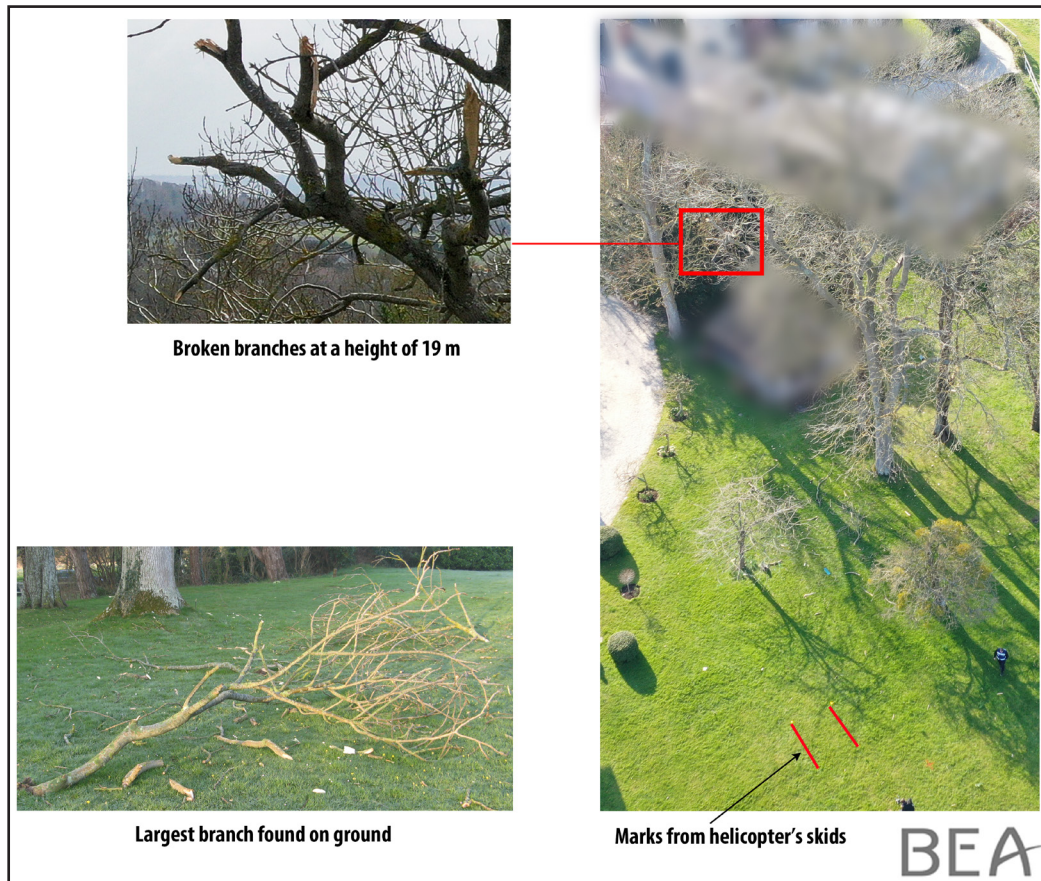
Figure 6: Severed branches

The highest severed branches of the ash tree were situated at a height of around 19 m. These branches were all in the same small area of the tree covering a sector of around 140° (view from helicopter). When the aircraft was on the ground in its take-off area, the distance between the perpendicular of the severed part of the branches and the main rotor blade tips was around 8.50 m.

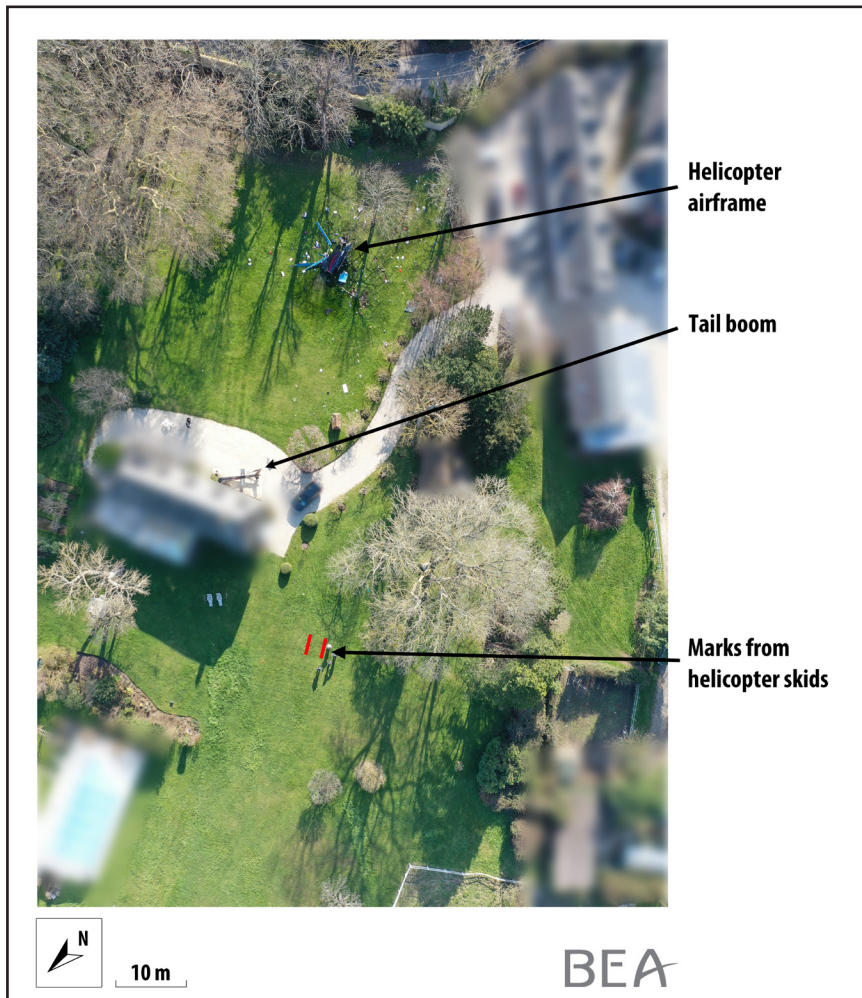
Figure 7: Aerial view of accident site

The helicopter airframe was found around 50 m forward of the take-off point, the tail boom had separated from the airframe.

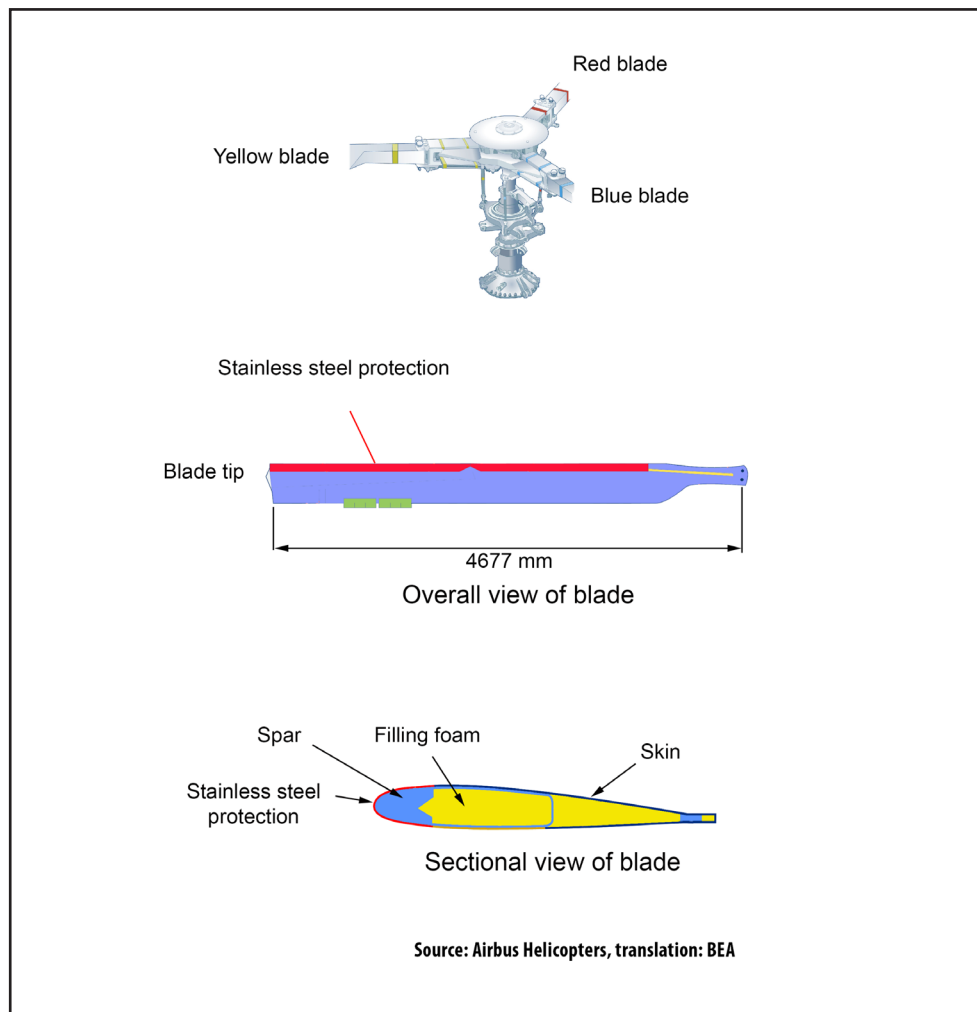
Figure 8: Elements of the main rotor of the AS350

The blade roots were still assembled to the rotor hub which was integral with the Main GearBox (MGB) which was itself in position on the transmission deck. The blades had completely or partially ruptured at 3.70 m from their tip.

The three blades of the main rotor were substantially damaged. This damage was the consequence of the blades colliding with the tree branches and the impact with the ground.

Damage resulting from the collision with the branches was identified on the red and yellow blades over a length of around 2.60 m from the blade tips. The red blade had at least seven points of damage, the yellow blade had suffered at least one impact while the blue blade did not seem to have suffered an impact.

The distribution of the damage on the main rotor blades tends to show that it occurred during a single rotation of the rotor. A succession of impacts over several rotations would probably not have left the blue blade without visible impact marks.

The other damage observed on the red and yellow blades and the deformation of the blue blade was the result of the impact with the ground.

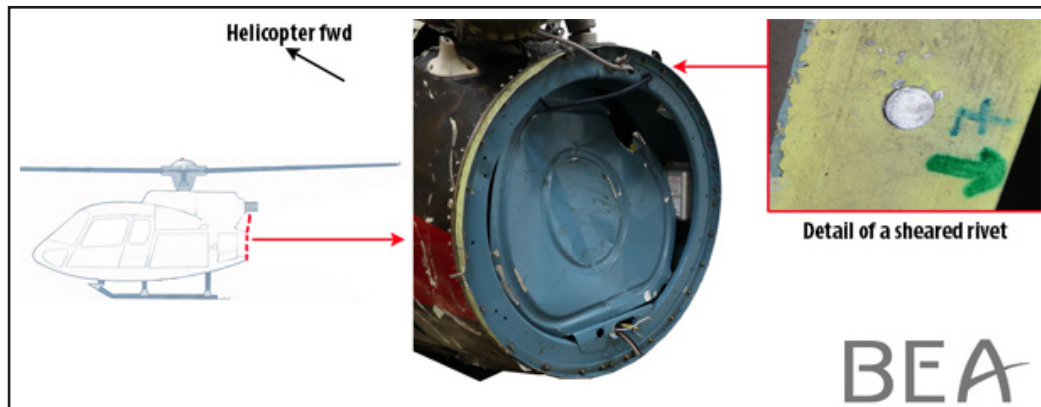
Figure 10: Junction between tail boom and airframe, airframe side

The area where the tail boom separated from the rest of the airframe can be characterized by:

- ❑ Shear failure of 90% of the rivets mechanically assembling the tail boom and airframe together. The skin around the remaining 10% of the rivets deformed, leading to the separation of the tail boom.
- ❑ The deformation of the left part of the tail boom.

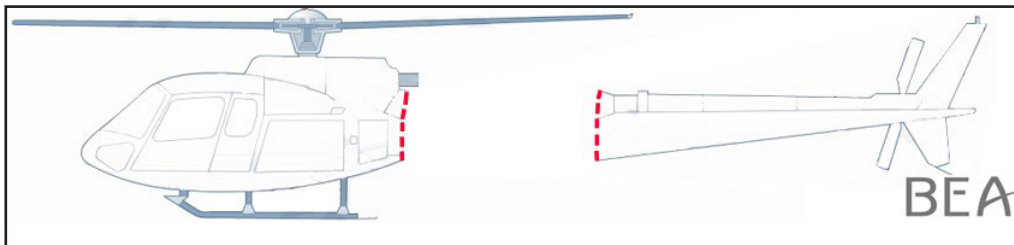
Figure 12: Diagram of tail boom separation area

The diagram below illustrates the area where it was observed that the tail boom separated from the airframe.

The tail boom separated from the main part of the helicopter in line with this riveted junction. Ninety percent of these rivets were found to have sheared (see [paragraph 1.12.2](#)).

The overtorque led to loads, in line with the riveted junction, greater than the ultimate shear strength of the most loaded rivet. When one of the rivets sheared, it overloaded the neighbouring rivets which failed in turn, until the remaining section of the tail boom skin bent.

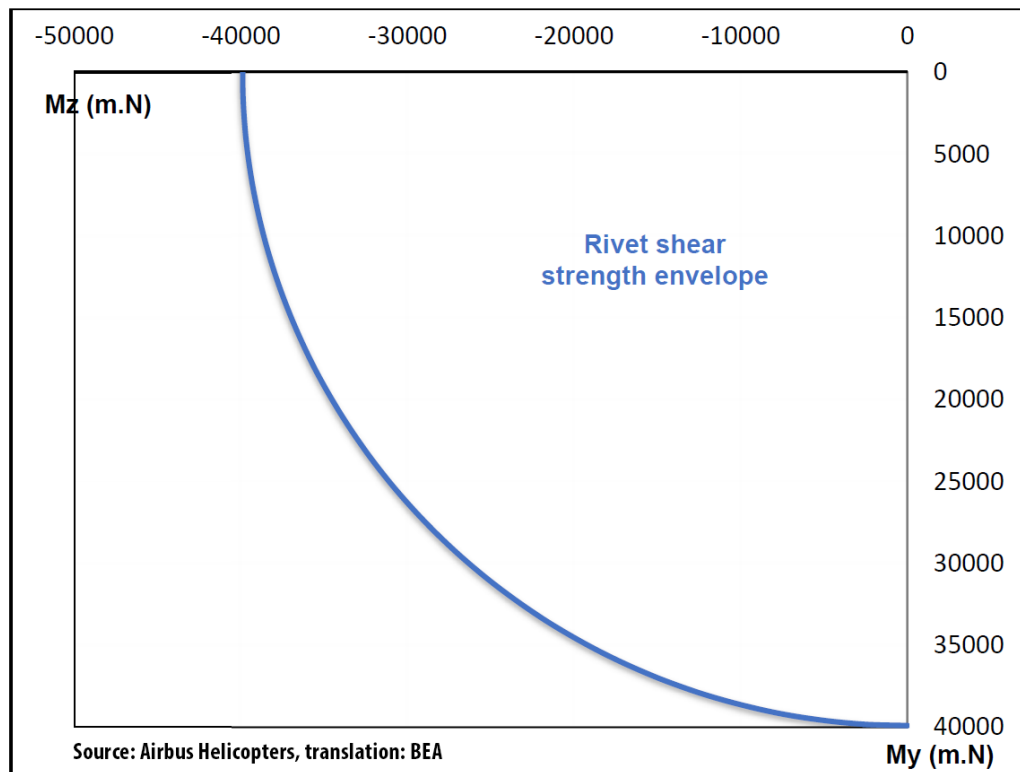
Figure 27: Shear strength envelope of 99 rivets

The graph below shows the shear strength envelope of the most loaded rivet ensuring the mechanical junction between the airframe and the tail boom. In this figure, the envelope is represented in terms of moments generated (on the  $\vec{y}$  and  $\vec{z}$  axes) in line with this junction.

The failure of the most loaded rivet leads to an overloading of the neighbouring rivets which are going to fail in turn, until the remaining section of the tail boom skin becomes too weak and bends.

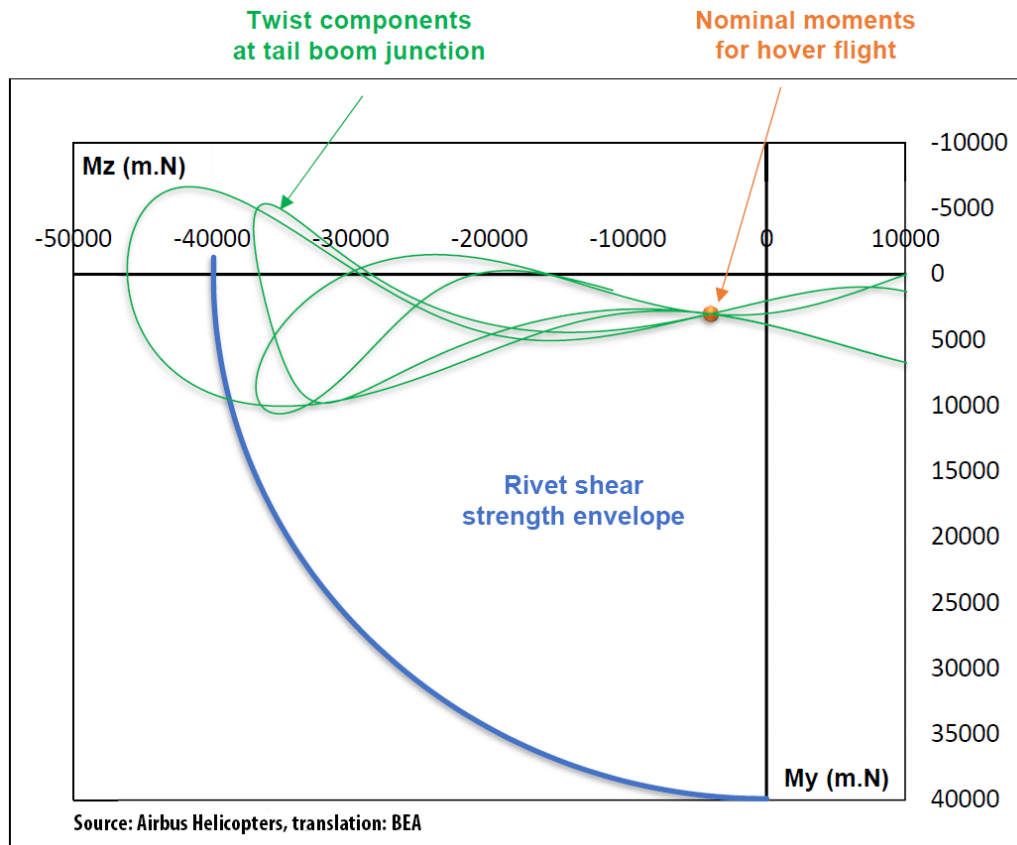
Figure 28: Point of rivet failure

As the forces and moments generated on the main rotor are periodical sinusoidal signals whose amplitude decreases with time, the components of the screw, in line with the tail boom junction, are represented by curves. On taking the AS350 B, in hover flight, in standard atmospheric conditions (ISA), close to the ground, the expected moments in line with the airframe-to-tail boom junction are indicated by the red spot in the following diagram.

The amplitude of the first moments generated at the junction between the airframe and the tail boom by the overtorque on the main rotor is outside the shear strength envelope of the most loaded rivet. In these conditions, and based on the hypotheses retained, the failures, leading to the separation of the tail boom, occur 0.072 s after the main rotor blades' interaction with the branches.

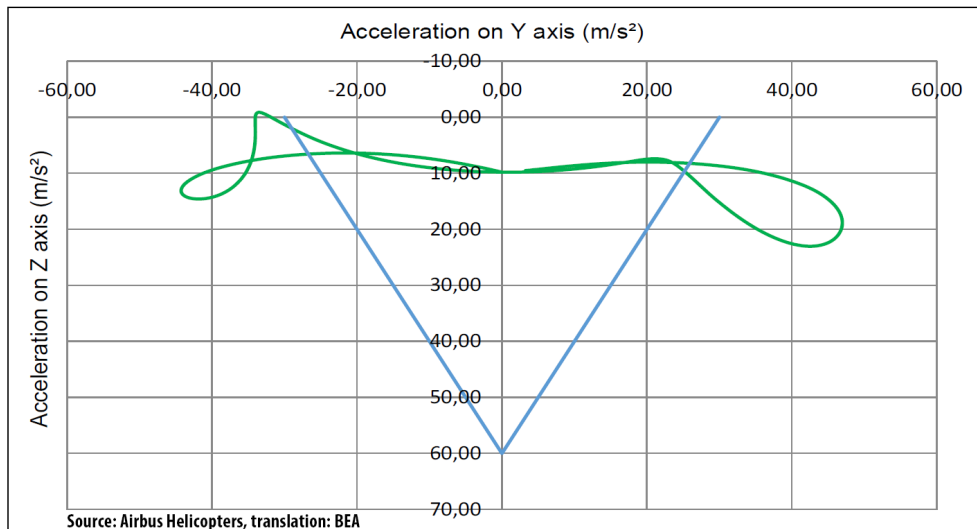
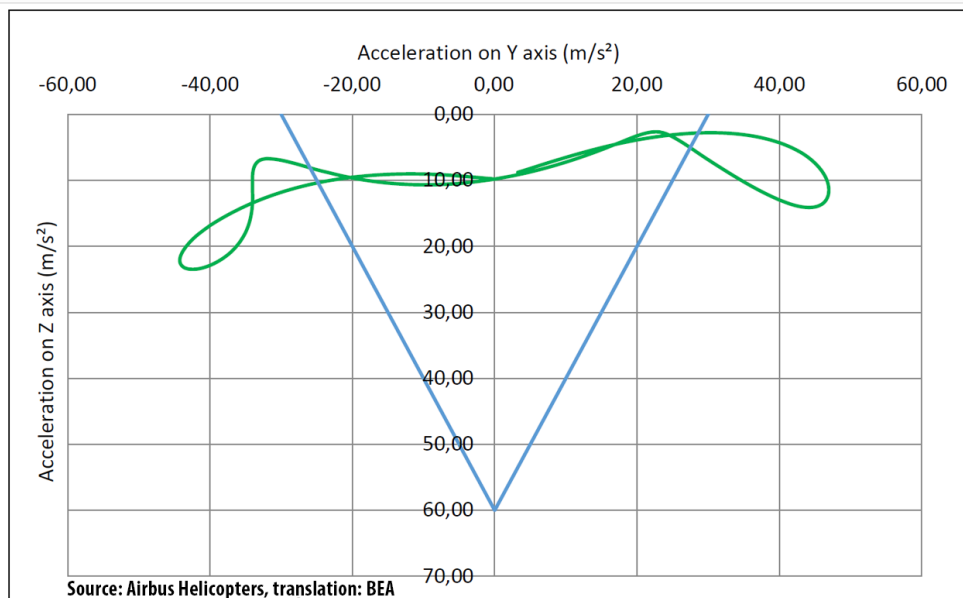
Using the dynamic model for the AS350 B, the screw in line with each front seat, generated by the overtorque on the main rotor was calculated. The associated accelerations are shown in green in the diagrams below.

Taking the hypotheses described in [paragraph A2.1](#), the lateral accelerations, generated when the main rotor blades interacted with the branches, exceeded the envelope which could be borne by the seats. The seats would have been torn from the deck around 0.03 s after the main rotor blades came into contact with the tree branches.
