*Accident
on 25 July 2000
at "La Patte d'Oie"
in Gonesse (95),
to the Concorde,
registered F-BTSC,
operated by Air France*

Preliminary report
translation
f-sc000725pa

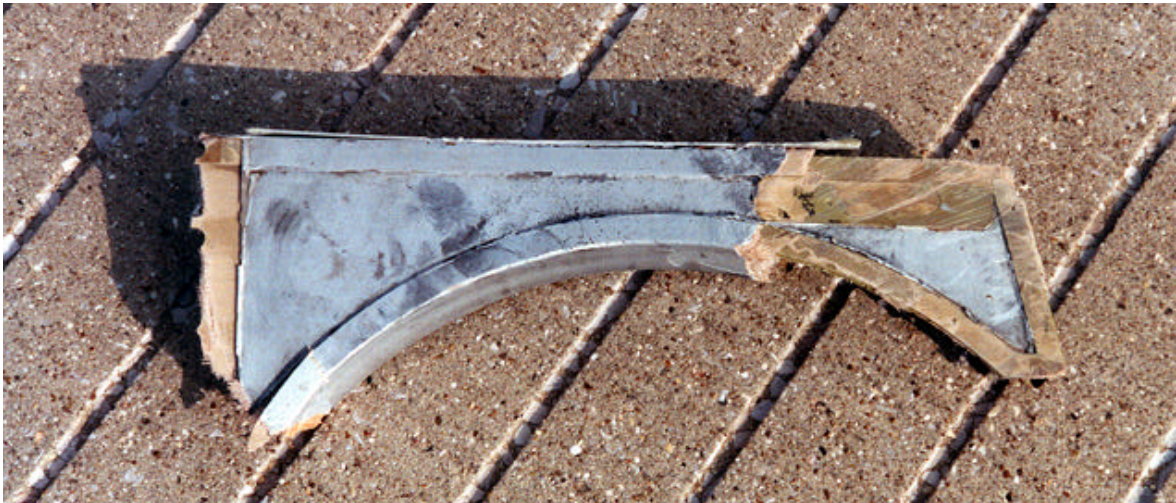
Part found at Slab 166 level: right part of the deflector

Parts of the water deflector of the left main landing gear were found between Slabs 139 and 166, that is 1 642 to 1 845 m from the beginning of runway 26 right, more precisely at 139, 149, 151, 157 and 166. The parts found did not include metallic parts.

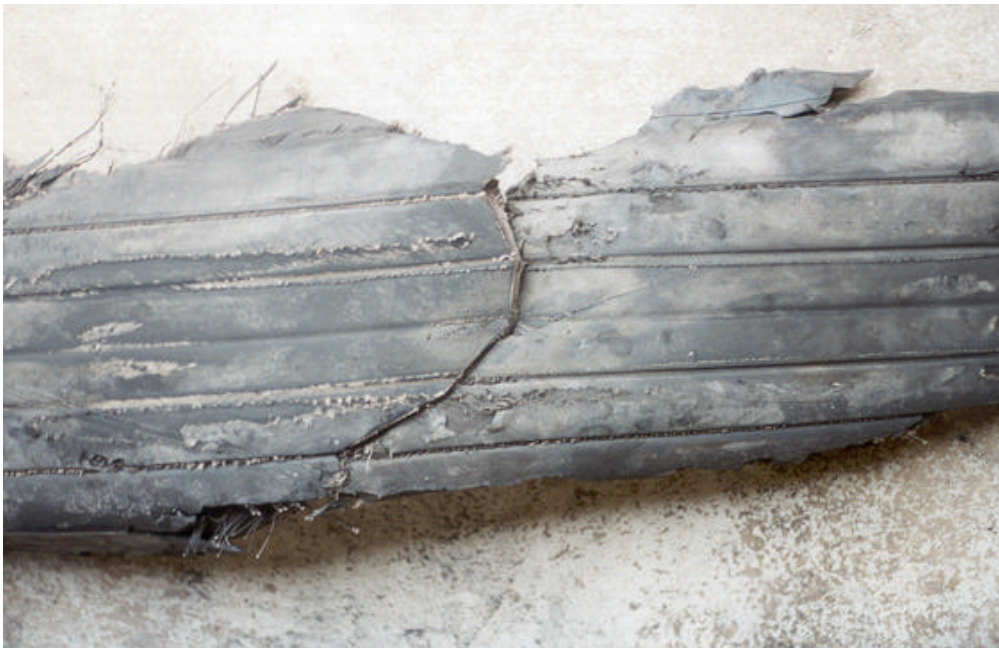
Pieces of tyre from the Concorde were found at slab levels 146, 152, 166, 180, 186 and 187. The parts found at Slab 152 level (a piece measuring 100 x 33 cm and weighing more than 4 kg) and that found at Slab 180 level fitted together. Vis-

ual inspection revealed a transverse cut about 32 centimetres long.

Piece of tyre at Slab 180 level

Piece of tyre at Slab 152 level

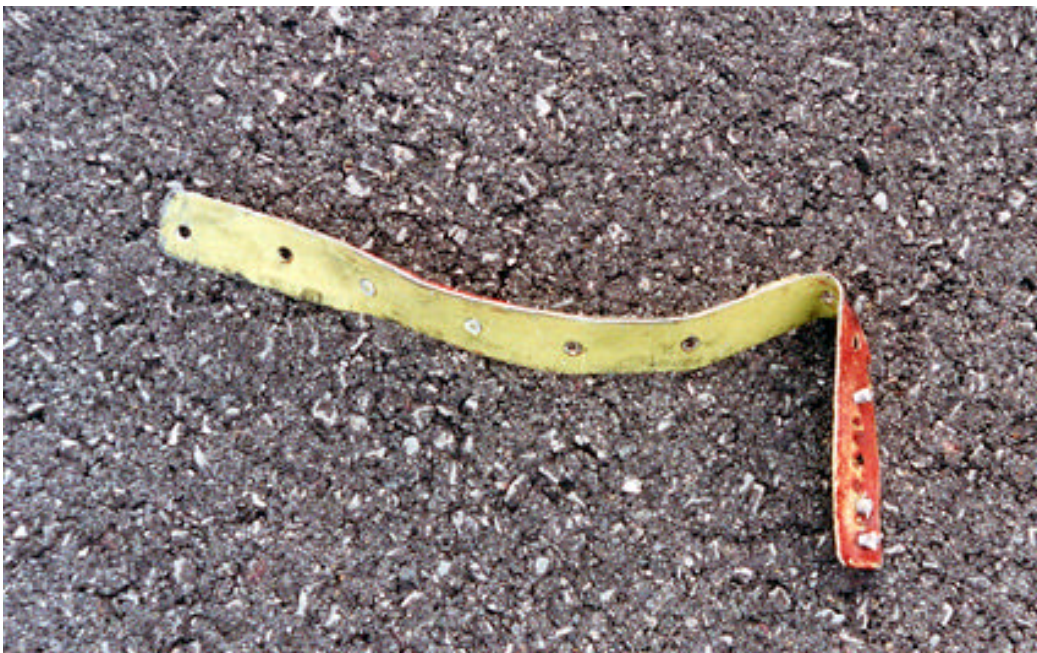
Piece found at Slab 152 level

A strip of metal about 43 centimetres long, bent at one of its ends, was found on the runway shoulder at Slab 152 level. Its width varies from 29 to 34 mm and it has drilled holes, some containing rivets, similar to the Cherry aeronautical type. The holes are not at regular intervals.

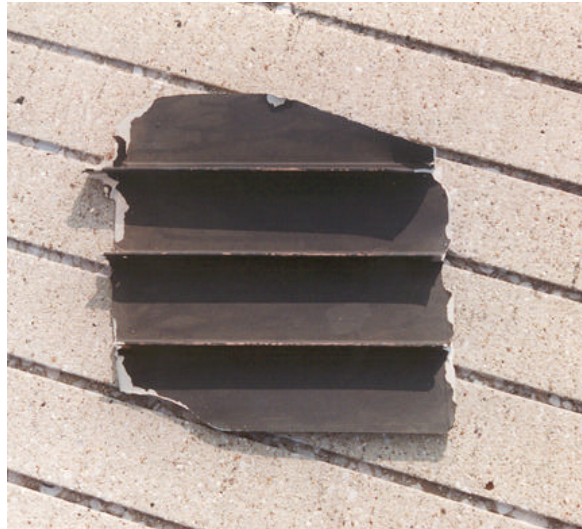
Part found at Slab 160 level

A ribbed structural part measuring about 30 x 30 cm was found at Slab 160 level. It was white on the external side and dark on the ribbed side. It came from the aircraft's No. 5 fuel tank. It showed no signs of impact damage.

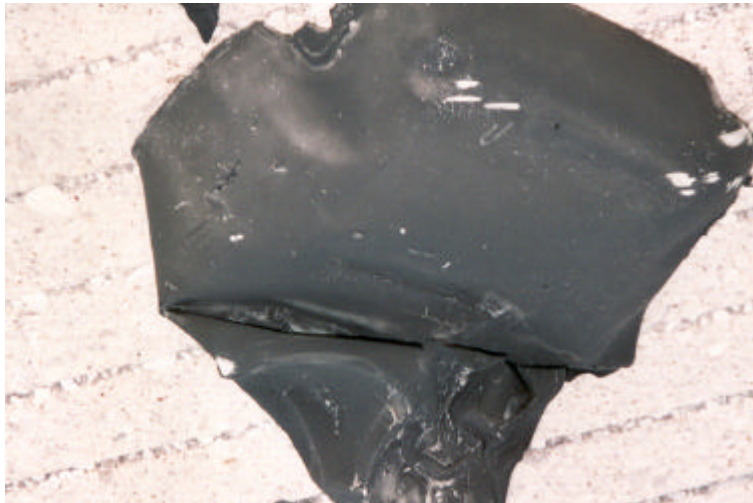
Part found at Slab 175 level

An alloy part, identified as the brake servo valve case, from the left main landing gear, was found at Slab 175 level. This part was sooted and had clearly been overheated. It had impact deformation.

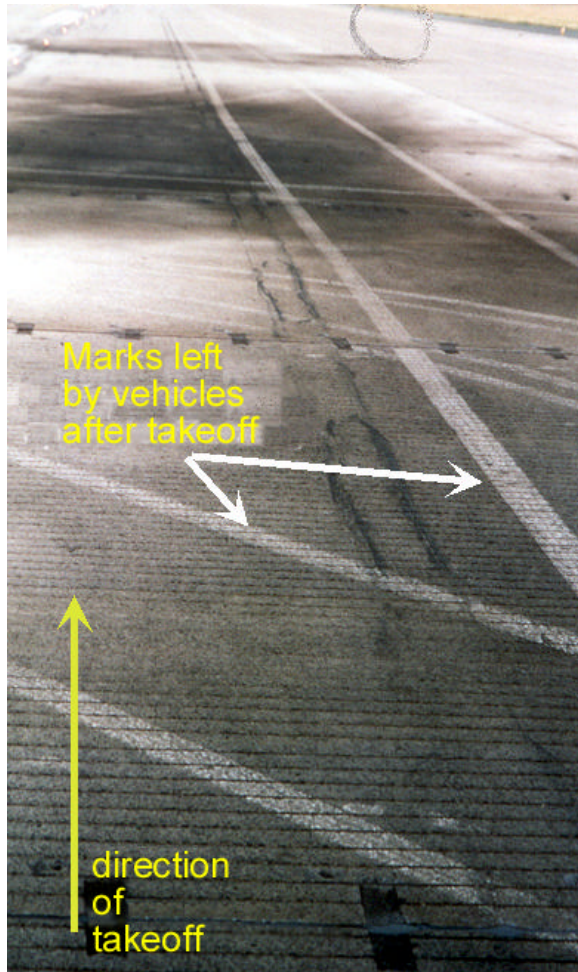
Irregular marks made by the left landing gear were noted up to the broken light (around 2 800 metres).

After this point, the marks became intermittent then disappeared at about 2 830 m from the runway threshold.

From Slab 161 level to Slab 232 level, that is between 1 807 and 2 340 m, the mark of a flat tyre with an incomplete tread was observed.

This mark was parallel to the runway axis (at about 3.8 m) then diverged at about 2 200 metres.

When this mark disappeared at about 2 340 m, its displacement from the centreline was about 8 m. This corresponded to the right front tyre of the aircraft's left landing gear.

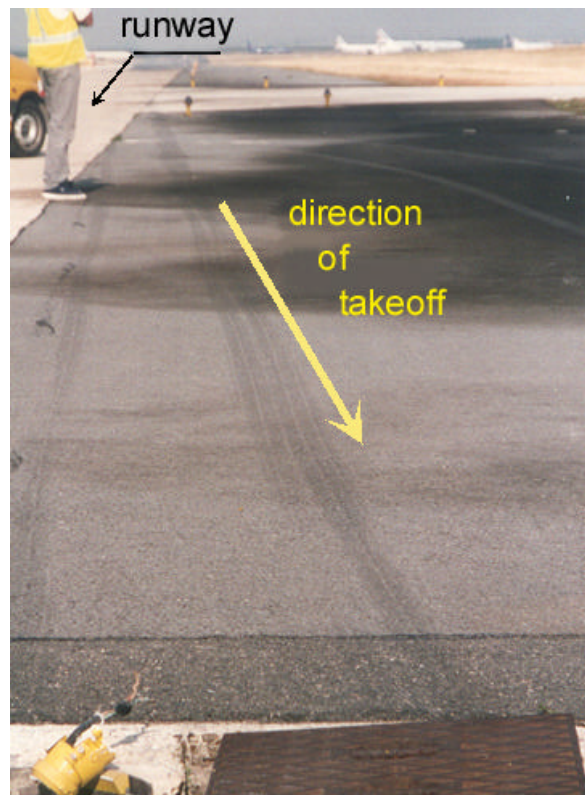
The runway edge light at the Slab 293 level (about 2 800 m from the origin) was broken and small pieces of the light were found nearby. Ground marks showed that this light was broken by the Concorde's left main landing gear.

Mark left by the left truck and broken light

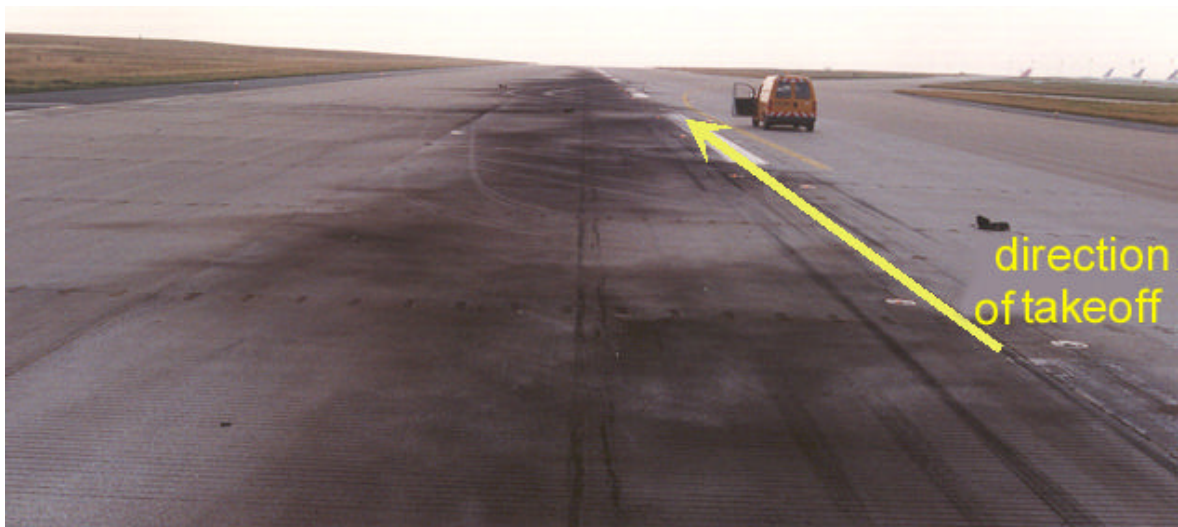
Slab 202

Traces of soot, produced by incomplete combustion of kerosene, were apparent on the runway 1 860 m onward from the origin (Slab 168). These were large and dense up to 2 300 m and then became less dense and rich in carbon up to taxiway S4, at 2 770 metres. The traces, which were on average 7 m wide, were initially centred on the damaged wheel ground mark and progressed to a position corresponding to the far left of the aircraft.

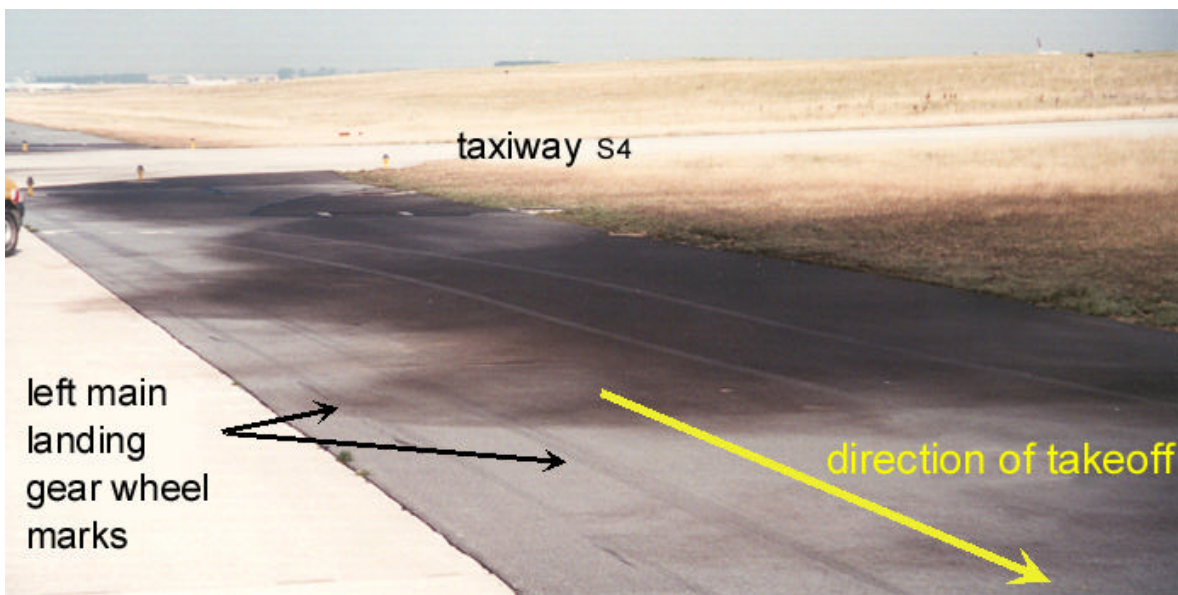
Slab 290

A further sooted area was apparent after taxiway S4 up to the broken edge light.

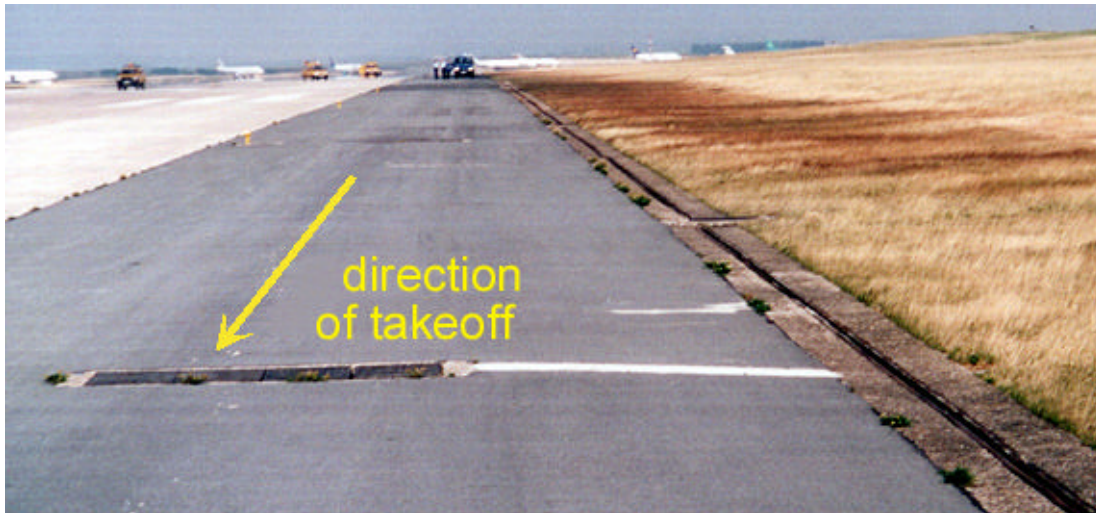
Between Slabs 310 and 340

The grass was burnt adjacent to the runway edge, between 2 902 and 3 165 metres. This area, also featuring soot deposits, indicated that there was an extensive flame after the aircraft became airborne.

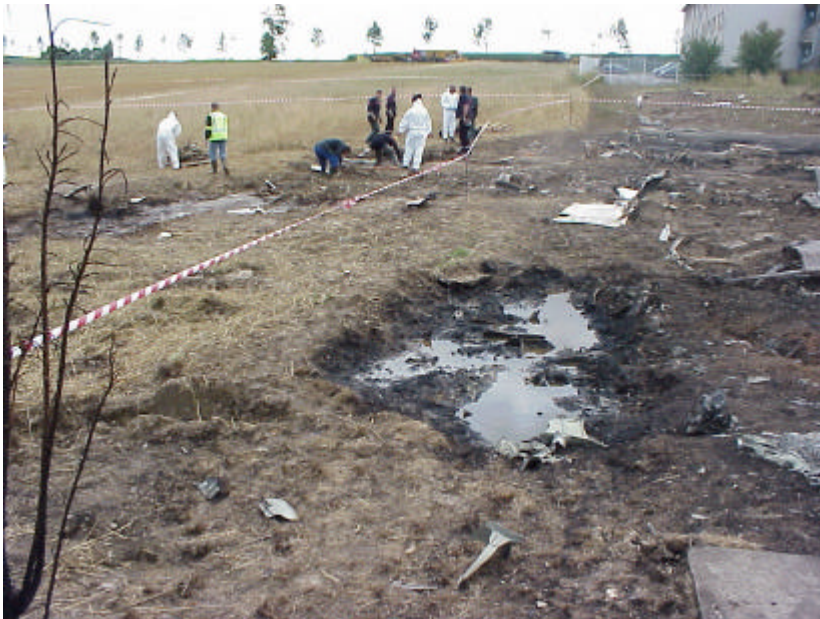
Signs of ground impact were found to the north of the site at the intersection of areas A and B. There was a row of trees about three metres high, oriented east to west, then a crater at the bottom of which was rear tank No. 11. Pieces of engine air intake were found half-buried at A3 and signs of ground impact were apparent at A3 and CB2-North. Wheel N° 6 was embedded in the ground.

Ground impact marks

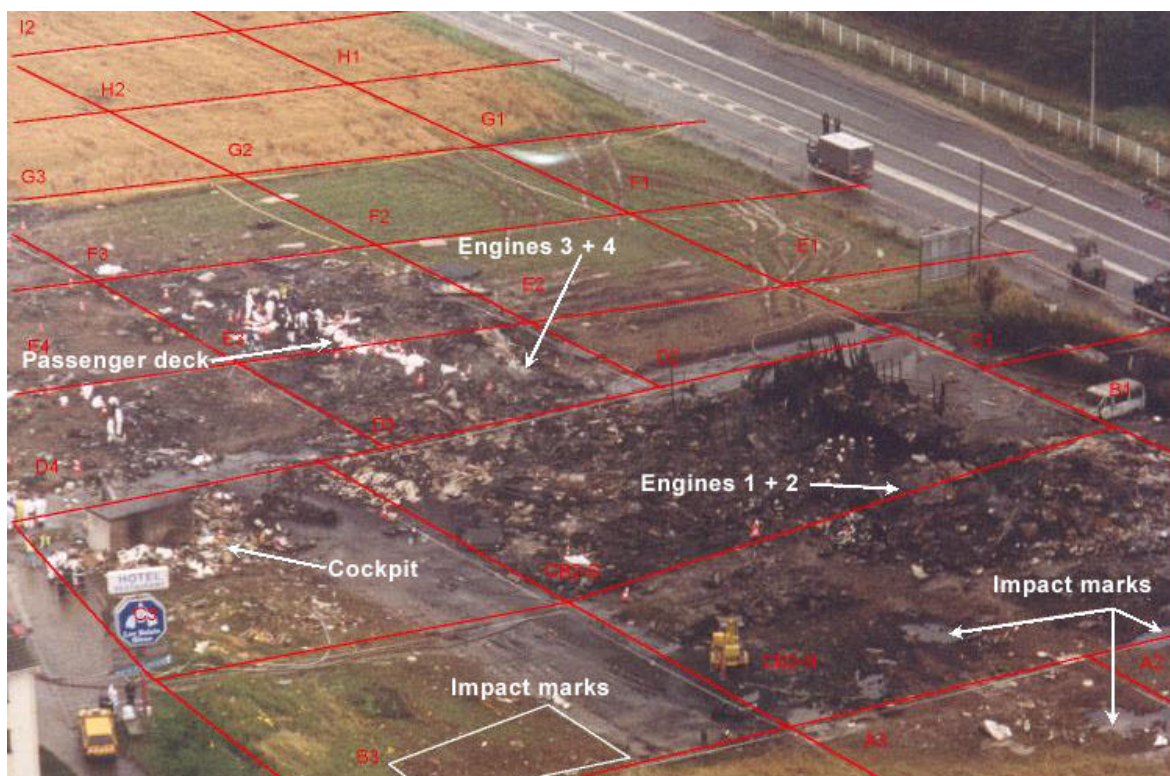
Aerial view showing location of the main parts

The hotel located at CB2-North was almost entirely flattened. The lower parts of the left and right main landing gears were close to the initial impact marks.

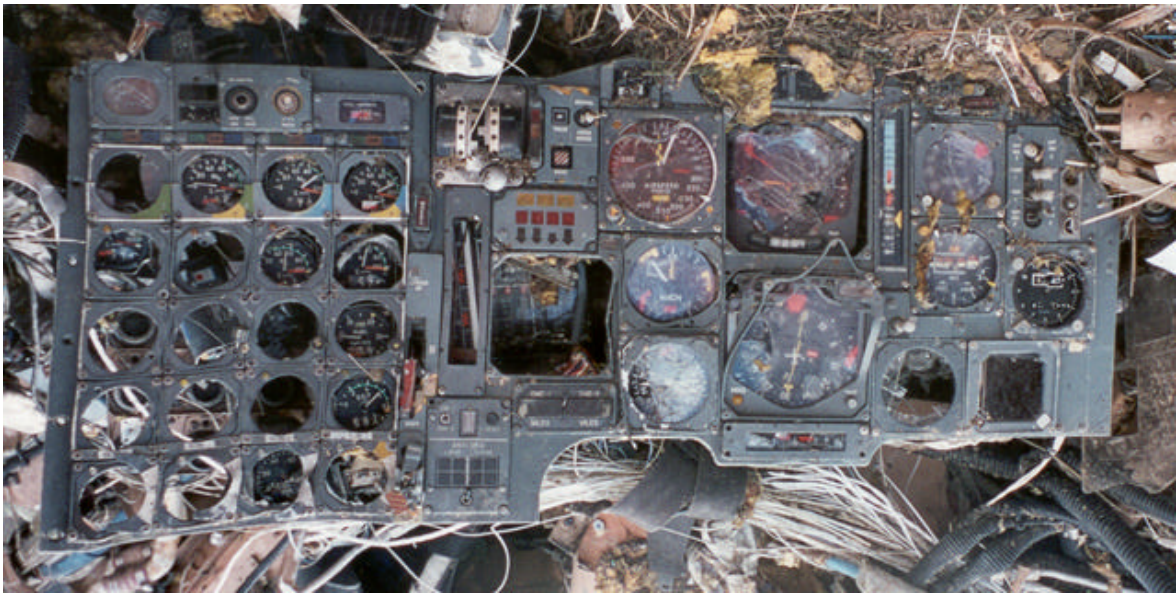
Instrument panel

- the Nose/Visor lever was in the "Down" position
- the landing gear selector was towards the "Down" position, past the gate
- on the rudder position indicator (damaged on impact), the rudder indicators were at 20° left for the upper control surface and 12° right for the lower control surface on "G" (Green). The indicators for the elevons were on "M" (Mechanical) and provided no information
- the airspeed shown on the airspeed indicator was 99 Kt, "STBY" flag, and V2 bug was on 230 kt
- HSI heading 105°, ADI 30° roll to the left and 32° nose down. Vz – 1 800 ft/min, altimeter - 240 feet "STBY" flag, radio altimeter unreadable, VOR1 028°, VOR2
- FD switch on number 2
- attitude selector on ATT INS3, comparator on COMP2, deviation on DEV2, navigation on NAV INS2
- clock on 14 hours 45 UTC

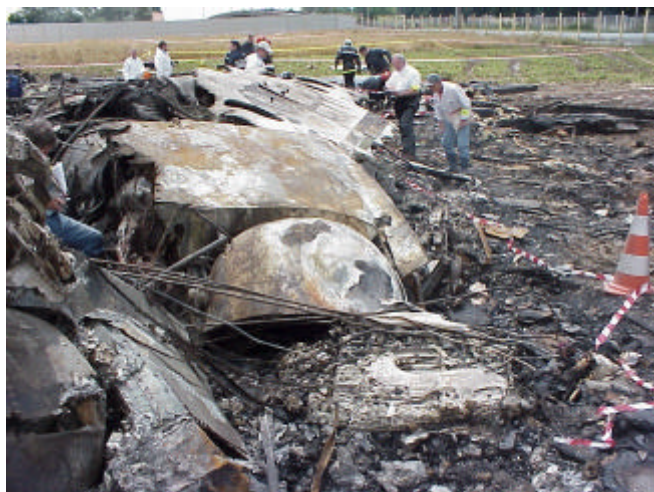
*General view of engine
n° 4 upper secondary
exhaust nozzle*

The upper secondary exhaust nozzles were still in place on engines 1, 2, 4 and separated from the nozzle structure on engine 3. The lower secondary exhaust nozzles were separated from the structure and three of them were found intact. The upper actuators from engines 2 and 4 were attached to the structure and to the nozzles. The lower actuators were found at the site with the exception of that of engine 3.

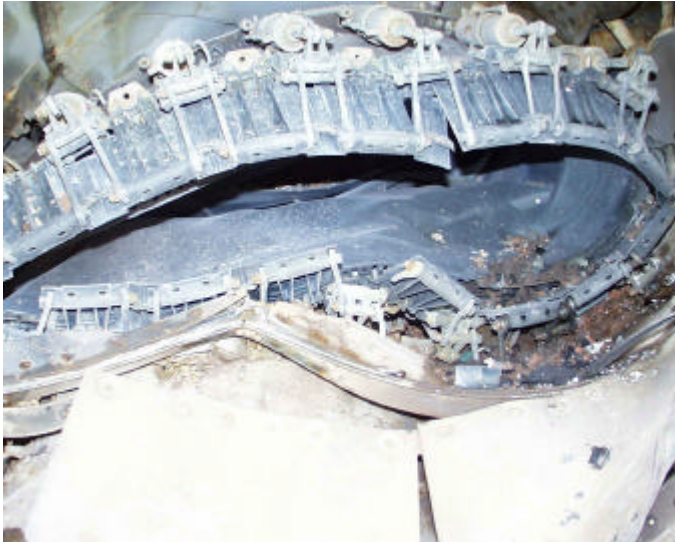
The primary exhaust nozzle from engine 3 was separated from the structure of the secondary nozzle. The latter was torn away from the rest of the engine. The nozzles from engines 1, 2 and 4 were in place but flattened by the impact with the ground.

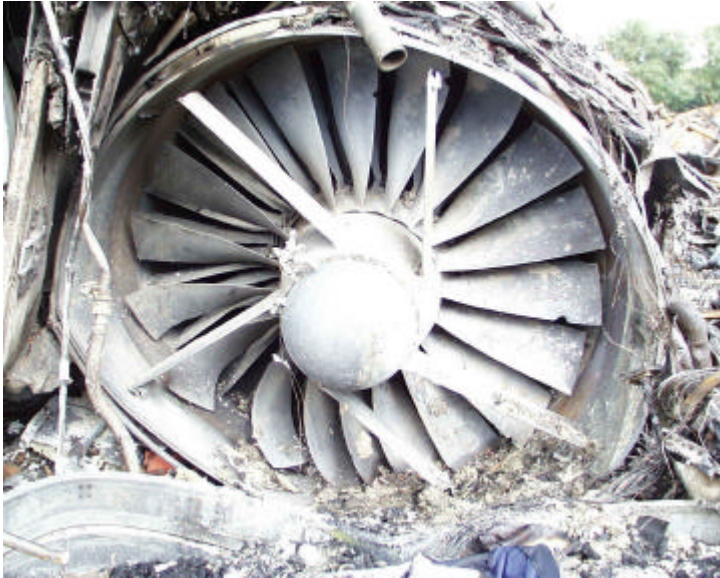
Engine n° 1 LP compressor

Examination of engine n° 2 appears to indicate a negligible N1 before impact. The rotor of the LP compressor of engine n° 1 apparently made less than a quarter of a revolution after the impact before being stopped by the casing being crushed.

Engines 1 and 2 showed signs of damage (FOD) by a soft object on the LP compressor rotor blades. Engine 1 also showed signs of FOD by a hard object. The damage found on engines 3 and 4 showed that they hit the ground with an N1 much higher than that of engine n° 1.

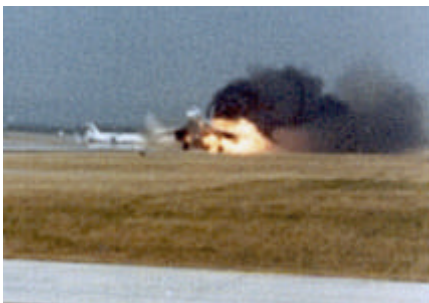
The initial fire began under the wing, between the left engine nacelles and the fuselage, a few seconds before the start of takeoff rotation, the aircraft being in the vicinity of W7 or S5. A small flame apparently appeared suddenly, similar to a blowtorch, and then got wider (enveloping the left engines) and longer (about the length of a fuselage). This flame was accompanied by thick black smoke. The noise of the aircraft was perhaps different from normal.

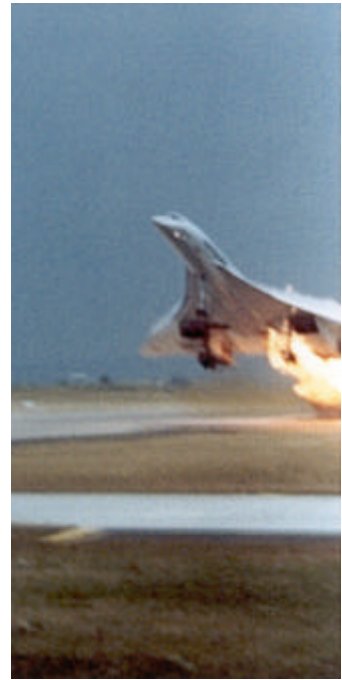
After having passed over the freight zone, the aircraft stopped climbing, with an apparently constant pitch attitude and with the landing gear extended. It flew over the N17 road at about two hundred feet, turned to the left at a steep bank angle, pitched nose up and crashed left wing first. There was a conflagration followed by one or more explosions.
