## CHAPTER 9

# INTERNATIONAL CONVENTIONS, LEGISLATION, REGULATIONS AND CO-OPERATION

# BOW DOOR FAILURES AND INCIDENTS

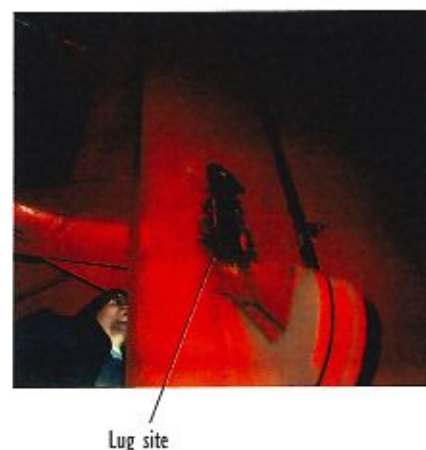
**Figure 11.1 Loss of the starboard visor locking lug of DIANA II in January 1993.**

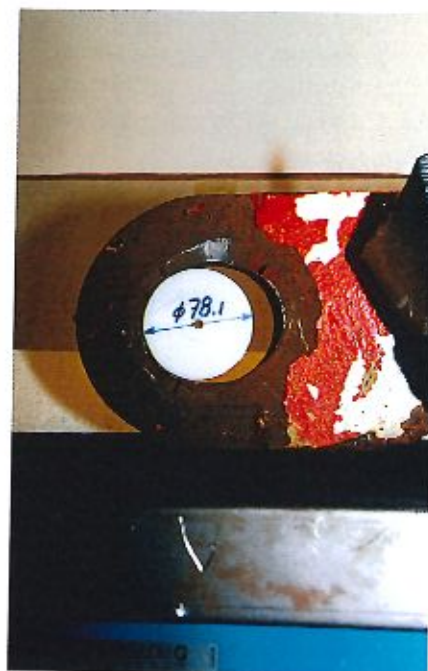
Figure 12.17 The visor lug for the bottom lock with a disc of the same diameter as the bolt inserted.

estimate the contribution from the welds. The calculation indicates that the effective size of the weld joint could have been around 3 mm. This was also observed, although the actual weld joint was quite irregular.

The mating visor lug was bent and elongated (Figures 12.17 and 12.18). Hardness testing showed the plate material to be most probably mild steel and

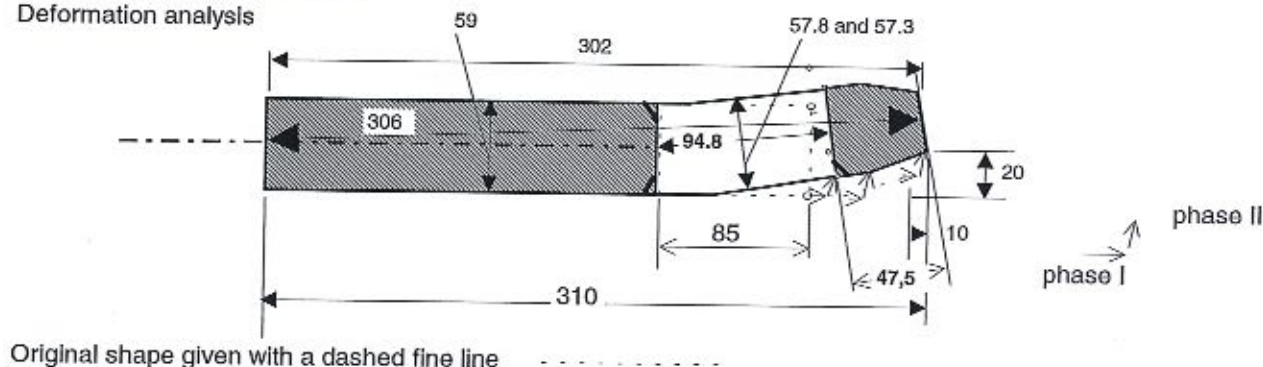
#### ATLANTIC LOCK VISOR LUG Deformation analysis

similar to the material of the hinge plate. The aft or eye end of the mating lug had been elongated and bent to starboard. By analysing the shape of the hole and lug rim it was concluded that the original dimensions of the lug aft end had conformed to drawing. In its retrieved condition the aft end eye ligament had the designed dimension of 47.5 mm suggesting no damage by wear to this side of the eye.

Comparison with tests with several mock-ups of full or subsize scale showed that the lug had been stretched, most probably prior to the bending. The tests indicate that permanent yielding in the authentic lug started at a tensile load of about 0.5 MN. The measured net stretching of around 6 mm may have occurred under a load of about 1.5 MN. In addition wear of up to 2 mm was observed on the stem (forward) side of the eye suggesting leaning of the visor against the locking bolt. The dimensional analysis indicated that the initial length of the lug stem was 3 mm less than the drawing dimension.

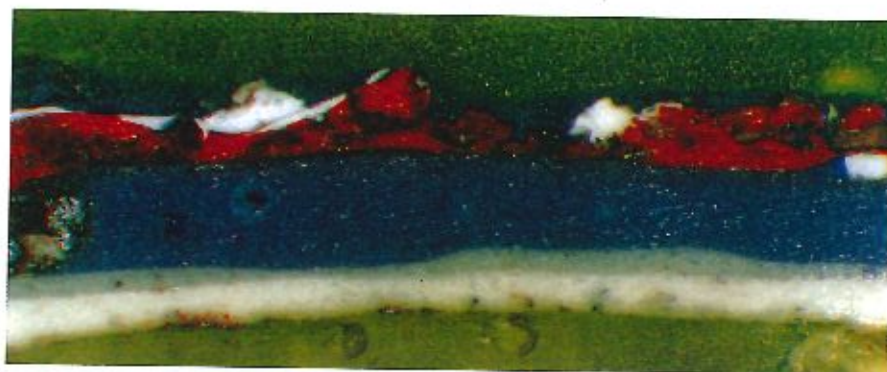
Figure 12.19 Cross-section of a paint sample from the forepeak deck starboard lug.

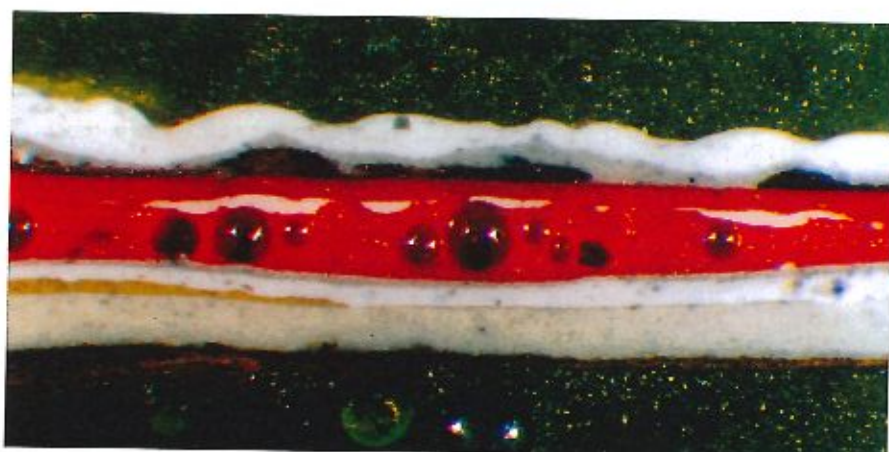
Figure 12.20 Cross-section of the paint sample from the visor lug for the bottom lock.

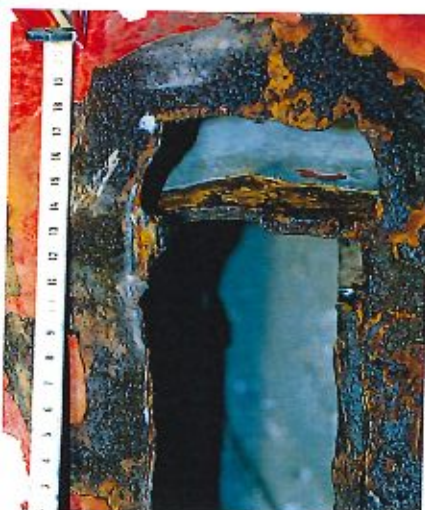
Figure 12.22 Failure at port side lug location at horizontal stringer.

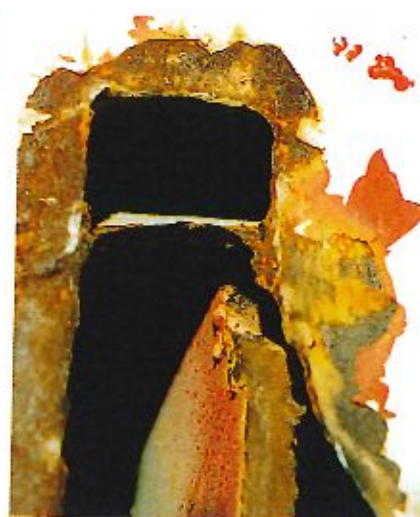
Figure 12.23 Failure at starboard side lug location at horizontal stringer.

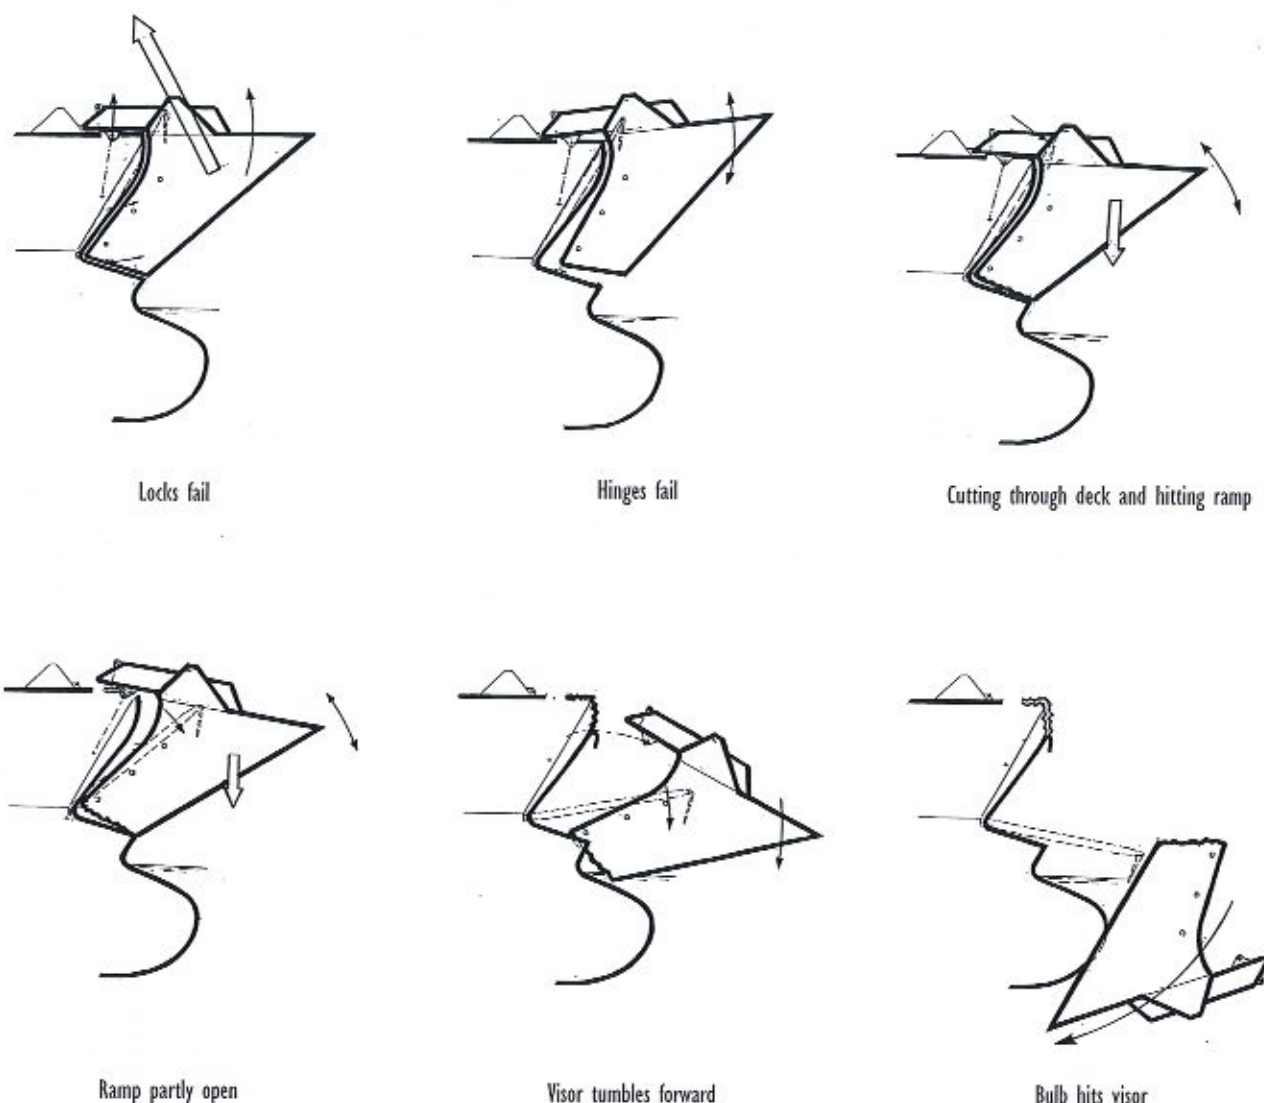
Figure 13.6 Probable failure sequence of the bow visor.

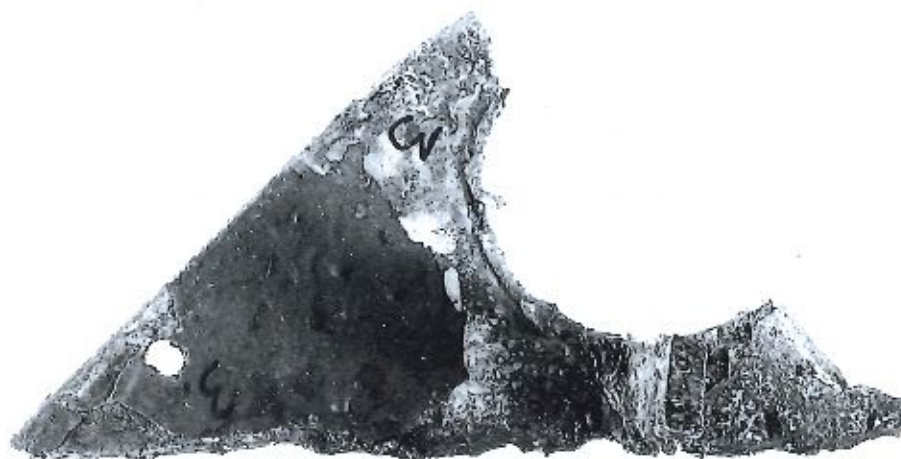
Figure 15.1 The failed starboard mounting lug for the bottom locking device.

to a tensile load of up to 1.5 MN (Supplement).

The Commission has learnt that the bottom locking device assembly was manufactured by the yard as a shop sub-assembly that was subsequently welded to the forepeak deck. No detailed drawing with welding data was issued specifically for this subassembly as welding data was generally contained in yard standard tables. The Commission has not found information on any modifications or repairs of the bottom lock. The paint test (see 12.7 and the Supplement) and statements by people involved in maintaining the lock indicate that it is original or dates back to a very early period of the vessel.

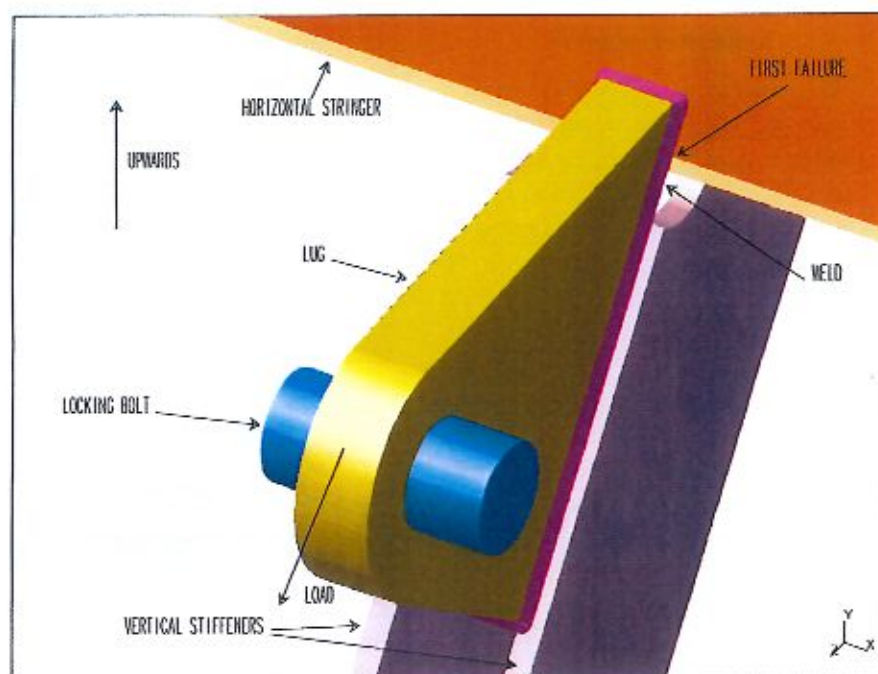
Figure 15.3 The visor side locking lug assembly with bulkhead plating removed.

the very modest vertical stiffener weld added some holding strength.

The ultimate load-carrying capacity of the side locking lug welds has been calculated to be less than the value above for a weld bead of 8 mm, but the thickness and strength of the weld material is uncertain. The actual failure did not, however, occur in the welds.

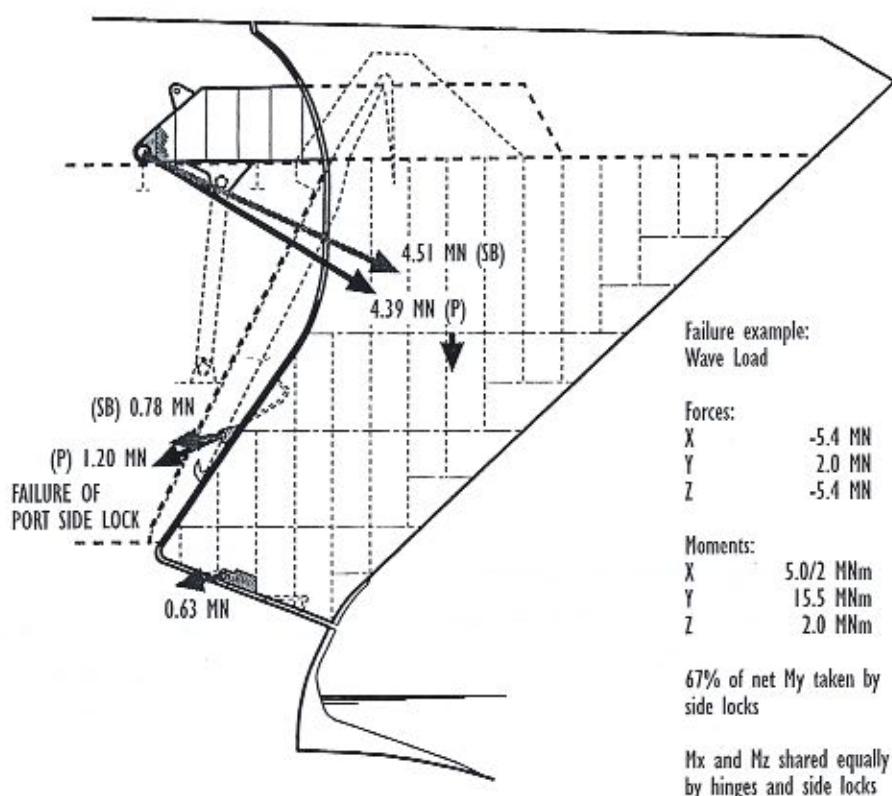
Figure 15.4 Example of reaction force distribution resulting in port side lock failure.

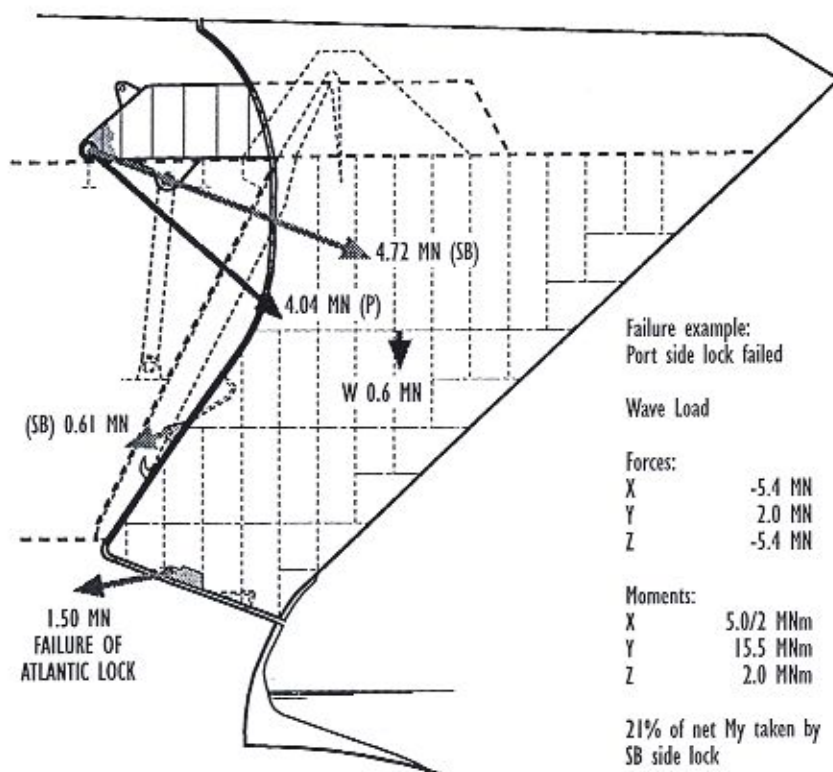
Figure 15.5 Example of reaction force distribution after the port side lock had failed.
