## Port State Control Training on MV ESTONIA

### 1. Objective

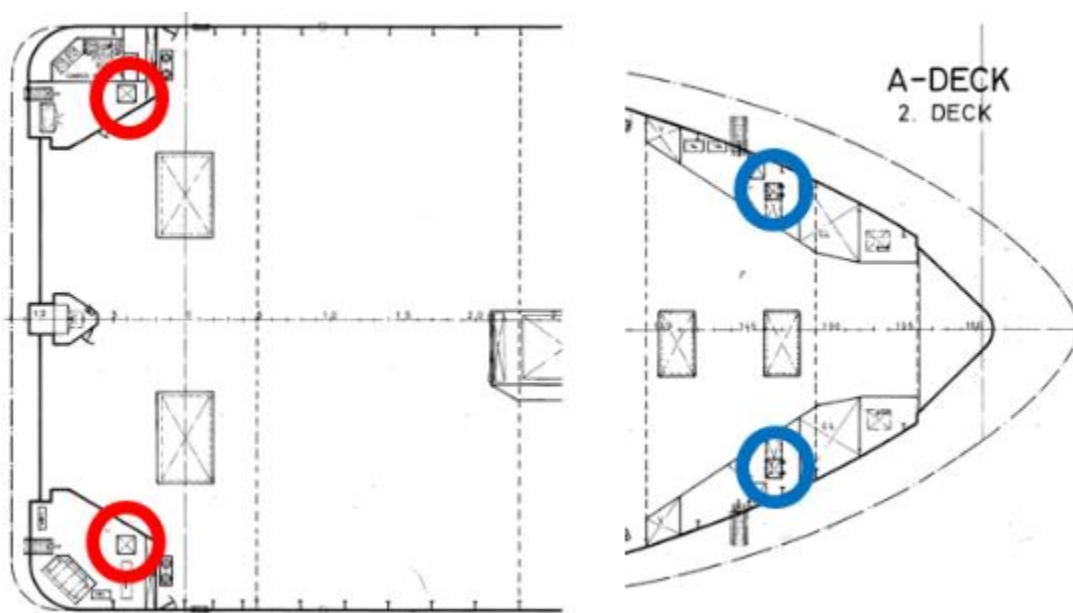
Fig. 8. The image shows the aft (left) and forward (right) parts of deck 2, i.e., the car deck. In

The deficiency that potentially could cause some concern in this very accident is the “covers on bulkhead deck to be closed”. These covers were not clearly identified, but based on the use of plural, taking witness statements into consideration, and combining this with the vessel’s drawings, it seems likely that the covers mentioned are those in the forward wing houses on the car deck (see Figure 8). These are man hatches with the function of reaching the below area, i.e., the bow thruster room, one hatch on each side. Alternatively, the reference could refer to two similar hatches in aft wing houses, emergency exits from the steering gear room. The covers were, according to statements from different and independent witnesses, closed as the training went on. New footage show, however, that at least the port side hatch to bow thruster room today is open. There are several possible explanations to that (e.g. that it was not properly closed during the training exercise, that it was opened again after the training exercise, or that it has turned open as a consequence of the sinking process or when the vessel hit sea bottom) and it is not possible to determine if it was open during the sinking process. If the hatch, and the corresponding hatch on starboard side, were open during the sinking process, they have significantly speeded up the water ingress in the water tight section, consisting of the bow thruster room.<sup>28</sup>
