Marine Inquiry 11-201, Passenger vessel *Volendam*, lifeboat fatality,
Port of Lyttelton, New Zealand, 8 January 2011

Final Report

Approved for publication: October 2011

Transport Accident Investigation Commission

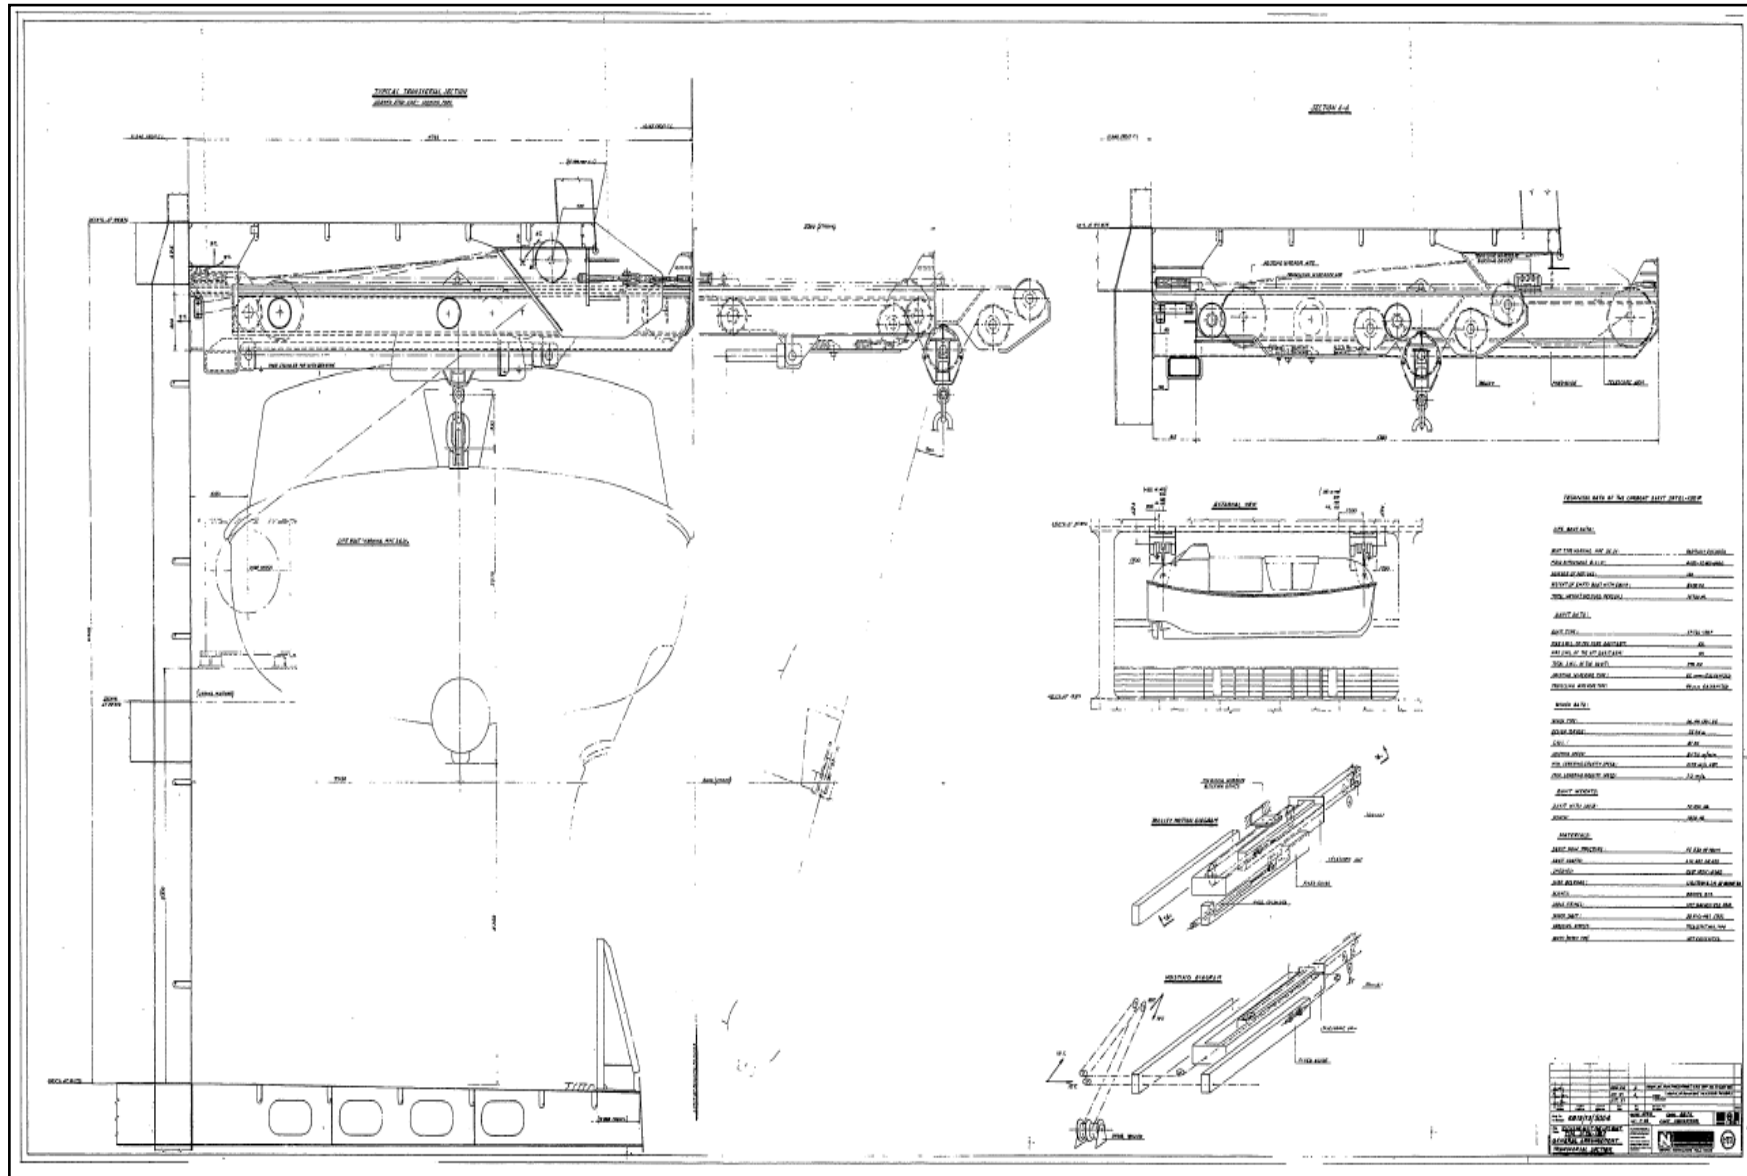
Figure 2
Diagram of the telescopic davit system as fitted to the Volendam

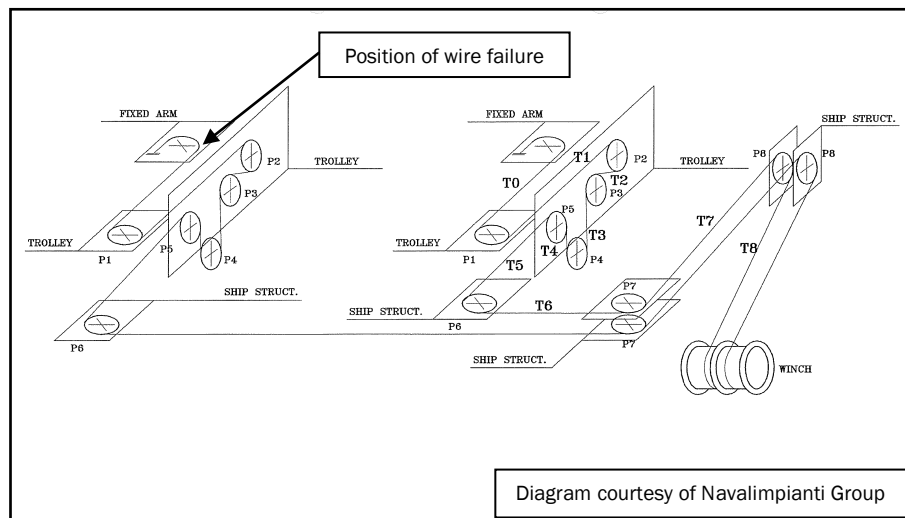
Figure 3
Wire fall reeving diagram

- 3.3.7. The wire falls were wound onto 2 hydraulically-driven winch drums and reeved through a series of sheaves located on the ship, on the telescopic trolley arms and on the fixed arms. Both wire falls terminated after passing around fixed guides located on the outboard end of the fixed arm of the davit (see Figure 3).

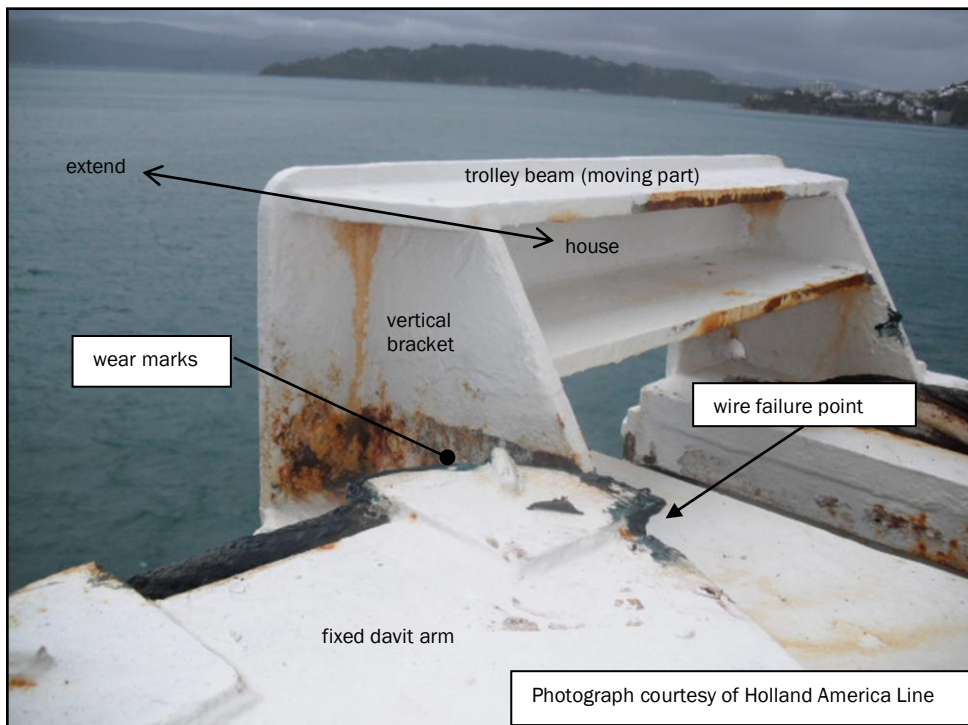
Figure 5
Number 7 forward davit showing moveable trolley beam and wire break point

- 3.4.2. The wire failed at a point just inboard from the end of the fixed guide on the inside of the forward davit arm (see Figures 4, 5 and 6). When being extended, and re-housed the moving trolley arm moved horizontally past this fixed guide. The groove on the fixed guide was of sufficient size to accommodate a 22 mm wire under tension. A vertical bracket on the moveable trolley beam lay adjacent to the fixed guide when the davit was in its stowed position.

- 3.4.3. Figures 4 and 5 show where the vertical bracket had been rubbing against the fixed guide, causing wear marks on the bracket. When number 5 davit was inspected, there was evidence of wire score marks on the bracket (see Figure 7).

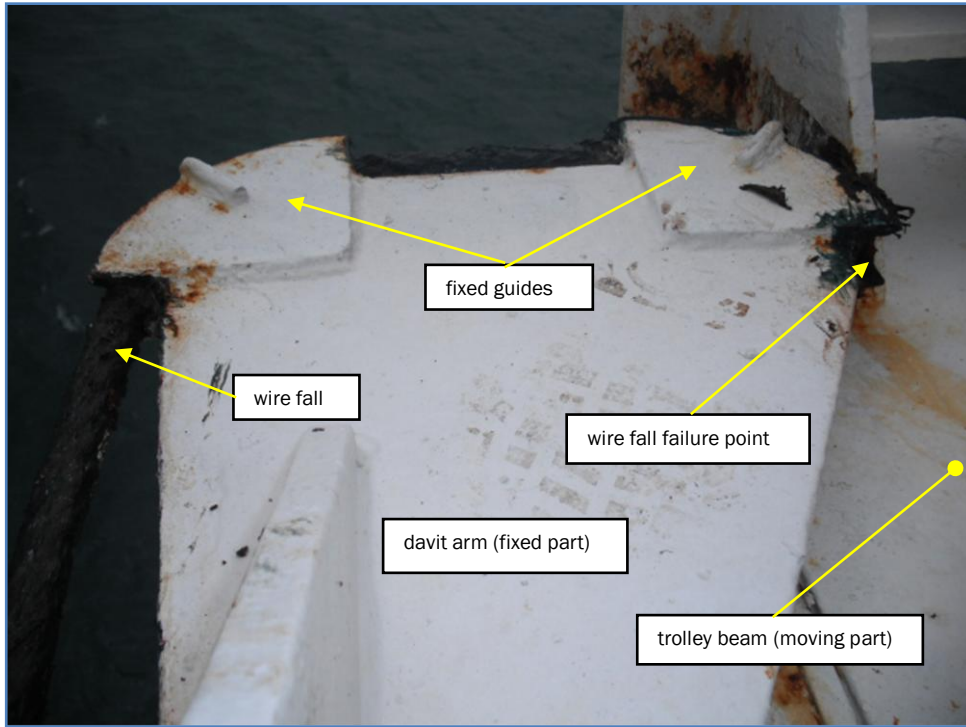
Figure 6
Head of number 7 forward fixed davit arm

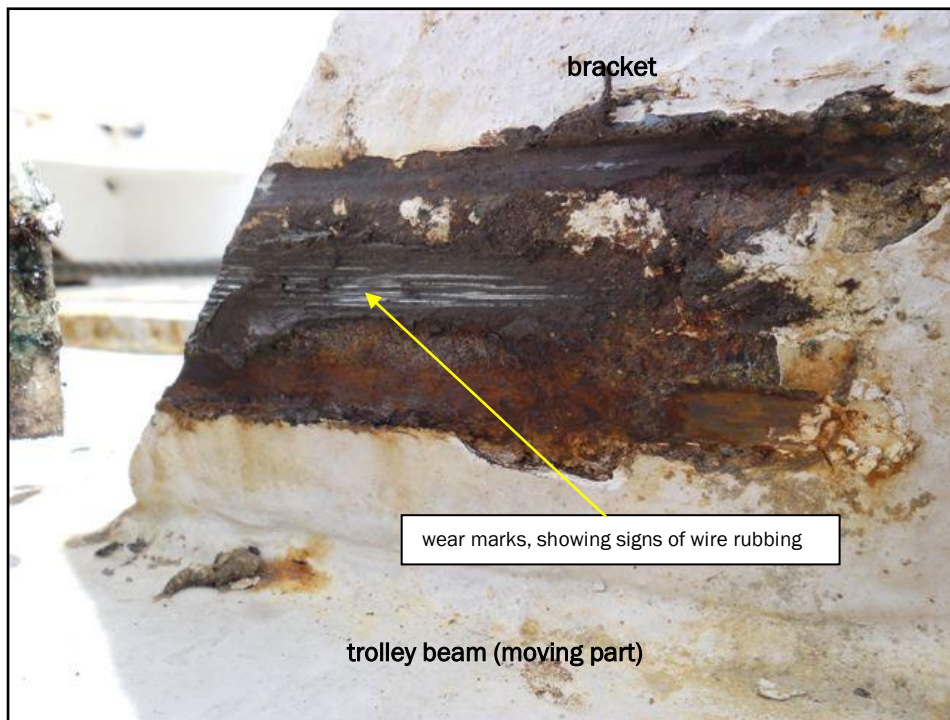
Figure 7
Vertical bracket from number 5 trolley beam

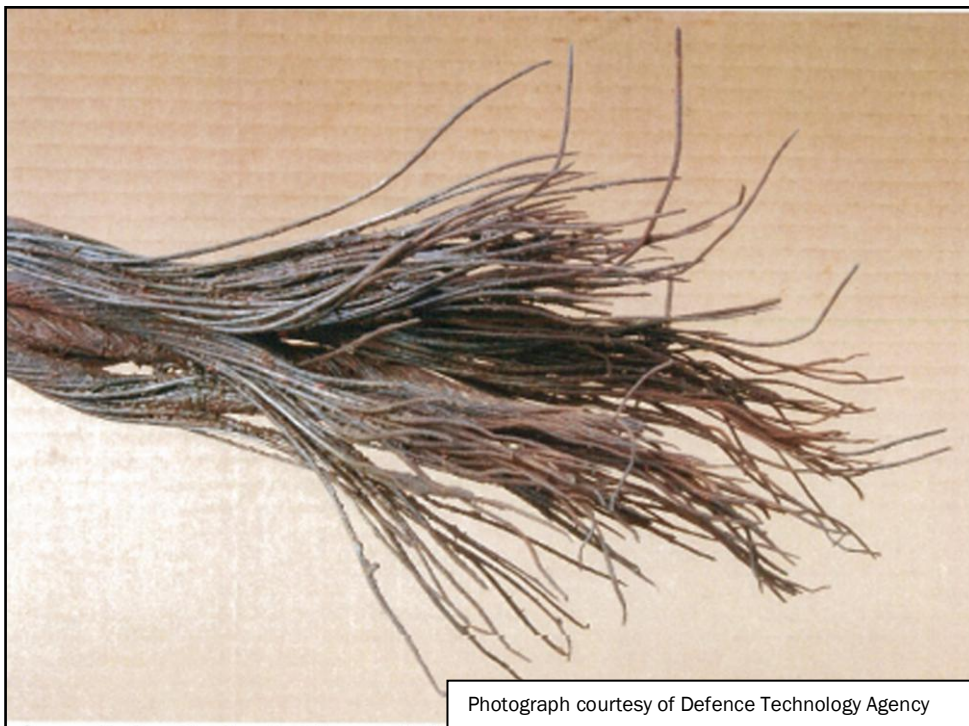
32. The failure had occurred in a severely corroded section of the hoist wire. A high proportion of the wires had corroded through and the corrosion had caused a significant reduction in the cross sectional area of other wires which finally failed by tensile fracture. This corrosion was associated with a relative absence of grease in the immediate area of the failure compared to that observed elsewhere.

Figure 9
Photograph of the failure point of number 7 lifeboat forward wire fall

- 4.2.4. Salt-laden water was then easily able to penetrate the core of the wire from the inside of the guide, and in the absence of lubricant the corrosion process accelerated. The fall wire failed when the corrosion weakened it to a point where it could no longer support the weight of the lifeboat. The wire failed in tension overload.

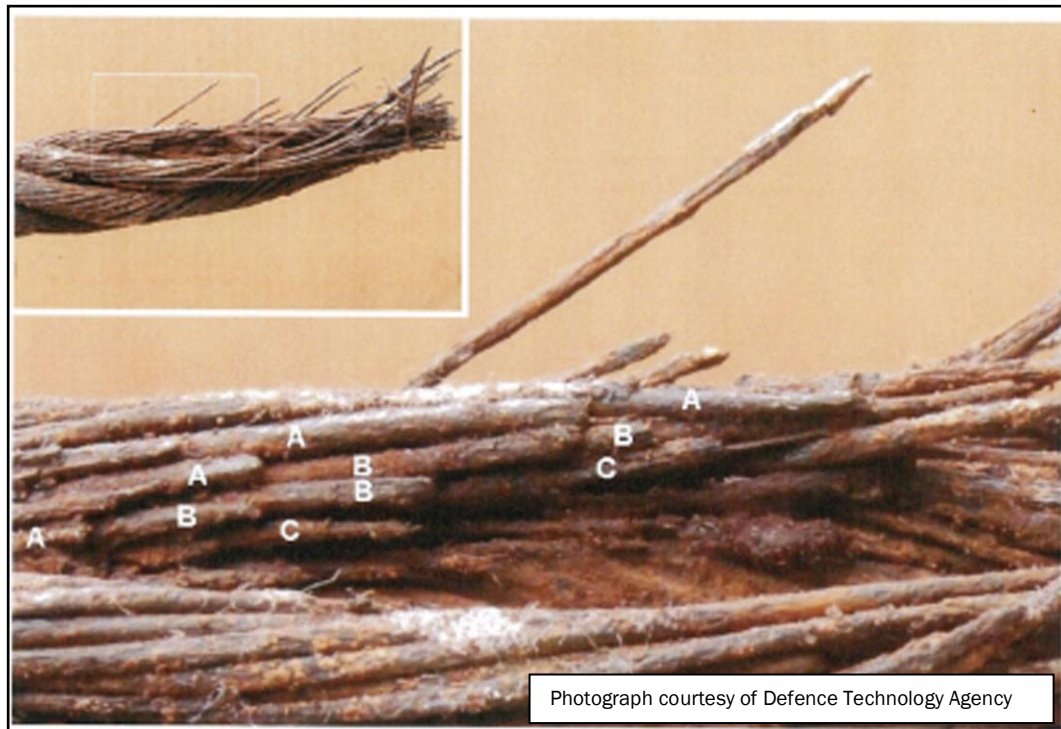
Figure 10
Enlarged photograph of failure point of number 7 lifeboat wire fall

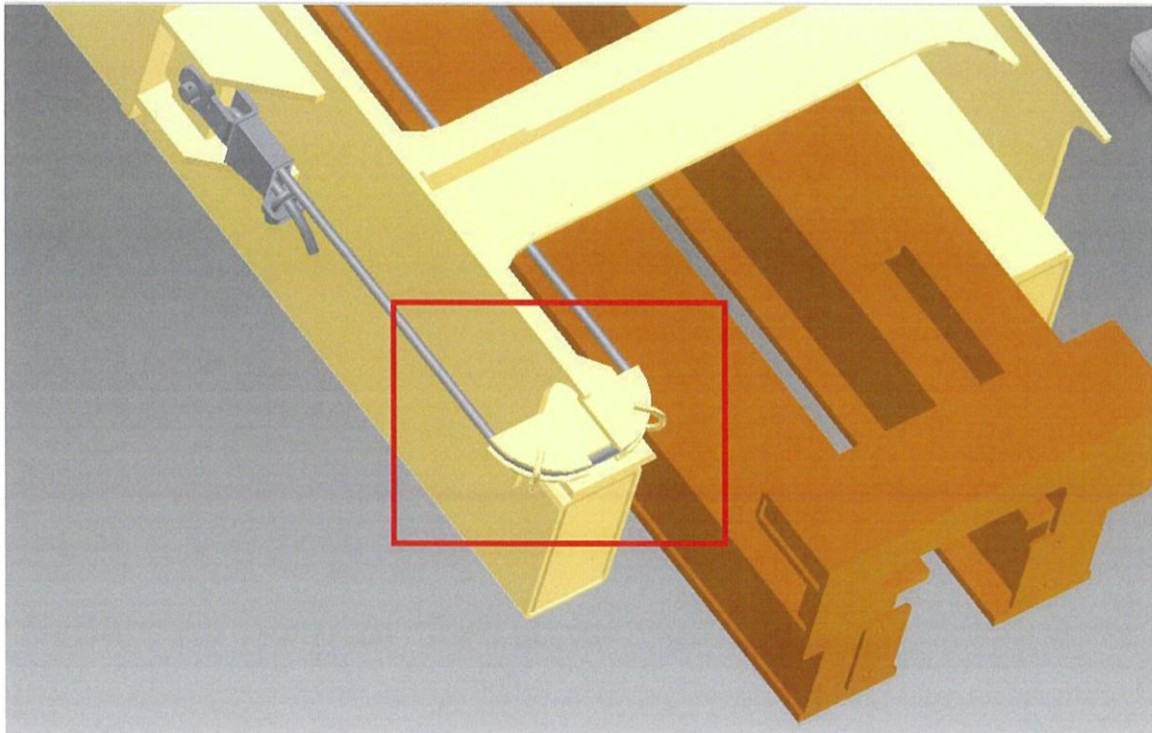
In several types of telescopic davits the fixed end of the wire rope is deviated before to reach the spelter socket of the fixed connection by means of a fixed steel sheave guide. This steel sheave guide is arranged in front of the fixed frame of the davit arm (see the detail in the picture).

It is mandatory to inspect periodically the efficiency of the whole length of the wire rope with special regard to the areas passing through the sheaves including the rope's length along this guide.

It is also mandatory to renew the falls when necessary in way of deterioration or at intervals of not more than 5 years, whichever comes earlier.
