Safety Investigation Report of the Sinking of the Fishing Trawler, 501 Oryong

Date of Casualty: 2014.12.01

Date of Publication: 2016.03.11

**Special Investigation Team,
Korea Maritime Safety Tribunal**

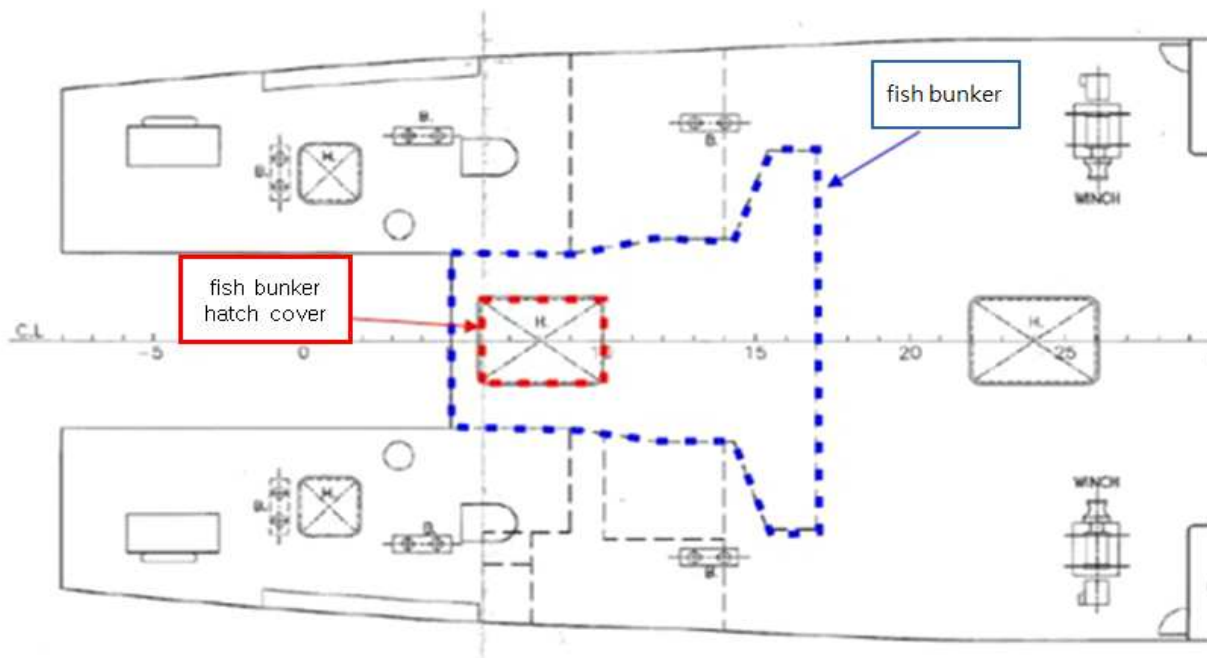
2.3.7 Fourth, there were previously two small fish bunker hatch covers (1.5m x 1.5m) but these were replaced with one large hatch cover in the middle (transverse 1.5m x length 2.4m). This was because the captain who oversaw this work on site deemed it necessary for the convenience of operation.

[Image 5] Expansion of the fish bunker hatch cover (red box)

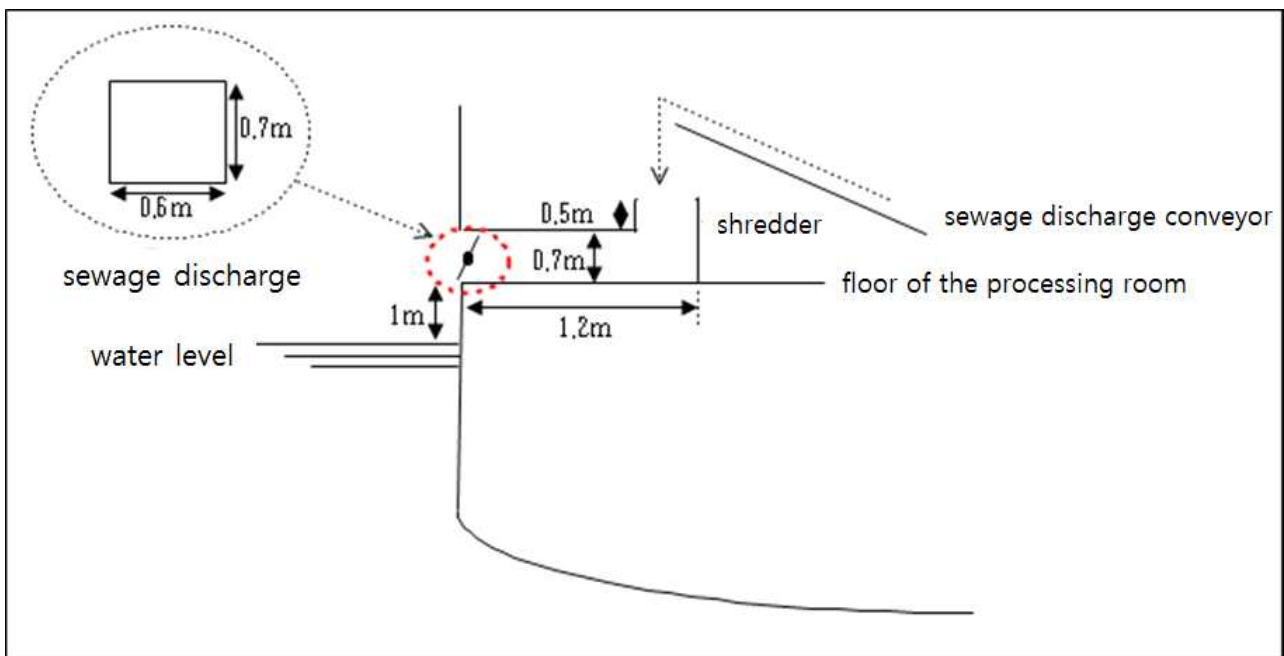
3.1.4.1 A sewage discharge outlet (0.6m wide and 0.7m high) has been installed on the floor of the processing room (6.8m high) between portside frame numbers 17 to 19, as can be seen on Image 7 and Image 8, to discharge waste produced from processing fish in the processing room.

[Image 7] Installation status of sewage discharge outlet

3.1.4.3 After the vessel departed from Gamcheon Port in Busan in July 2014, the shutter of the sewage discharge outlet fell off in mid-September of the same year during operation at the fishing ground, but it was left neglected until the day of the casualty without any repair.

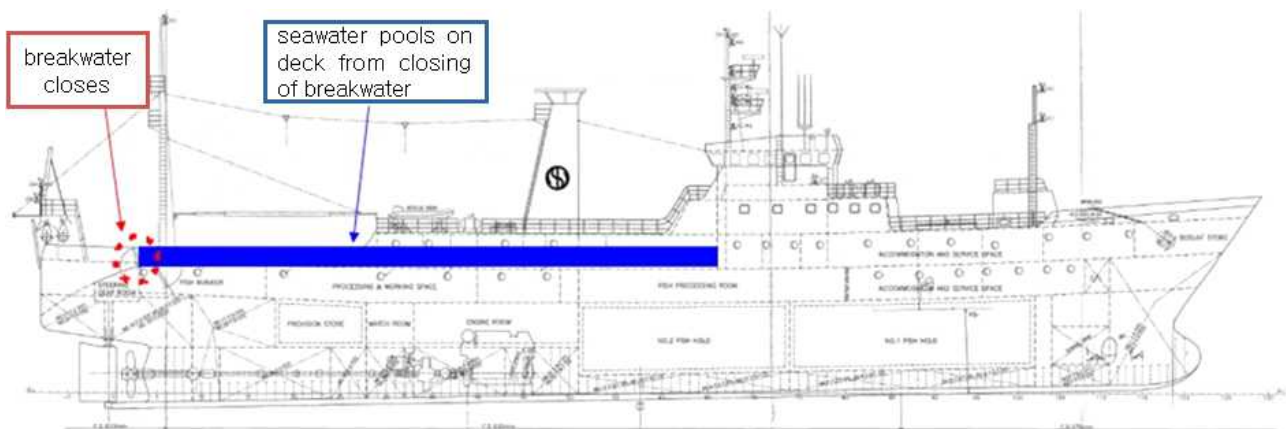
3.3.2.7 Even with the seawater rising, the crew members positioned at stern followed the captain's order and prepared to unload the catch into the fish bunker by hanging the net on the gallows²⁴⁾. When seawater swelled on deck, crew members found shelter behind nearby structures and came back to finish the work repeatedly.

[Image 16] Inflow of seawater onto deck from closing of breakwater

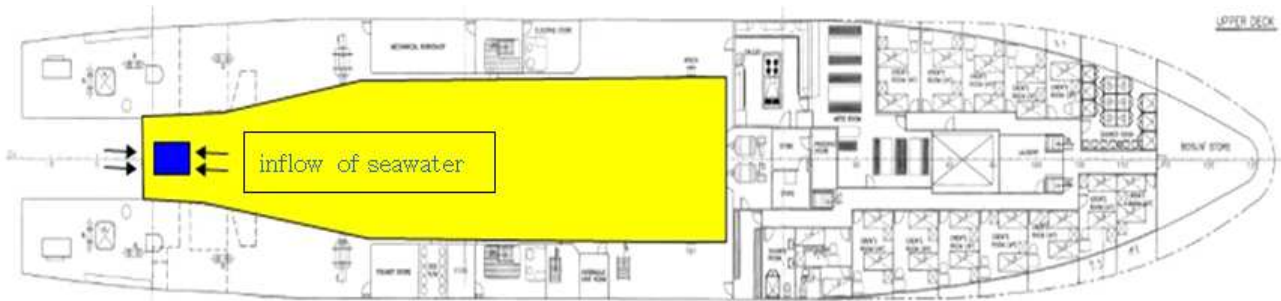
3.3.2.10 When seawater continuously flowed in through the open fish bunker hatch cover, the hatch cover was quickly closed from the stern. However, the net, which got pulled into the fish bunker along with the catch, got caught between the hatch cover and the deck, making it impossible to close the hatch cover completely. The gap was about 10cm.

3.3.2.11 From around 12:06 on the same day, when unloading the catch into the fish bunker was completed, 501 Oryong fixed its route towards the west to the Port of Navarin, and began to get underway. All the while, seawater continued to swell onto the deck and flowed in through the gap of the hatch cover.

[Image 18] Inflow of seawater into fish bunker through the hatch cover

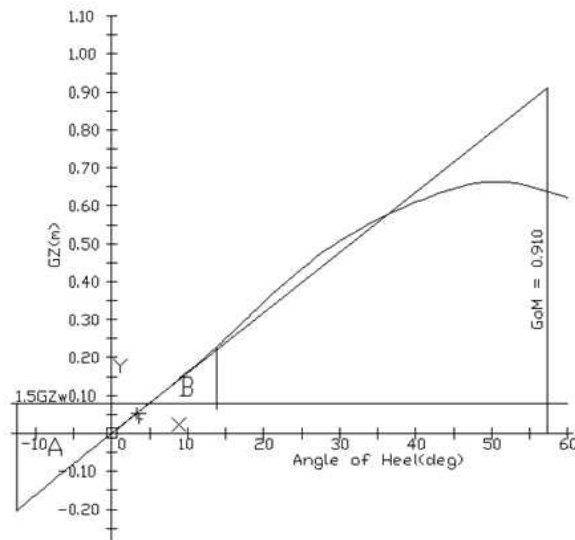
[Image 26] Stability curve on Dec. 1, immediately before the casualty

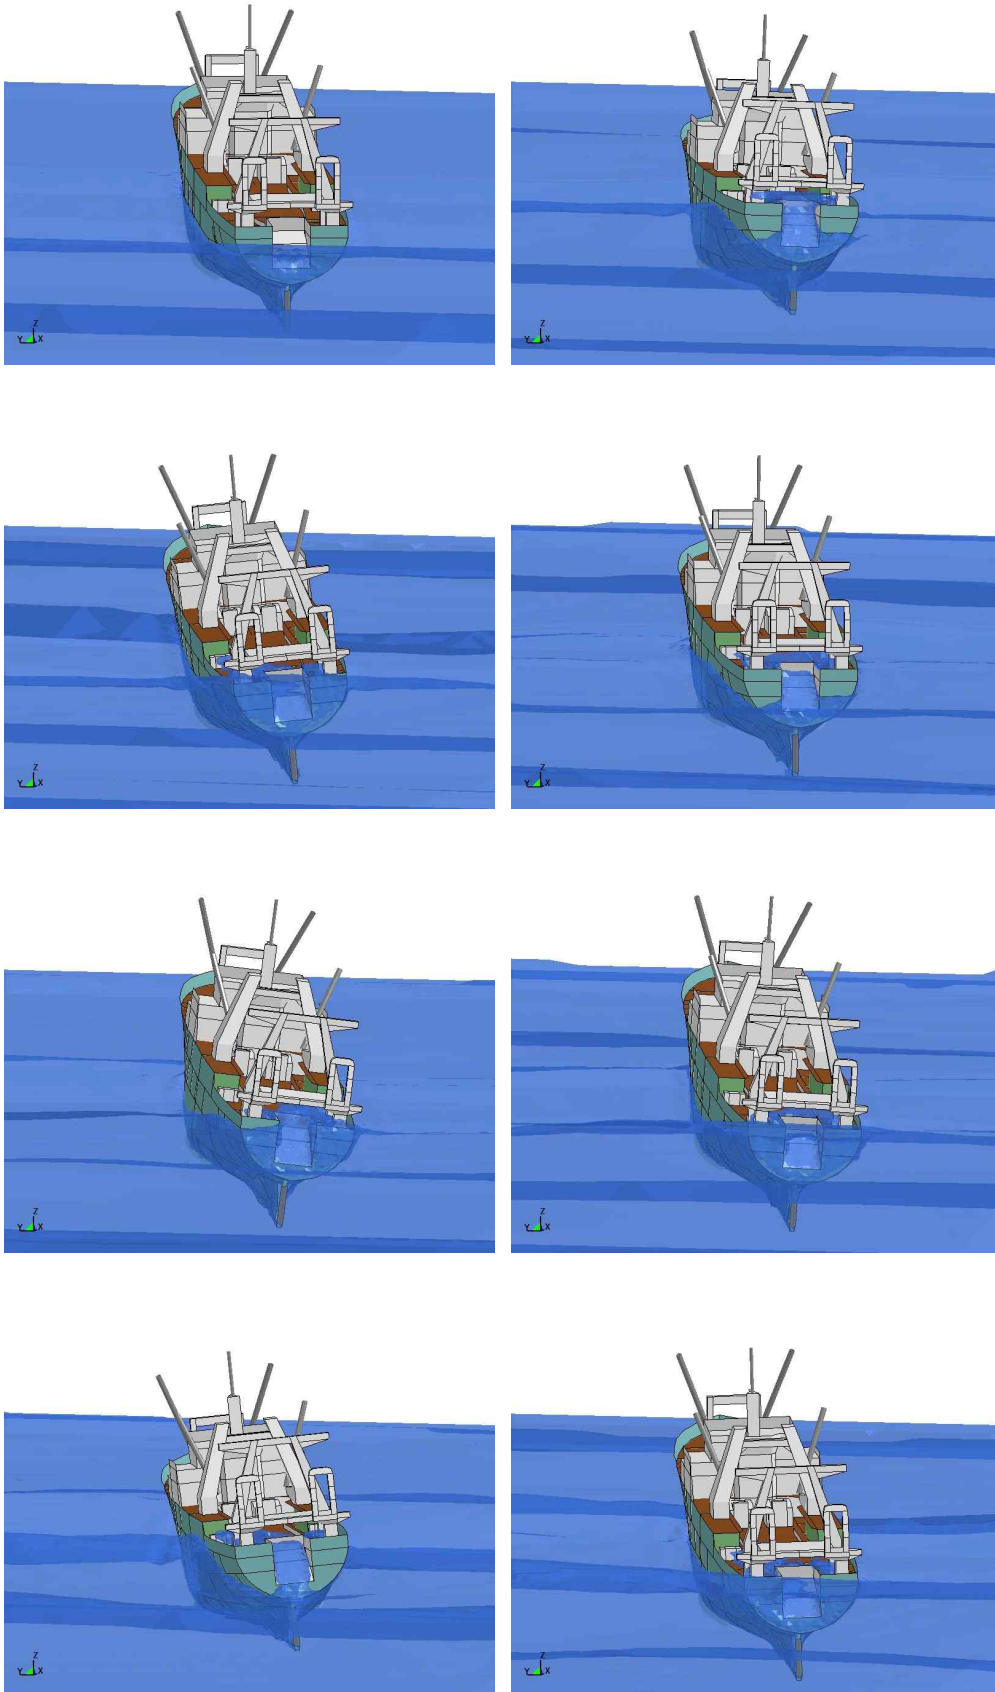
4.3.4.2 At the time, a part of the starboard stern had sunk underwater and waves were swelling over the stern deck. The sewage discharge outlet at stern port was located relatively higher than the water level as the hull had been tilted starboard, but there was still some inflow of seawater as the port stern periodically sank underwater as waves rolled onto the hull at a sharp angle.

[Image 34-1] Movement in Case 1-1 (waves, stern port 20°)

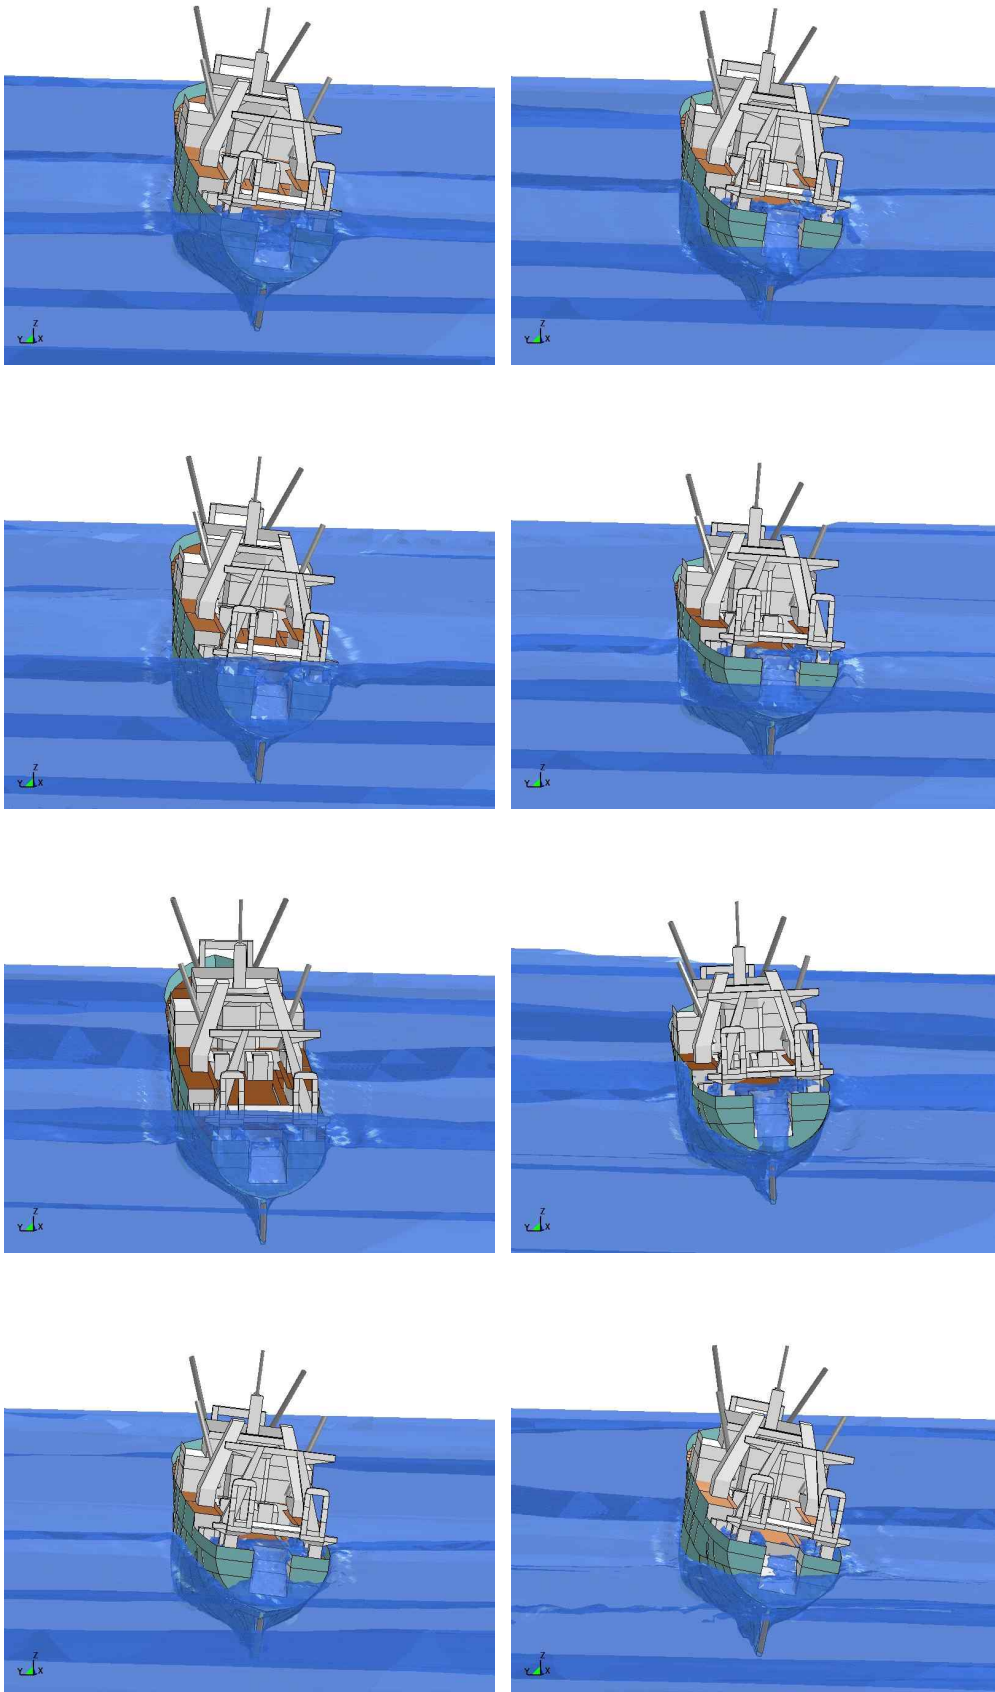
4.3.4.8 The continuous inflow of seawater and the large incline towards starboard caused part of the starboard stern to sink from due to the pitching and rolling of the vessel. As a large amount of water flowed into the steering room, 70% of the steering room gets flooded and the rudder stops at hard port.

[Image 36-1] Movement in Case 1-2 (waves, port stern 20°)
observed from stern

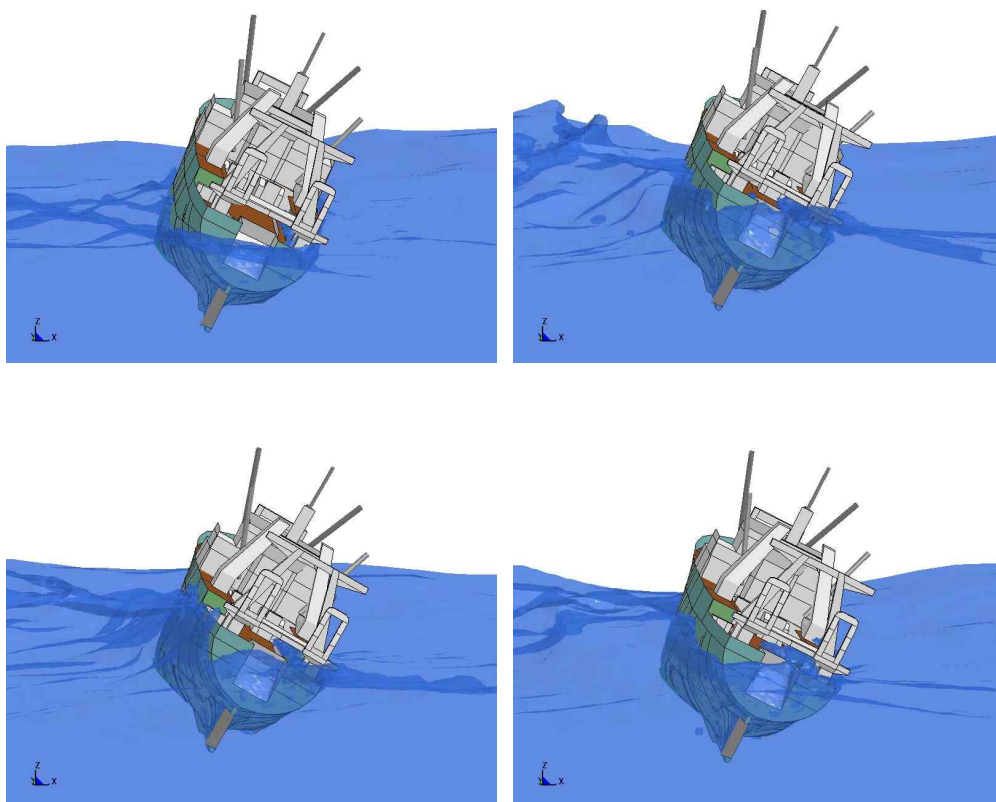
4.3.4.10 With the hull tilted 25° to starboard, waves rolled into the port stern at an angle of 72.5° , which caused seawater amounting to 471 tons to continue flowing in through the hatch cover and the sewage discharge outlet. The seawater flowed into fish holds 1 and 2 and filled up the lower part (6% of the entire area) of the fish hold.

[Image 37-2] Movement in Case 1-3 (starboard incline 30°) observed at stern
