## MARINE SAFETY INVESTIGATION REPORT

<b>Ships' Name</b>	ALHENA	YALOVA PILOT 2
<b>IMO No</b>	9538141	
<b>Ships' Flag</b>	The Bahamas	Türkiye
<b>Location Of Accident</b>	Yalova Anchorage / Türkiye	
<b>Date &amp; Time of Accident</b>	18 July 2022	12:32 LT (GMT+3)
<b>Fatality &amp; Injury</b>	1 / -	
<b>Damage &amp; Pollution</b>	- / -

Board Decision No: 10 / D-01 / 2025

Date: 14 / 04 / 2025

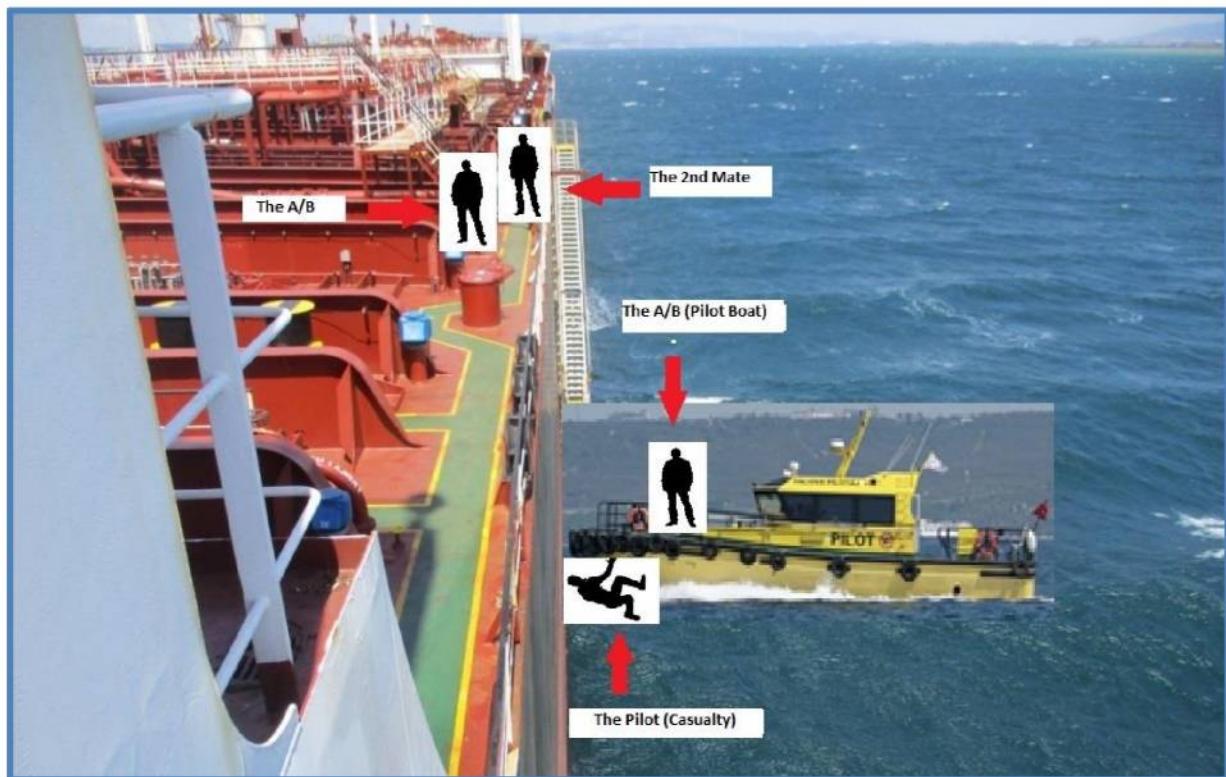
**Figure 4:** Demonstration of the accident

The Pilot was not successful in his first attempt to hold the ladder. While he had attempted to climb the ladder a second time, at 12:32, he lost his balance with the boat's heavy rolling and fell overboard from the port bow of the boat. (Figure 4)

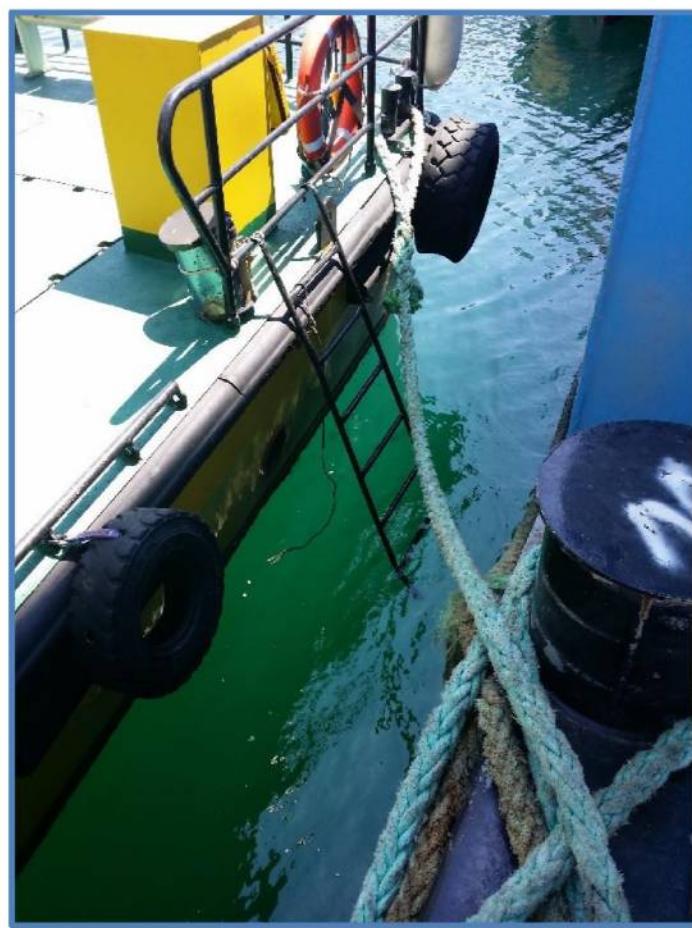
However, since there was no manrope attached to the thrown lifebuoy, the skipper, seeing that the casualty was moving away from the boat due to the current and the wave effect, threw another rope towards the casualty. The casualty let go of the lifebuoy and grabbed the thrown rope. In the meantime, the A/B swinged a bulwark ladder from the stern. (Figure 6)

**Figure 6:** View of the bulwark ladder swinged from the pilot boat

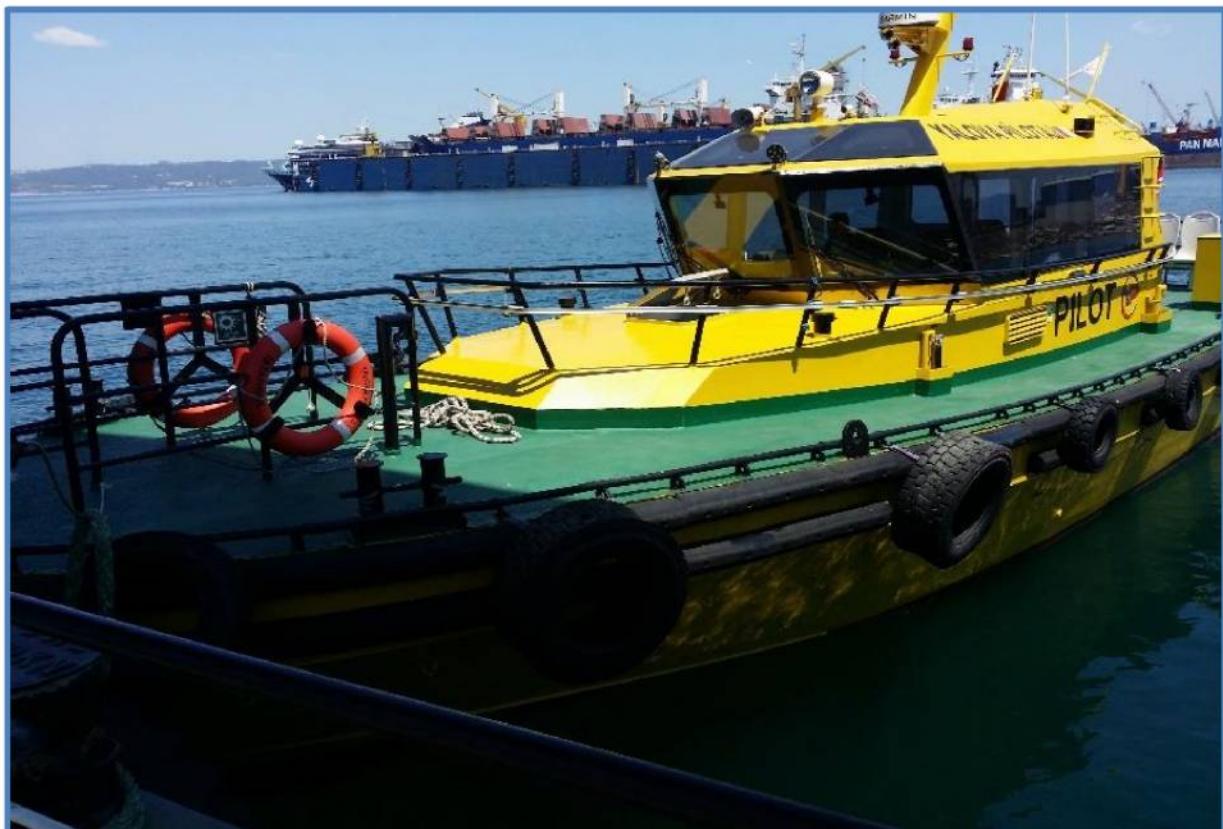
Subsequently, the A/B jumped into the sea without delay and put the rope through the casualty's armpits (Figure 7).

**Figure 7:** The used lifebuoy and the rope for rescue

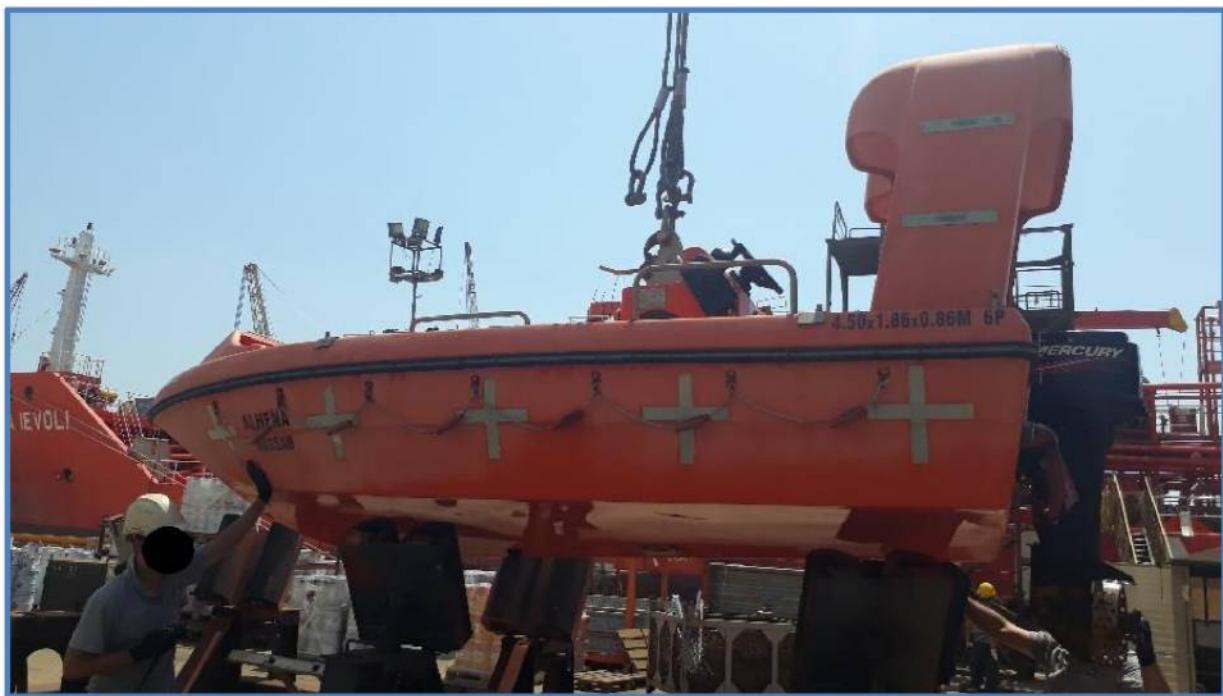
**Figure 8:** ALHENA's rescue boat

The rescue boat had proceeded towards the pilot boat, however, due to rough seas, they suspended the operation and returned to the vessel. In the meantime, the skipper took the opportunity to call the Yalova Coast Guard and requested assistance. The Coast Guard rescue boat arrived at the scene around 13:13 and launched rescue assistance (Figure 9).

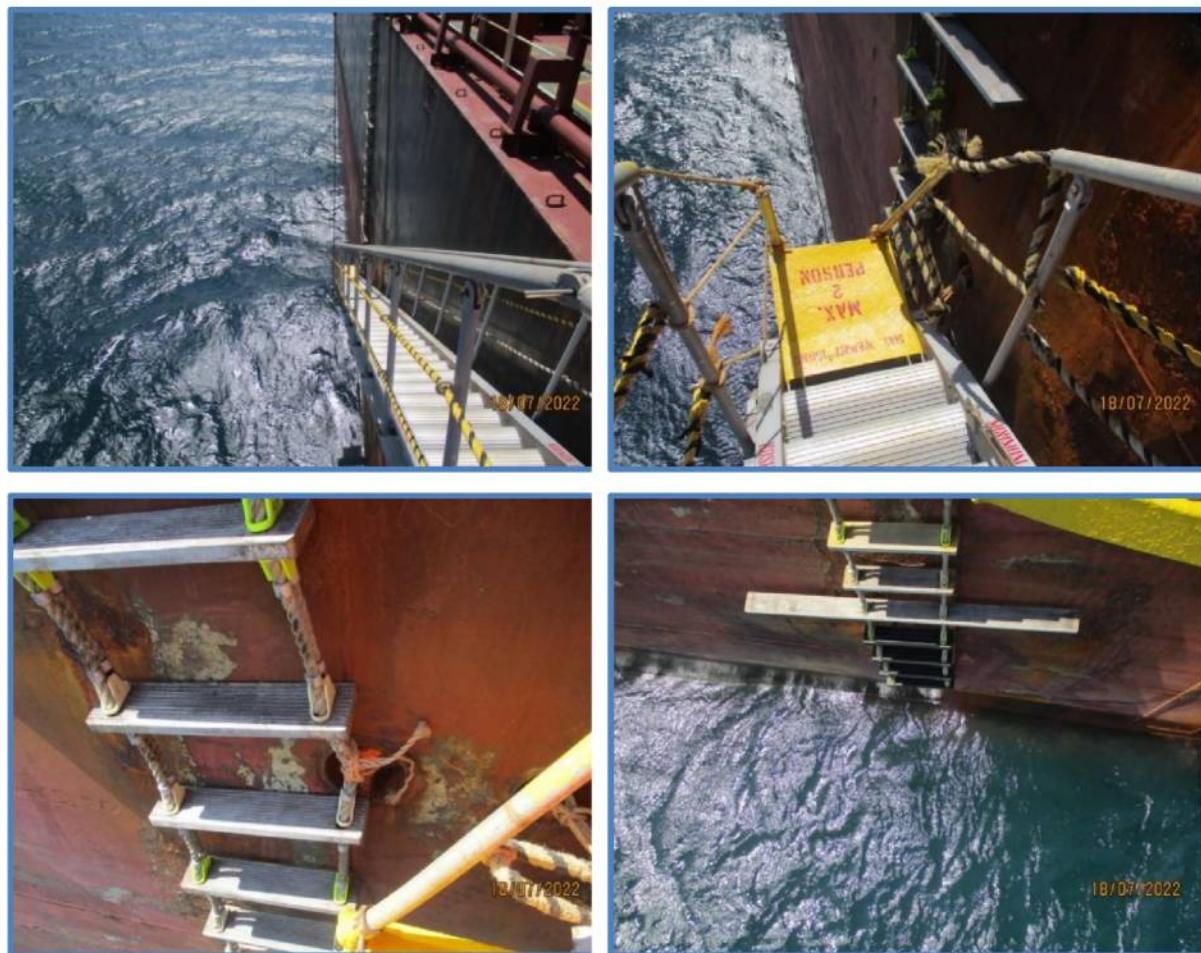
The parties did not report any non-compliance as to whether the pilot station was properly prepared or not. The investigation team investigated the pilot ladder rigged on the port side of ALHENA and non-compliance was not found in regard to the relevant IMO Resolution.

**Figure 9:** ALHENA – Rigged combination ladder at the port side

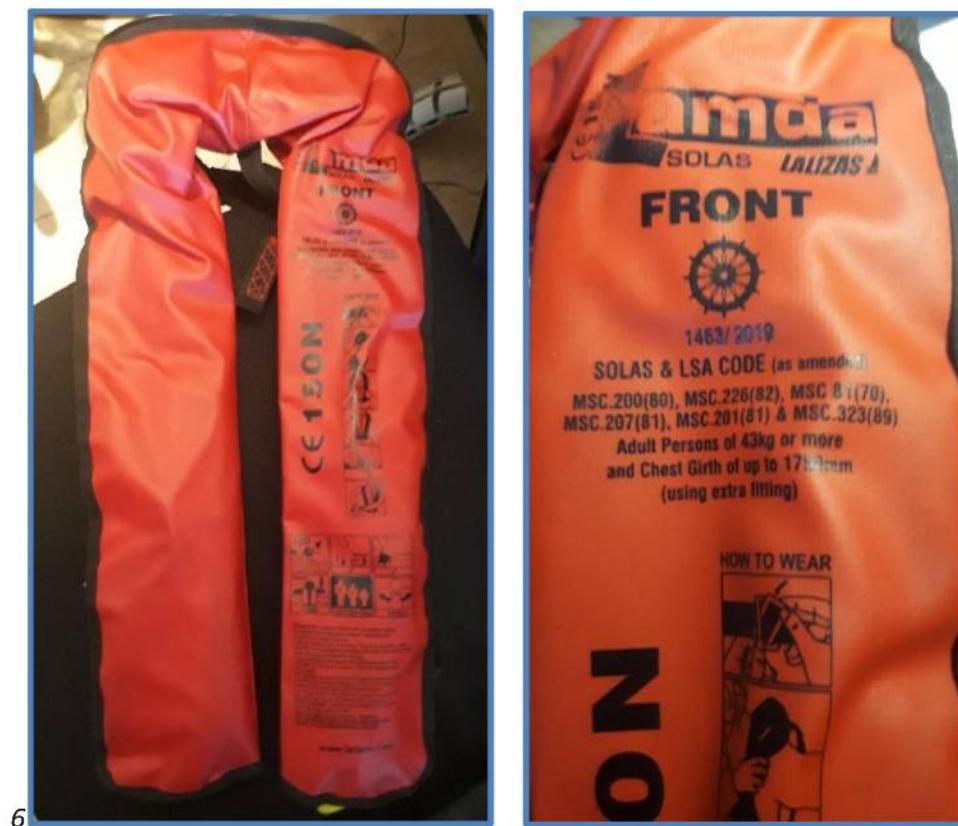
During the interviews and investigations carried out, it was observed that inflatable life jackets (Figure 10-11) were provided to the pilots but the use of them was discretionary. It can be said that the fact that the pilotage organization did not have an internal directive on the use of life vests and its use was under initiative can be said to be one of the factors affecting the fatal outcome of the accident. However, there is no clear data as to why the casualty did not use the lifejacket, and it could not be more than a rumor, difficult to make an assessment.

**Figure 10:** Illustration of a self-inflatable life vest provided to the pilots

- With the regulation dated 29.08.2024 made by the Maritime Administration regarding seafarers and pilots, it is stipulated that pilots and pilot boat personnel shall wear winter or summer life jackets according to the season in each transfer.

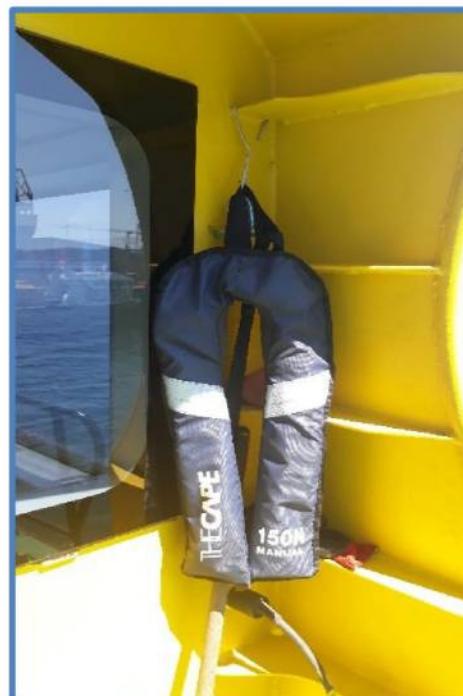
**Resim 11:** Inflatable life vest seen on the pilot boat

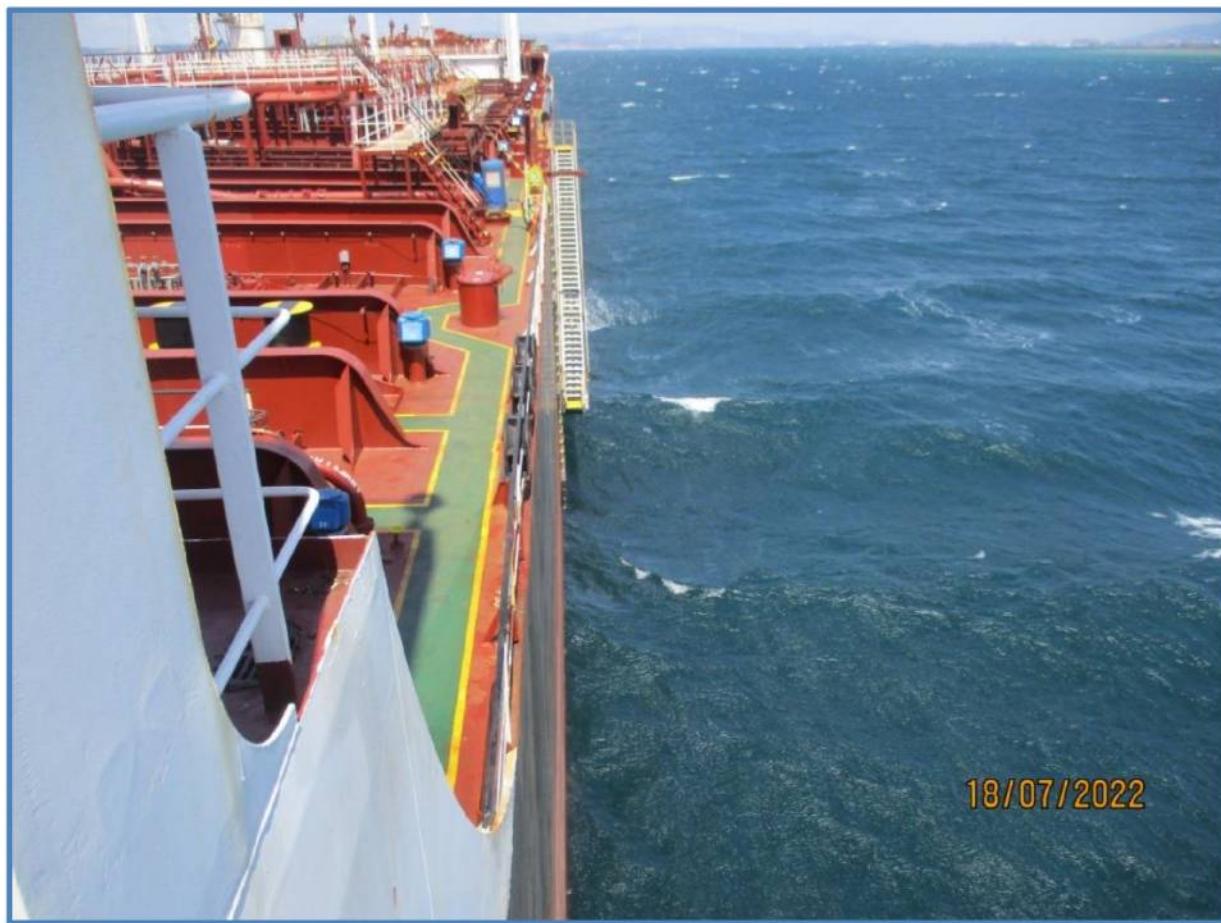
As seen in Figure 12, the skipper considered that he would need quite considerably engine power to keep the boat alongside in the current position in such weather conditions, thus he pushed the boat vertically to the ALHENA's hull in full engine speed.

In fact, the pilot had proceeded by holding the railings and while hands off to grasp the ladder, he lost his balance and fell overboard due to the heavy roll of the boat.

As a result, it is considered that the lack of a holistic risk assessment of the weather and sea conditions and conceding the operation completely to the pilot's initiative was one of the factors that contributed to the accident.

**Figure 12:** Image taken shortly after the accident

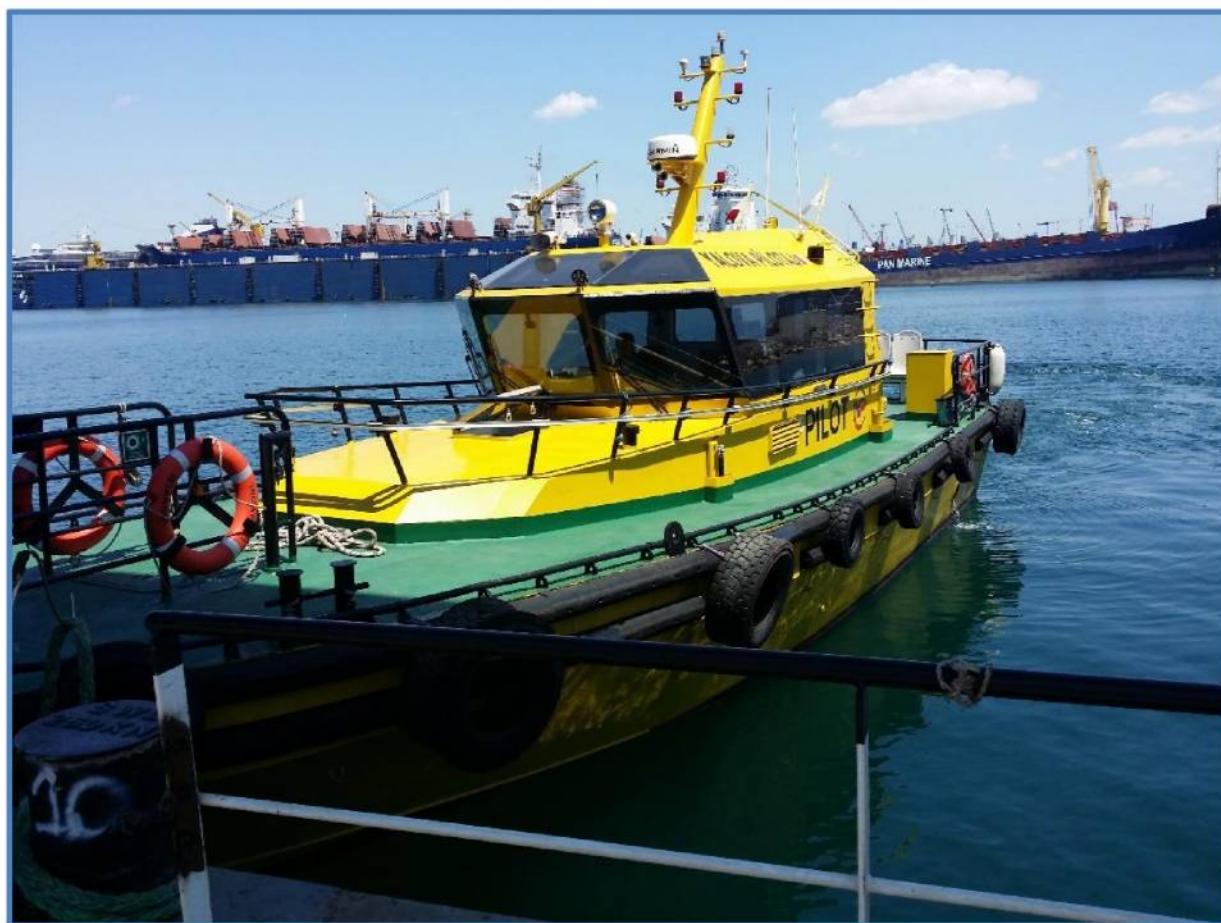
The boat was also fitted with an additional handrail on the bow to ensure a safe fore-and-aft transit. Therefore, it was observed that the boat's handrail arrangement was sufficient for a person to exit the pilothouse and walk easily in the starboard-port and fore-and-aft directions.

It should also be noted that the anti-slip feature of the deck walkway coating was satisfactory and the pilothouse was designed with a 360-degree view of the pilothouse in order to monitor the transfer operation.

**Figure 13:** A view of the pilot boat
