AIRCRAFT ACCIDENT FINAL REPORT

AIR FRANCE

AIRBUS A 300 B4, F-BVGK

SANA'A AIRPORT (YEMEN ARAB REPUBLIC)

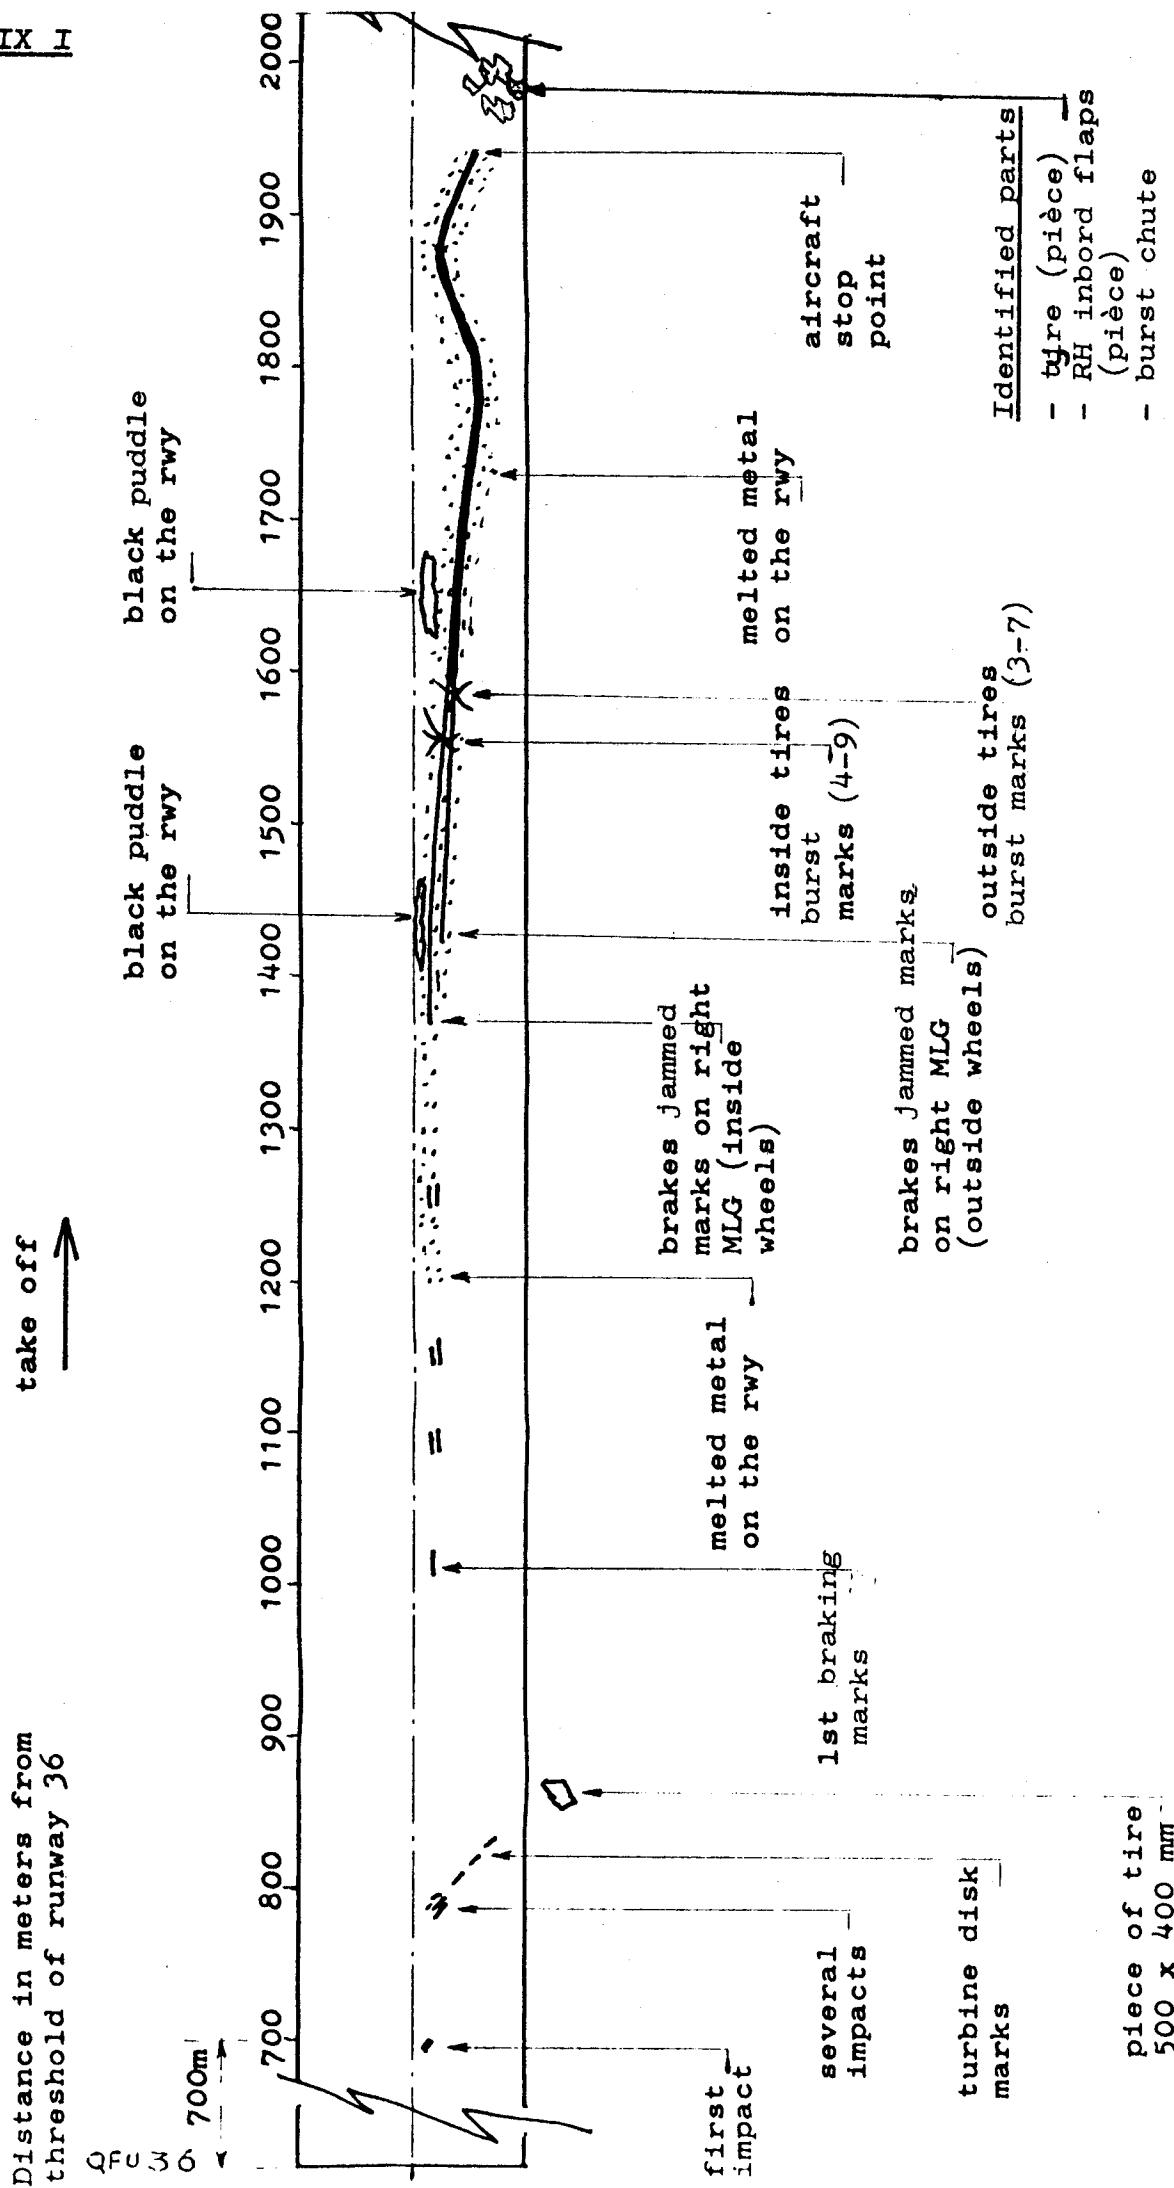
APPENDIX I

DIAGRAM OF MARKS ON THE RUNWAY
