**AIRCRAFT ACCIDENT INVESTIGATION COMMITTEE
MINISTRY OF TRANSPORT AND COMMUNICATIONS
THAILAND**

AIRCRAFT ACCIDENT INVESTIGATION REPORT

**THAI AIRWAYS INTERNATIONAL COMPANY LIMITED
AIRBUS A310-204, HS-TIA**

**SURAT THANI AIRPORT
THAILAND**

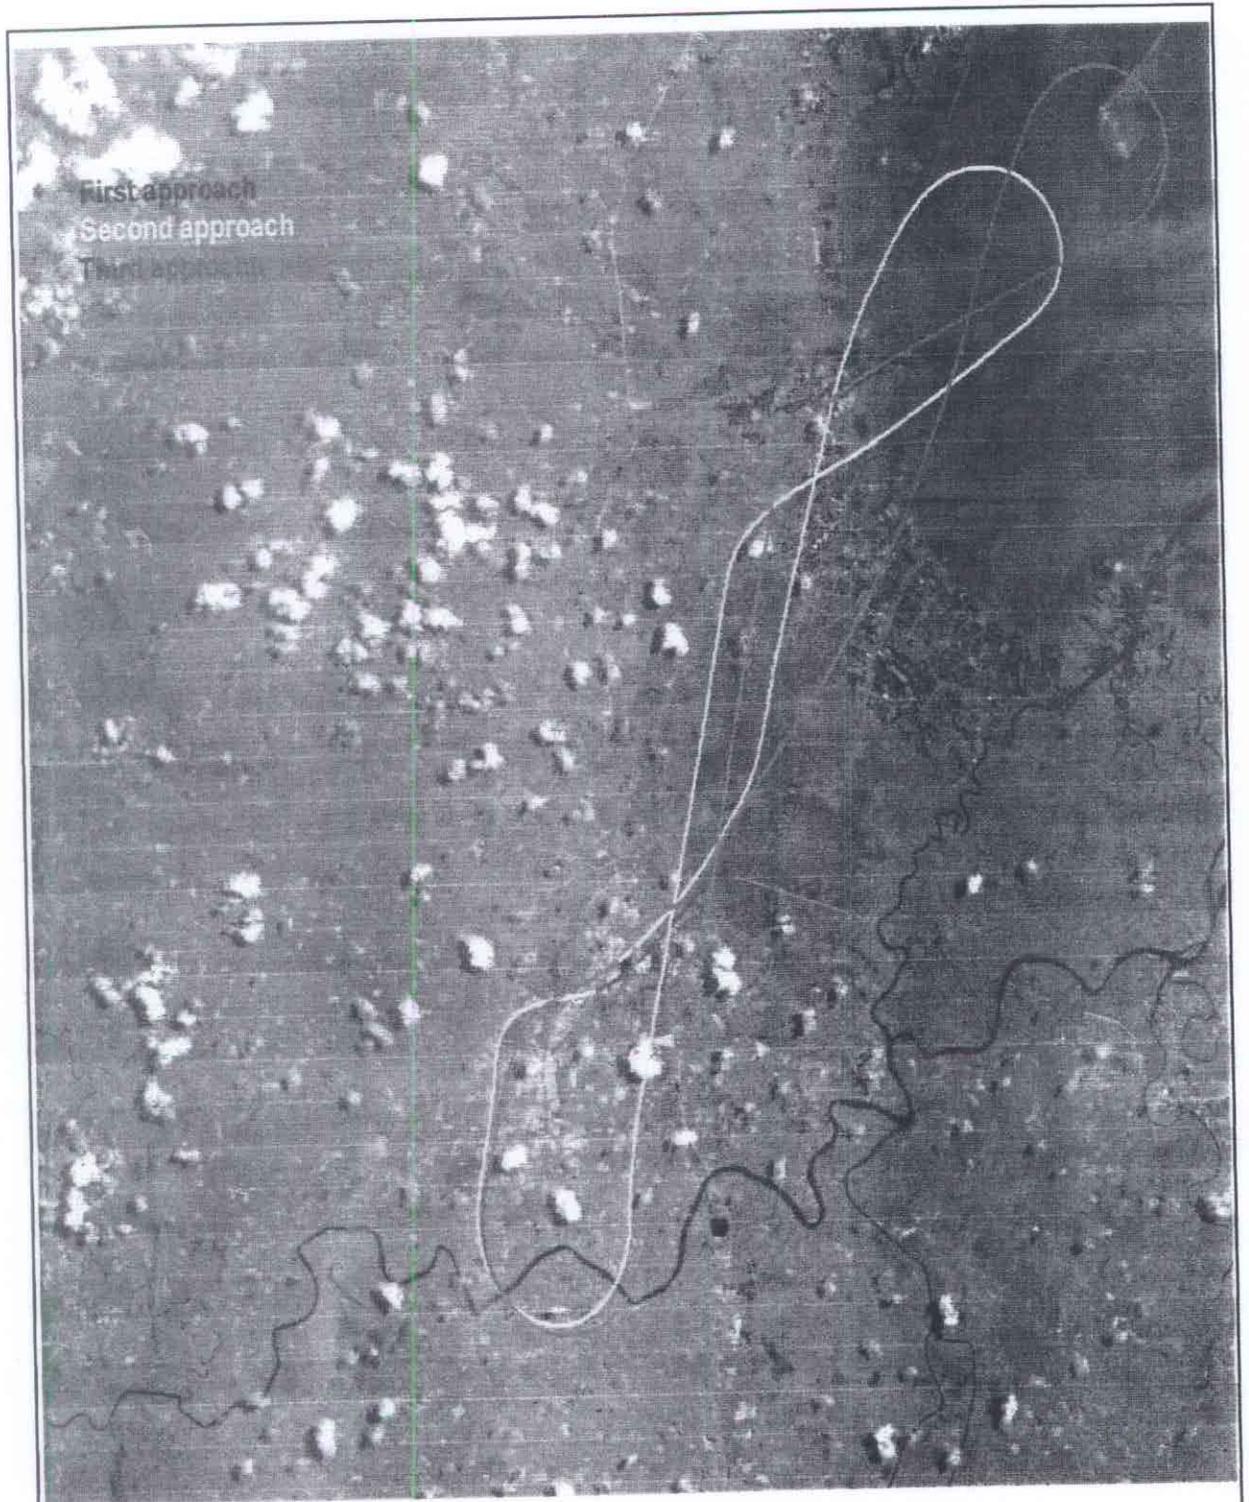
Approach from 11.37.33 UTC to 12.07.35 UTC

Accident of HS-TIA A310 from THAI Airways
occured on December 11, 1998 at Surat Thani
