CIVIL AIRCRAFT ACCIDENT

Report on the accident to Nigeria Airways VC 10 5N ABD

at Lagos Airport, Nigeria

on 20 November 1969

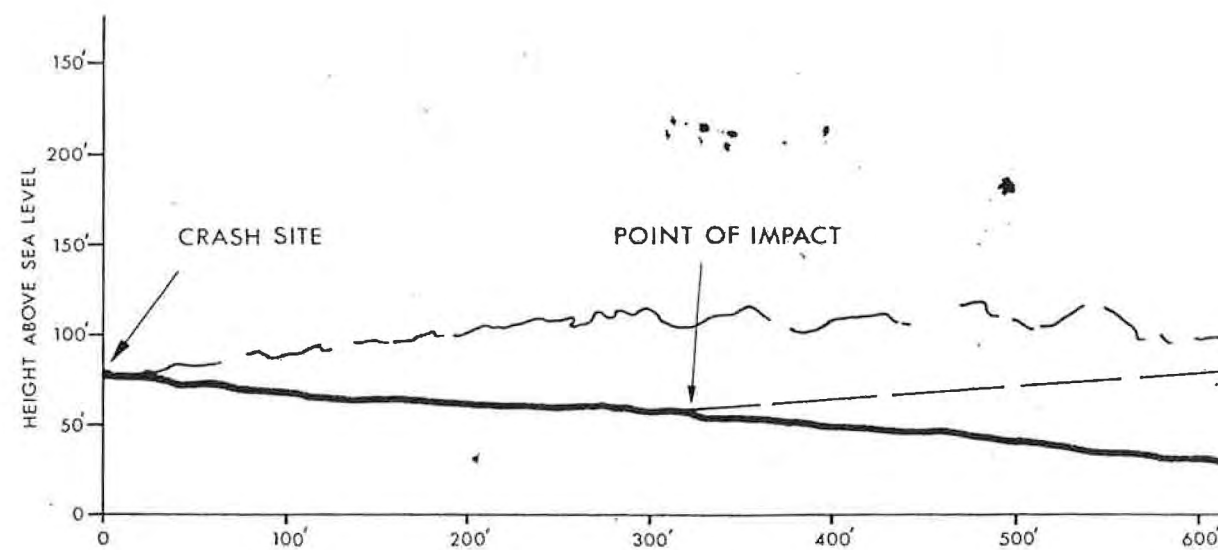
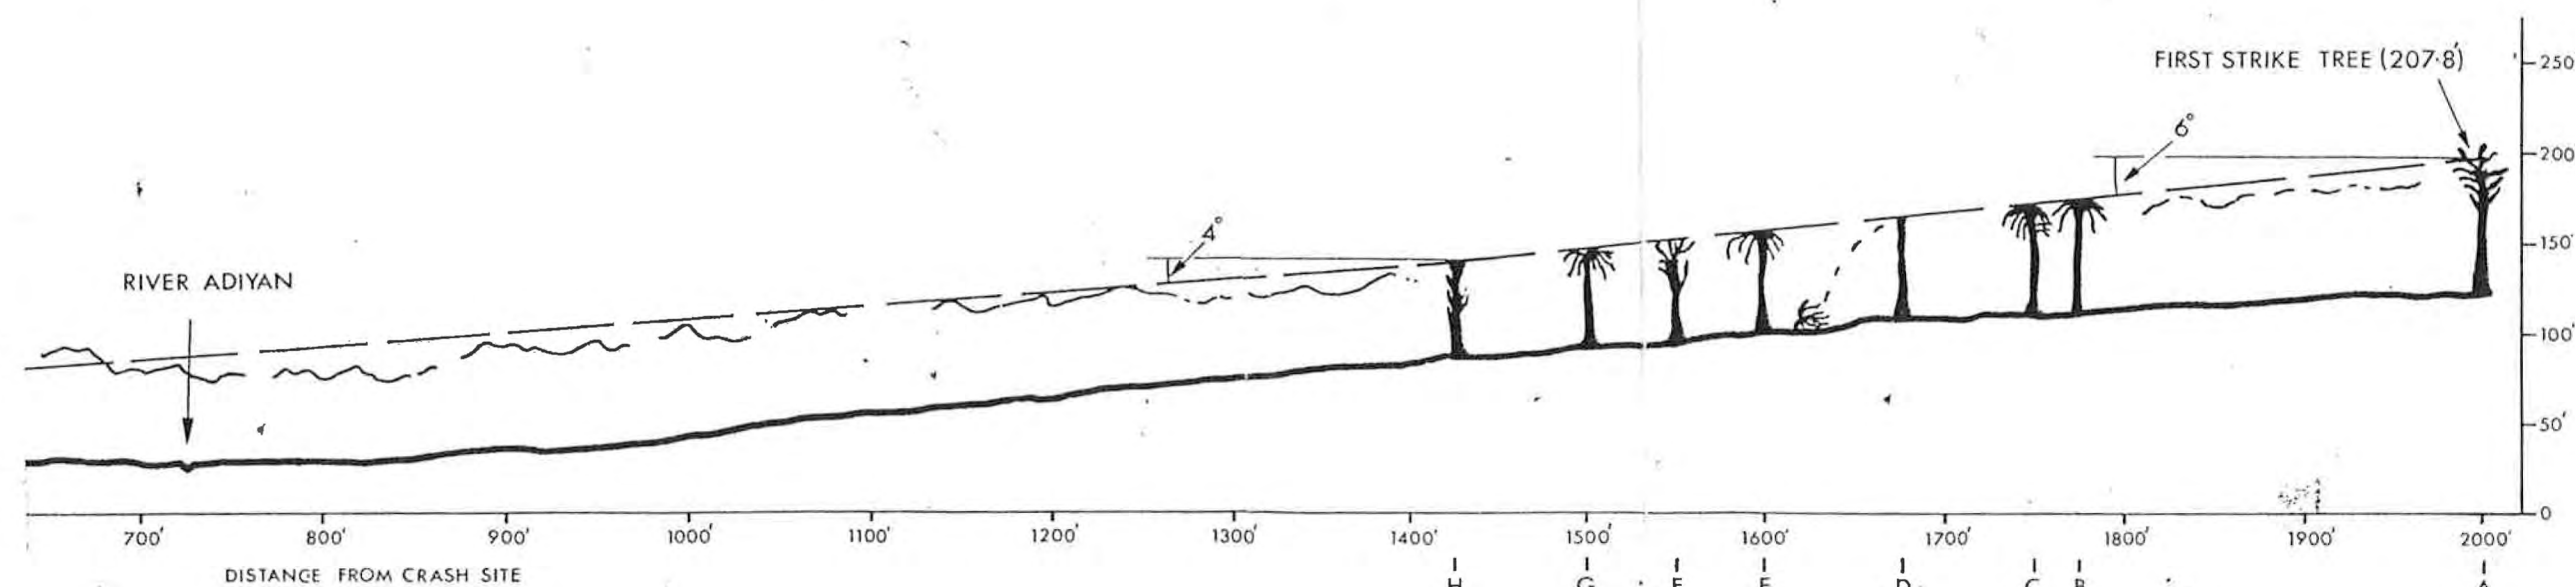
An examination of the wreckage trail, together with survey measurements, indicated that the aircraft first struck the top of a tree 207 feet above mean sea level (amsl) at a position 8 nm on a bearing of  $002^{\circ}$ (M) from the threshold of runway 19 at Lagos Airport. The first impact was taken by No 2 and 3 port flaps, the port undercarriage fairing and the cooling drain beneath Nos 1 and 2 engine nacelles. The aircraft then brushed through the heads of two trees, respectively 250 and 280 feet further on before the port wing tip was ripped off in collision with the trunk of a tree 350 feet from the first impact point. The aircraft then collided with three other trees within the next 250 feet, removing Nos 2, 3 and 4 starboard flaps and No 4 port flap. The damage to the trees all occurred along a descending plane inclined at  $6^{\circ}$  to the horizontal. Over the total distance of 600 feet between the first and last tree in the initial impact area, the ground sloped down towards the south at an angle of approximately  $3^{\circ}$ . It continued to fall away until it reached 30 feet amsl some 1,250 feet from the first impact point, after which it began to rise gradually. The angle of descent of the aircraft reduced to  $4^{\circ}$  after it had struck the last tree in the initial impact area, and the aircraft remained clear of all other obstructions until it struck the ground in a pronounced nose up attitude and left wing down about 1,700 feet from the first impact point.

The force of the impact with the ground broke off the whole tail assembly and the four engines. The remainder of the aircraft came to rest 300 feet further on, the flight deck being crushed in the latter stages by collision with a tree. The cabin remained relatively intact, but both wings were severely damaged and all the fuel in the tanks was released.

The overall length of the wreckage trail from the point of first impact to where the aircraft finally came to rest was 2,025 feet. The axis of the trail varied between  $188^{\circ}$ (M) at its most northerly point to  $169^{\circ}$ (M) at the point where the aircraft finally came to rest.

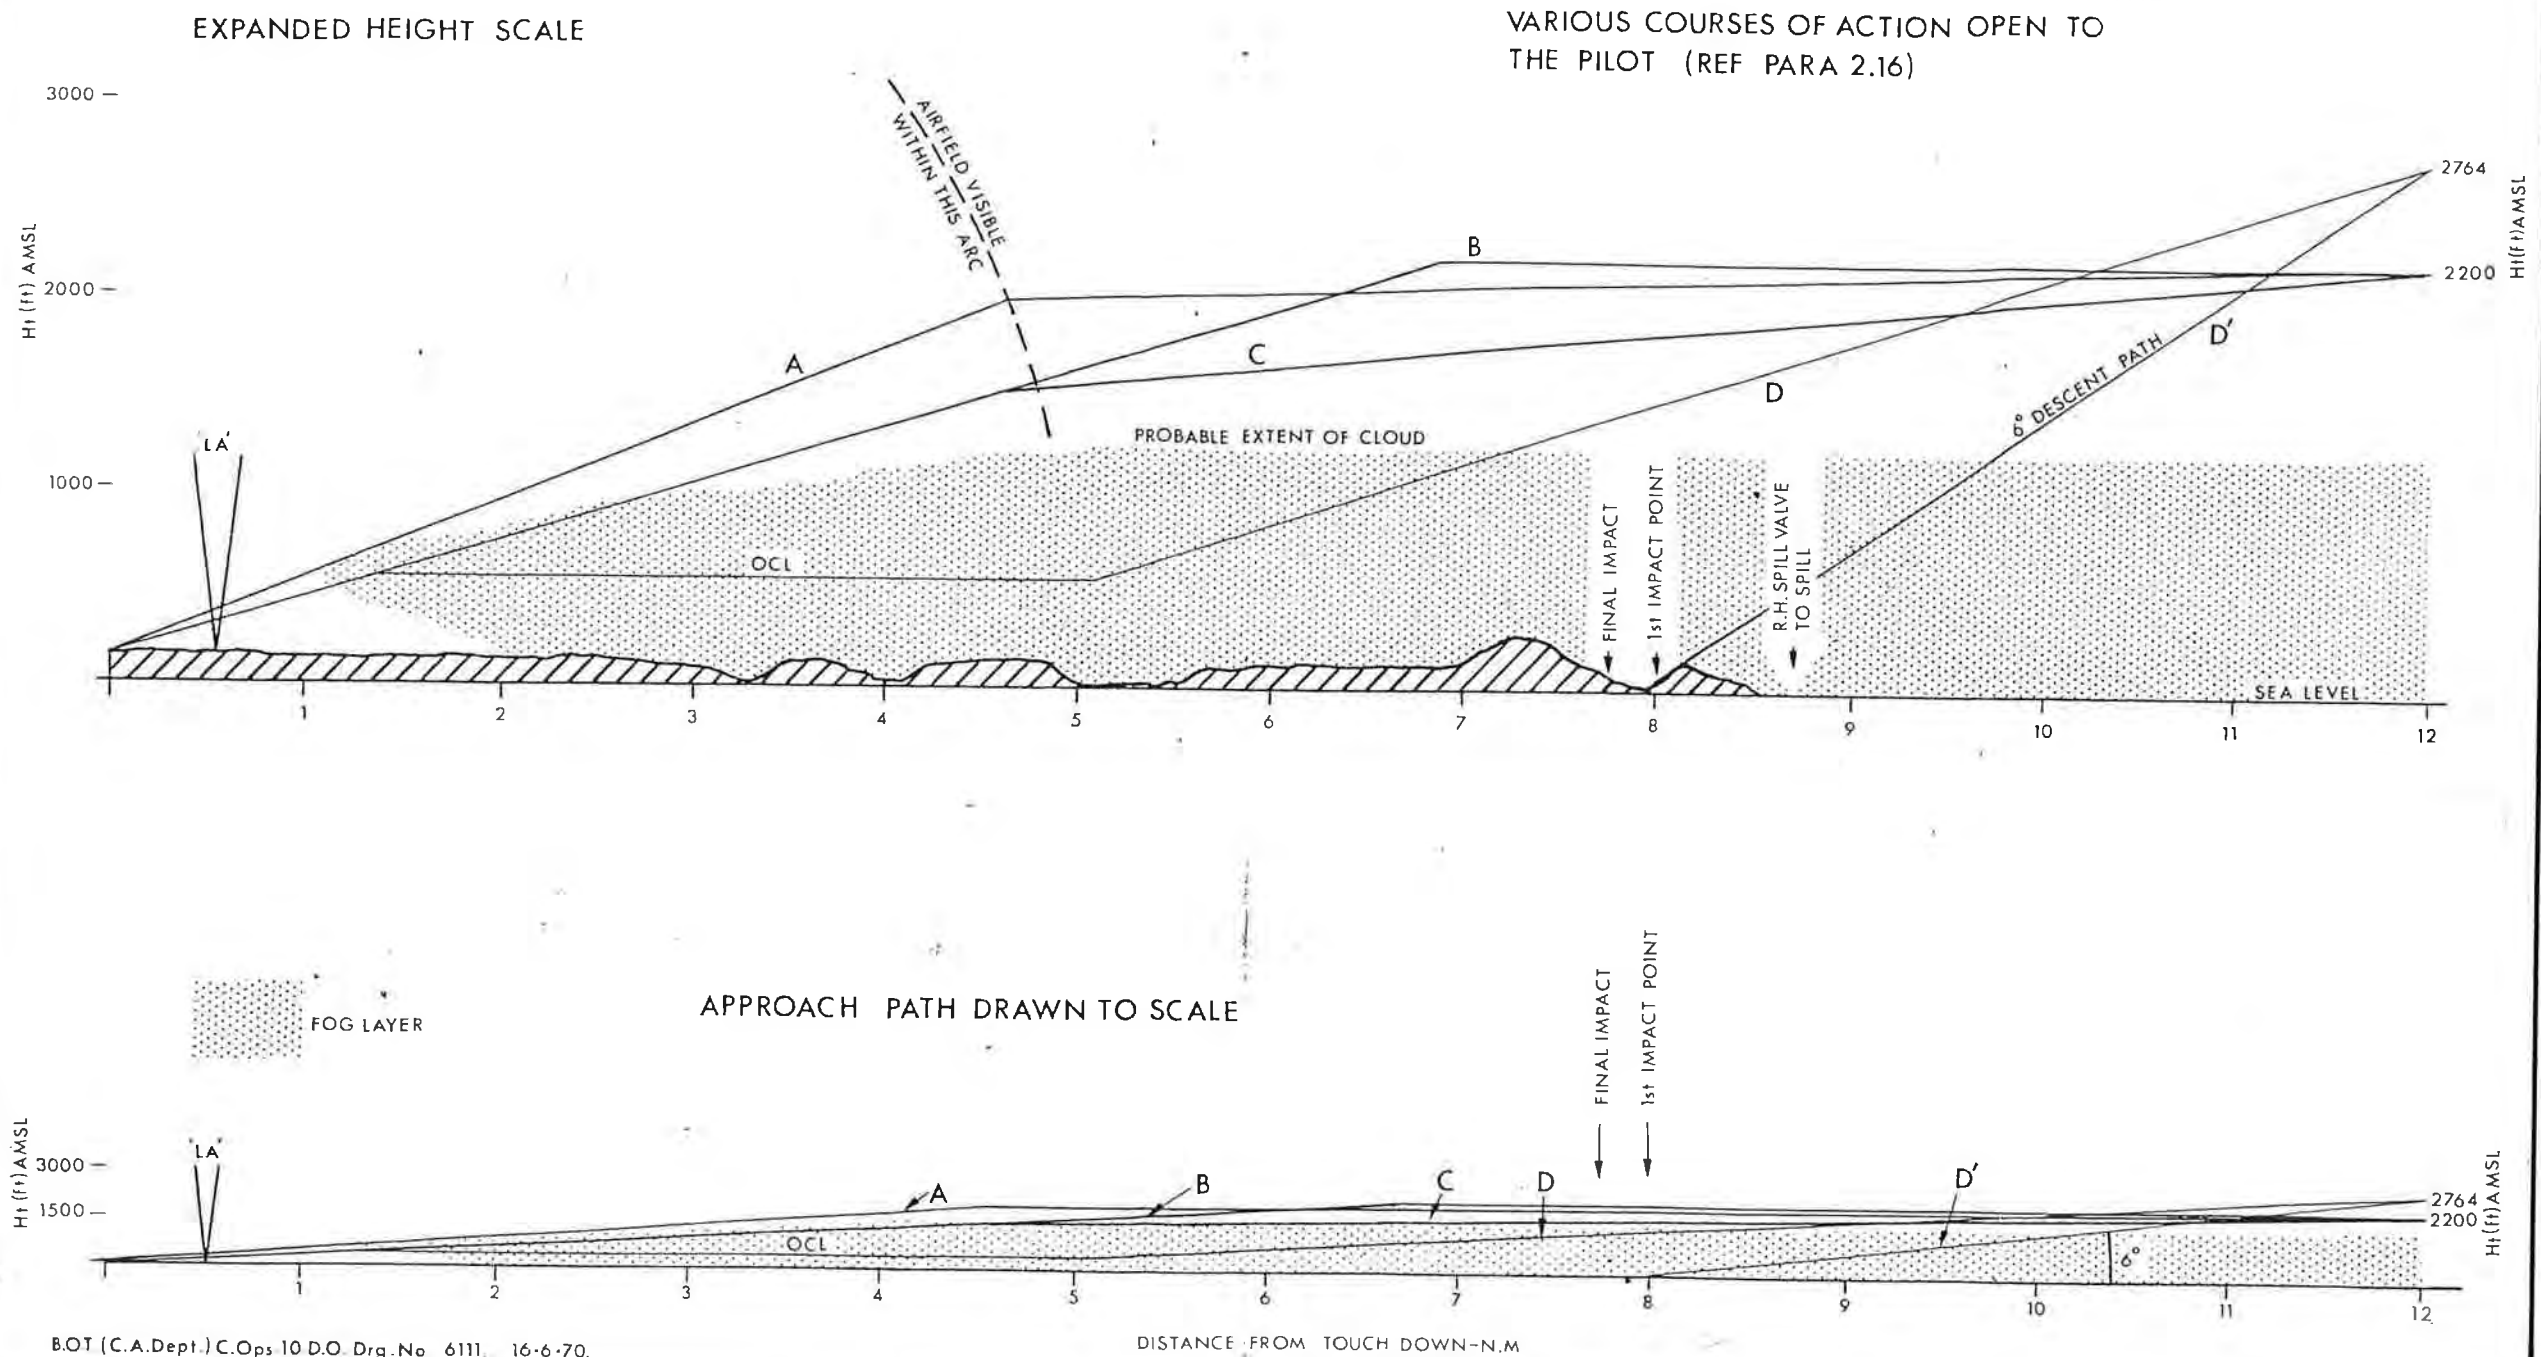
GRAPH SHOWING VERTICAL CROSS SECTION  
OF THE APPROACH TO RUNWAY 19 AND THE  
VARIOUS COURSES OF ACTION OPEN TO  
THE PILOT (REF PARA 2.16)

This alternative was also contrary to the ATC clearance. In following it the Commander had the choice of reducing height at a rate between that required to intercept the OCL at about 5 nm and that achievable by fully throttling the engines with 35<sup>0</sup> of flap (ie as shown by the lines D' and D' on the diagram at Appendix 4). It has been already noted

- (a) The practice of allowing aircraft to carry out straight in approaches in Instrument Meteorological Conditions to Lagos Airport should be discontinued for as long as the airfield lacks adequate glide path guidance and compatible Distance Measuring Equipment.
- (b) The installation of an Instrument Landing System and compatible Distance Measuring Equipment at Lagos Airport should be accorded as much priority as possible.
