## FINAL RUNWAY EXCURSION INCIDENT REPORT 24 June 2025

Runway Excursion Divi Divi Air

Divi Divi Air, Air Operator Certificate No. 10  
De Havilland/Viking DHC-6-300 TWIN OTTER  
PJ-DVG, MSN 347  
Flight DVR 269 from Aruba (TNCA) to Curaçao (TNCC)

**Final Incident Report  
CURCW/22/555-4**

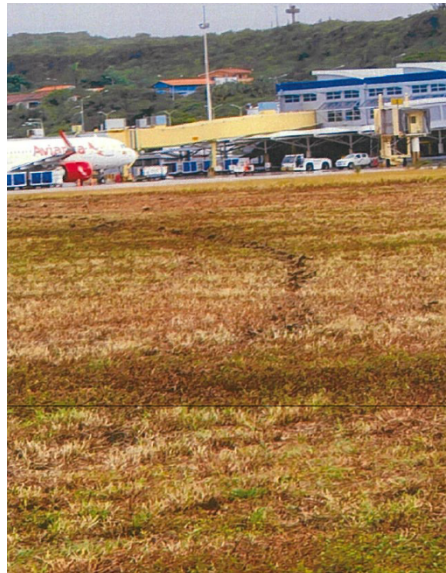
Tire Tracks

- 2.8 The movement to the right occurred in such a way that the aircraft finally stopped off the runway. Once the nose wheel got more out of line of the aircraft displacement, the possible drag caused by nose wheel skidding, further contributed to the displacement to the right. As directional control was being lost, a lateral runway excursion was inevitable. The aircraft ended up 90 meters to the right of the centerline or +/-60 meters from the runway edge.

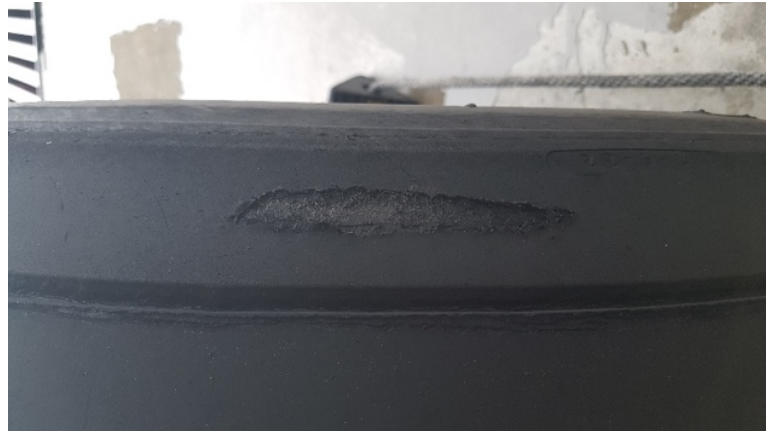
Tire PJ-DVG

1.4 **Other Damage:** Damage found was the tire on the captain's side (Tread Rubber Reversion).

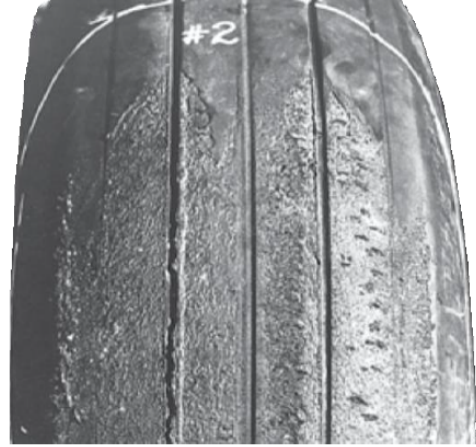
**Tread Rubber Reversion**

An oval-shaped area in the tread similar to a skid, but where rubber shows burning due to hydroplaning during landing, usually caused by wet or ice-covered runways.  
Action: Remove from service if balance is affected, or normal wear criteria is exceeded.

- f. The captain's inability to maintain lateral control of the aircraft was a factor.
- g. No walk around was performed in Aruba before departure so the condition of the tires could not be verified before the incident. Since the crew, in accordance with their statements, failed to perform the walkaround before the flight, it cannot be confirmed that the condition of the tires originate from the relevant runway excursion event. However, the first officer stated that aquaplaning was a fact. In the Goodyear Maintenance Manual effective 01/2020, Aircraft Tire Care & Maintenance, tread conditions are described where aquaplaning clearly matches the overview Tread Rubber Reversion of the incident aircraft.
