Aircraft Impact Simulation of the WTC tower for Investigation on True Cause of the Total Collapse

Daigoro ISOBE

Univ. of Tsukuba, Japan

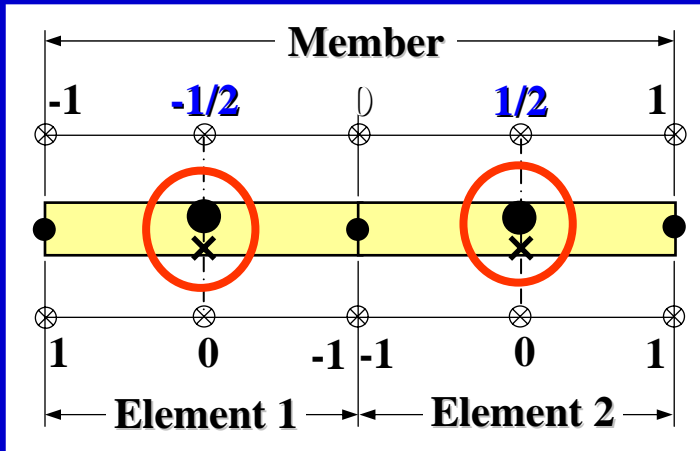
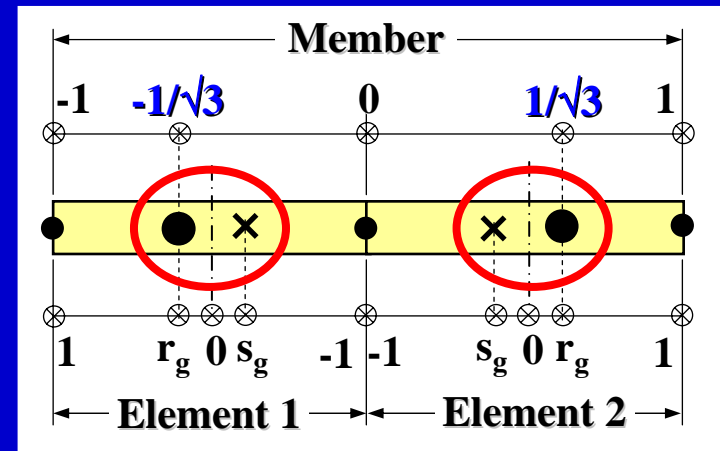
ASI-Gauss Technique

$s = 0$ × Numerical integration point

$$s_g = 1 - (2/\sqrt{3})$$

$r = 0$ ● Stress evaluation point

$$r_g = -1 + (2/\sqrt{3})$$

Place stress evaluation points of two consecutive elements at Gaussian integration points

Optimal for two-point integration, accuracy mathematically guaranteed

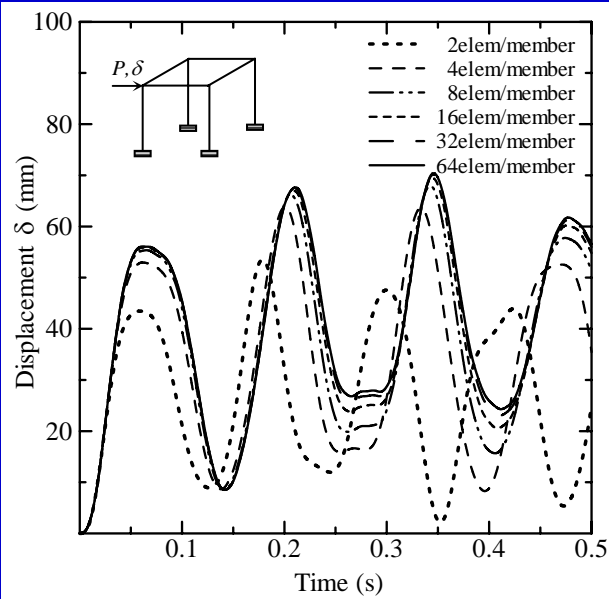
Estimation on ASI-Gauss Technique

Conventional FEM

ASI technique

ASI-Gauss technique

Elasto-plastic response analysis of a space frame

Achieved high accuracy in elastic range by using ASI-Gauss technique

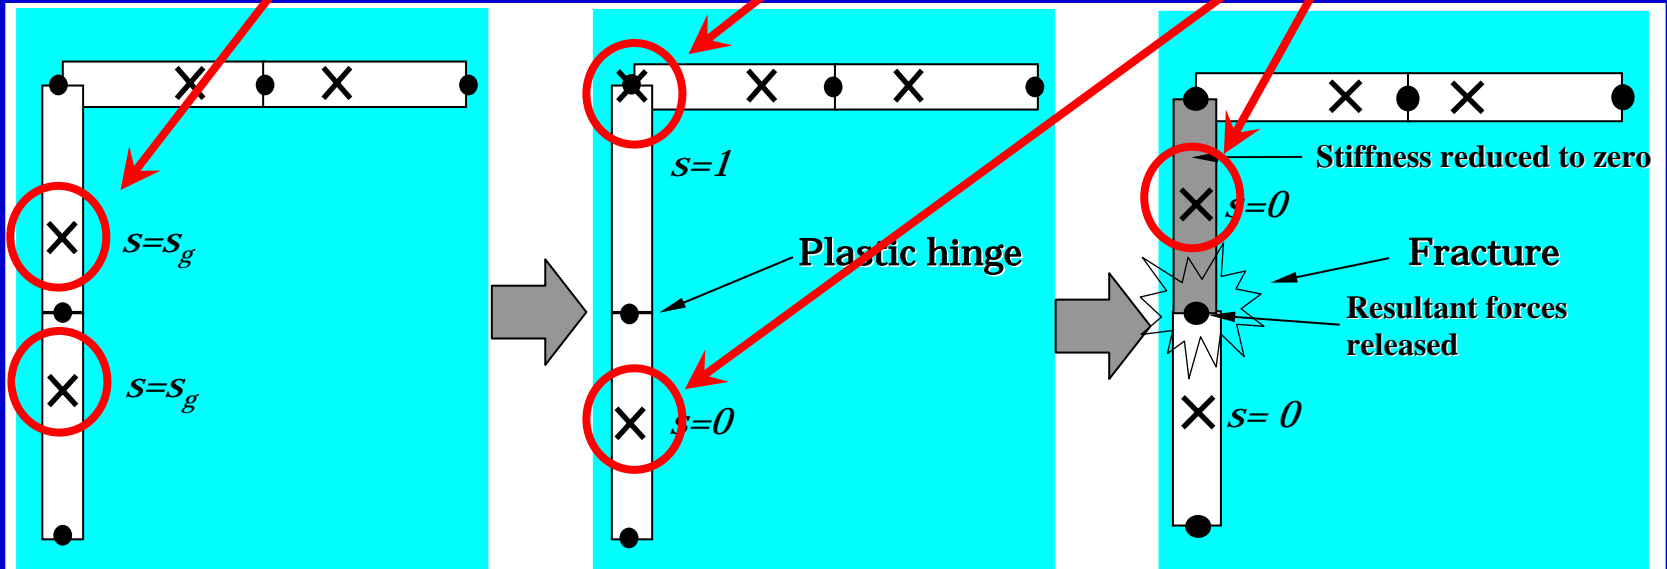
● Node × Numerical integration point

(a) Elastic stage

(b) Plastic stage

(c) Member fracture

Locations of numerical integration points in each stage

Shift to locate stress evaluation points at Gaussian integration points

shift to opposite end

Re-shift to midpoint

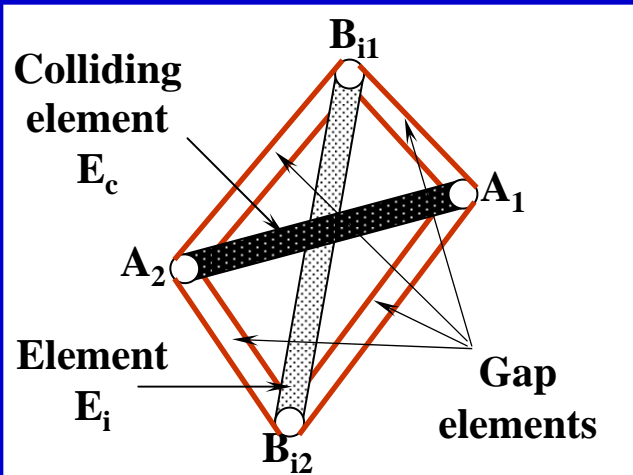
- ✧ 4 gap elements connecting 2 elements after determination of contact
- ✧ Gap elements automatically eliminated after certain time of contact

Connection of elements in contact

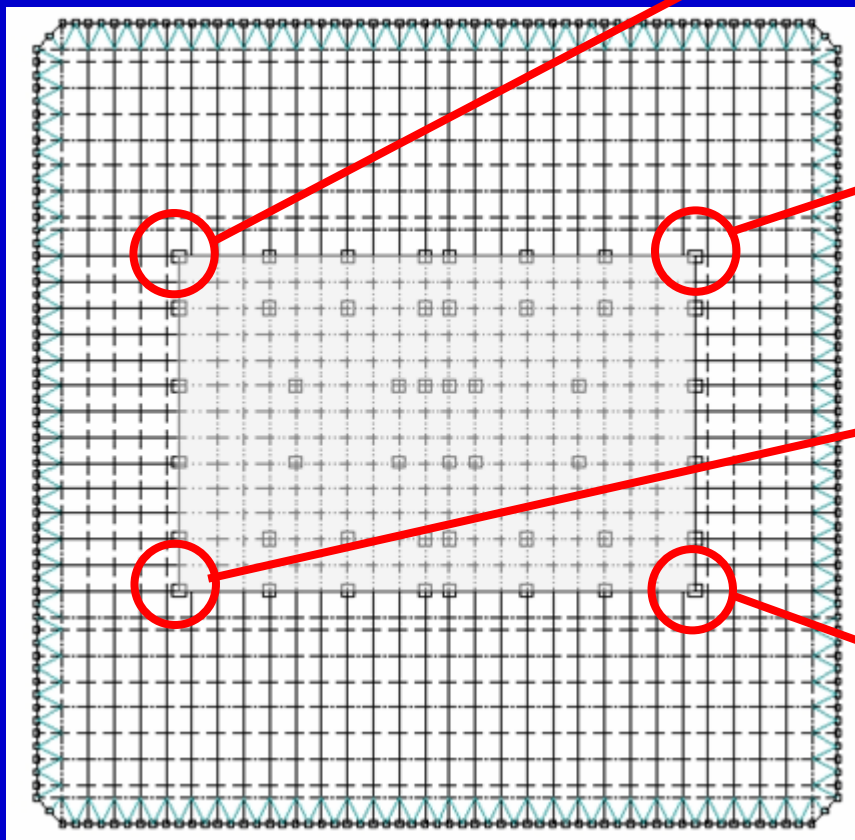
Locations of core columns

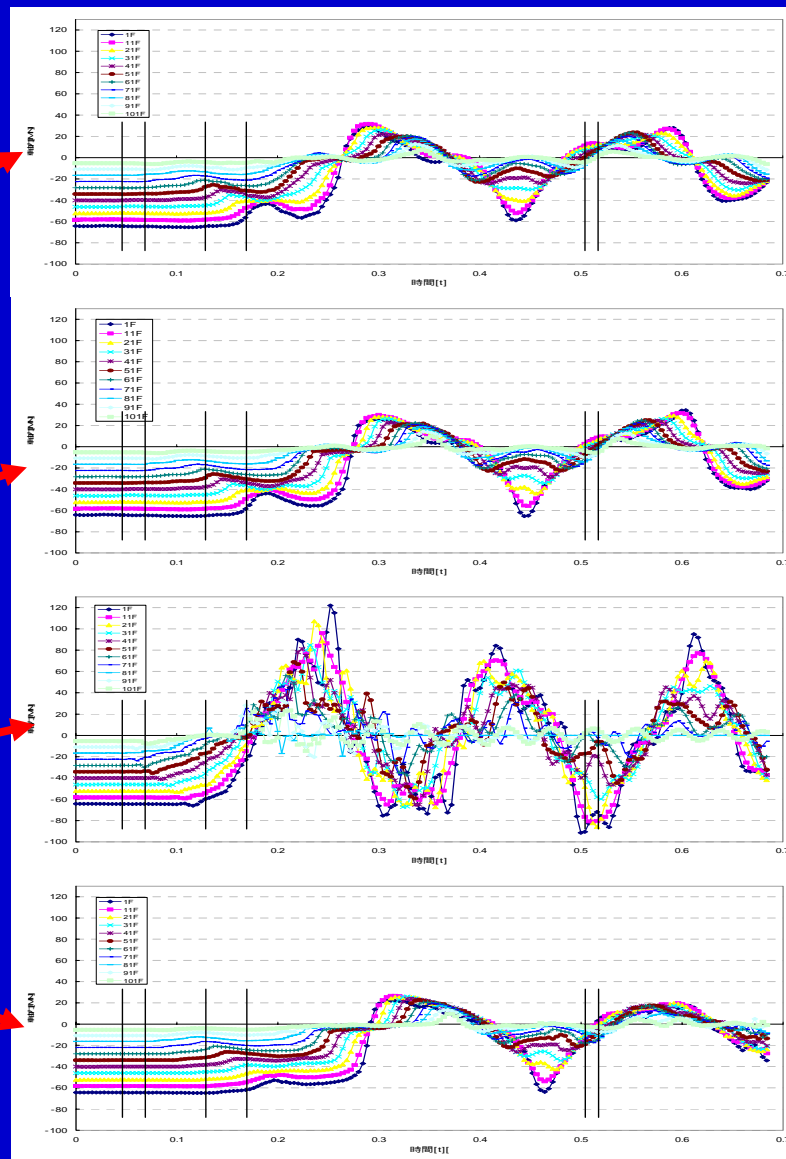
Axial force produced in core columns

Time histories of axial forces

What produced the gigantic tensile force?

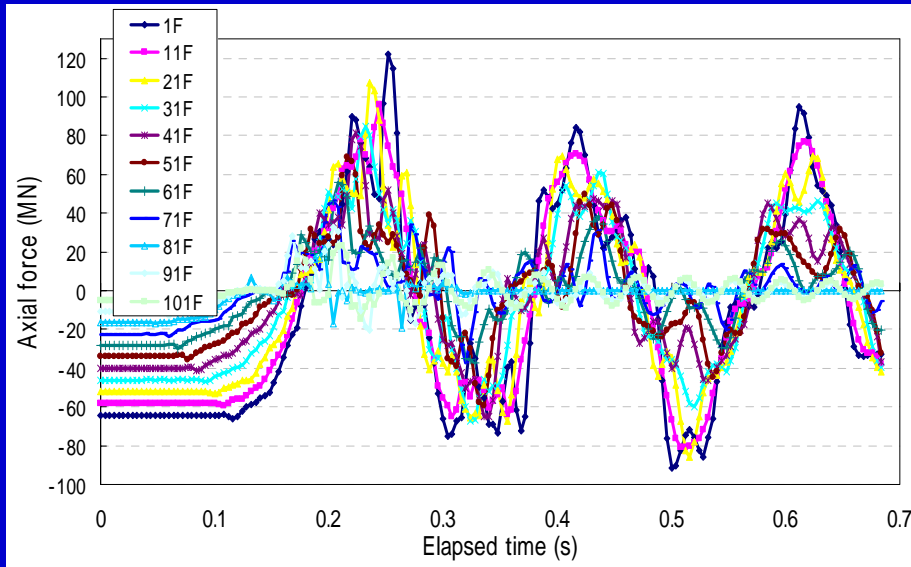
Time histories of axial forces (core column No. 1001)

A spring-back phenomenon of the core columns due to a very rapid unloading is observed. The spring-back phenomenon is fatal enough to produce gigantic tensile force to the columns. This might have triggered some connections to become totally fractured, and thus, eventually, have led to a total collapse of the towers.
