Photogrammetric, Satellite-Based Survey of Toluca Airport and Its Surroundings

Field Validation, Verification and Ground Truth Visit Report

Photogrammetric Survey of Toluca Airport and its Surroundings:

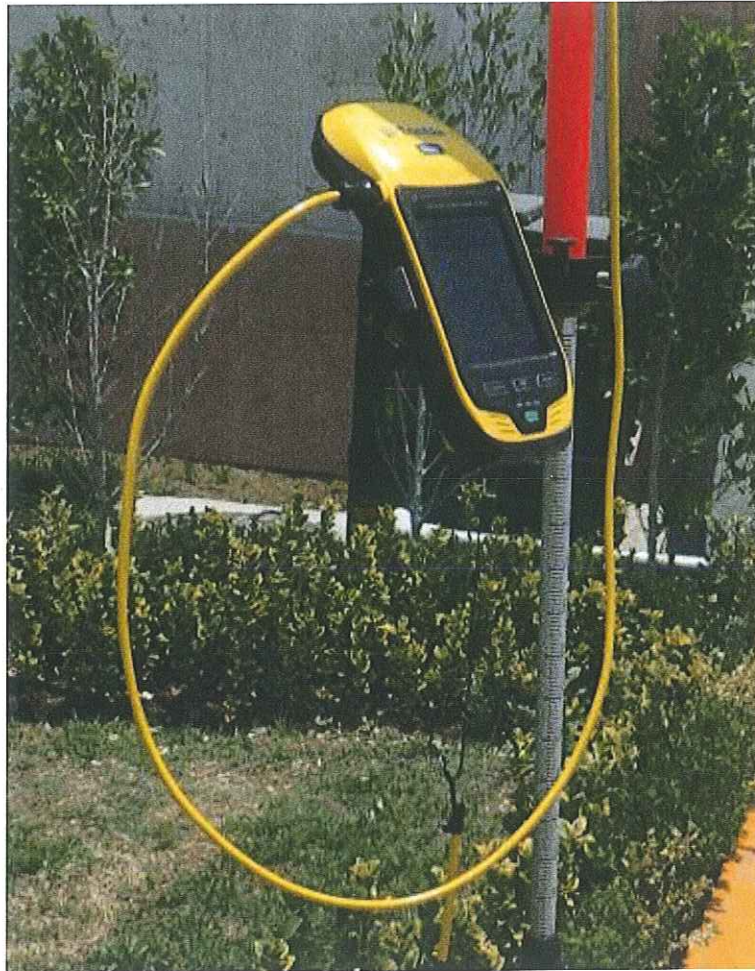
Figure 1 – A Trimble GeoXT Explorer 6000 GPS used to Collect Field Measurements during the FVVGT Visit

The Trimble GeoXT Explorer 6000 is a high performance GPS receiver with an on-board computer loaded with ArcGIS Mobile Geographic Information System (GIS) support software (see Figure 1). An external antenna, resistant to signal interference and multipath was used to obtain a higher yield of GPS satellite positions and to improve performance and accuracy. The

antenna was connected to the GPS on top of a mounting pole to improve satellite visibility. The GPS collects GCPs and other field data measurements in X, Y, Z, latitude, longitude and height above Ellipsoid.

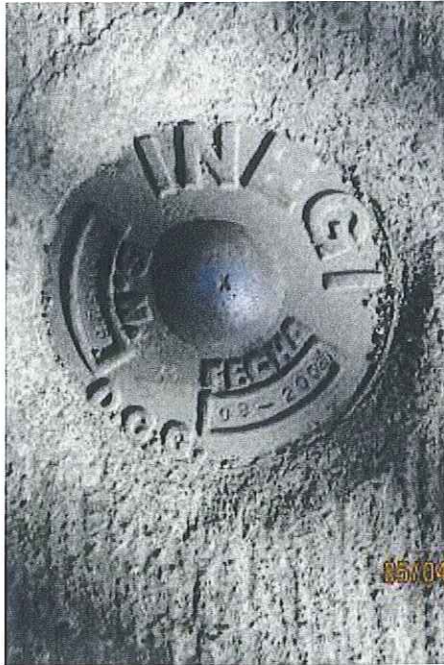
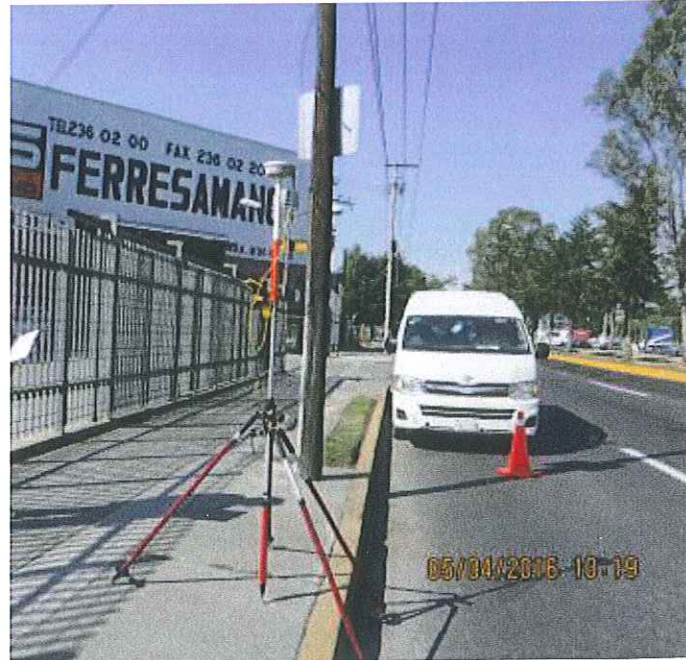
Figure 5 – Reference Photographs Taken of GCP Locations

The GCP locations were measured using a high-precision GPS with an antenna, as described in Section 2.2. Photographs were taken of each location for reference (see Figure 5). Full descriptions and coordinate information for each GCP is provided in Appendix A.

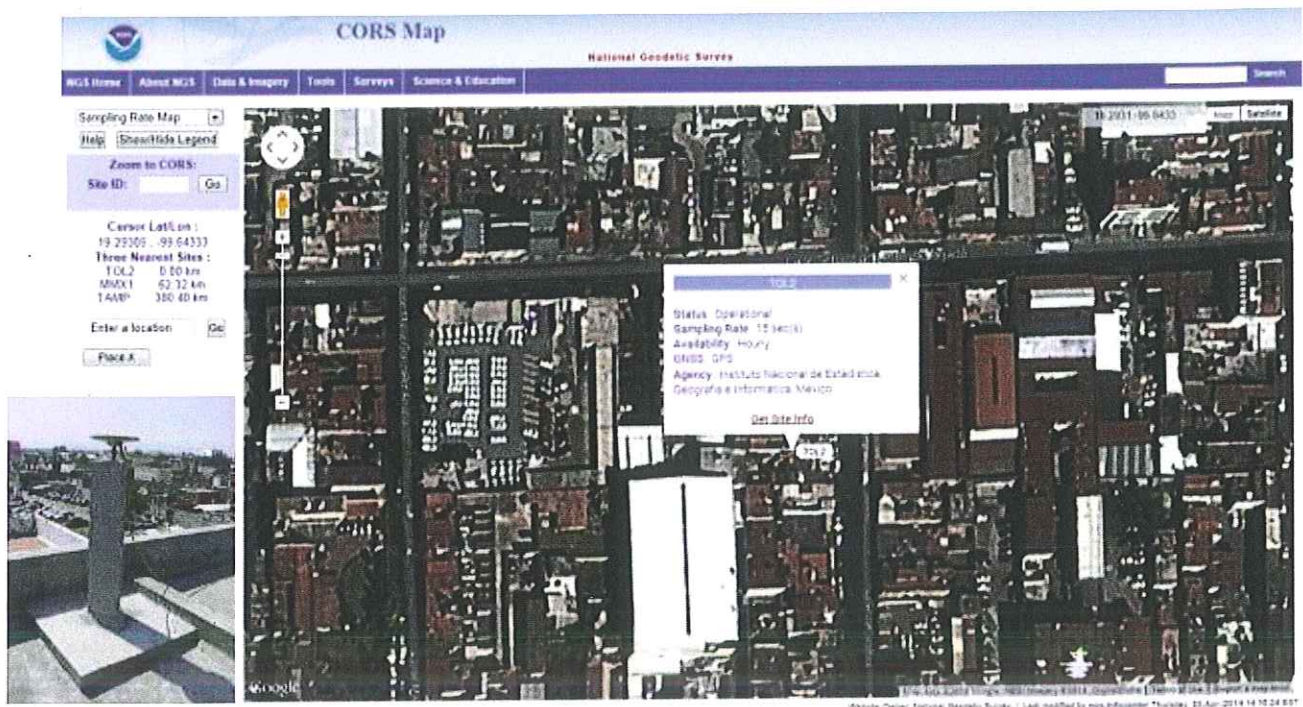
Figure 6 – Location of Toluca CORS Base Station Used to Post Process GCPs

The closest base station to the Project area was located in the City of Toluca. The Toluca CORS base station site location, which transmits at a 1-second interval, is provided in Table 2 and Figure 6 below. The Toluca station was operational during the FVVGTT Visit, as shown in the data availability profile in Figure 7 for the Julian days 86 through 114 (March 29 through April 22), which were the days MDA was in the field. There were several periods of inoperability during this time period which is shown in grey as opposed to the operational blue colour in Figure 7. The first period was during Julian day 94, or 3 April, and did not impact any measurements as it was on a Sunday. The second period was on Julian day 95, 4 April, only until approximately 10 am that morning. On 4 April, Team 1 set-up for the first Validation Point at 9:50 am and collected data until 10:25 am. For this location, the GPS was used as a base for the Validation Points, and the primary measurements collected were with the Laser Range Finder. Any points above the accuracy tolerance were removed during post processing. The next outage period was 16-17 April, which were weekend days and did not affect the project. On Julian day 109, 18 April, the team was collecting data during the outage, but the GPS was only used as a base for the Laser validation measurements. While there were outages reported, fortunately they did not occur during any time periods that would have affected the GPS instrument, and there was no impact to project accuracies.

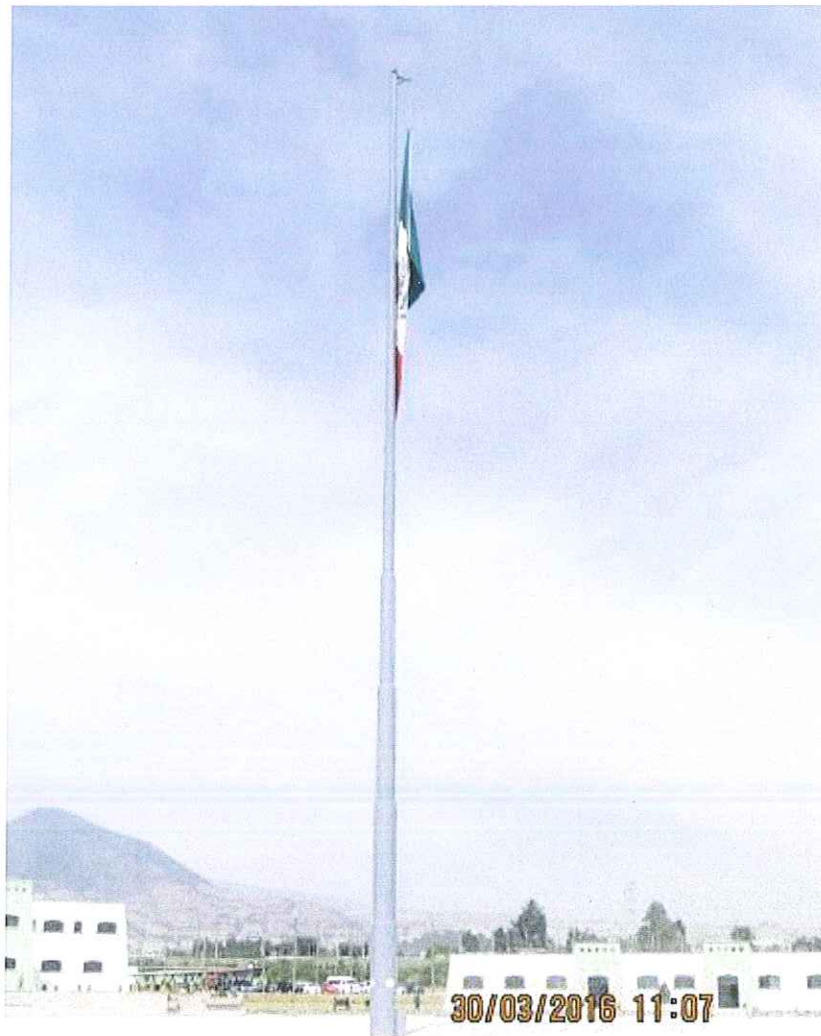
Figure 12 – Military Flagpole at Campo Militar No. 22-A

On Wednesday, 30 March, the team left the hotel in Toluca and headed towards the southwest of Area B to Tenancingo. The roads were difficult and the target locations to visit that day were located at a considerable distance from Toluca. The Team requested permission to measure a large Flag Pole on a Military Base called "Campo Militar No. 22-A" near Santa María Rayón. The permission was granted after going through some formalities and a security check. The team also spent time searching for more Obstructions visible within the area as they were driving using binoculars. Eight (8) Obstructions were collected on 30 March. Figure 12 shows the Flag Pole located at Campo Militar No. 22-A.

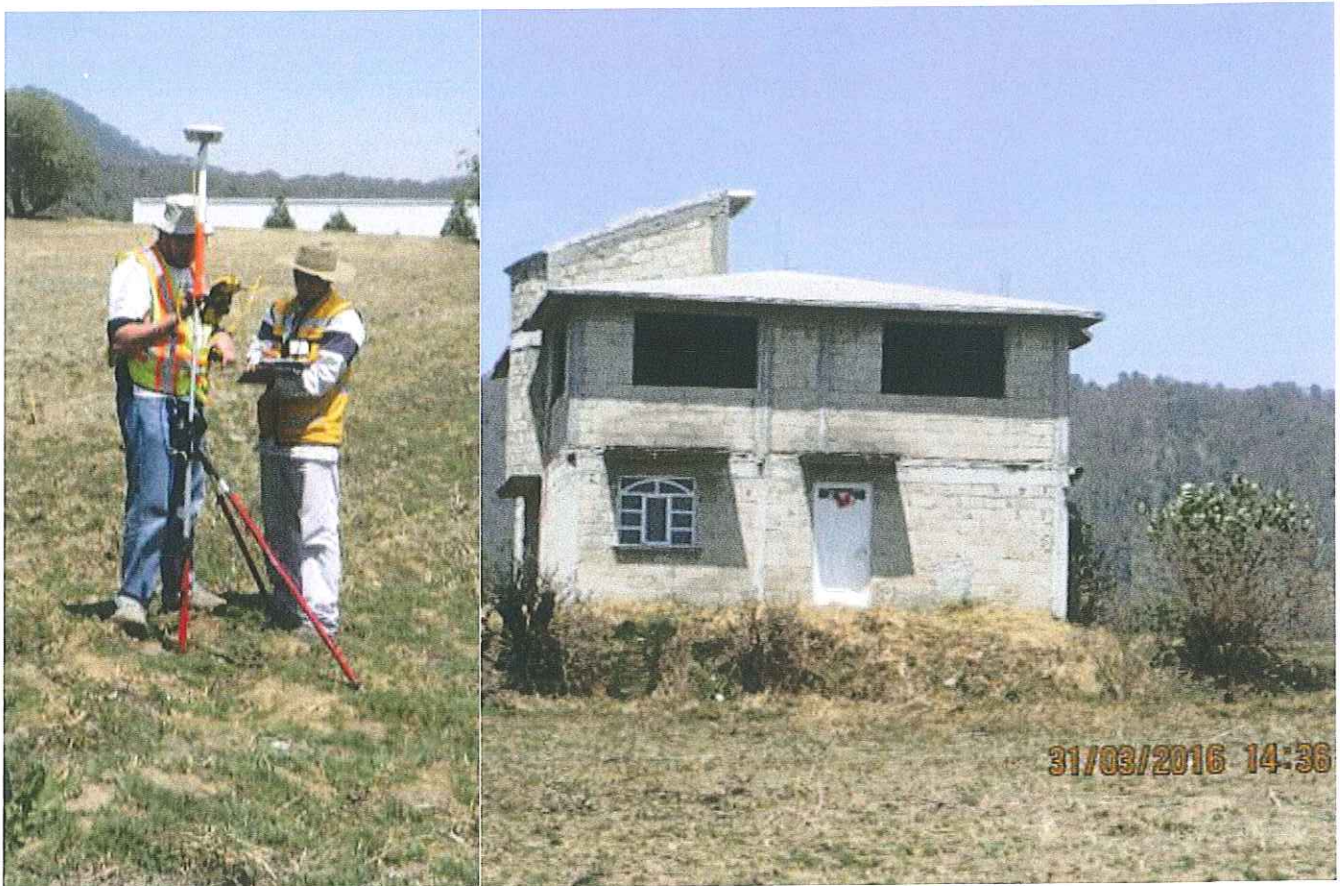
Figure 13 – Ing. Caballero and Mr. Legasse Collecting Anchor Point and Obstructions near Town of Col. Álvaro Obregón

Figure 13 shows one of the Anchor Points where random obstacles were collected in the surrounding area and one of the random features collected in the surrounding area of Col. Álvaro Obregón.

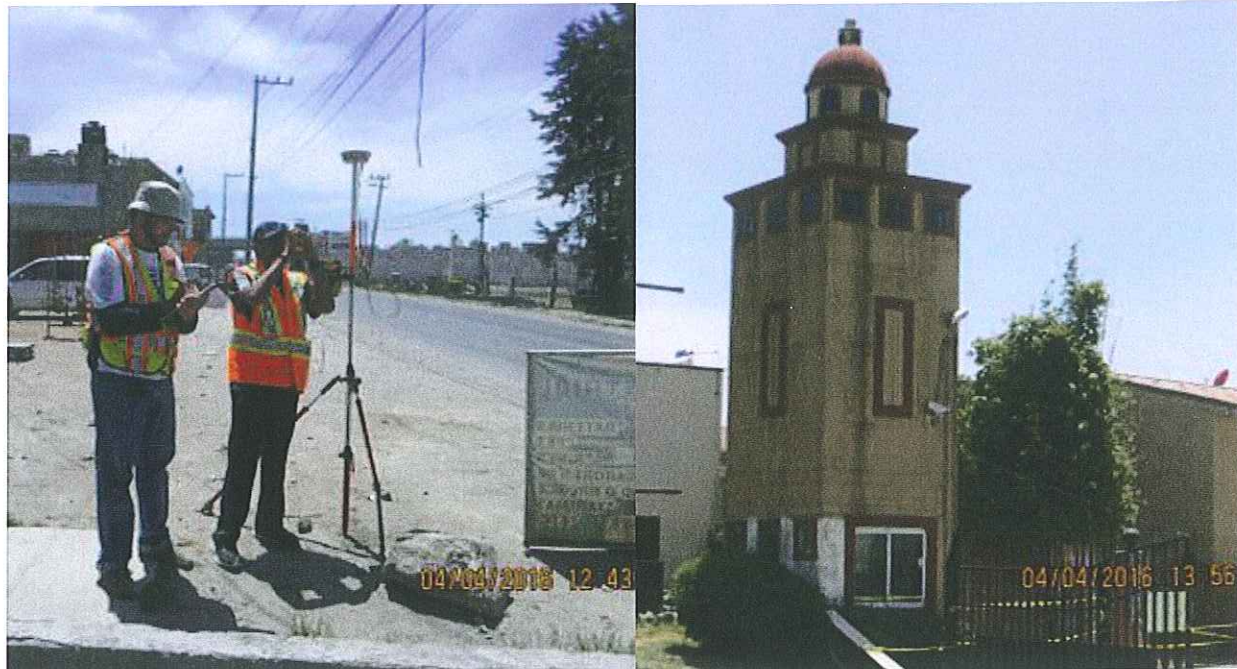
Figure 15 – Anchor Point (left), and Watch Tower (right) near Town of El Cerrillo

On Monday, 4 April, the team headed to the eastern part of the PSA to collected random validation area measurements. The team had to change locations twice due to local residents being hostile and unwelcoming, and were causing a problem for the team to complete the necessary measurements. Despite these issues, most of the survey proceeded without any major incidents. Eight (8) Anchor Points and one hundred and sixteen (116) random Validation Points were collected on 4 April. Figure 15 shows an Anchor Point near the town of El Cerrillo Vista Hermosa (hereafter referred to as "El Cerrillo") and one of the features measured there.

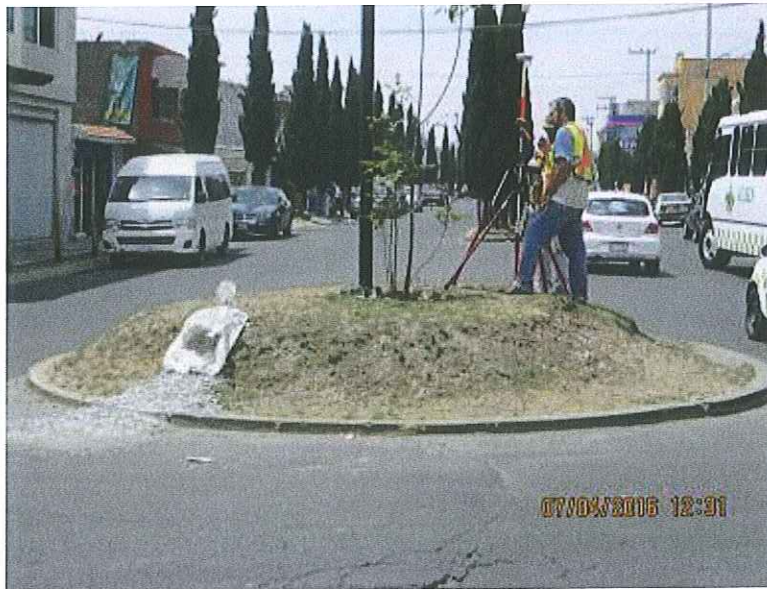
Figure 19 – Anchor Point in the Conj U Los Sauces IV Area

On Thursday, 7 April, the team headed north of the PSA to measure random Validation Points. Six (6) Anchor Points, two (2) single Obstructions and eighty (80) random Validation Point measurements were collected. Figure 19 shows the collection of an Anchor Point in the area

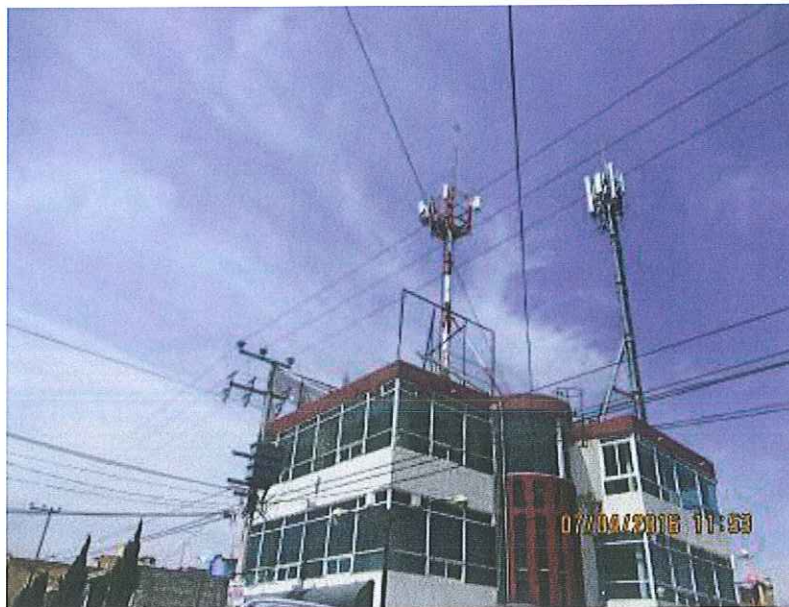
Figure 20 – Obstructions (Antennas) on a Building in the Conj U Los Sauces IV Area

known as Conj U Los Sauces IV and Figure 20 shows two antenna Obstructions that were measured on top of a building in the same area.

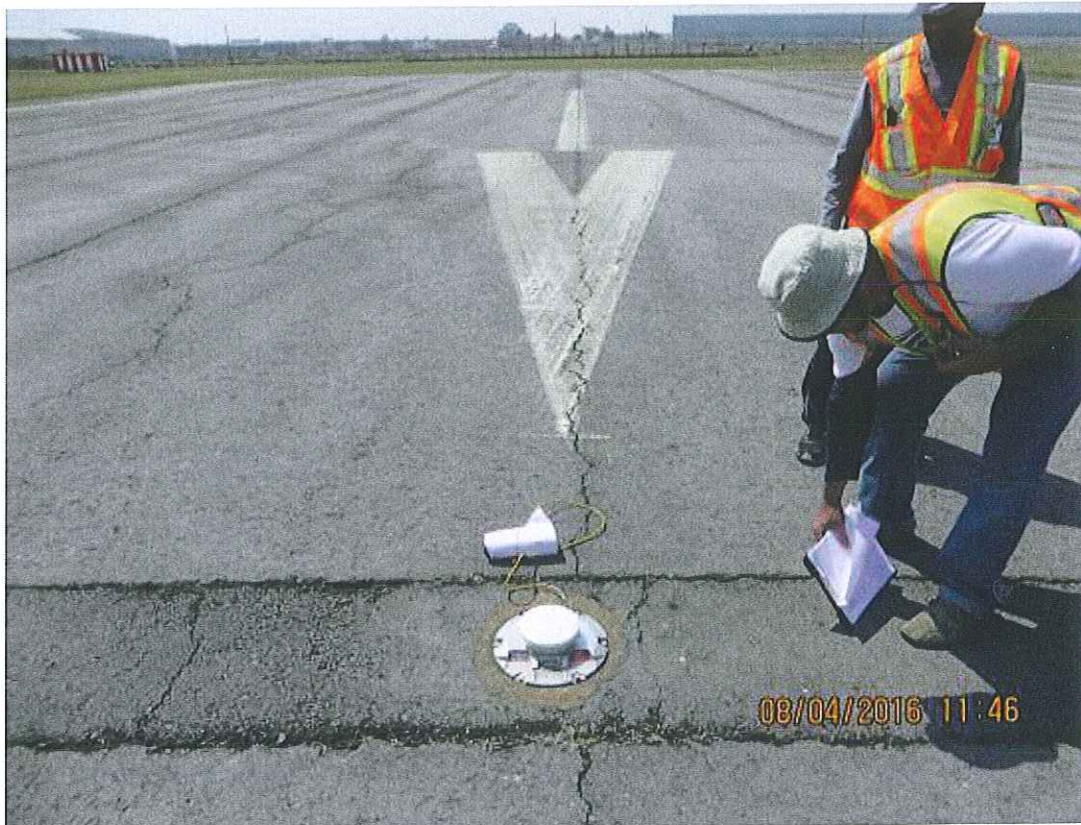
Figure 21 – Runway Threshold 33 Measured at Toluca Airport

personnel and was later granted permission to survey the single runway thresholds. The threshold measurements were completed without the use of the antenna poles. The team measured all three (3) threshold points successfully with great accuracy. Unfortunately, the INEGI GCP BN622002 located at the airport no longer exists due to the Terminal expansion that was completed several years ago. The team also spent time measuring some Obstructions that were close enough to the threshold locations to access with permission. Three (3) runway threshold points (see Figure 21 for Threshold 33), and five (5) Obstructions were collected on 8 April, including the Airport Surveillance Radar (ASR) Tower shown in Figure 22.

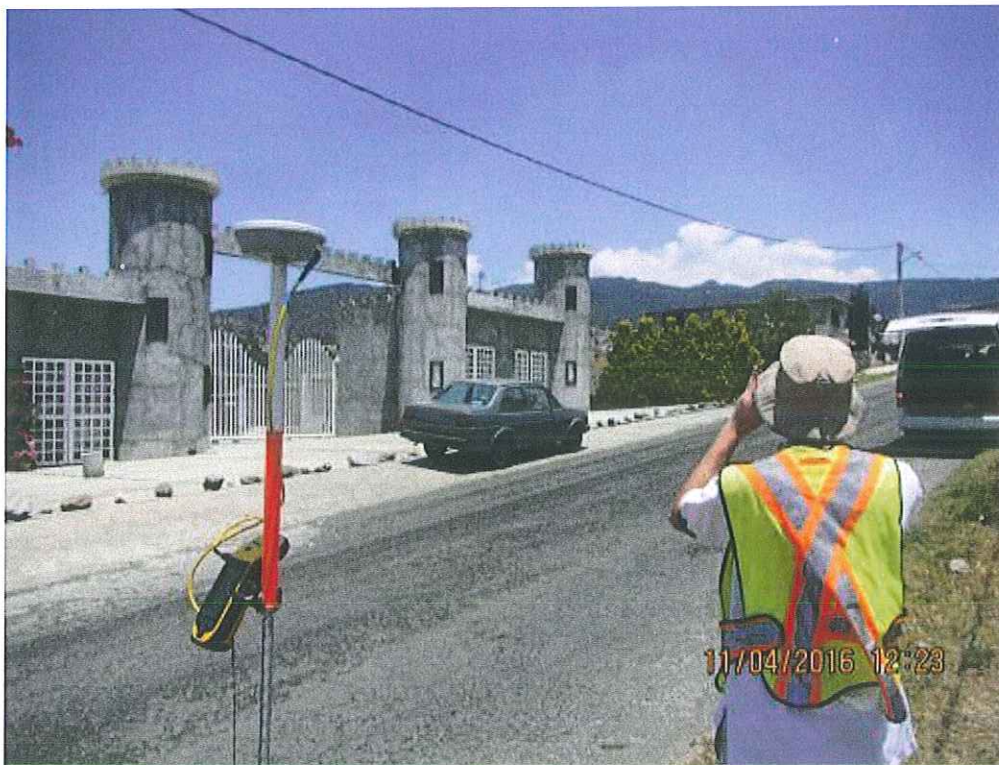
Figure 24 – Mr. MacCulloch Verifying the Height of an Obstruction in the Field

On Monday, 11 April, the team headed to the northeast corner of Area A and into Area B. A total of six (6) Obstructions were collected, as well as five (5) random Validation Point locations were visited with thirty-six (36) points measured in and around San Mateo Capulhuac. See Figure 24 for one of these validation areas.

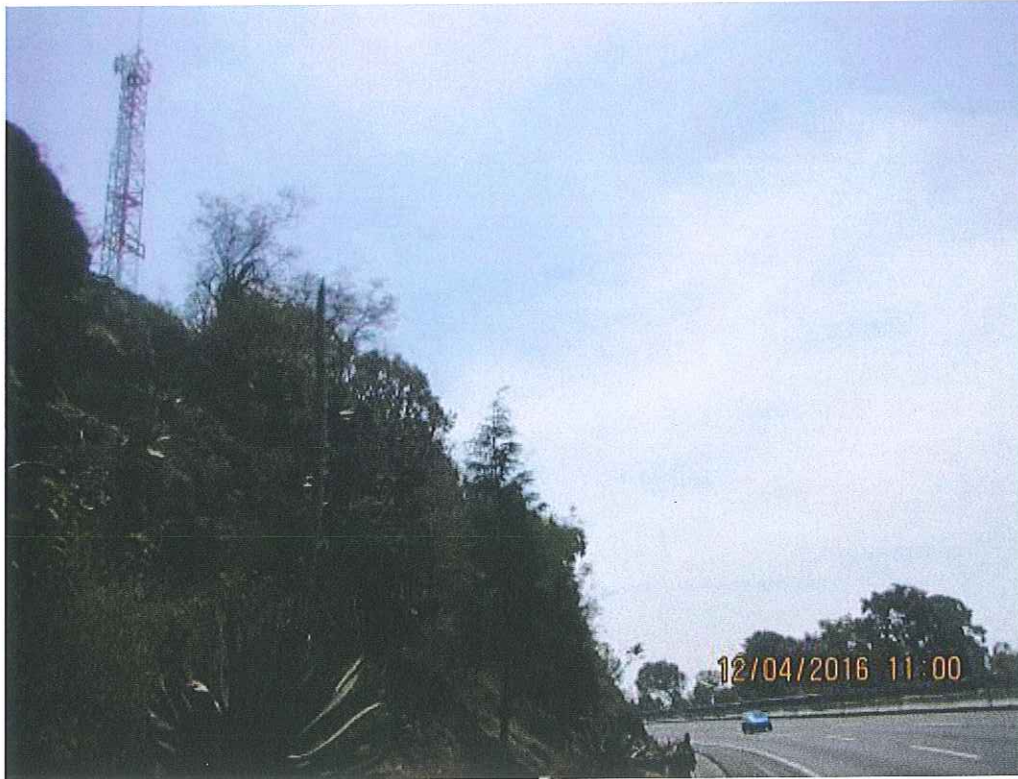
Figure 25 – An Antenna beside a Major Road in the Southwest Corner of Area B

On Tuesday, 12 April, the team started at 8 am and headed to the southeast corner of Area B. The team collected two Obstructions on route to the planned area, with one significant Obstruction, an antenna, measuring 82 m AGL in height. All Obstructions noted in the monoscopic search were easily accessible by vehicle, except for an Obstruction which required a short walk along the highway and through some bushes near the town of Coajomulco (see Figure 25). The team collected thirteen (13) Obstructions and one (1) GCP in the Toluca 2000 Industrial Park, which required special permission.

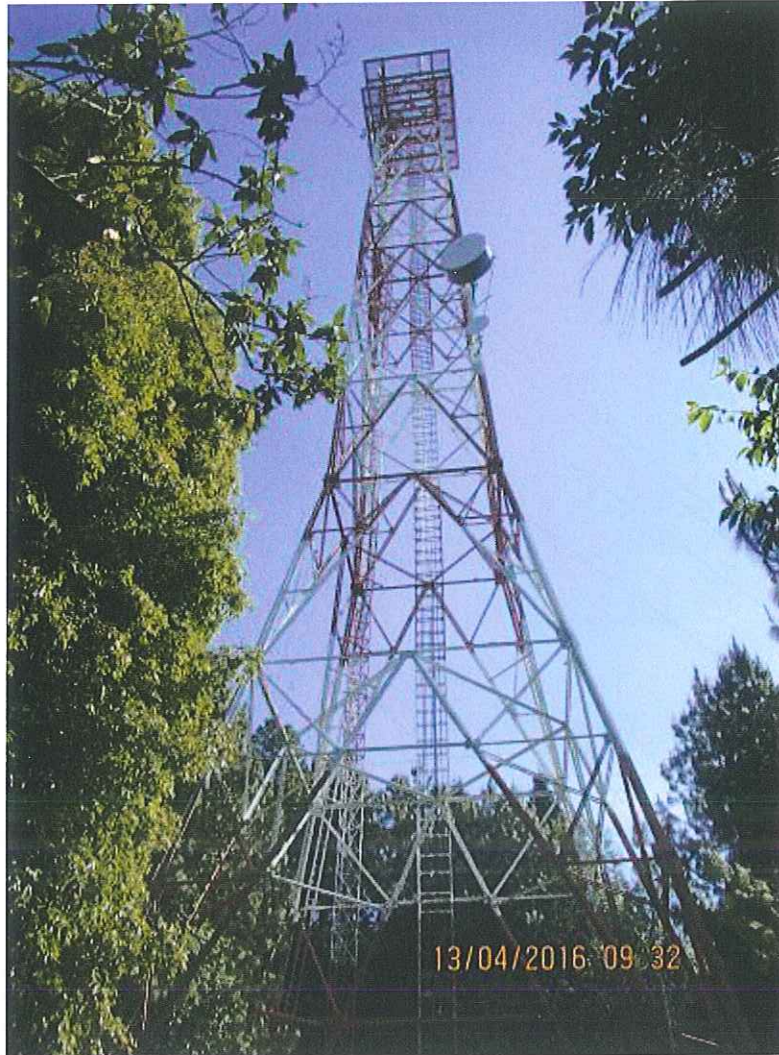
Figure 26 – Antenna 2 Accessed with a 4 x 4 Vehicle

On Wednesday, 13 April, the team was met at 8 am by Ing. Caballero and the driver with a 4 x 4 vehicle to transport the team for the day. The team headed south of Toluca to complete the Fieldwork Area assignment and continued directly to Antenna 2 (see Table 5 above for the coordinates). Antenna 2 was the first of two Obstructions that were accessible only through the use of a 4 x 4 vehicle, and permission to access was required. The condition of the road was very manageable with the 4 x 4, with direct access all the way to Antenna 2. Antenna 2 was measured at 72 m AGL in height. See Figure 26 for a field photo.

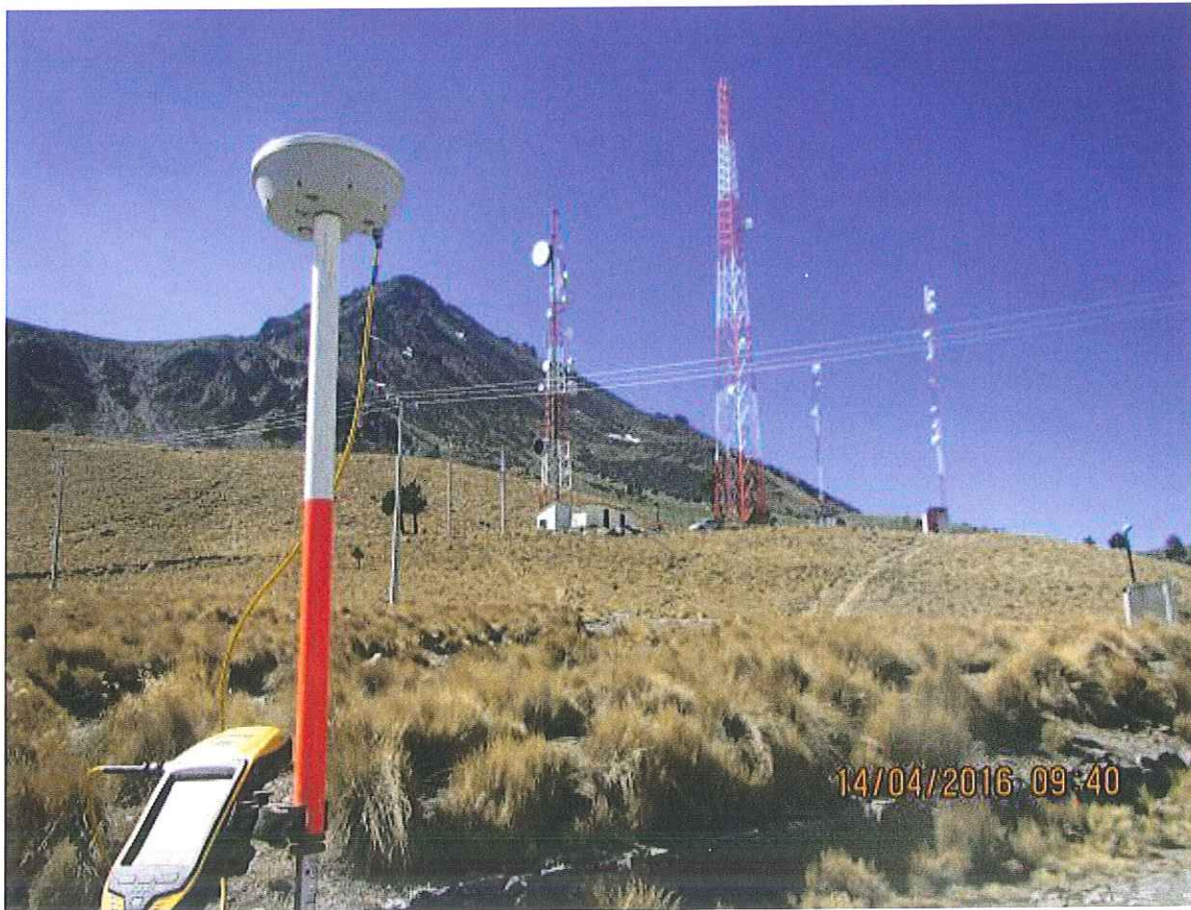
Figure 28 – The Largest of the Four Antennas Measured on Nevado de Toluca

The Fieldwork Area was scheduled to include a trip to Nevado de Toluca, west of Toluca, to measure seven (7) Obstructions, the largest of which was measured at 60 m AGL in height, and is pictured in Figure 28. The condition of the road was manageable without a 4 x 4 vehicle. After the team finished with the collection at Nevado de Toluca, the team attempted to collect INEGI Point V150354. However, the team was unable to locate this point in the field after twenty minutes of searching (see Figure 29).

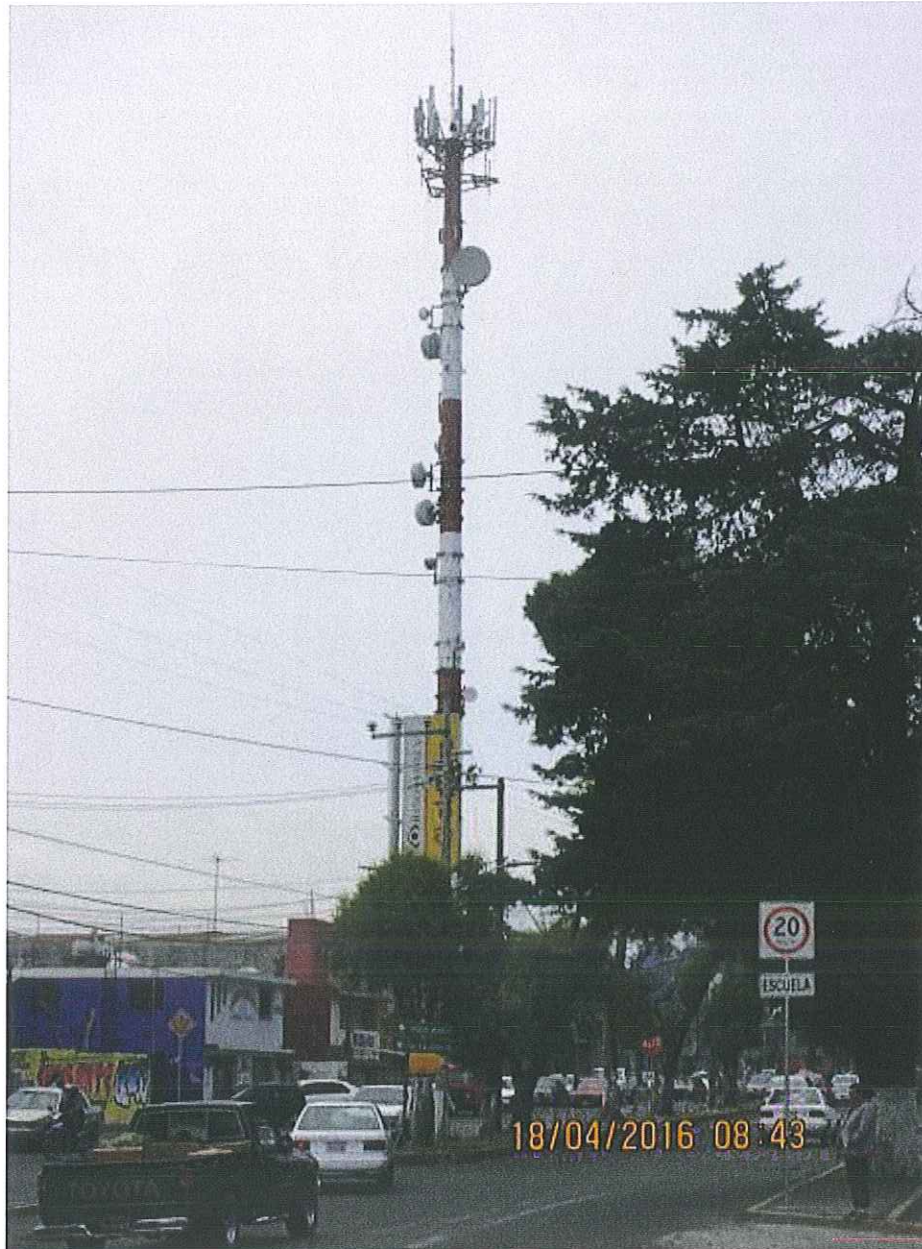
Figure 31 – Locating Obstructions in Fieldwork Area Day 7

On Monday, 18 April, the team changed the day plan from Fieldwork Area Day 6 to Day 7 and Day 8, which is west and northwest, respectively, of Toluca. This decision was made to accommodate the required additional points to be collected at Toluca Airport the following day. The team collected twenty-one (21) Obstructions (see Figure 31 for an example).

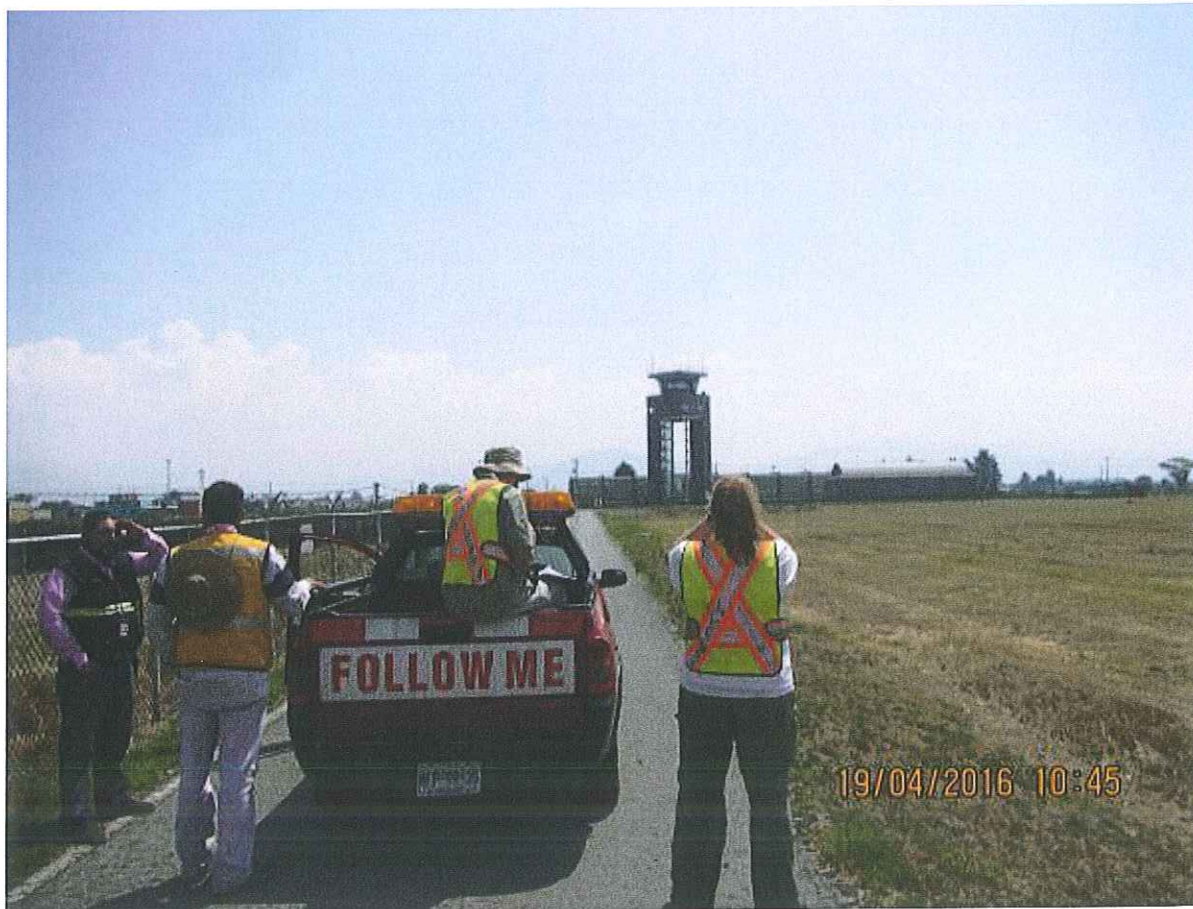
Figure 32 – Mrs. Brunke Measuring the ATCT at Toluca Airport

Mrs. Brunke joined the team at 8 am at the Holiday Inn Express in Toluca. The team then proceeded north of Toluca Airport in Area A to the electrical substation, where an appointment that required special permission was planned. An Anchor Point was collected along with eight (8) Obstructions in and around the electrical substation. The team then proceeded to Toluca Airport to collect all of the Obstructions on the grounds of the airport. A total of twenty (20) Obstructions were measured within the active airport area. Figure 32 shows Mrs. Brunke measuring the height of the Air Traffic Control Tower (ATCT). The staff at Toluca Airport were very accommodating and allowed the team to traverse the airport to any location they targeted.

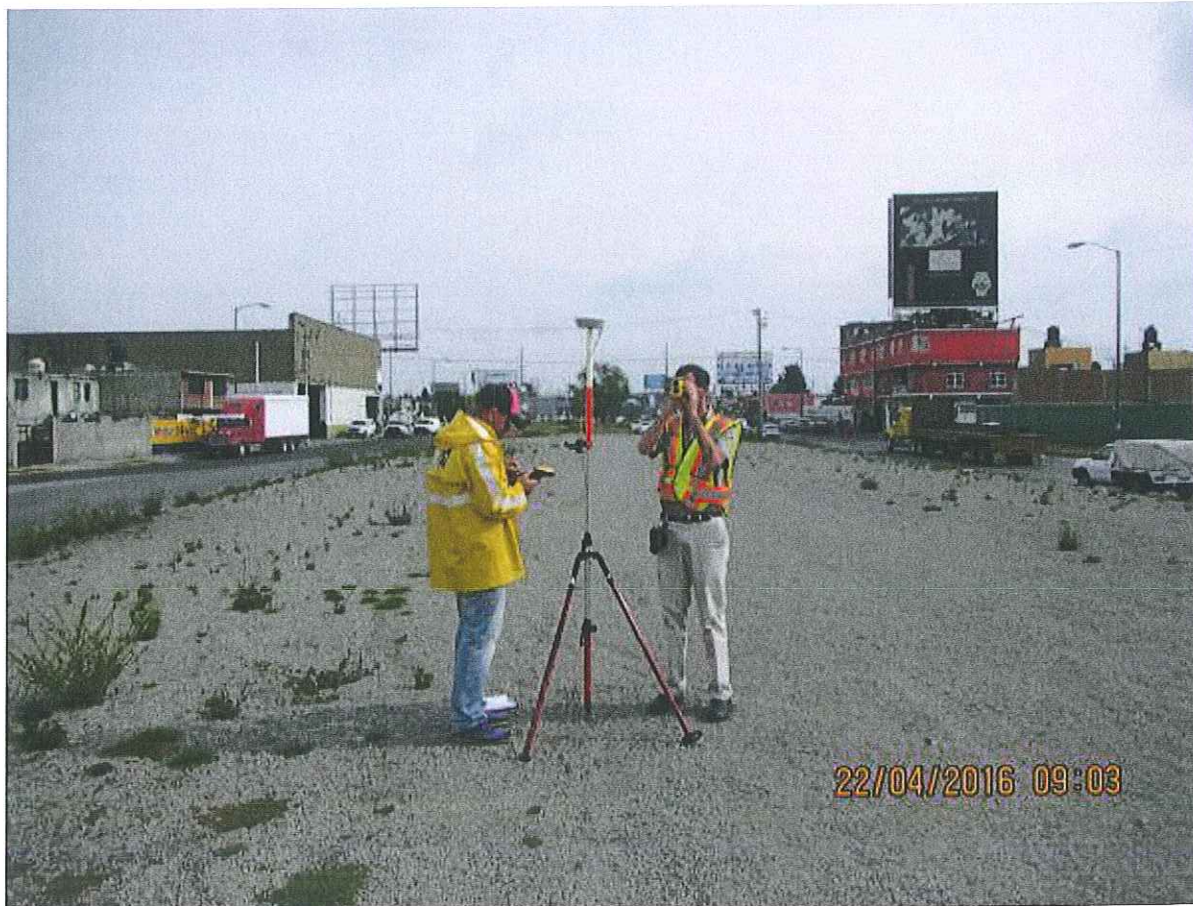
Figure 35 – Mr. MacCulloch and Mr. McConachie Measuring Validation Points

With all of the Fieldwork Areas completed in the previous nine days, the team set out to collect two (2) additional Anchor Points, which resulted in a total of thirty-two (32) Validation Points. See Figure 35 for one Anchor Point location that was measured before the team drove back to Mexico City in the ASA-provided van. Once in Mexico City, Ing. Caballero and the team organized the equipment into what would stay at the ASA office, and what the team was bringing back to Canada. Once that was complete the team thanked Ing. Caballero for his efforts and entered the Airport Hilton for their flight back to Canada the next day.

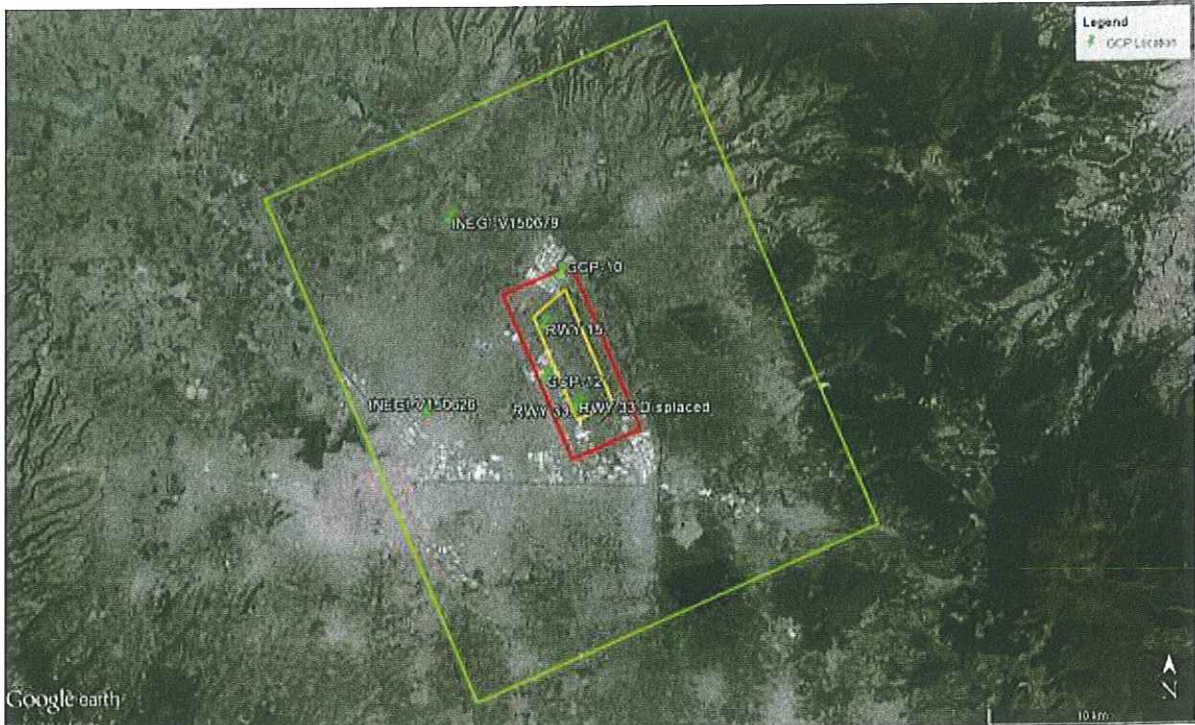
This Appendix contains information on all seven collected GCPs shown in Figure 37 below. Each GCP collected is described on a whole page, with the coordinates, date collected and field photographs.

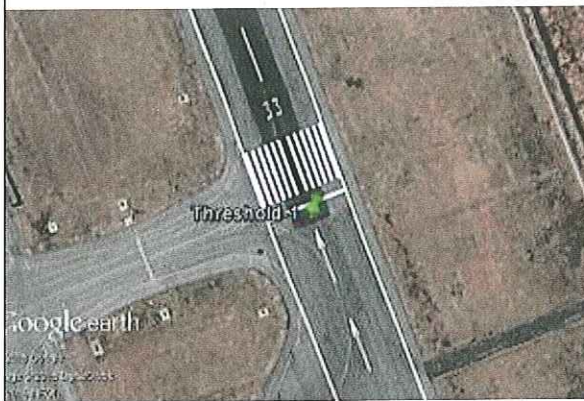
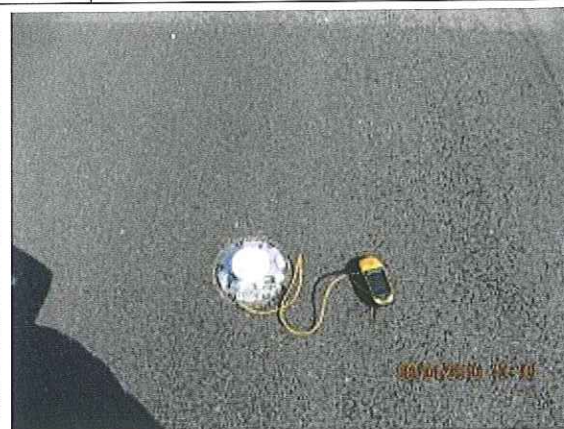
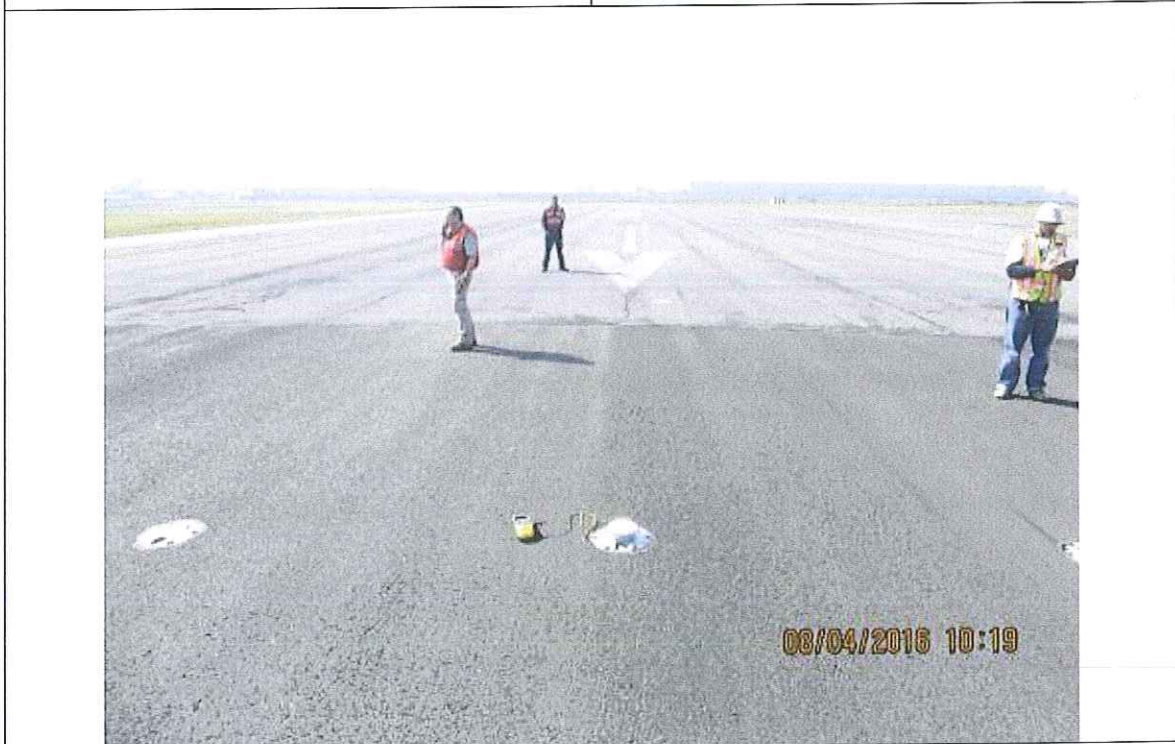
Project: Toluca Area Survey	Country: Mexico	Region: Toluca Area, Mexico
Control Point ID: Threshold-1	Collection Date: 08 April 2016	Instrument: Trimble GeoExplorer
Latitude: 19° 19' 15.52" N	Longitude: 099° 33' 31.48" W	Height (above sea level): 2579.131 m
Project Area: PSA		Datum: World Geodetic System 1984 (WGS84) / Earth Gravitational Model 1996 (EGM96)

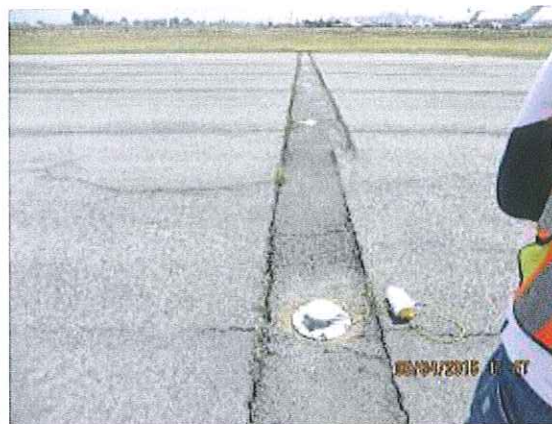
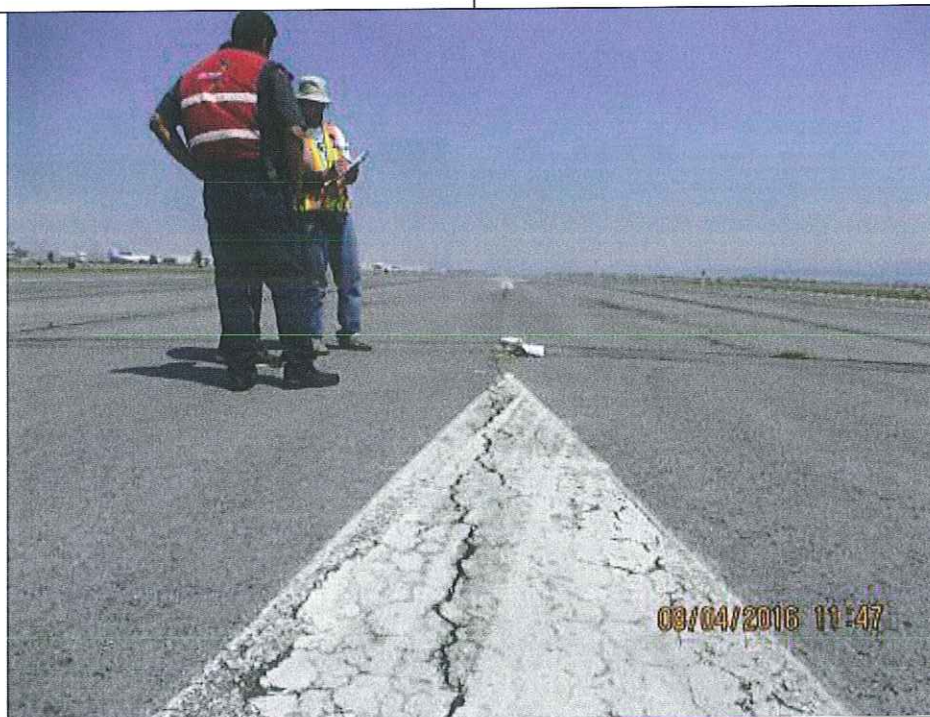
Project: Toluca Area Survey	Country: Mexico	Region: Toluca Area, Mexico
Control Point ID: Threshold-2	Collection Date: 08 April 2016	Instrument: Trimble GeoExplorer
Latitude: 19° 19' 10.78" N	Longitude: 099° 33' 29.33" W	Height (above sea level): 2578.879 m
Project Area: PSA		Datum: WGS84/EGM96

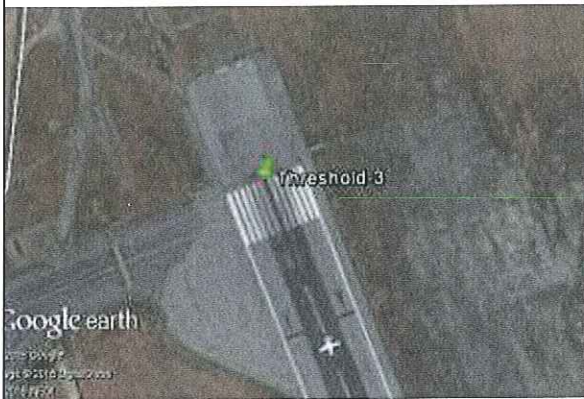
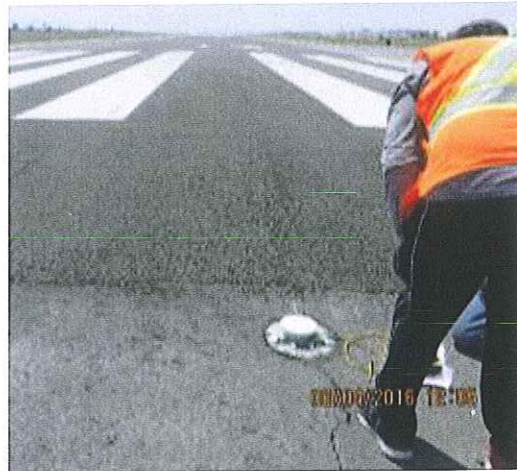
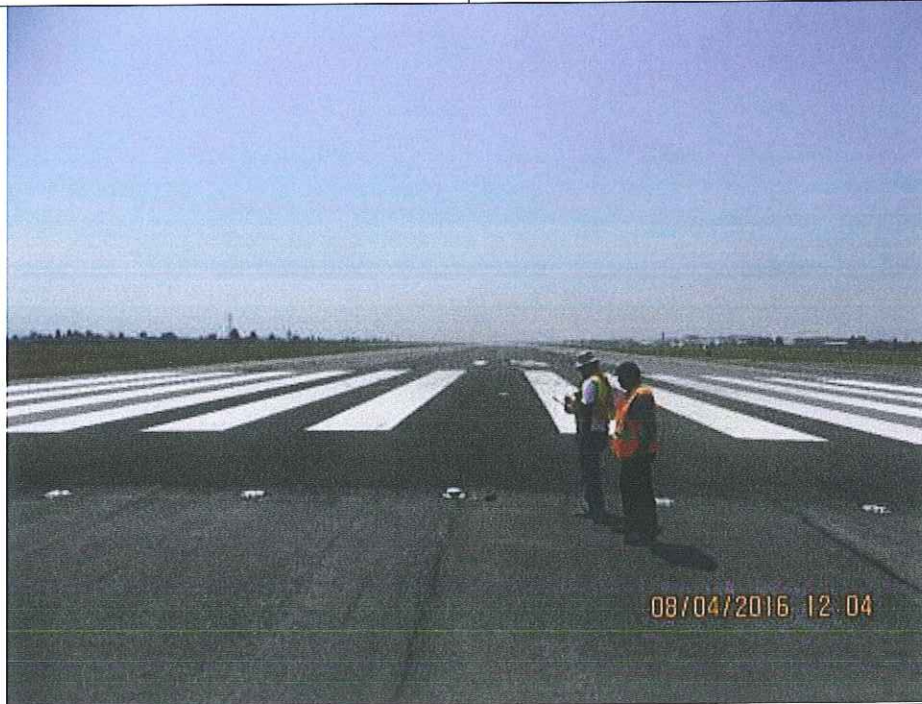
Project: Toluca Area Survey	Country: Mexico	Region: Toluca Area, Mexico
Control Point ID: Threshold-3	Collection Date: 08 April 2016	Instrument: Trimble GeoExplorer
Latitude: 19° 21' 16.25" N	Longitude: 099° 34' 26.15" W	Height (above sea level): 2578.77 m
Project Area: PSA		Datum: WGS84/EGM96

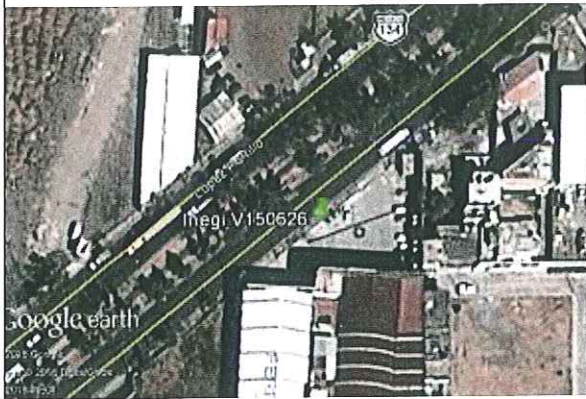
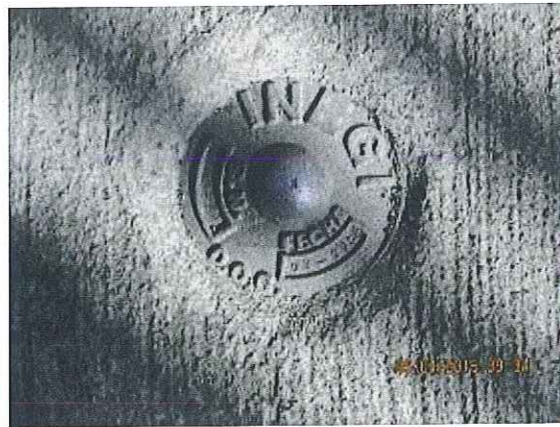
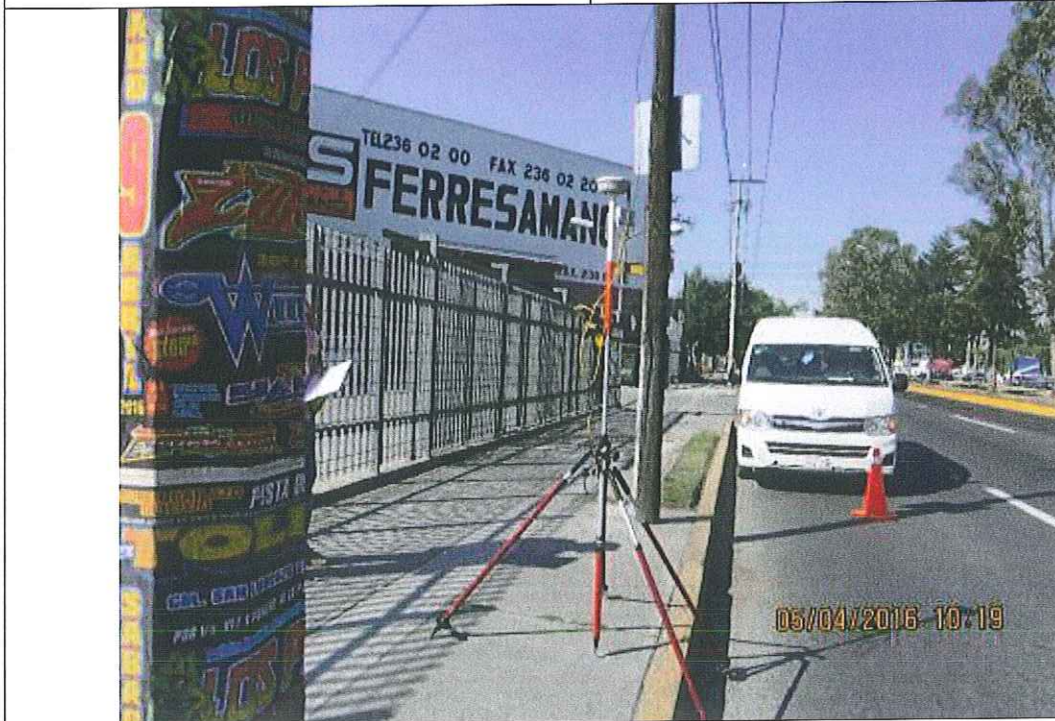
Project: Toluca Area Survey	Country: Mexico	Region: Toluca Area, Mexico
Control Point ID: INEGI V150626	Collection Date: 05 April 2016	Instrument: Trimble GeoExplorer
Latitude: 19° 37' 41.96" N	Longitude: 099° 33' 29.33" W	Height (above sea level): 2615.972 m
Project Area: Area A		Datum: WGS84/EGM96
