Photogrammetric, Satellite-Based Survey of Toluca Airport and Its Surroundings

Field Validation, Verification and Ground Truth Visit Report

Photogrammetric Survey of Toluca Airport and its Surroundings:

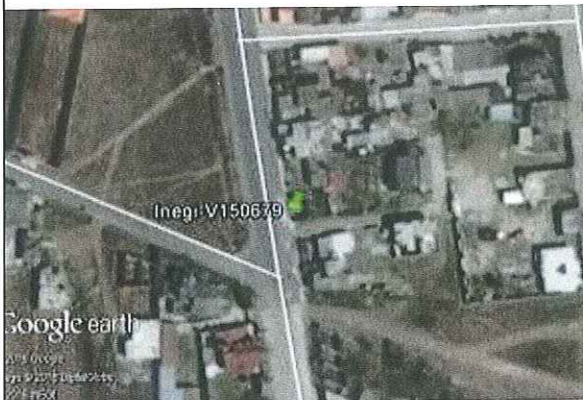
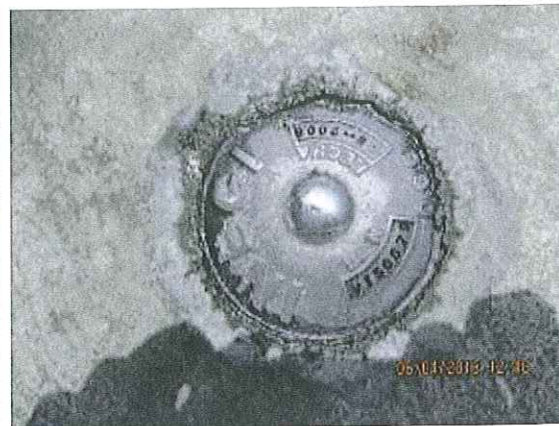
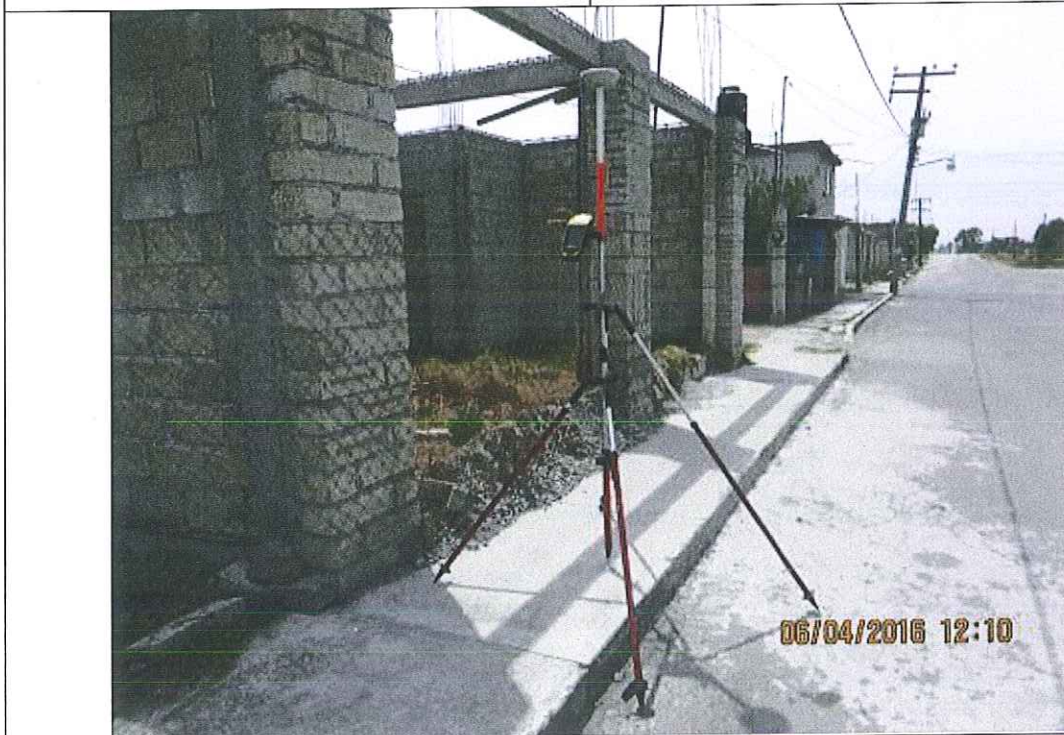
Project: Toluca Area Survey	Country: Mexico	Region: Toluca Area, Mexico
Control Point ID: INEGI V150679	Collection Date: 06 April 2016	Instrument: Trimble GeoExplorer
Latitude: 19° 24' 0.91" N	Longitude: 099° 37' 2.71" W	Height (above sea level): 2574.275 m
Project Area: Area A		Datum: WGS84/EGM96

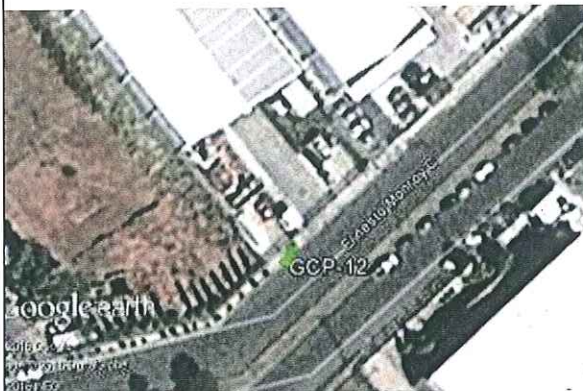
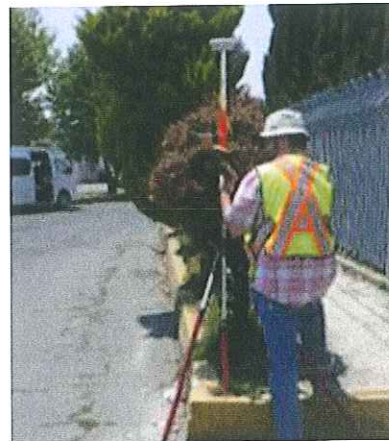
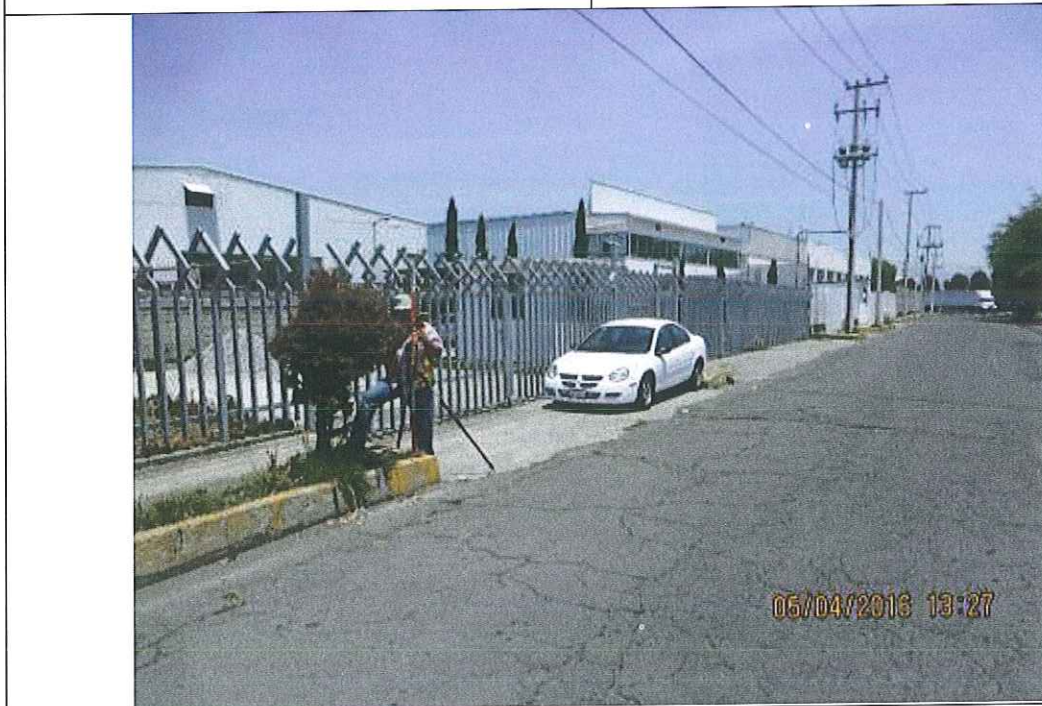
Project: Toluca Area Survey	Country: Mexico	Region: Toluca Area, Mexico
Control Point ID: GCP 12	Collection Date: 05 April 2016	Instrument: Trimble GeoExplorer
Latitude: 19° 19' 56.11" N	Longitude: 099° 34' 25.24" W	Height (above sea level): 2581.417 m
Project Area: PSA		Datum: WGS84/EGM96

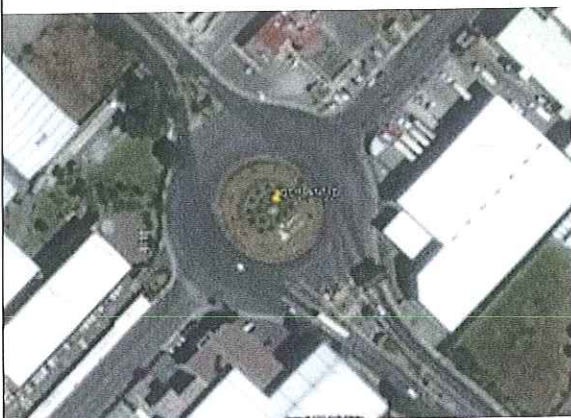
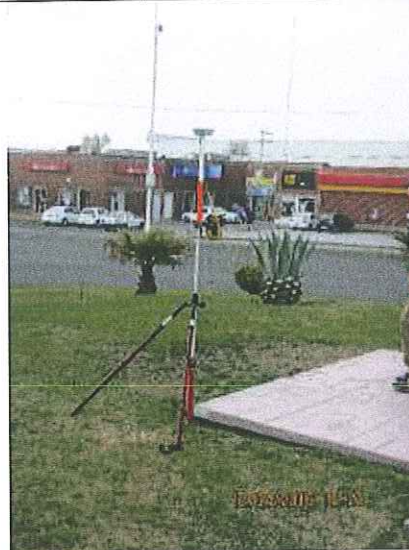
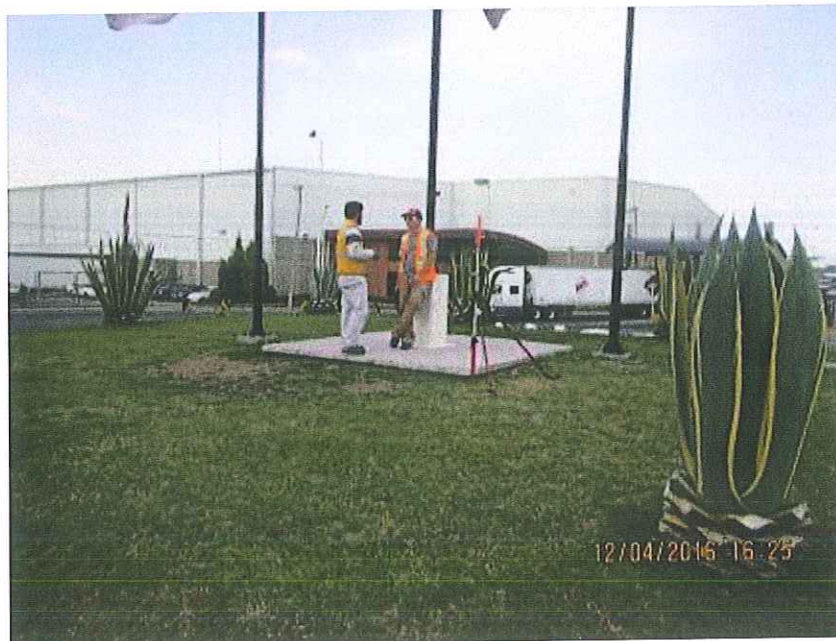
Project: Toluca Area Survey	Country: Mexico	Region: Toluca Area, Mexico
Control Point ID: GCP-10	Collection Date: 12 April 2016	Instrument: Trimble GeoExplorer
Latitude: 19° 22' 16.86" N	Longitude: 099° 34' 07.14" W	Height (above sea level): 2575.292 m
Project Area: Area PSA		Datum: WGS84/EGM96
