UNMASKING MAIN STREET: A LOOK AT SLIPCOVERED BUILDINGS IN HOUSTON

By Paul Homeyer

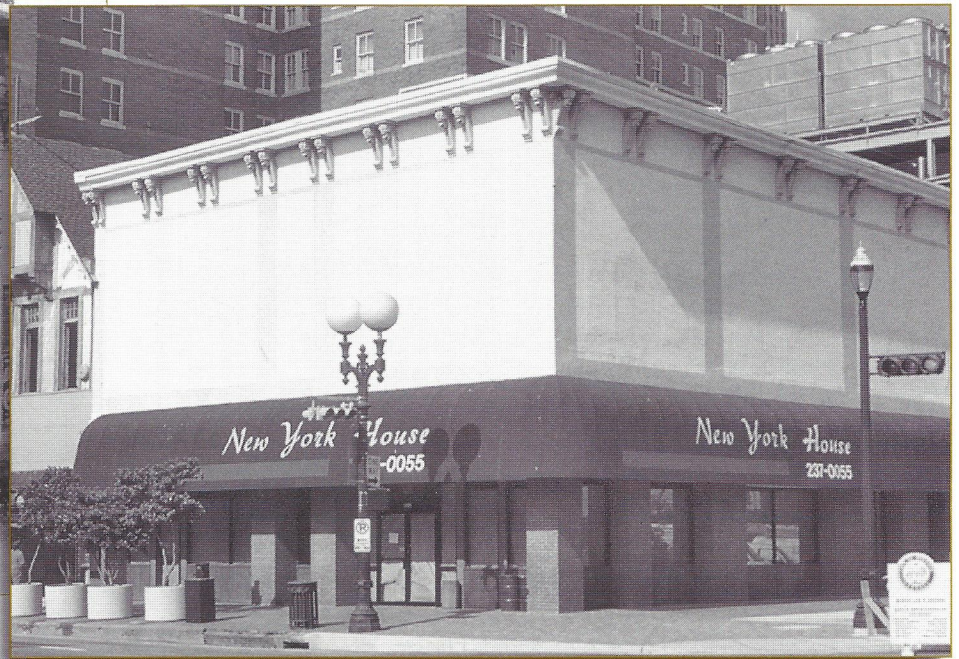
The slipcovering of 1879 Stegeman Building at 502 Main did not fully obscure the upper ornamental brackets and cornice capping the building. These visible remnants of the past helped to inspire the building tenant to remove the slipcover and begin restoration work on the original façade beneath.

The degree to which the slipcover altered the original appearance of the building also varies. The alterations to the 1879 Stegeman Building at 502 Main included the slipcovering of the upper façade but failed to obscure the ornamental brackets and cornice capping the building—leaving little doubt that there was an older building behind the visible façade. These visible remnants of the past helped to inspire the building tenant to remove the slipcover and begin restoration work on the original façade beneath.

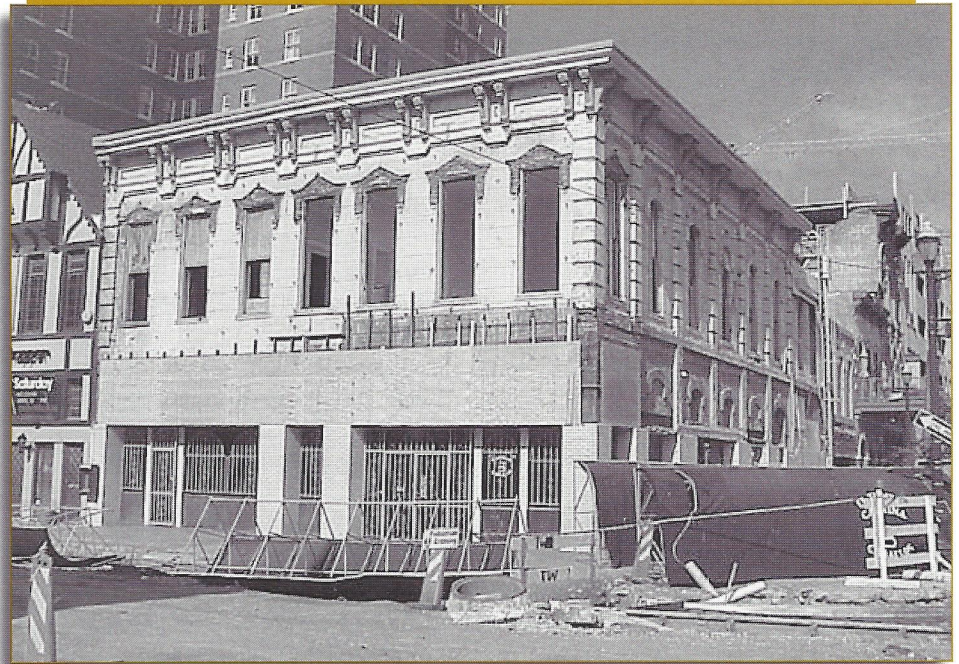
A fire at the West Building at the corner of Main and Walker in 2000 revealed what had been a secret for years. Behind the gold grille work encasing the top three-quarters of the building resided a 1912 façade of brick and stone that had been hidden for decades. The current owner

of the building has since removed the remaining panels to expose the entire façade and plans a restoration of the building in the near future.

The slipcover materials vary as much as the buildings they cover. Plaster and marble were popular materials and their installation often resulted in extensive damage to the original façade beneath. Grille work, like that encasing the West Building, were typically more lightweight, hung out further away from the original face of the building

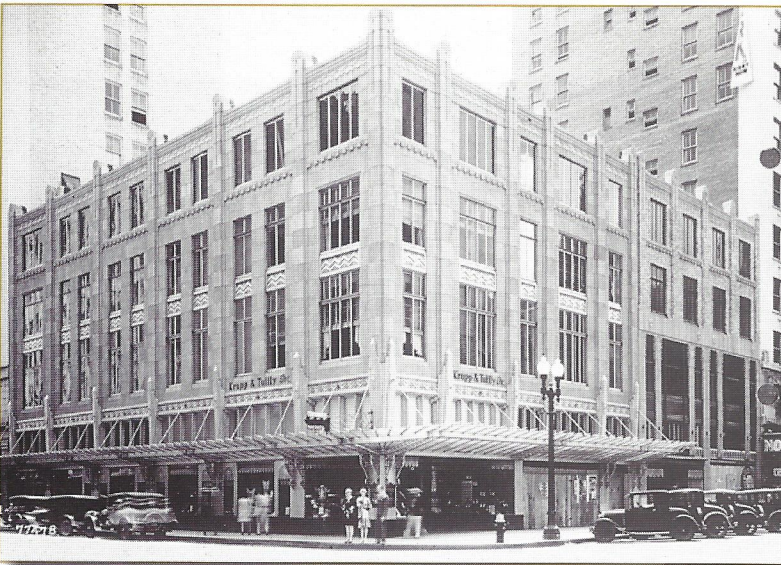
The Krupp & Tuffly Building at 900 Main Street and its neighbor at 905 Main Street (right side of image without awning), fell victim to the slipcovering trend. San Jacinto Savings took occupancy of 905 Main in the mid-1960s and covered its façade with a mosaic of the San Jacinto Monument.

In contrast to the Stegeman Building, the original exterior face of the building at 905 Main was completely sheathed in granite panels—giving no indication of what lay behind. Even upon further investigation at the interior of the upper floors it is not immediately apparent that there was more to this building than met the eye. Great care, it seems, was taken to infill the original window openings with

concrete block and cover over them from the interior as well as the exterior. The primary clue to the building's original identity were the historic photographs depicting a building of identical massing. The slipcover of 905 Main was removed in 2002 and the façade meticulously restored to its original appearance.

Next door to 905 Main, the Krupp & Tuffly Building, a fanciful art deco edifice designed by prolific Houston architect Alfred Finn, was slipcovered around the same time as its neighbor. The only hint of what lies behind the current monolithic façade is the deco detailing decorating the elevator penthouse visible from the street.

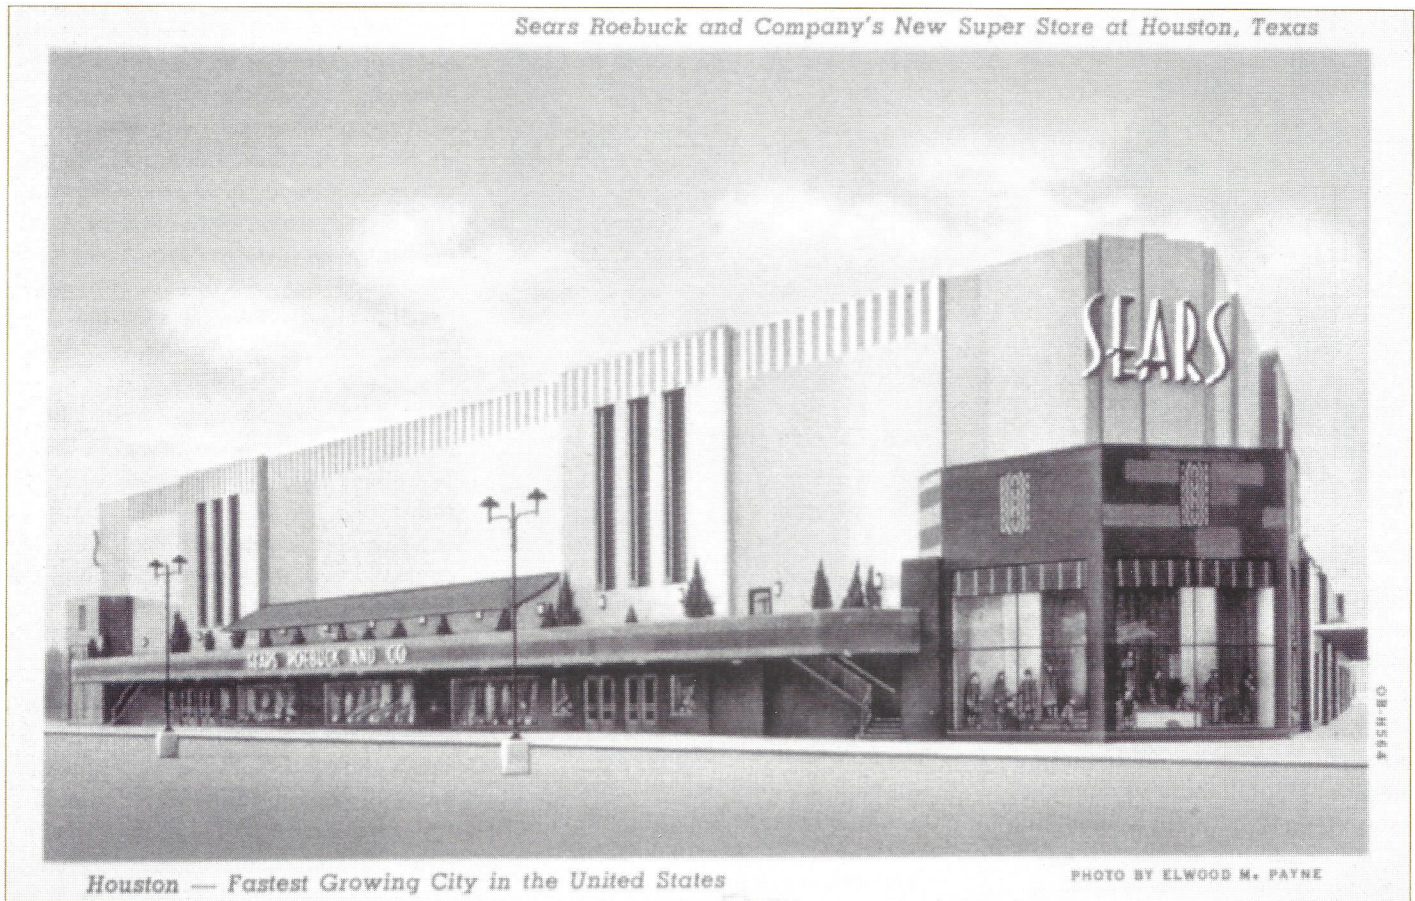
In the late 1960s, almost all the show windows on the ground floor of the Sears building were bricked in. Sears feared that riots might erupt in Houston, as they had in other cities, due to the recent assassination of Martin Luther King, Jr. The rest of the building was slipcovered at the same time.

Slipcovered buildings were not limited geographically to downtown Houston. Further south on Main Street—outside of what is considered downtown sits an art deco gem, though you wouldn't know it by looking. Sears & Roebuck opened in 1939 to much acclaim. At the time of its completion it was the largest department store in Houston and the first major department store located outside the central business district. Sears boasted the city's first escalators that were capable of carrying 6,000 people per hour between the three levels. In the late 1960s, fearing that the race riots that had ignited in other cities following the assassination of Martin Luther King, Jr. would erupt in Houston, the powers that be at Sears had almost all of the show windows at the ground floor bricked in. At the same time, the sleekly elegant upper façade was clad in beige metal siding.
