# APPENDICES

# **APPENDIX A**

## **Photographs, figures and graphs**

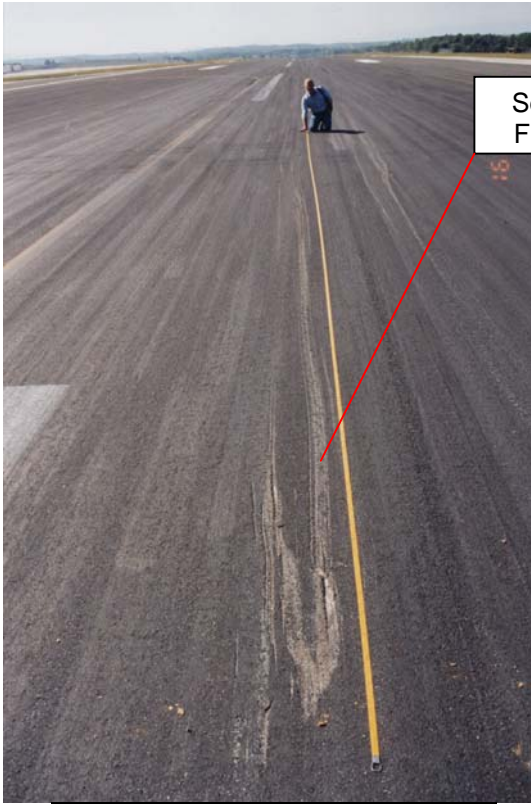
**Figure 23.1 – Fuselage Marks**

Second Runway  
Fuselage Marks

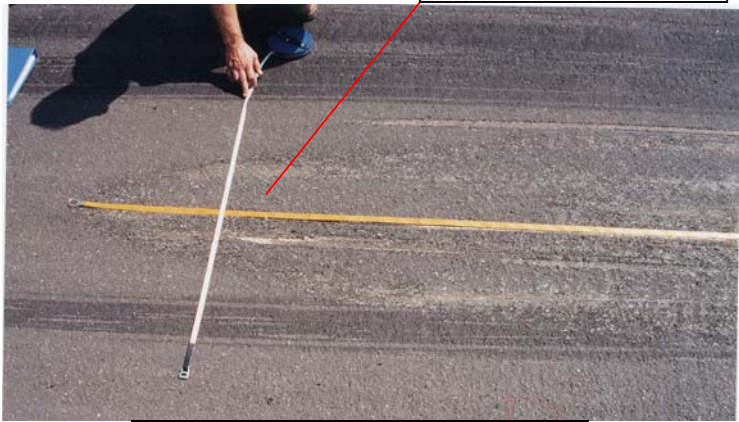
**Figure 23.2 – Nacelle Marks**

Second Runway  
No 2 Nacelle Marks
