MH17: Source of the Separatists' Buk
A bellŕngcat Investigation

Summary

This report analyses evidence from open sources, in particular social media, relating to the Buk missile launcher filmed and photographed in eastern Ukraine on July 17th that many have linked to the downing of Malaysia Airlines Flight 17.

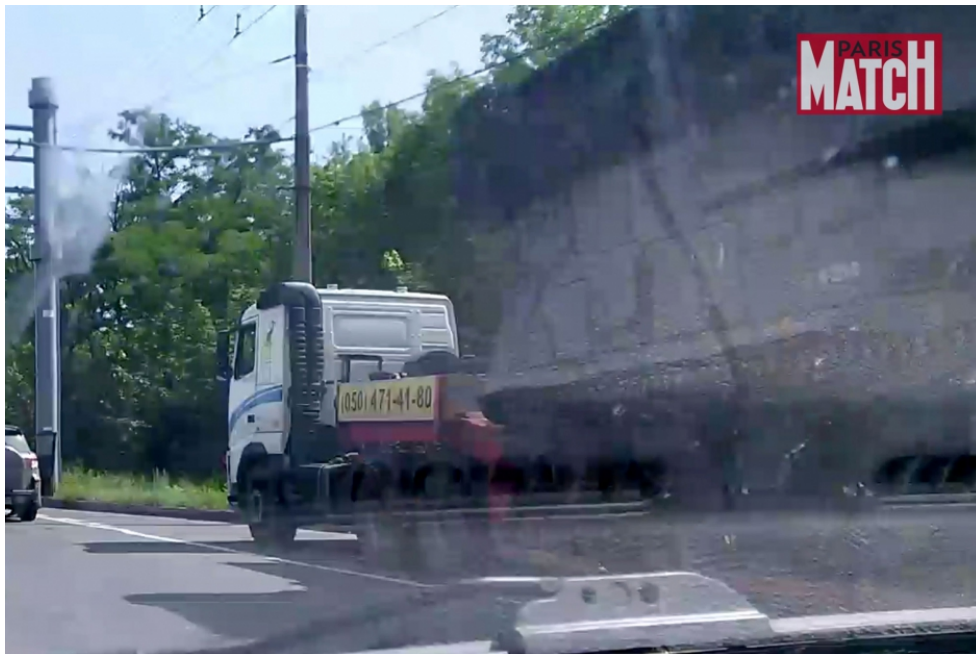
Photograph from Paris Match of the Buk missile launcher in Donetsk, Ukraine, July 17, 2014.

On July 25th, the weekly magazine Paris Match [published](#)¹ a photograph of a Buk missile launcher being transported on a low-loader truck through the separatist-controlled city of Donetsk. The location of the photograph was [precisely located](#)², showing an eastward direction of travel along the H21 motorway.

[Inquiries by Storyful](#)³ with Paris Match established that the photograph was taken at “about 11 am on the morning of July 17.” Shadows cast by the vehicle are consistent with this time of day. Paris Match also confirmed this was the best quality version of the image available. A Twitter post from [12:32PM](#)⁴ (local time)⁵ on July 17 reports the sighting of a Buk at the intersection of Shakhtostroteley Boulevard and Ilych Avenue heading east in the direction of Makiivka. This tweet supports the location and route provided by the Paris Match photograph. Using the phone number on the side of the low-loader truck, Paris Match contacted the owner of [the company](#)⁶, who claimed the truck had been stolen by separatists and that the vehicle was unique in the region.

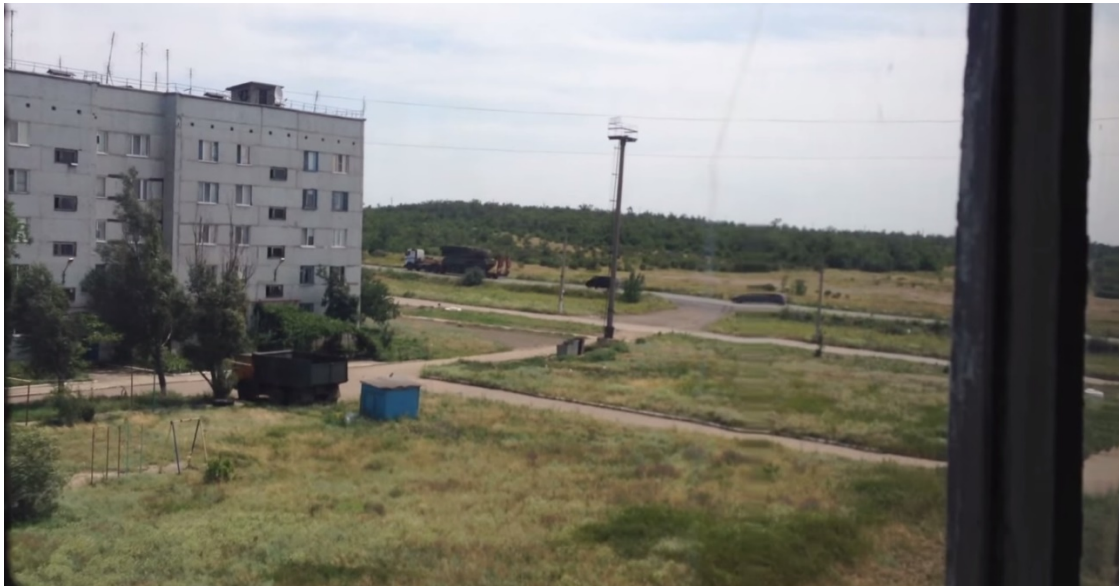
Screenshot from footage filmed in Zuhres, Ukraine, July 17, 2014.

On July 17th [a video](#)⁷ was uploaded to YouTube showing the Buk photographed in Donetsk travelling through the town of Zuhres, approximately [36 kilometers east](#)⁸

along H21 from the location in the Paris Match image. Using information provided with the video, it was [possible to find](#)⁹ the exact location the video was filmed, the H21 motorway running through Zuhres, and to show the Buk missile launcher continued to travel east. It was also claimed in a [now-deleted Tweet](#)¹⁰ that the video was filmed at around 11:40am, although it has not been possible to verify that time with available information. A [tweet posted at 12:41PM](#)¹¹ (Kyiv time) reports that three tanks and a Buk covered in netting passed by Shakhtarsk, a city that lies east of Zuhres and west of Torez, connected by the H21 motorway.

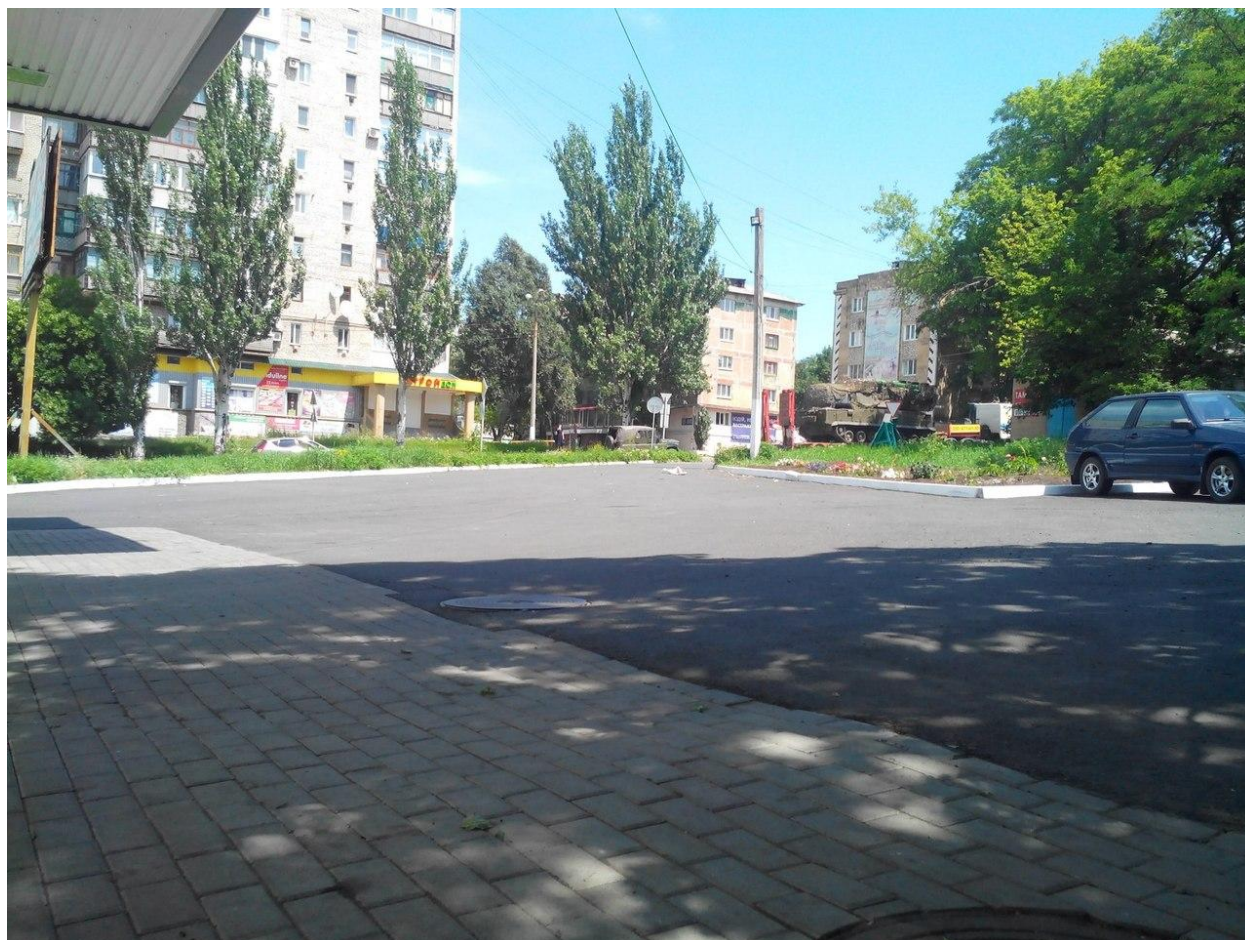
Photograph from Torez, Ukraine, July 17, 2014.

The above image was shared widely during the evening of July 17th. The Bellingcat MH17 investigation team has been unable to find any earlier example of the photograph being shared than a [post made by a user of the Russian social media site VKontakte \(VK\)](#)¹² at 8:09pm (Kyiv time) on July 17th. The investigation team suspects that the image was originally posted in the “[Overheard in Torez](#)”¹³ VKontakte page, but has since been deleted. It was again possible [to find the exact location the photograph was taken](#)¹⁴, and using shadows visible in the image it was estimated the time the photograph was taken was approximately 12:30pm.

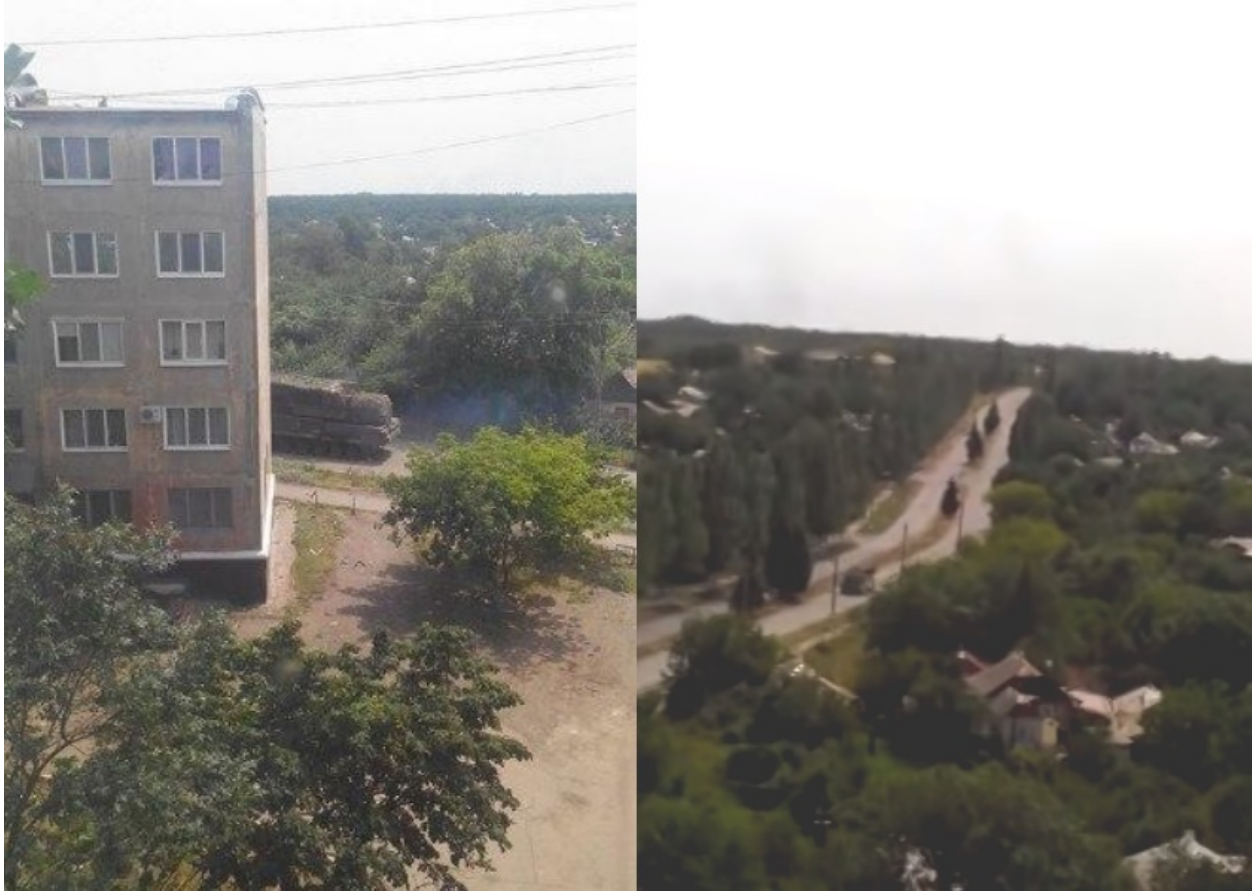
Photograph and screenshot from footage of the Buk missile launcher in Snizhne, Ukraine, July 17, 2014.

A [photograph](#)²² and [video](#)²³ posted on Twitter and YouTube showed a Buk missile launcher in the town of Snizhne. Unlike previous images and video, the Buk was not shown on a low-loader truck, but moving under its own power. The location shown in the video was [precisely located](#)²⁴ and showed the Buk heading south out of Snizhne. The photograph was also [located](#)²⁵ to [13a Karapetyan Street](#)²⁶, less than 1 kilometer

northwest of the location on the video. Based on the shadows in the photograph, the photograph was taken at approximately 1:30PM.

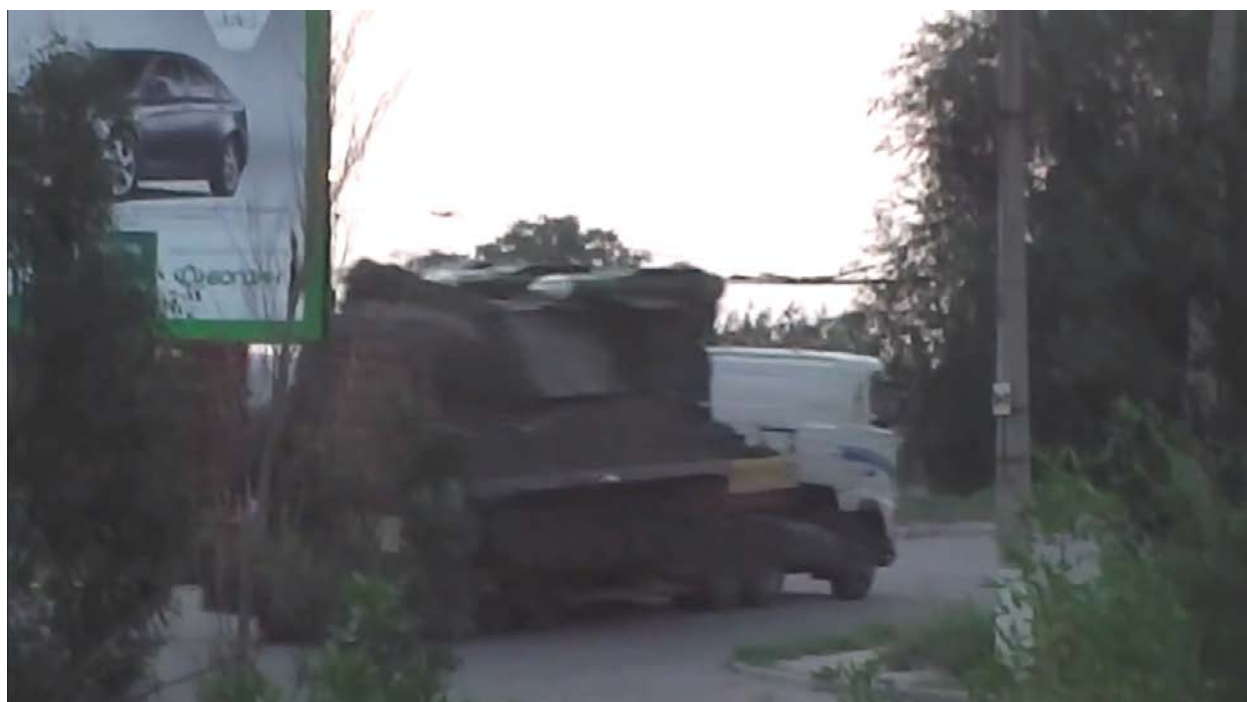
Screenshot from footage filmed in Luhansk, Ukraine, July 17, 2014.

The [final video](#)²⁸ was posted online by the Ukrainian Ministry of Interior on July 18. In this video, the Buk missile launcher is back on the low-loader truck, but is now missing at least one missile. The Russian Ministry of Defence [claimed in a press conference on July 21](#)²⁹ that this video was in fact filmed in Ukrainian government-controlled territory, stating that the “media circulated a video supposedly showing a Buk system being

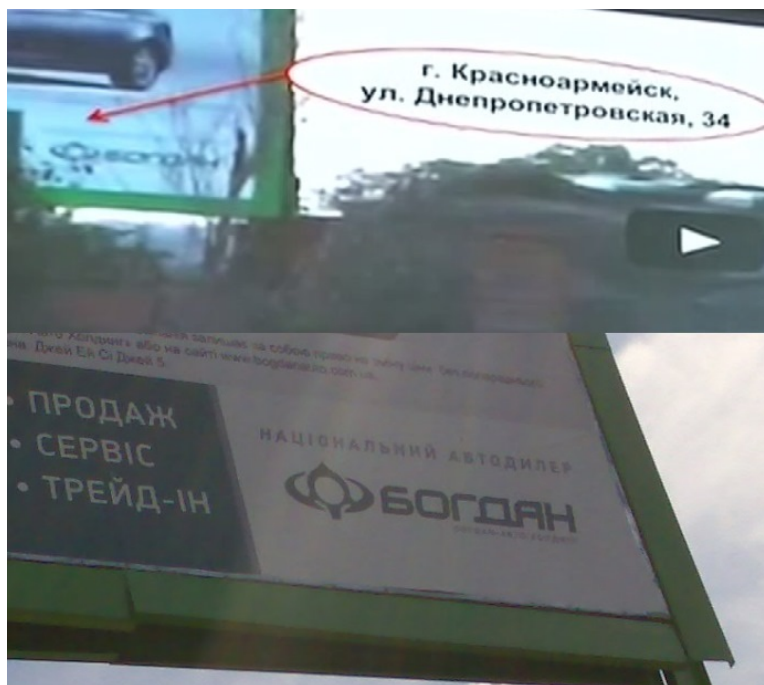
*Top, text on Luhansk billboard, as cited in the Russian Ministry of Defence press conference.
Bottom, photograph of the same billboard taken by a Luhansk resident.*

However, [investigations by Bellingcat](https://www.bellingcat.com/news/uk-and-europe/2014/07/24/caught-in-a-lie-compelling-evidence-russia-lied-about-the-buk-linked-to-mh17/)³⁰ have shown this statement from the Russian Ministry of Defence to be untrue, and it has been possible to find the exact location in the separatist-held area of Luhansk where this video was filmed. While it is not possible to discern the exact time this video was filmed, there are three pieces of evidence that lend credence to the Ukrainian Ministry of Interior’s claim that the video was filmed on the early morning of July 18:

- The video was filmed approximately 75 kilometers north of Snizhne.
- At least one missile is missing from the set of four missiles that the Buk missile launcher is normally armed with. Additionally, the photograph of the Buk missile launcher in Torez shows four missiles, and local witnesses noted that the Buk missile launcher moving through Torez had four missiles.
- The netting visible in the photograph from Torez is absent from the top of the missiles in Luhansk.

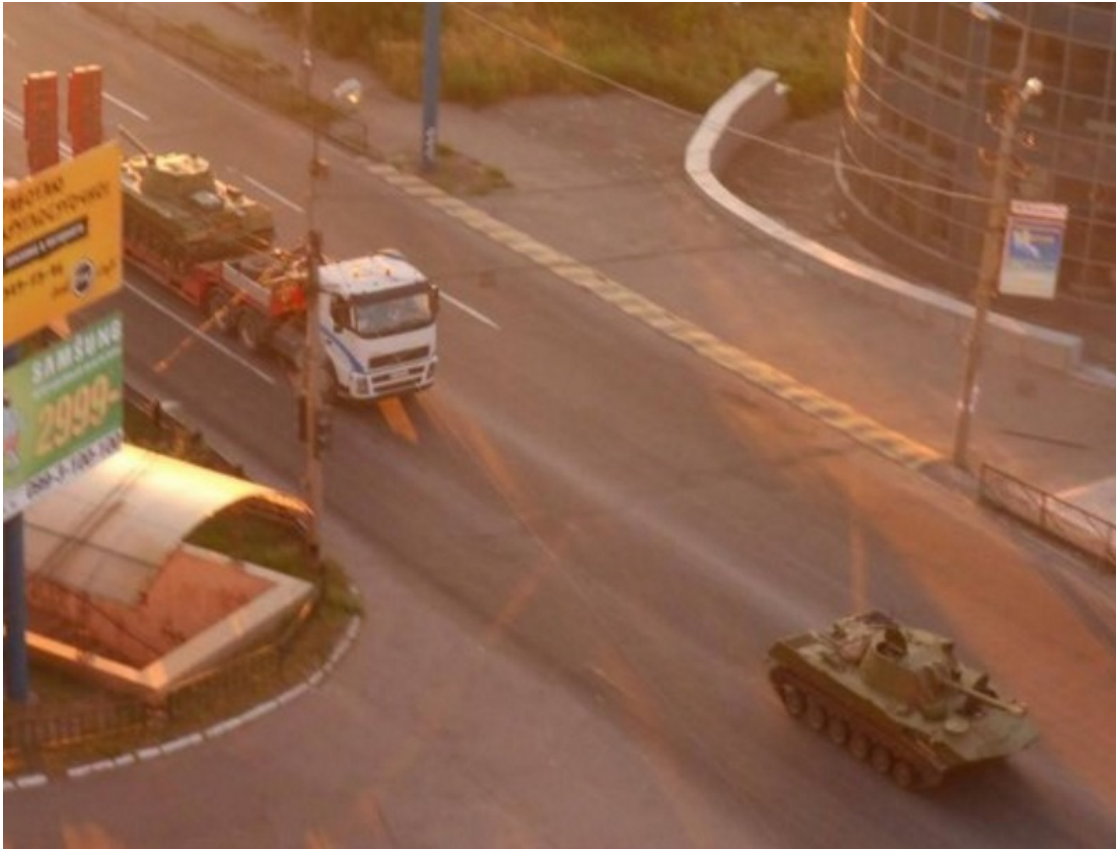
Photograph from Makiivka, Ukraine, published August 6, 2014

On August 6th 2014, [a photograph was shared online](http://informer.lg.ua/?p=18281)³¹ showing the low-loader truck carrying a military vehicle through the town of Makiivka, just east of Donetsk. While the board with the phone number painted onto it was removed, it is still a clear match to the same vehicle used on July 17.

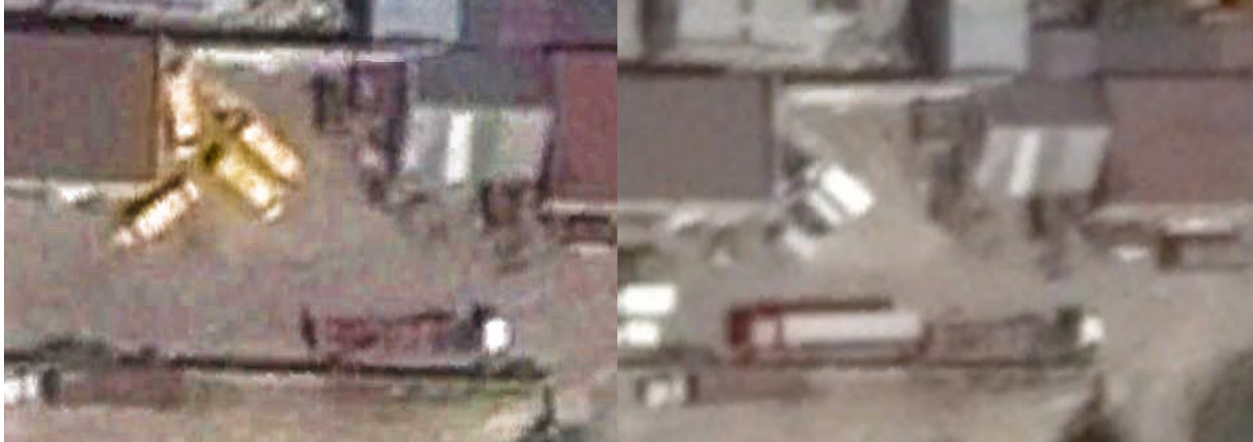
*Left, Google Earth satellite map imagery of the low-loader at vehicle rental site on July 24, 2014
Right, Google Earth satellite map imagery of the low-loader at same location on August 9, 2014*

By examining historical satellite map imagery of the vehicle rental site that the low-loader truck was taken from, it is possible to identify a red low-loader with a white cabin, only one of which is ever present at the site. By comparing satellite map imagery from July 24, 2014 and August 9, 2014, it is clear that the low-loader truck was moved during that period, which would fit with it being used elsewhere on August 6.

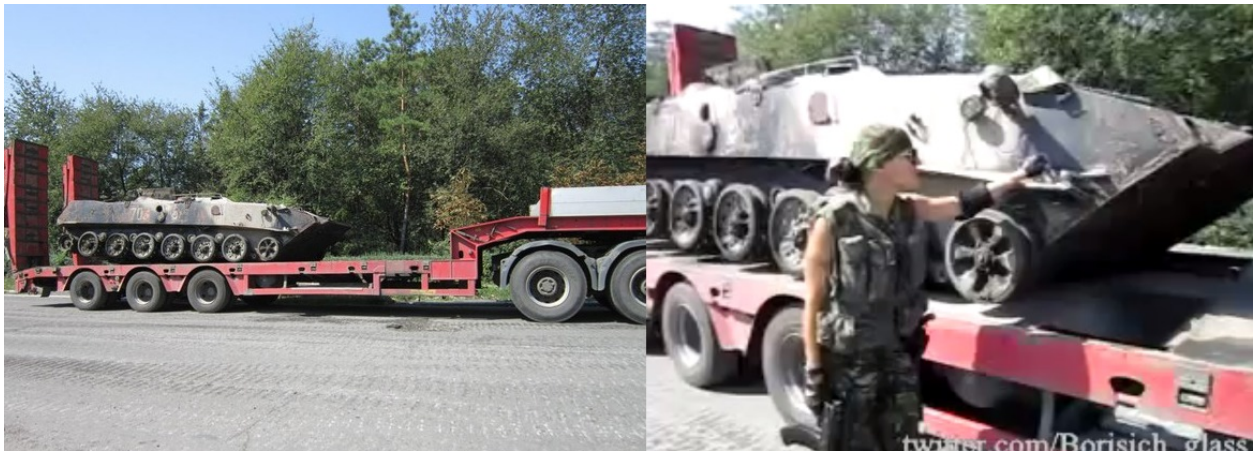
*Left, photograph of the low-loader truck from August 26, 2014.
Right, screenshot from footage of the same low-loader truck filmed by separatists on August 26*

On August 26, 2014 a [photograph](#)³² and [video](#) of an identical low-loader truck were posted online. The video featured a woman who had appeared in previous separatist-filmed videos, and it appears the low-loader truck was being used to transport a damaged vehicle.

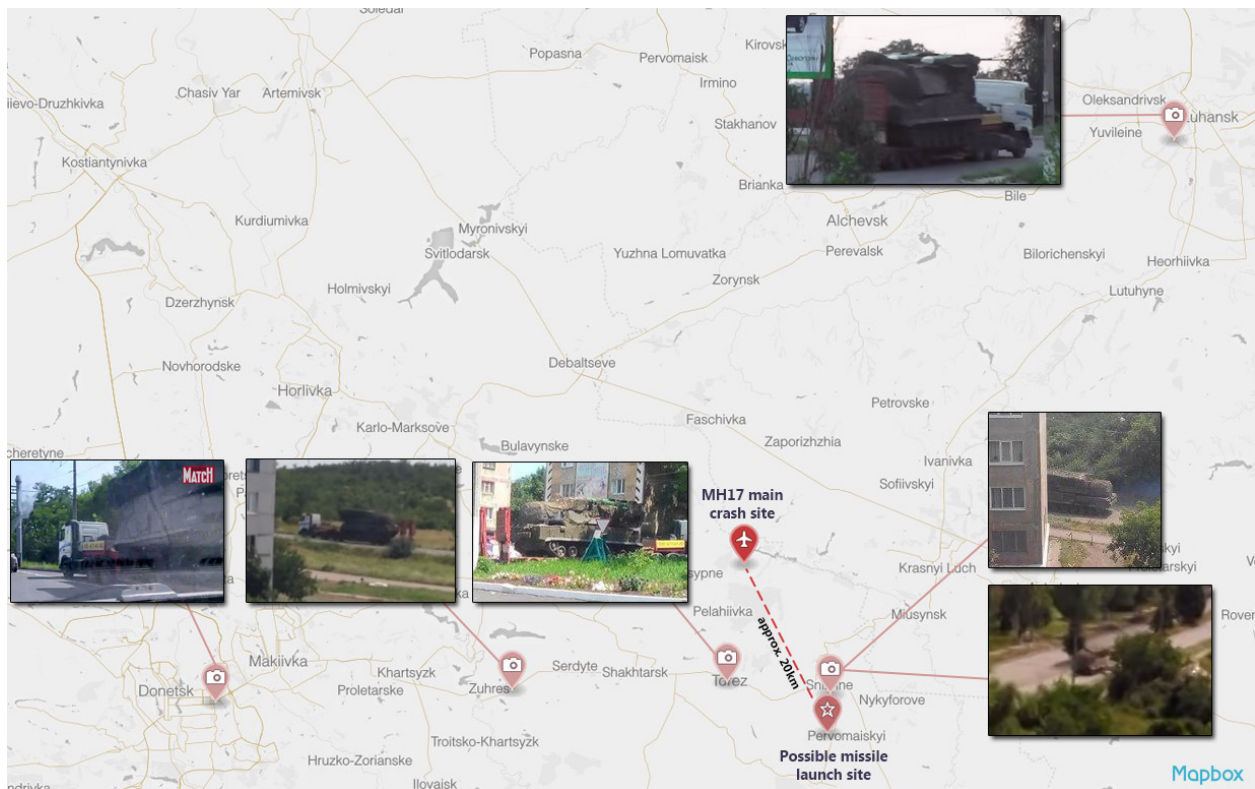
Map of the six sightings of a Buk missile launcher on July 17 and 18 in separatist-controlled territories of eastern Ukraine.

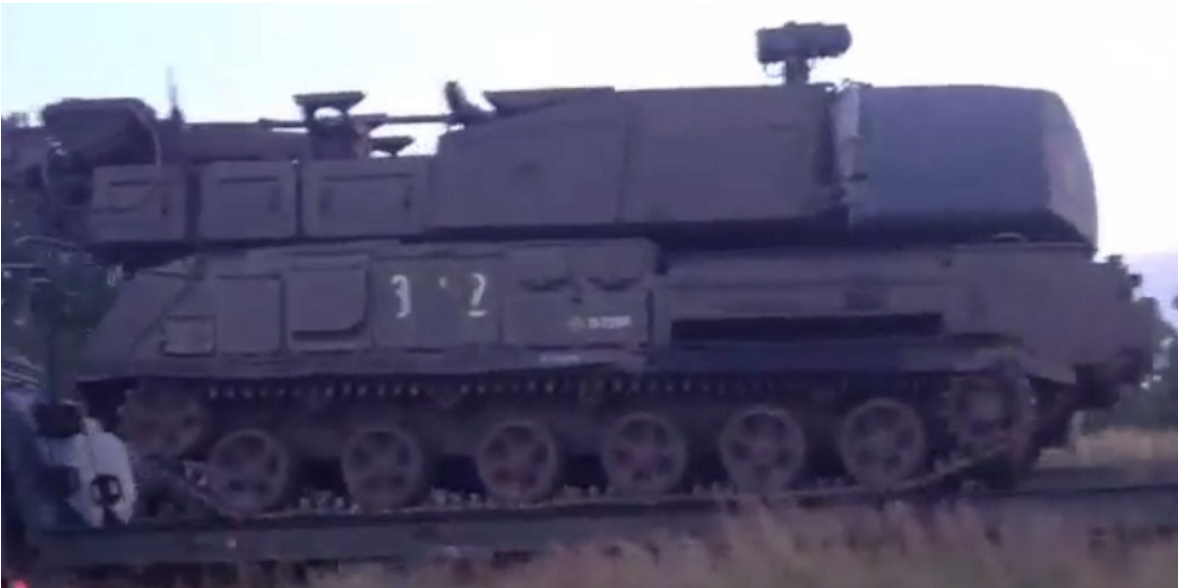
The most important feature of this convoy is the presence of the same Buk missile launcher filmed on July 17th 2014 travelling through separatist territory and linked by some to the downing of MH17. The Bellingcat MH17 investigation team refers to this Buk as "Buk 3x2" as the middle number appears to have been worn off. It appears in 8 of the 16 videos showing the convoy travelling between June 23rd and June 25th, and the Bellingcat MH17 investigation team has been able to match features of the missile launcher in the convoy to those seen on the missile launcher filmed and photographed in Ukraine on July 17th. It is the opinion of the Bellingcat MH17 investigation team that because of these matches the vehicle seen in the convoy and travelling through separatists controlled territory on July 17th is the same vehicle.

A screenshot from footage of Buk 3x2 in Stary Oskol, Russia on June 23, 2014.

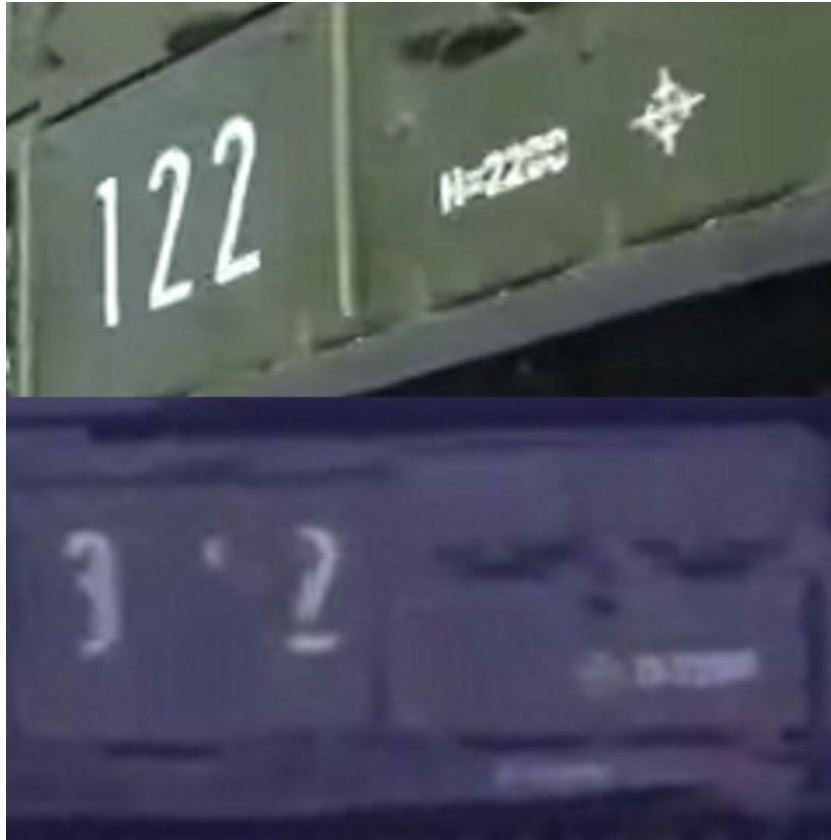
Markings on Buk systems that were part of the June convoy.

The markings on the side of Buk 3x2 consist of the following:

- Unit designation, typically 3 digits
- Transportation-related markings, in this case a circle with a cross in the centre and the marking "H=2200"
- A white mark visible on the side skirt
- Another white mark on the opposite side of the vehicle.

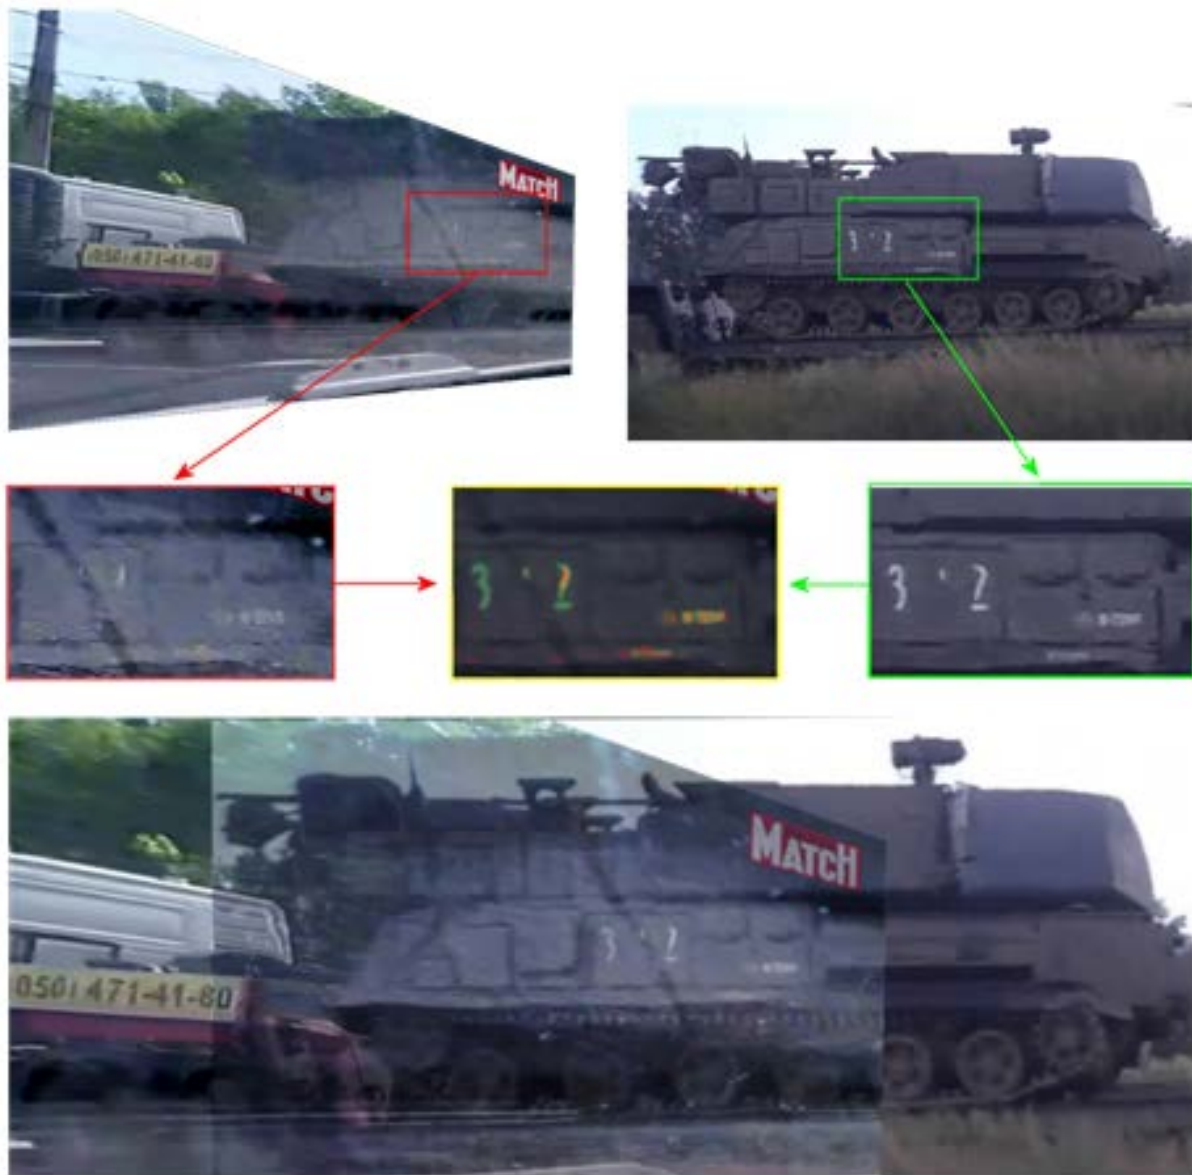
Overlaid comparison between Buk in Paris Match photo in Ukraine and Buk 3x2 in Russia.

It's clear from these images that the positions of the markings match. In addition, the Bellingcat MH17 investigation team has attempted the same type of comparison with other Buk missile launchers from both Ukraine and Russia. No other comparison made by the Bellingcat MH17 investigation team has come close to matching all the matching elements between the images of Buk 3x2 in Russia and the Paris Match Buk.

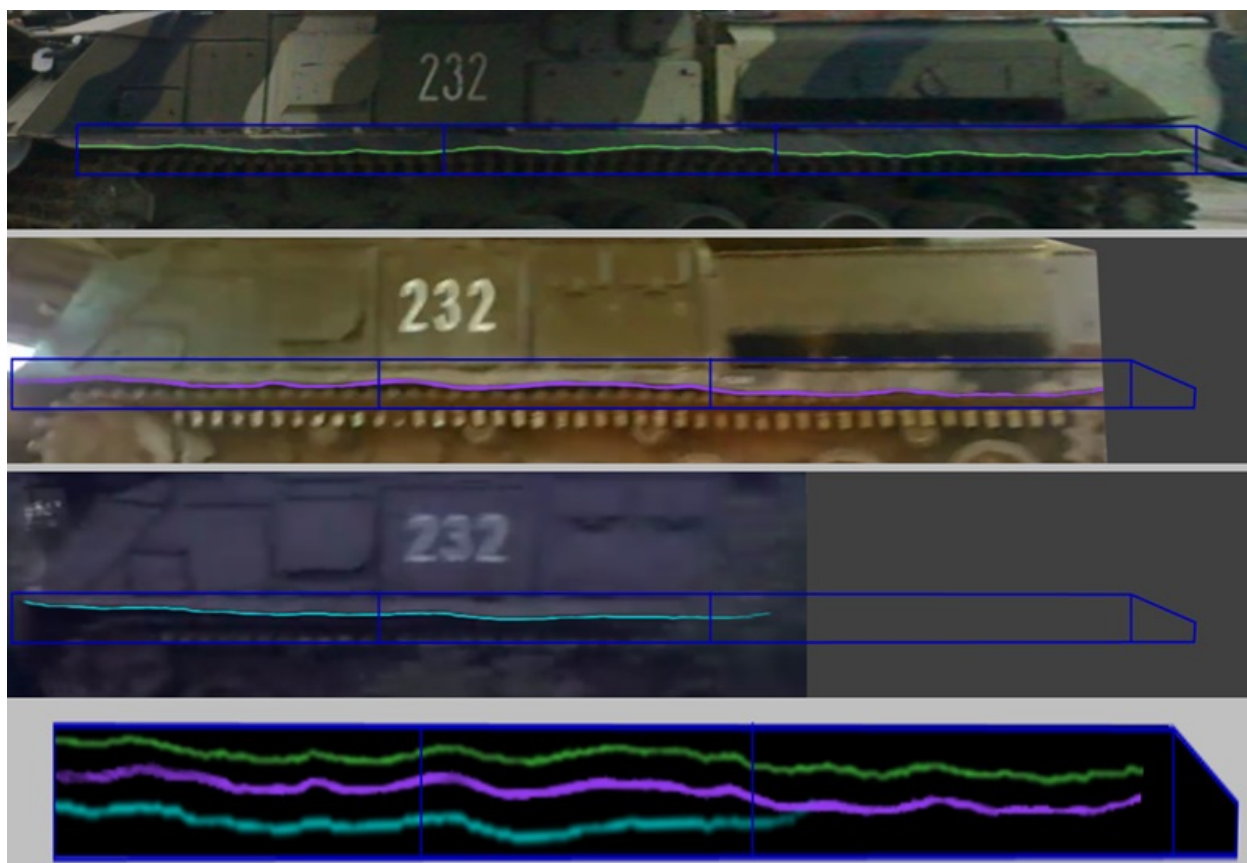
In addition to comparing the markings on the vehicles, the Bellingcat MH17 investigation team was also able to establish a second feature on Buk missile launchers that varies between units: side skirt damage. The side skirt that runs above the tracks of the Buk systems is prone to damage, and this creates a unique pattern of damage we refer to as the "side skirt fingerprint." Below, a Buk that is certainly the same in each photograph shows a high correlation in each side skirt profile.

Top, image dated November 29th 2013.

Middle, image dated June 23rd 2014.

Bottom, image dated June 23rd 2014.

The Bellingcat MH17 investigation team compared the side skirt fingerprints of a number of Buk missile systems in Ukraine and Russia in order to find possible matches to the Buk seen in the Paris Match photograph. In each of the following side skirt fingerprint images, the red line is for the Paris Match Buk.

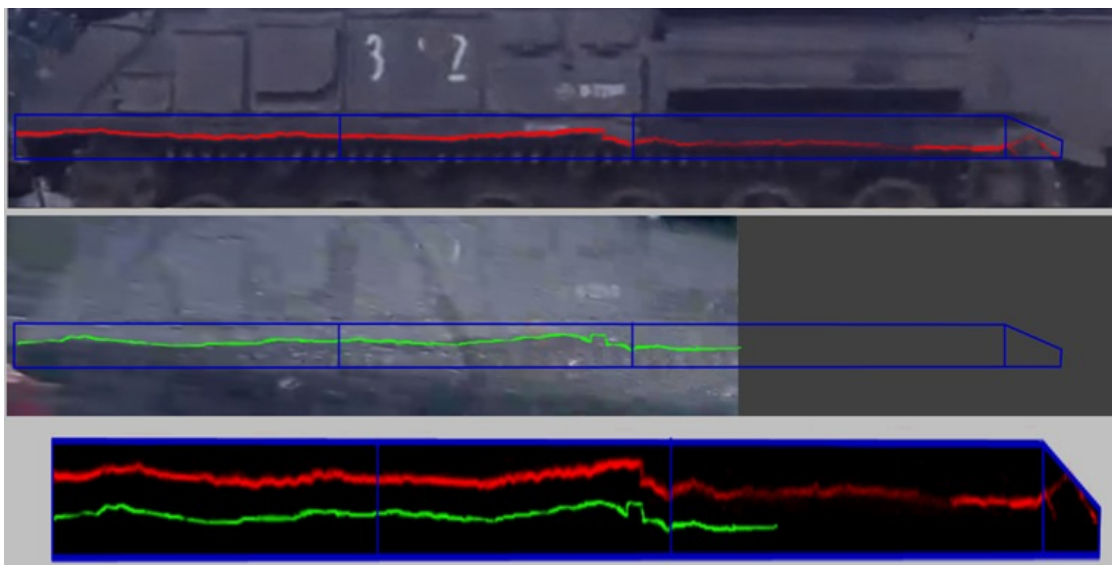
Of these Buks, the side skirt profile with the highest correlation is Buk 3x2 filmed transported near Stary Oskol in June. Many of the other photographs are clearly not matches for the Paris Match Buk, including Buk 312 filmed in Ukraine. Below, another comparison of the side skirt profiles between the two photos shows a similarity that can be seen in both the isolated amplitudes and in the photographs:

*Top: Buk 3x2 filmed in Stary Oskol, Russia in June
Bottom: Buk filmed in Donetsk, Ukraine by Paris Match on July 17, 2014*

However, there is one discrepancy: on the right hand side of the comparison, there is a small but significant difference underneath the transportation-related markings, but this in fact further confirms that these two Buks are one in the same. Because the Paris Match photograph has been flattened, any damage to the side skirt that projects outwards would cause a distortion that would not be visible in any images taken directly side-on to the vehicle, such as the images used to compare the side skirt fingerprints. This means that if there is a difference, that type of damage to the side skirt would have to be visible to account for the difference, and if that damage was visible then it would be further confirmation that it was the same vehicle.

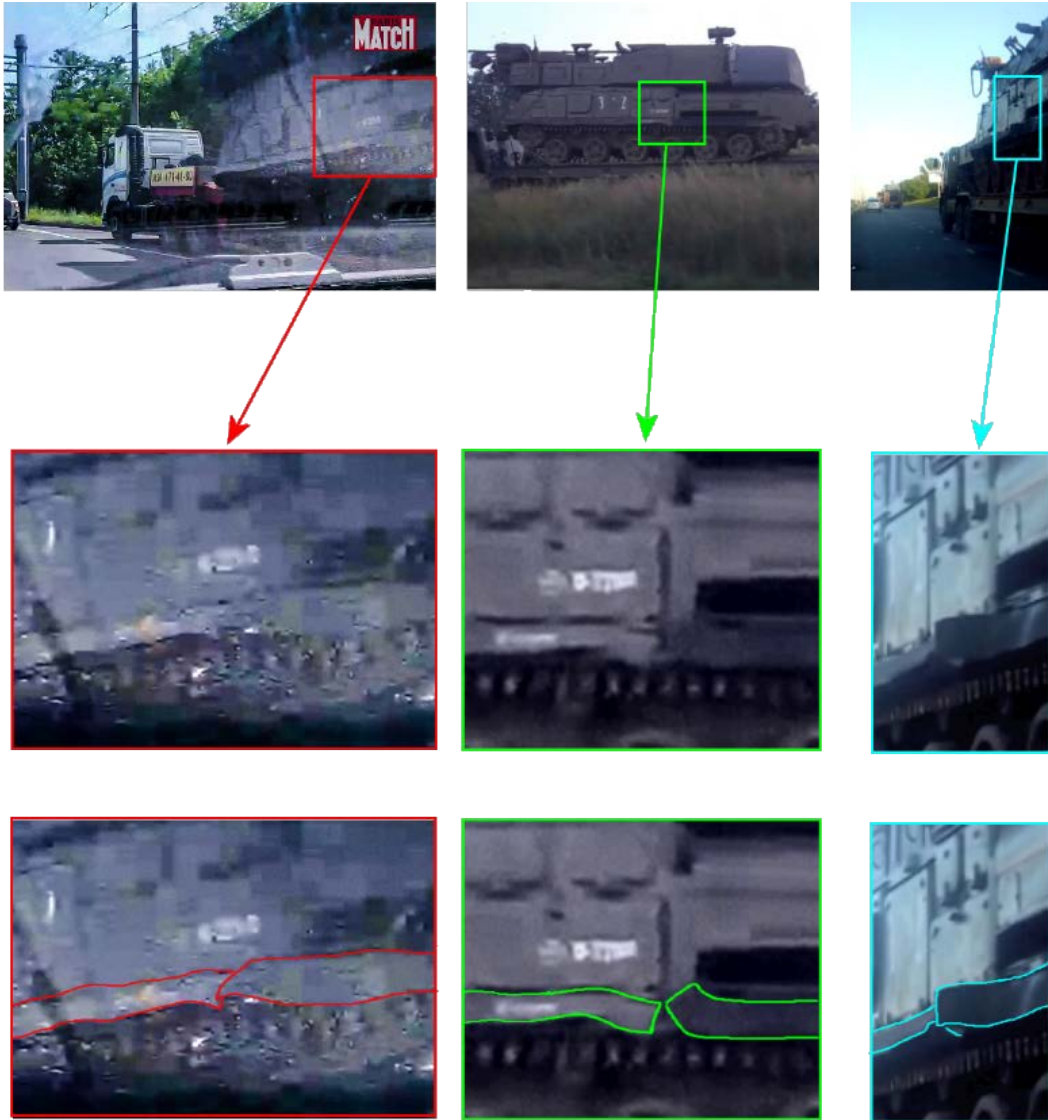
*Left, the Paris Match photograph from Donetsk showing side skirt damage on Buk
 Middle, screenshot from footage in Stary Oskol showing side skirt damage on Buk 3x2
 Right, screenshot from footage in Stary Oskol showing side skirt damage on Buk 3x2.*

This damage is in fact visible in two videos of Buk 3x2 filmed in Russia, one in Stary Oskol (2:02)³⁸ showing the damage from behind, and another from Alexeyevka (0:50)³⁹ showing the same damage from the opposite direction. The damage is in the same position as the discrepancy in the Buk fingerprint from the Paris Match photograph, and further confirms the Buk in the Paris Match photograph is the same vehicle travelling through Russia as part of the 53rd Brigade’s convoy towards the Ukrainian border in late June 2014.

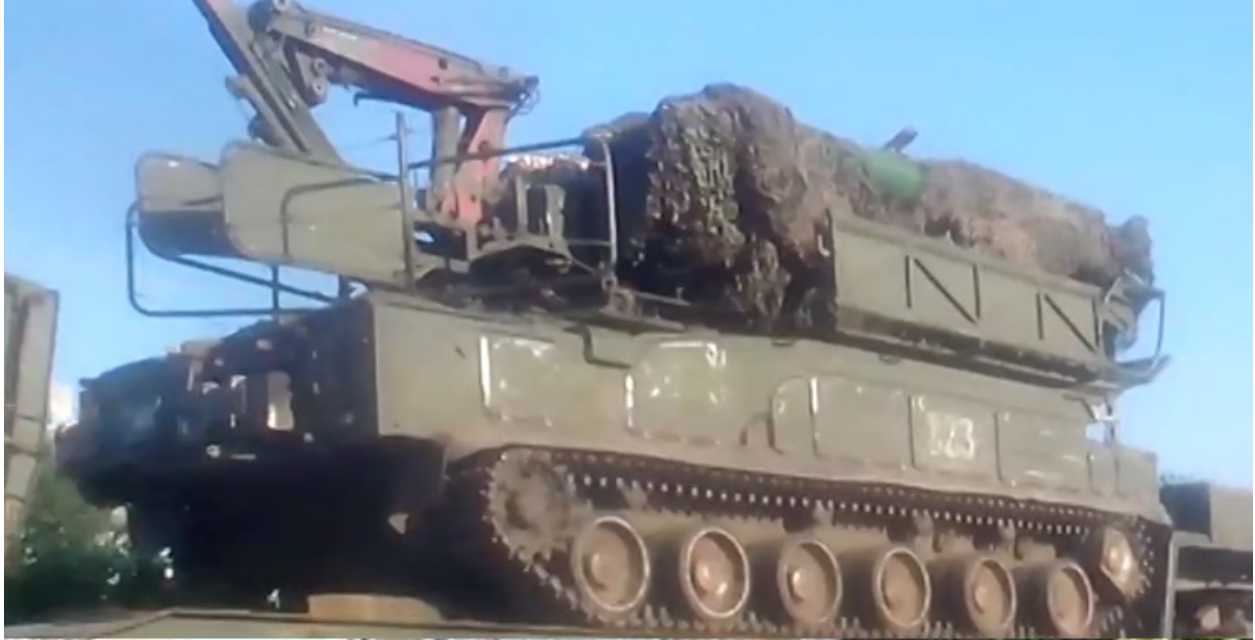
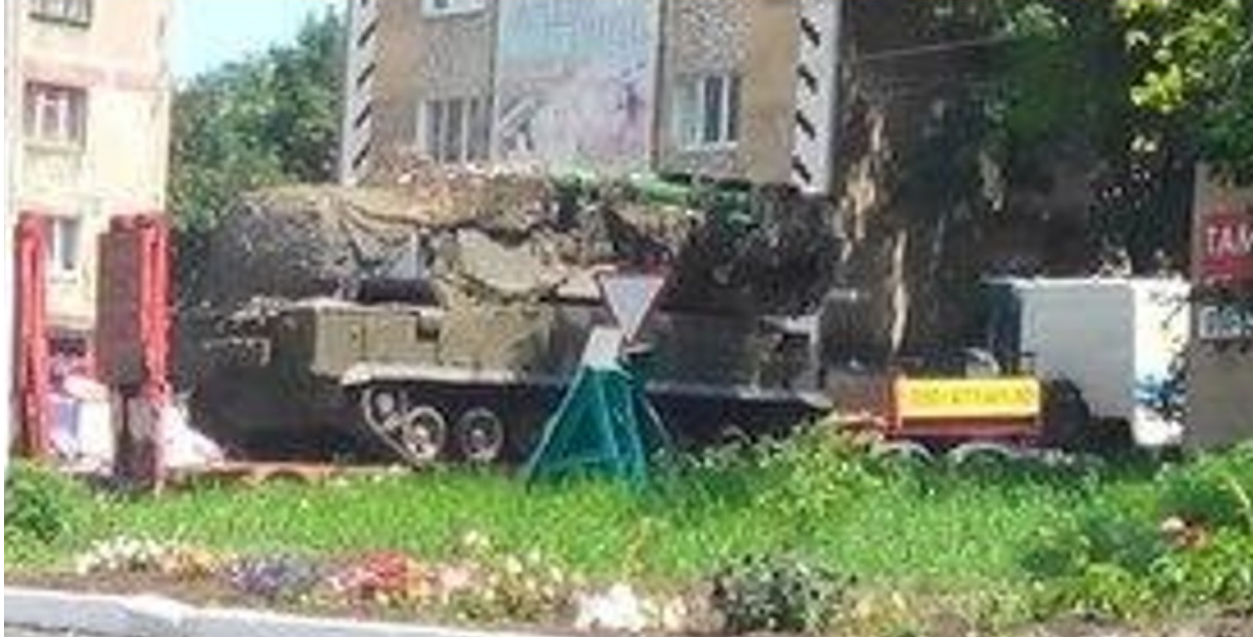
Two differences from the June recordings of the Buk are noticeable. First, the missiles are in different positions, and second, the missiles are covered in camouflage netting. While certainly not in any way conclusive, the Bellingcat MH17 investigation team notes that during their investigation, they have only seen netting used on one other vehicle: the Buk filmed inside Ukraine on July 17th.

*Top, a screenshot from the July 20th video in Kamensk-Shakhtinsky.
Bottom, the photograph of the Buk missile launcher seen in Torez on July 17th.*
