# Study

## ON SEA SEARCH OPERATIONS

Accident on 3 January 2004  
off Sharm el-Sheikh (Egypt)  
to the Boeing 737-300  
registered SU-ZCF  
operated by Flash Airlines

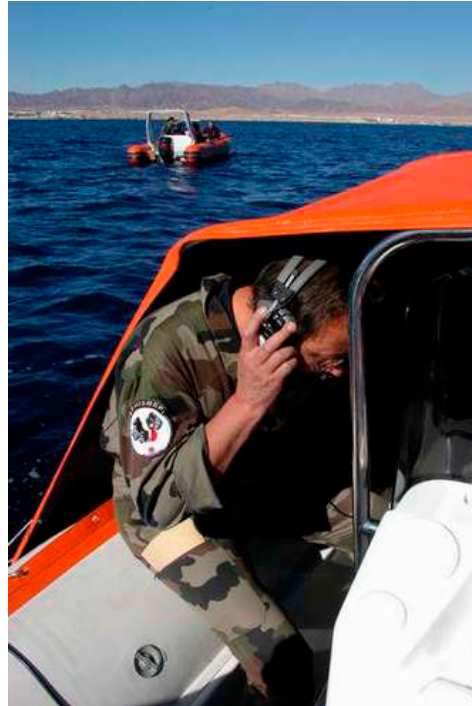
**Figure 3: French Navy listening to signals**

The first stage involved checking for the presence of signals from the beacons and defining an area approximately with the aid of the omnidirectional antenna. The bearing crosschecks made with the directional antenna confirmed transmissions from two beacons. Since the seabed type was relatively unknown, the localization of the beacons was subject to possible reflections of the sound waves transmitted and possible secondary echoes <sup>(4)</sup>.

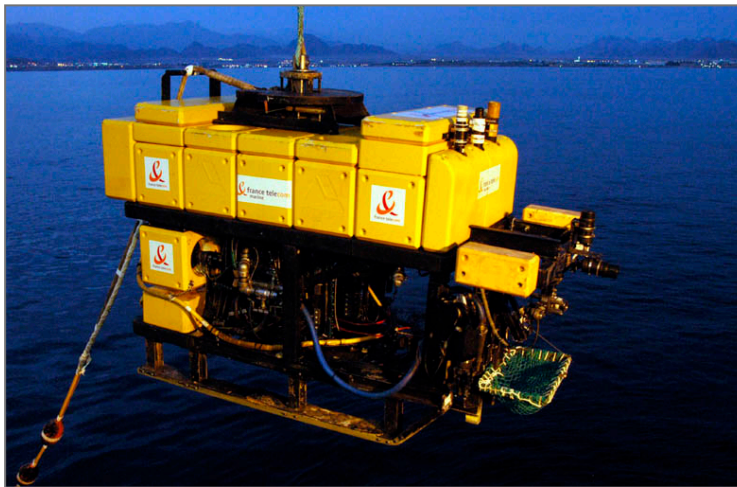
Figure 7: Photo of the Scorpio ROV

- ❑ Dimensions (in metres): length: 2.90 ; width: 1.50 ; height: 2.50
- ❑ Weight: 3.5 tons
- ❑ Maximum operating depth 1,200 m (limited by the length of its umbilical cable)
- ❑ Maximum speed: 2.5 kt
- ❑ Lateral speed: one knot

On the front of the vehicle the jetting tool, originally used for telephone cable work was cut off and replaced with a basket for the recovery of elements. This basket, with a double net, was the right size for the recovery of the recorders.

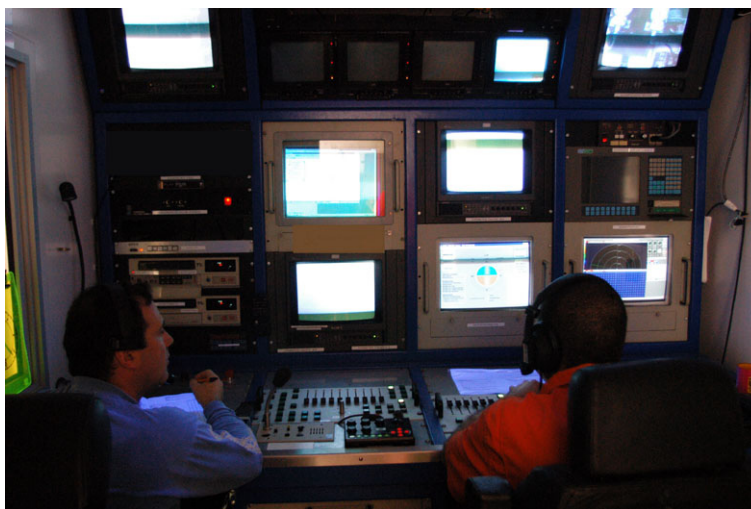
Figure 8: Photo of the control center of the Scorpio

A container equipped with the Scorpio control centre was installed on the deck of the *Ile de Batz* near the drum that rolled out the thousand two hundred metres of ROV umbilical cable. The Scorpio was controlled by two teams of three people working twelve hour shifts.

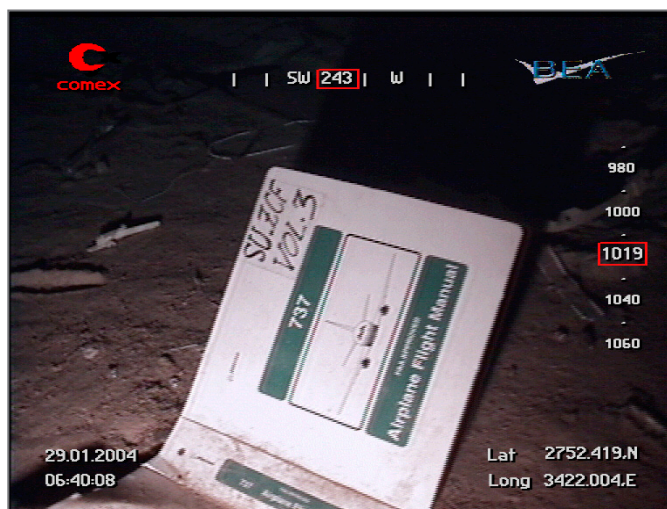
Figure 10: Example of photo taken on the seafloor (one of the airplane's manuals)

The Super Achille's swivelling camera is highly sensitive and can transmit high definition colour images like the one below, taken at a depth of around one thousand metres.

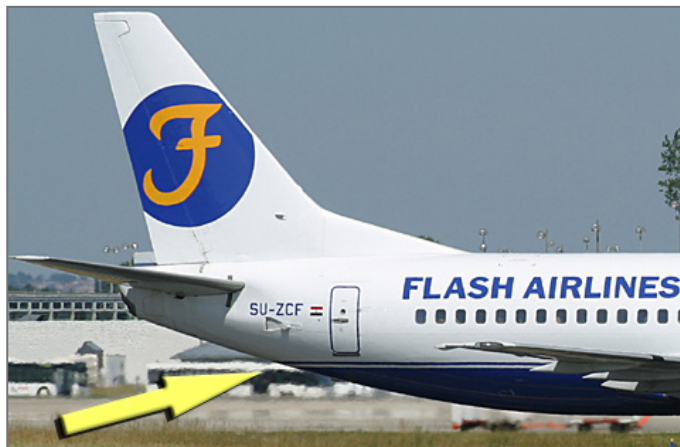
Figure 11: Flight recorder installation area

The recorders are at the rear of the airplane, in the area indicated in the photo.

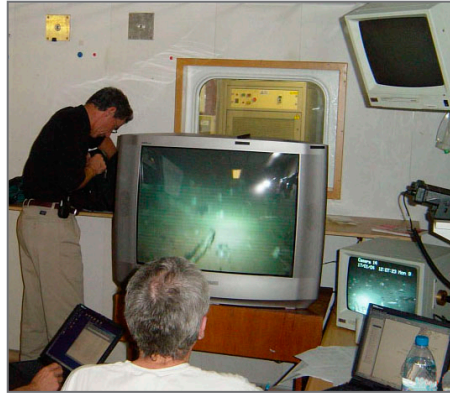
Figure 12: Photo of the work room

The use of a large TV screen connected to the panoramic camera helped in identifying the recorder (see photo). The setup of the work room on board the *Ile de Batz* and the consequent simplified coordination were determining factors in the rapid discovery of recorders.

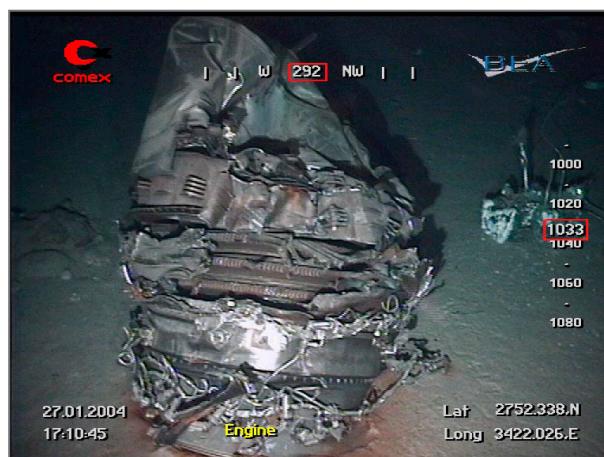
Figure 13: Photo of an engine

During these operations, it was important to have aviation specialists to coordinate these searches and identify the wreckage. The dives by the *Scorpio* and *Super Achille* were filmed. On board the *Ile de Batz*, the work room was equipped with a VHS recoder, which allowed some dives to be reviewed, especially during maintenance operations. The *Super Achille*'s video system, which recorded images in a digital format, could also take digital photos of some elements that were thought to be interesting to chart and examine (engines) with inset of parameters such as the coordinates, the depth, the date, time and the bearing on the photo (see figure 13).

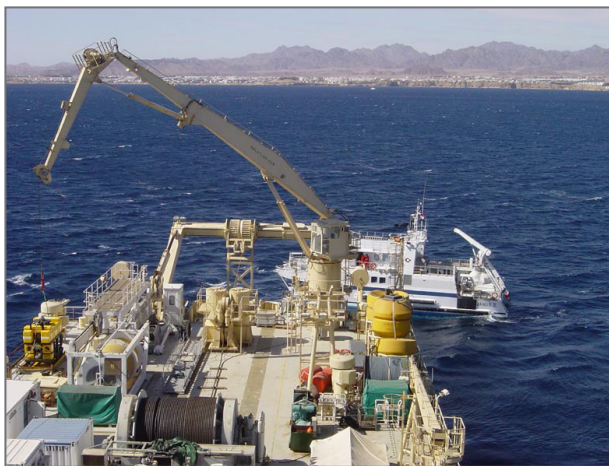
Figure 15: Two ships undertaking dynamic positioning work

In addition to mapping of the seafloor and the direct recovery of parts using its arm, the *Super Achille* was also able to raise wreckage weighing several tons with the aid of lift cables from the surface. Different line ends adapted to each situation were used: the ROV was able to work with a lasso, a cable, a hook, etc.

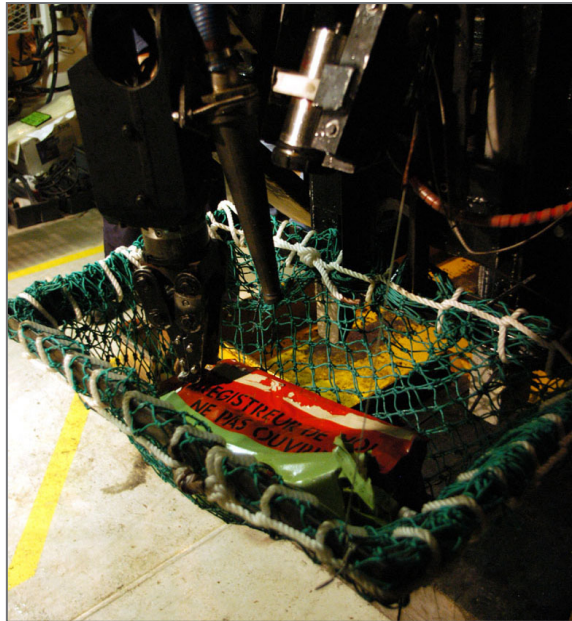
**Recovery of the FDR**

- ❑ 2 h 00 Presence of the Egyptian judicial authorities in the context of the international judicial commission and the commission of inquiry for the ROV surfacing with the FDR in its basket.
- ❑ Official handover of the FDR by the BEA to the Egyptian commission of Inquiry in the port of Sharm el-Sheikh via the judicial authorities.

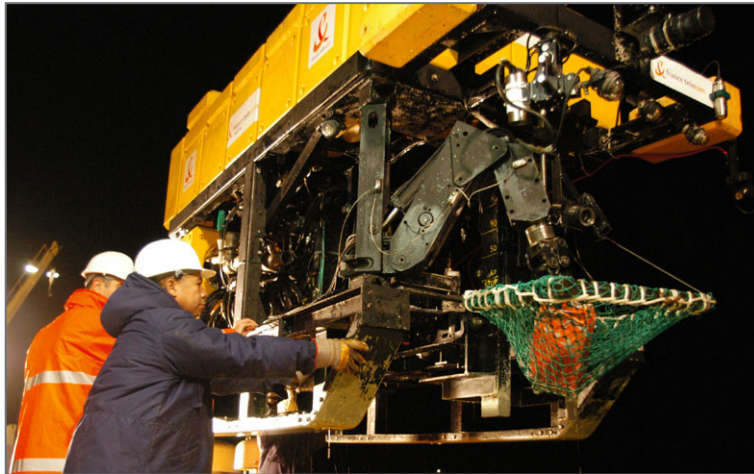
**Raising the CVR**

- ❑ 4 h 30: ROV with the CVR in its basket on the deck of the *Ile de Batz* in the presence of the Egyptian and French authorities (commission of inquiry and judicial authorities).
- ❑ Distribution of search zones of between the *Ile de Batz* and the *Janus II*.
- ❑ Collision involving the *Janus II* and a ship from the Egyptian Navy (consequences: examinations, repairs and Veritas agreement).
- ❑ Current measurement from the *Beautemps-Beaupré* over 24 hours from 9 h 30
  - Observation of the vertical structure of the current at a fixed point (27°52.7' N / 034°21.6' E)
- ❑ Test dive by Super Achille to 1,014 m (adjustment of lighting and controls)

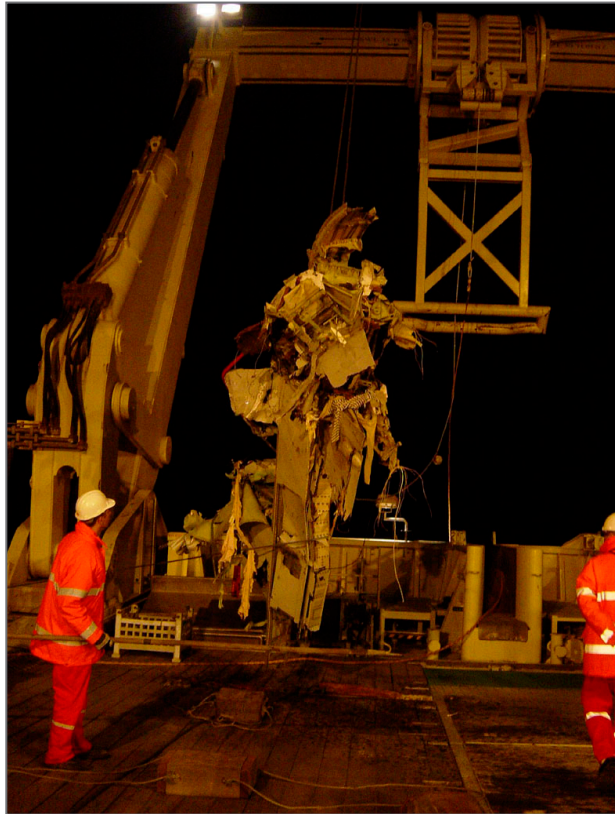
- ❑ Port of Sharm el-Sheikh closed due to sandstorm, no ferries between the port and the *Ile de Batz* (wind around forty knots).
- ❑ Recovery of six parts (RW4 → RW9) raised by the *Ile de Batz* (large basket).
- ❑ Beginning of joint operation by the *Janus II* and the *Ile de Batz* to raise a part of the horizontal stabiliser (four metres long, reference photo T87).

**Raising a part of the horizontal stabilizer**

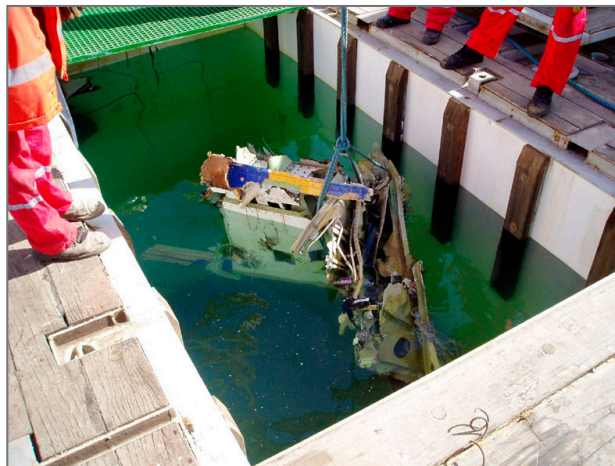
**Conservation of the part in tanks of seawater**

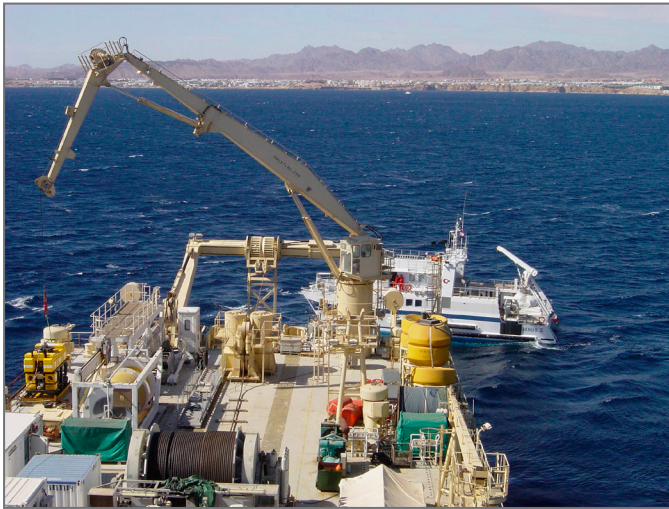
**Two ships working in close proximity**

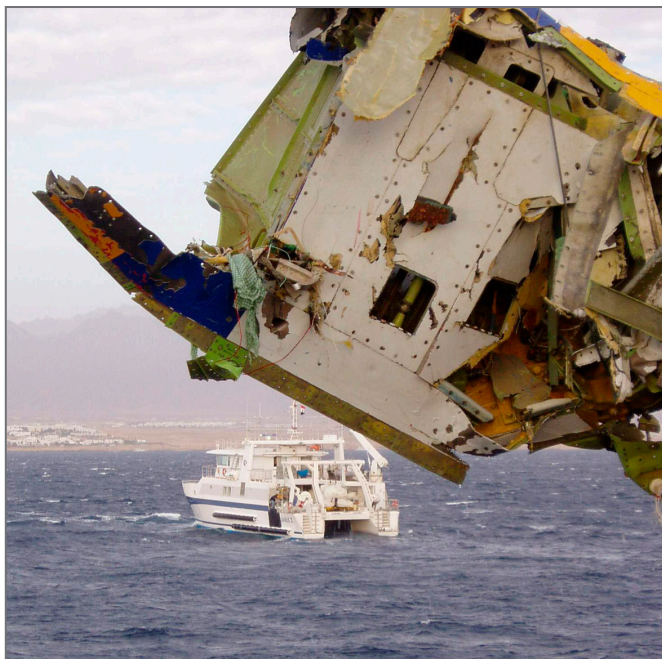
- ☐ Preparation of the equipment required to raise the tail (weights, acoustic beacon, hook, line end, etc.)
- ☐ Continuation of the recovery of part of the tail;
  - operation taken over by the Super Achille, using a line end equipped with a cable to attach the part.
- ☐ Transfer of parts raised by the Super Achille and the *Janus II* to the *Ile de Batz* (referencing and conservation of wreckage).

**Recovery of the tail**

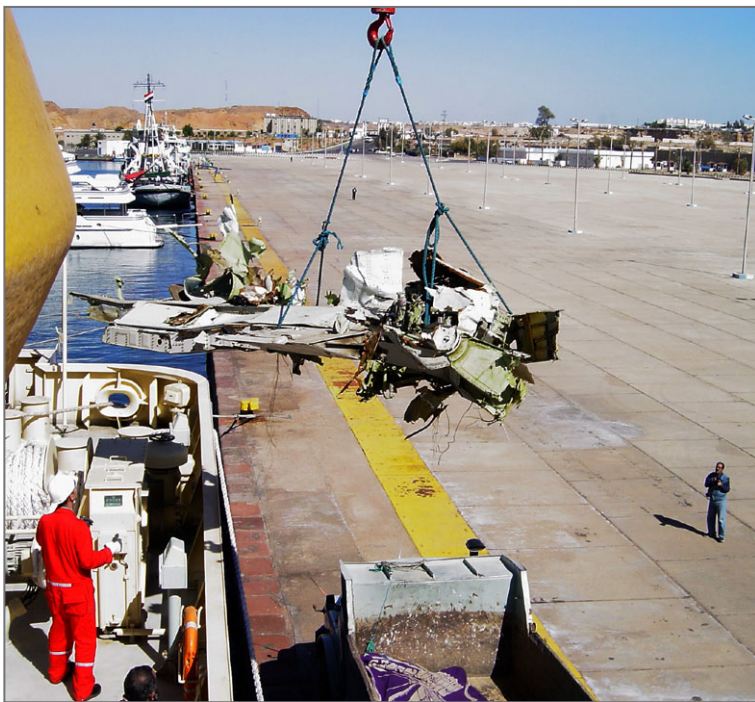
**Unloading operations**

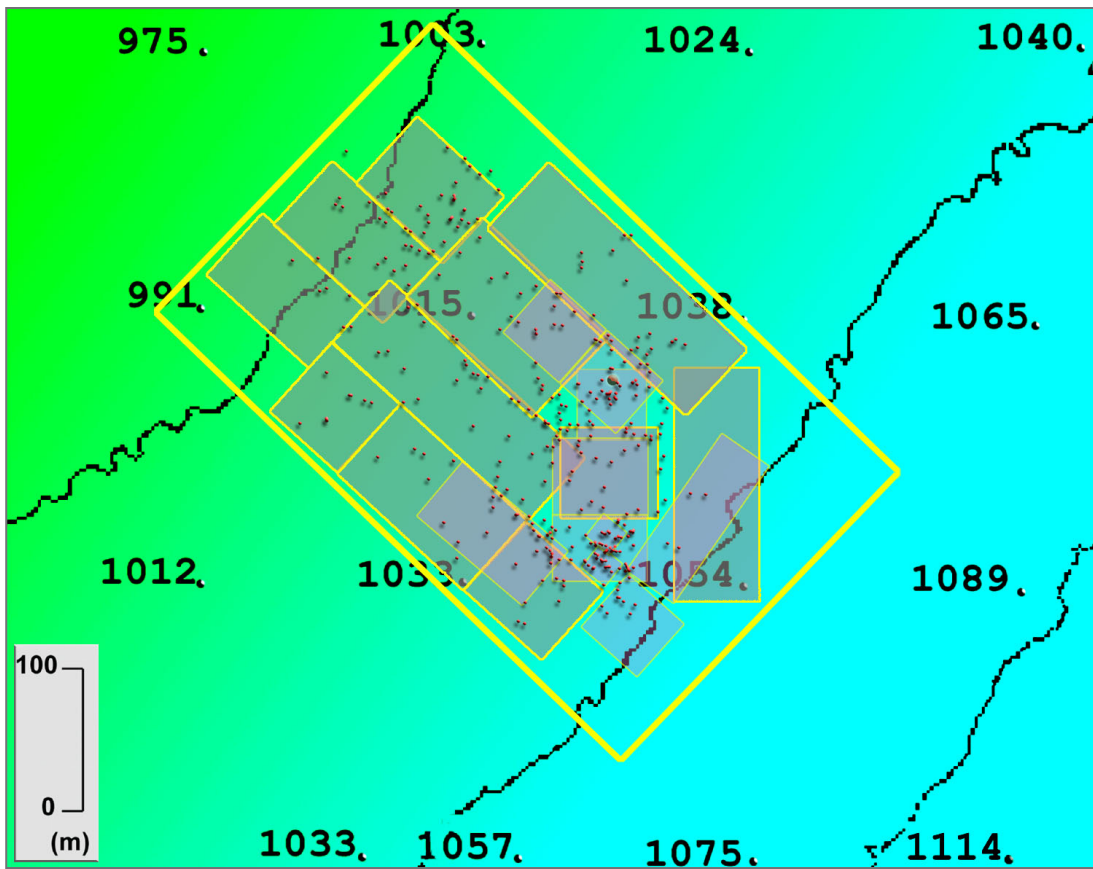
### Limits of the site

- The site represented a rectangle 275 m by 440 m and an area of around 121,000 m<sup>2</sup>.
