2. Damage caused by the earthquake and tsunami hitting Fukushima NPSs

(1) Seismic ground motion and tsunami height observed at Fukushima Dai-ichi NPS

(2) Seismic ground motion and tsunami observed at Fukushima Dai-ni NPS

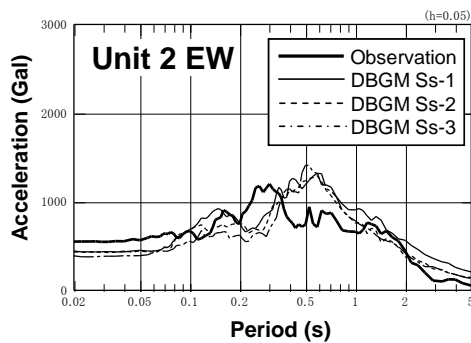
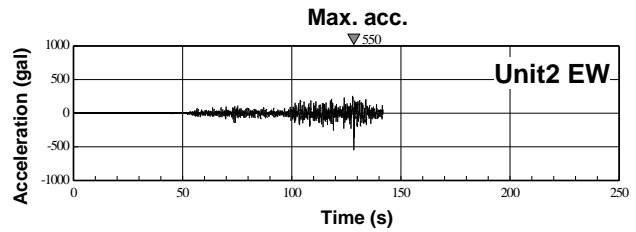
Fig. III-2-2(a) Acceleration seismogram on the base mat at R/B in Unit-2 at Fukushima Dai-ichi NPS.

Table III-2-1 shows the list of maximum acceleration of seismic ground motion observed in three components (east-west, north-south and vertical) at the base mat level of the reactor buildings. Maximum acceleration in horizontal direction was 550 Gal at Unit 2 (east-west) and that in vertical direction was 302 Gal at Unit 2.

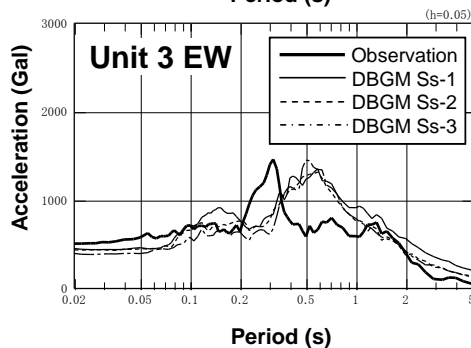
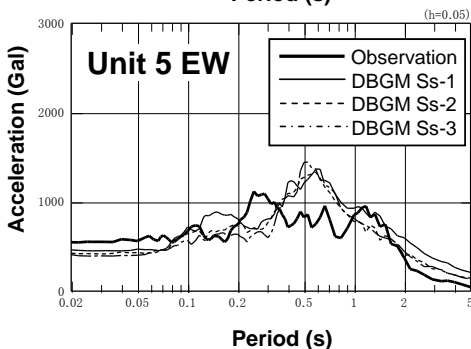
Fig. III-2-2(b) Response spectra on the base mats at R/Bs at Fukushima Dai-ichi NPS.

Table III-2-1 also shows maximum response acceleration to the standard seismic ground motion S_s at the site where seismometers were installed at the base mat level on the first

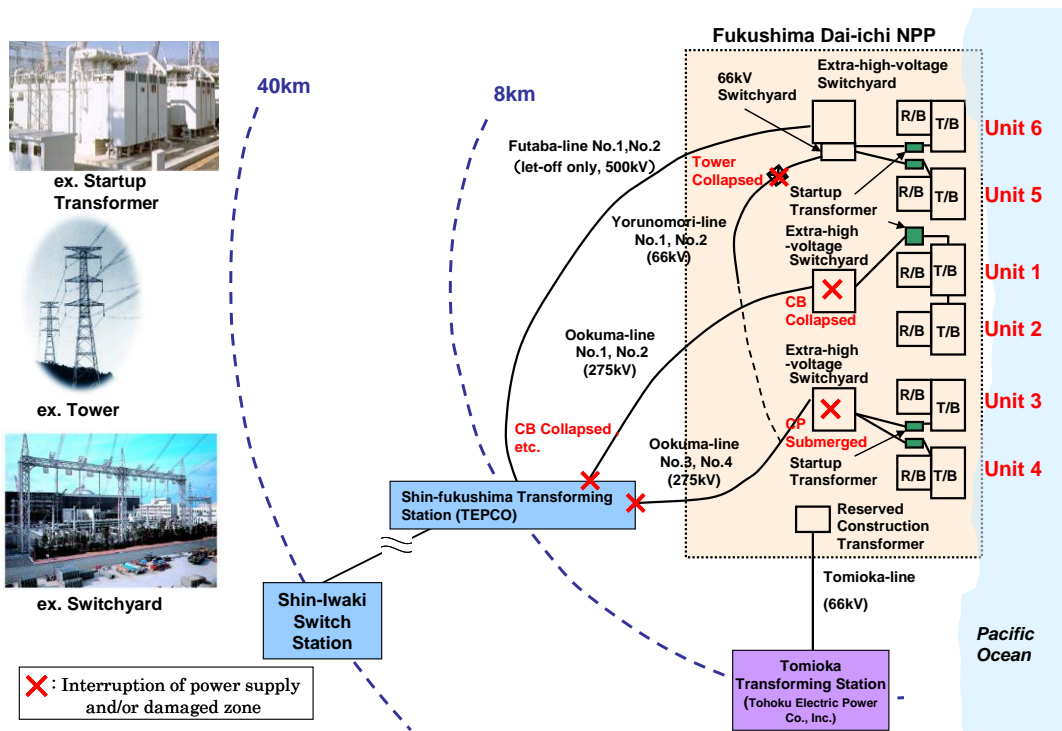
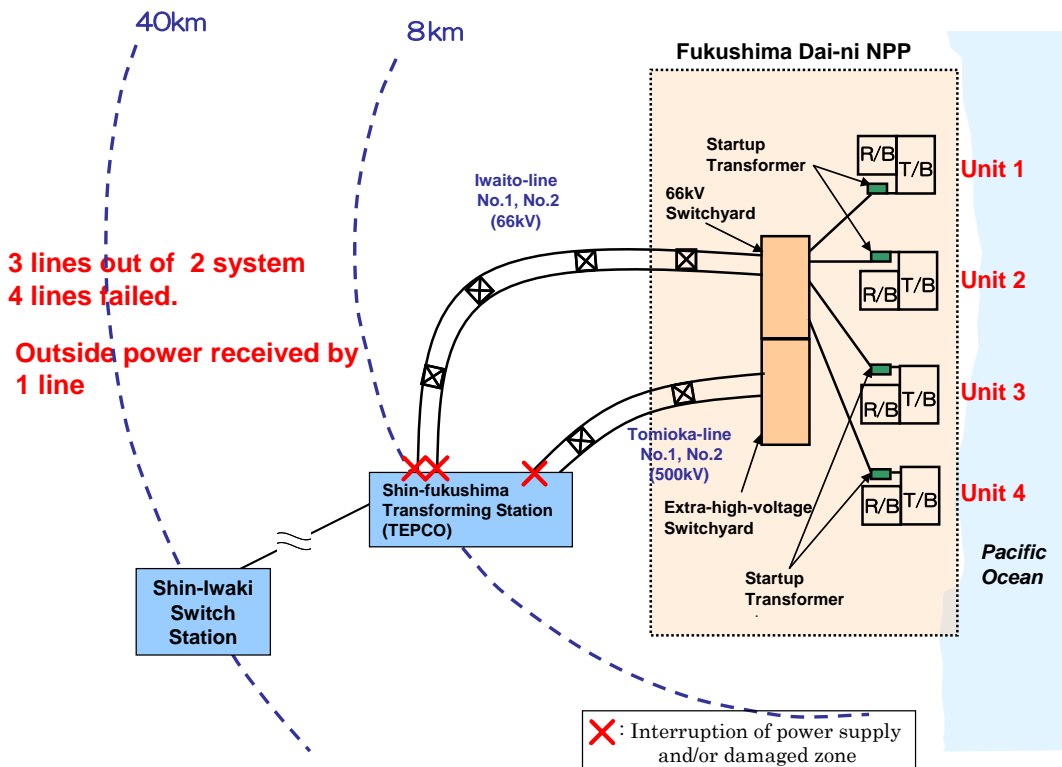
Fig. III-2-8(a) Damage of external power supply systems for the Fukushima Dai-ichi and Dai-ni NPSs (1).

Figures III-2-8(a) and III-2-8(b) show the transmission network of external power supply of Fukushima Dai-ichi NPS and the damage situation. As shown in the Figures, the Okuma Nos. 1 and 2 power transmission lines (275 kV) from Shin Fukushima Power Substation connected to the normal high voltage switchboards of Units 1 and 2 via the switchyards for Units 1 and 2, and in addition, TEPCO nuclear line (66 kV) from Tohoku Electric Power Co., Inc. connected to the normal high voltage switchboard of Unit 1 via

The earthquake caused damage to the breakers of the switchyards of Units 1 and 2. As to TEPCO nuclear line (66 kV) from Tohoku Electric Power, although it's not possible to estimate the cause, cables were damaged. Concerning Units 3 and 4, in addition to the Okuma No. 3 transmission line under construction, the breakers of Nos. 3 and 4 transmission lines on the side of Shin Fukushima Power Substation failed. In addition, about Units 5 and 6, one transmission line tower (No. 27 tower) connecting to the switchyards of Units 5 and 6 was collapsed. So, as a result, although damage caused by tsunami was not clear, all external power supplies of Units 1 to 6 were lost.

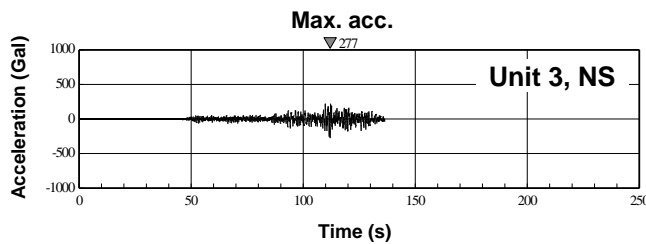
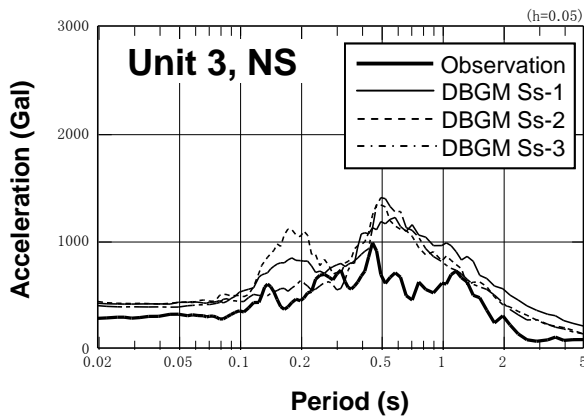
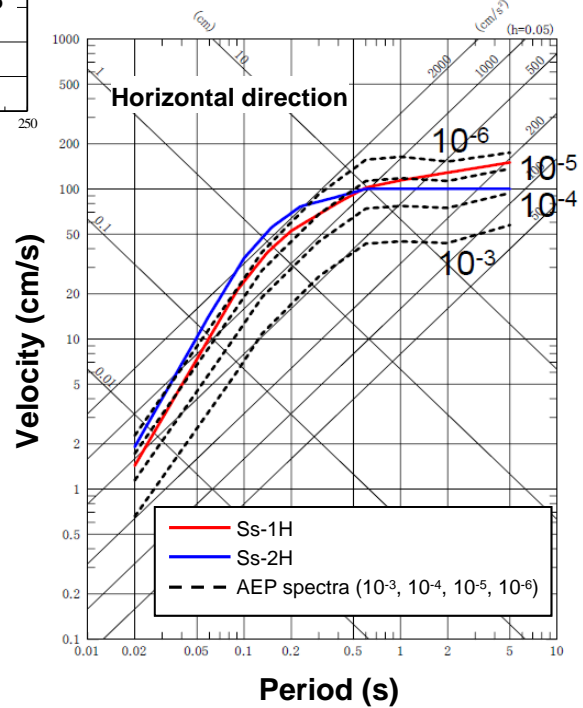
Fig. III-2-9 Acceleration seismogram and response spectra on the base mat at R/B in Unit-3 at the Fukushima Dai-ni NPS.

Figure III-2-9 shows the acceleration time history and the response spectra of observed seismic ground motion at the base mat level of the reactor building of Unit 3 whose acceleration in horizontal direction was highest. The figure also shows the response spectra on the base mat level inputting the standard seismic ground motion Ss into the base mat.
