THIS IS A REFORMATTED VERSION OF
THE ORIGINAL APPENDICES TO THE
REPORT ON
ACCIDENT TO
VISCOUNT 803 AIRCRAFT EI-AOM
NEAR TUSKAR ROCK, CO. WEXFORD
ON 24th MARCH, 1968
APPENDICES TO THE REPORT ON AN INVESTIGATION
MADE UNDER REGULATION 7 OF THE
AIR NAVIGATION (INVESTIGATION OF ACCIDENTS)
REGULATIONS, 1957 (S.I. No. 19 of 1957)

Appendix 1

"OPERATION TUSKAR"

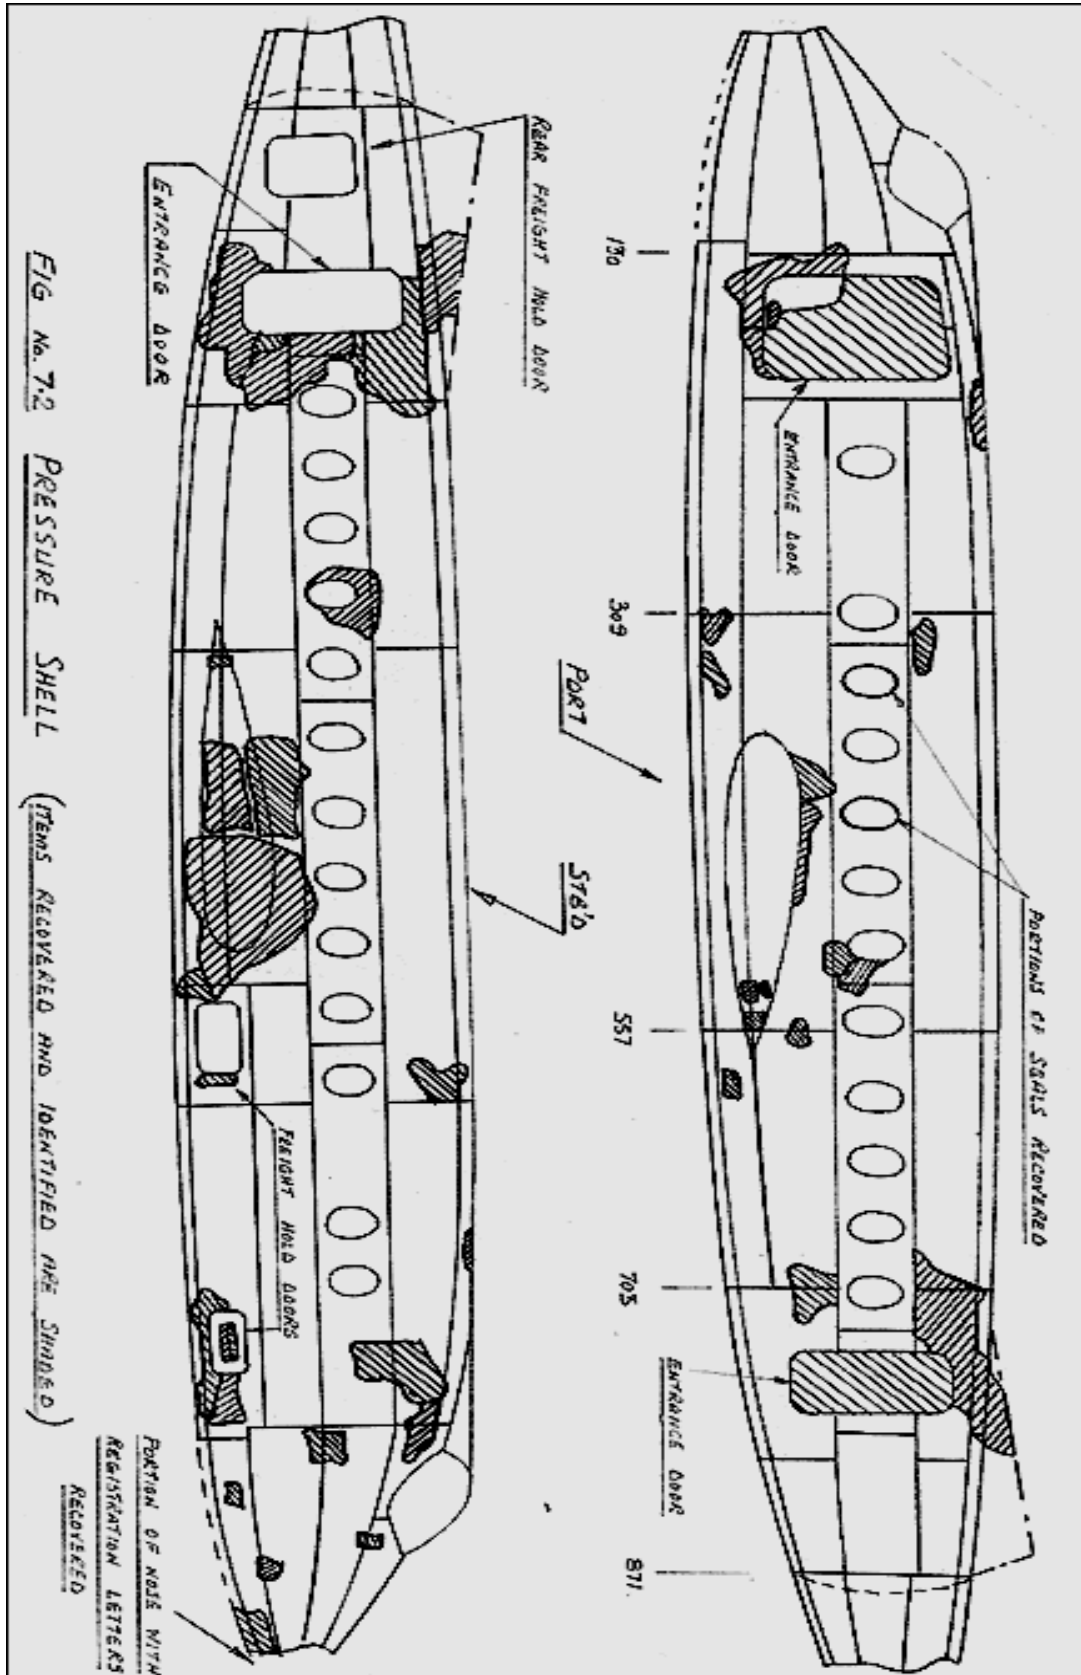
Fig 7.2 Pressure Shell (Items recovered and identified are shaded)

The fuselage pressure shell was severely fragmented and about 15% of it was recovered. The location and approximate size of the identified pieces are shown diagrammatically in Fig. 7.2. About 140 small pieces of skin stringers and frames were identified as from the pressure shell but were not placed.

Windows Items recovered: 3 pieces of perspex from the window panels, seals from the third and fifth window port side, the window surround structure illustrated in Fig. 7.2. and a few other pieces of surround structure not related to any particular window. No evidence was found of any defect or failure having been present before the crash.

Frames Items recovered: Most of the main spar frame and trailing edge member pick-up frame, lower portions of the leading edge frame, a portion of frame 132 above the pressure bulkhead on the port side, about sixteen unplaced short lengths of typical light frame, and the segments of frame which are still generally attached to the recovered skin items shown in Fig. 7.2. Altogether this makes up at 15% of the total frame structure.

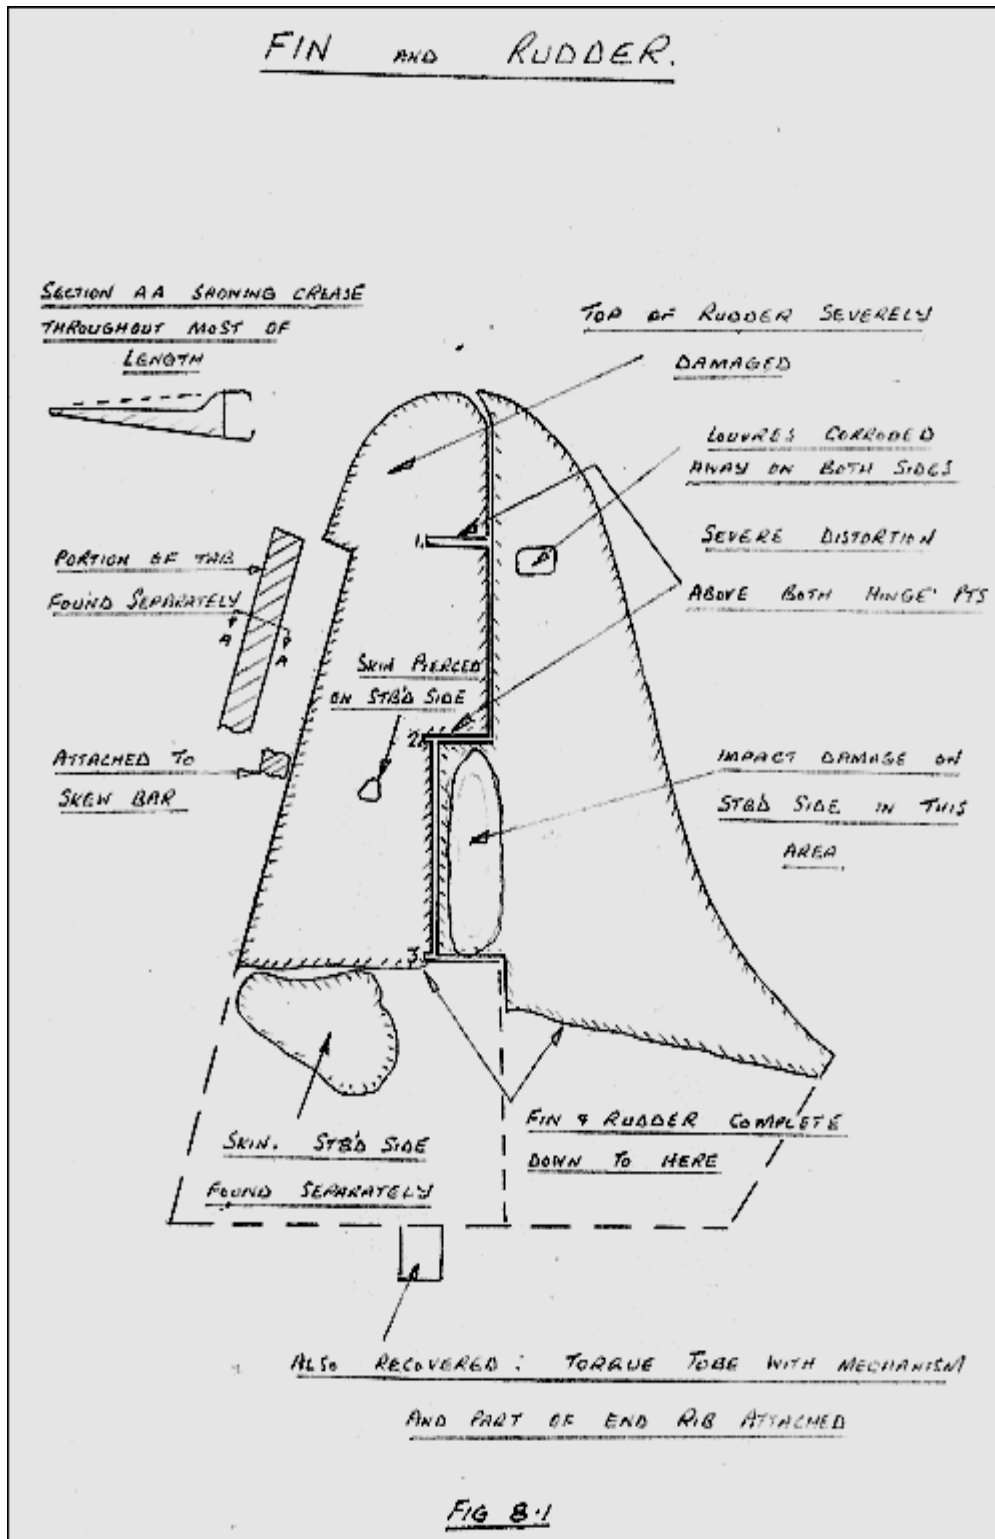
Fig 8.1

The rudder torque tube is dealt with as part of the flying control runs and the pertinent damage to the rudder and fin structure is illustrated on Fig. 8.1.

The upper portion of the tab was recovered separately, it had parted from the upper hinge spigot and was broken above the skew bar. The port side of the tab was creased along its length as shown in Fig. 8.1. A short length of tab was still attached to the skew bar and the fractured surfaces on this were severely mangled.

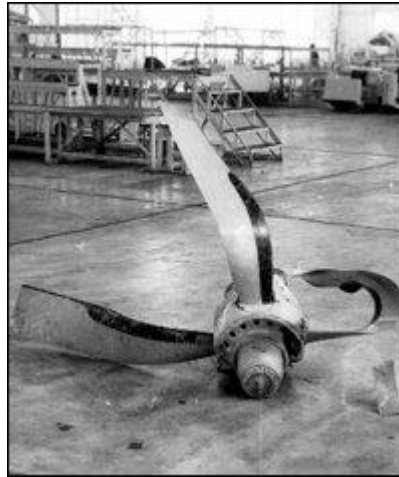
Plate 4

- 4.1.1 No. 2 Propeller with the whole of the reduction gear attached (Ref. Plate 4) was recovered from the main wreckage area approximately four months after the accident. The condition of the reduction gear and casings was very similar to those of propeller No. 1 and likewise it was not possible to establish whether the propeller had broken away from the engine at impact.

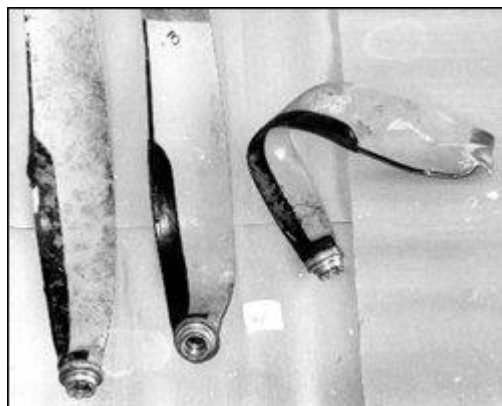
Plate 5

- 4.1.2 Blades Nos. 2, 3 and 4 were retained in the hub, but blade No. 1 was detached and was recovered approximately five months after the accident.
- 4.1.3 The three blades retained in the hub showed similar damage to those of propeller No. 1, namely general characteristics of axial bending into the pressure face with associated chordal fine pitch twisting, Ref. Plate 5.

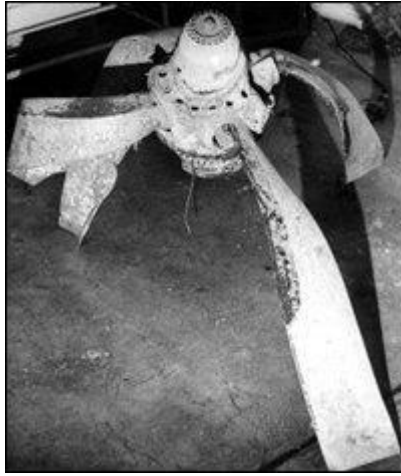
Plate 6

5.1.1 No. 3 propeller with part of the engine reduction gear attached, Ref. Plate 6, was recovered from the main wreckage area approximately seventeen months after the accident. All the magnesium parts of the reduction gear casing had completely corroded away as with No. 1 propeller and likewise it was not possible to establish whether the propeller had broken away from the engine at impact.

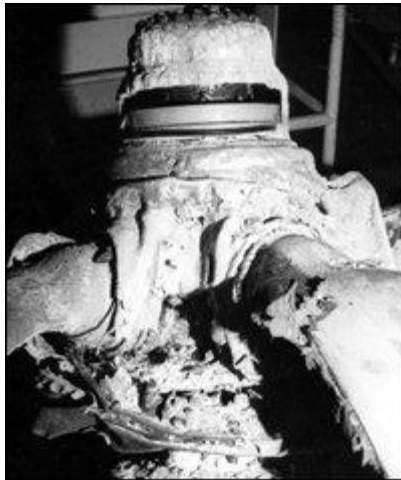
Plate 7

5.1.3 The spinner front shell was detached from the centre section and was not recovered. The centre section was locally severely crushed in the region of Nos. 3 and 4 hub arms, Ref. Plate 7, and was relatively undamaged in the region of No. 1 hub arm.

5.1.4 Some of the aluminium alloy components of the propeller operating mechanism had been affected by salt water corrosion, the main operating cylinder being the most severely affected with a large section of the barrel having corroded away, Ref. Plate 7. Locally in this region of the cylinder there was also evidence of longitudinal cracks.
