Chapter 1 Summary of recommendations and opinions issued in 2018

The recommendations and safety recommendations issued by the Japan Transport Safety Board in 2018 are summarized as follows.

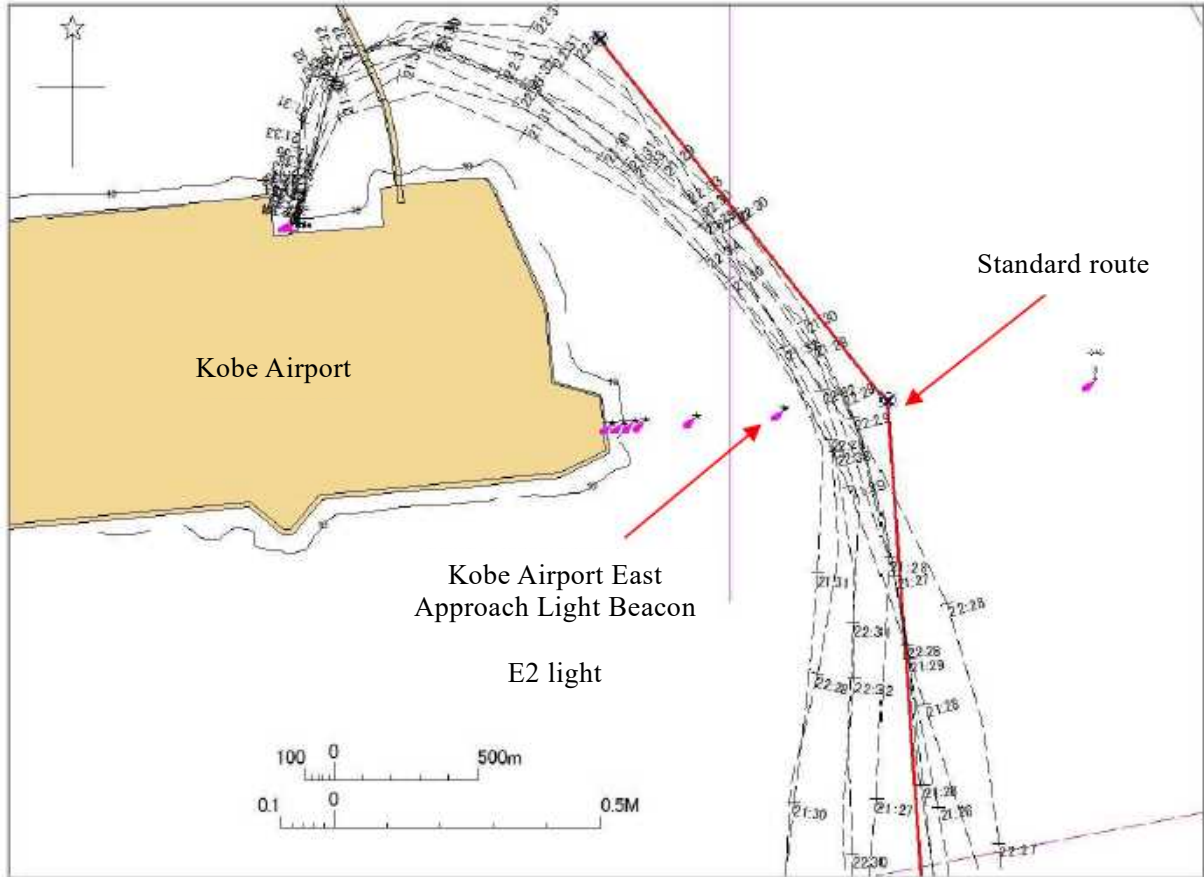
Annex Figure: Navigation Tracks (Nighttime, October 9 to 18, 2018)

Although OM Kobe Co., Ltd. implemented various measures to prevent recurrence after the accident, given that, when navigation routes were investigated following the accident, it was found that vessels are navigating near the Kobe Airport East Approach Light Beacon, it is probable that safety education and training on the importance of navigating on the standard route whenever possible were not sufficiently provided.

- (1) The importance of lookout that includes appropriate use of navigation equipment
- (2) The importance of sharing information on navigational safety among crew members
- (3) The importance of safe operation that includes use of equipment that aids for preventing grounding (collision)
- (4) The importance of conducting appropriate ship maneuvering, including recognizing the safety of navigating on standard routes and navigating on standard routes whenever possible

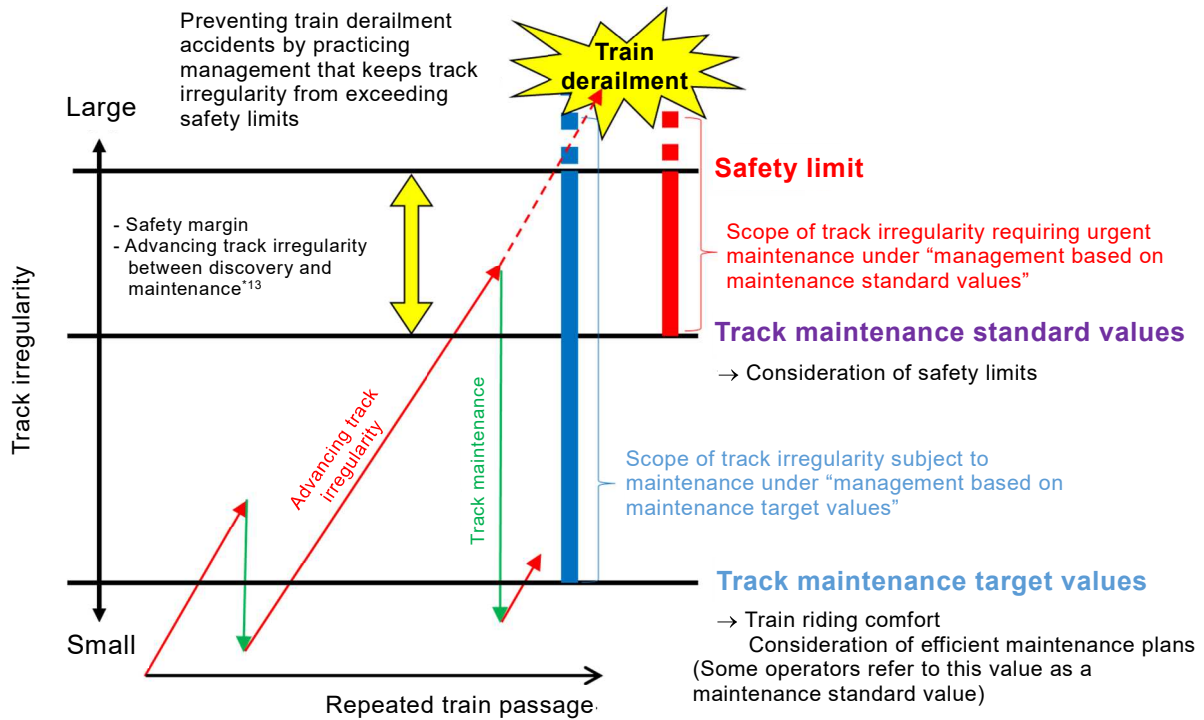
Figure 5: Conceptual image of maintenance standards for track irregularity

Maintenance standards for track irregularity include those established to ensure safe train operation and those established to ensure passenger comfort and efficient maintenance. In general, the former are called track maintenance standard values*11 and the latter are called track maintenance target values*12 (see Figure 5).

Note: Maintenance standards for track irregularity are established by each railway operator in accordance with each track section's facilities and vehicles running on the section.

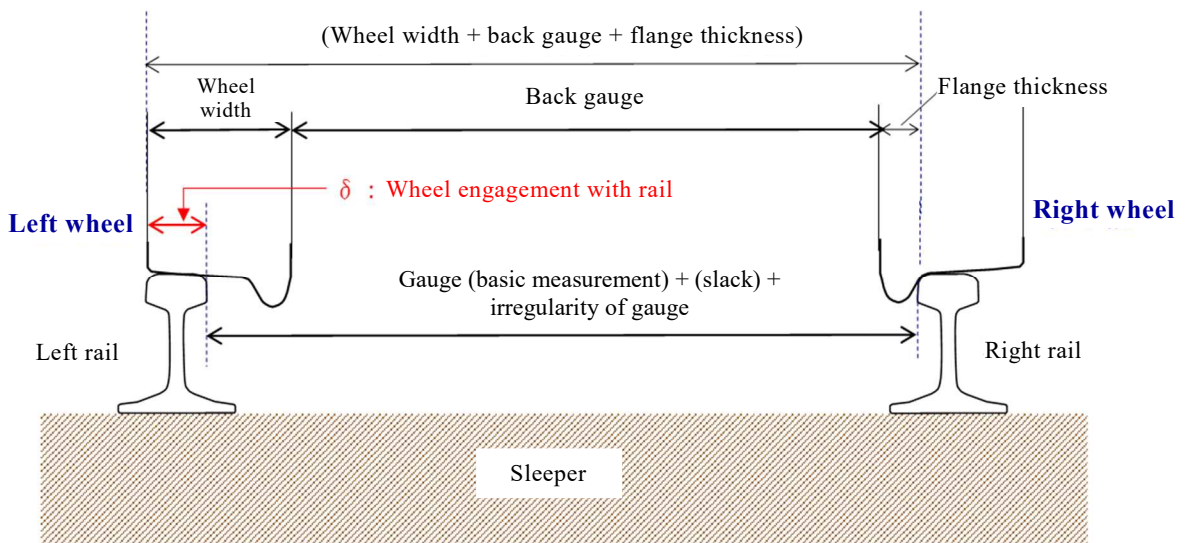
Figure 6: Limit values for irregularity of gauge

Here, when wheel and axle measurements (minimum values), gauge (basic measurement) of 1,067 mm, and slack of 0 mm are applied, irregularity of gauge irregularity limit value - (wheel width + back gauge + flange thickness) - gauge (design value) - 10 - 10

$$= (120+988+22) - 1,067 - 10 - 10 = 43 \div 40 \text{ (mm)}$$

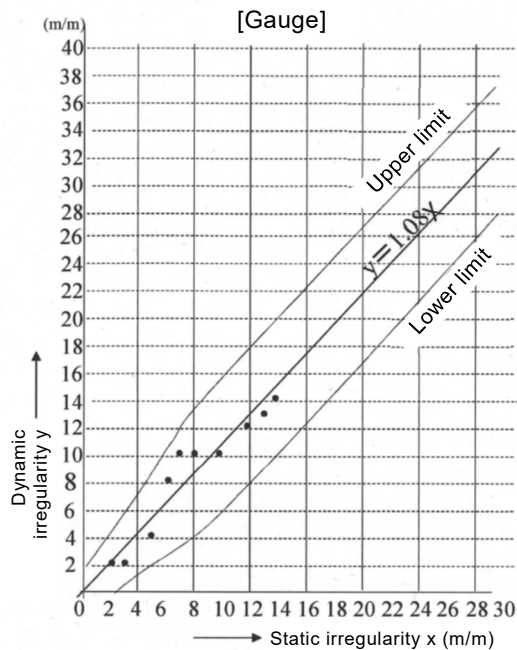
Figure 7: Relationship between dynamic irregularity of gauge and static irregularity of gauge

It is probable that the occurrence of these accidents was due to dynamic gauge widening caused by rail tilting and other factors with the presence of continuous defects in wooden sleepers and rail fastening devices.
