AIRCRAFT ACCIDENT REPORT 2/2013

**Report on the accident to Airbus A330-342
B-HLL operated by Cathay Pacific Airways Limited
at Hong Kong International Airport, Hong Kong
on 13 April 2010**

**Hong Kong
July 2013**

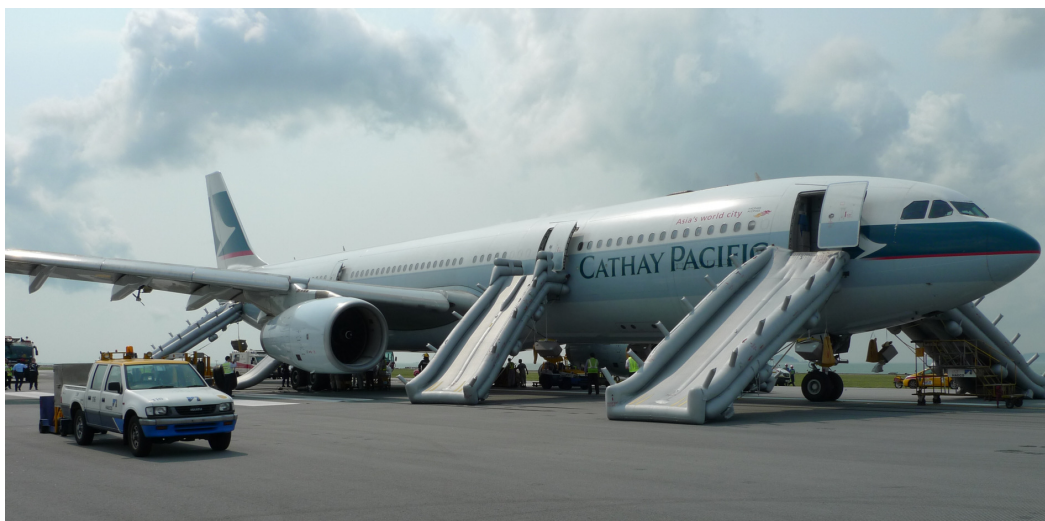
e. All eight emergency exits doors were used after the cabin crew had confirmed the absence of fire or smoke outside the exits. Exit doors L1, R1 and R4 were each attended by two cabin crew members, and the remaining five exit doors were each attended by one cabin crew member. Some passengers took their cabin bags along and did not follow the cabin crews' instruction to leave their bags behind before jumping onto the slides. The whole evacuation was completed in about two mins and 15 seconds. The Commander, the co-pilot and the ISM walked through the cabin to make sure there was no one left inside the aircraft before they left.

Figure 2: All Emergency Evacuation Slides were deployed

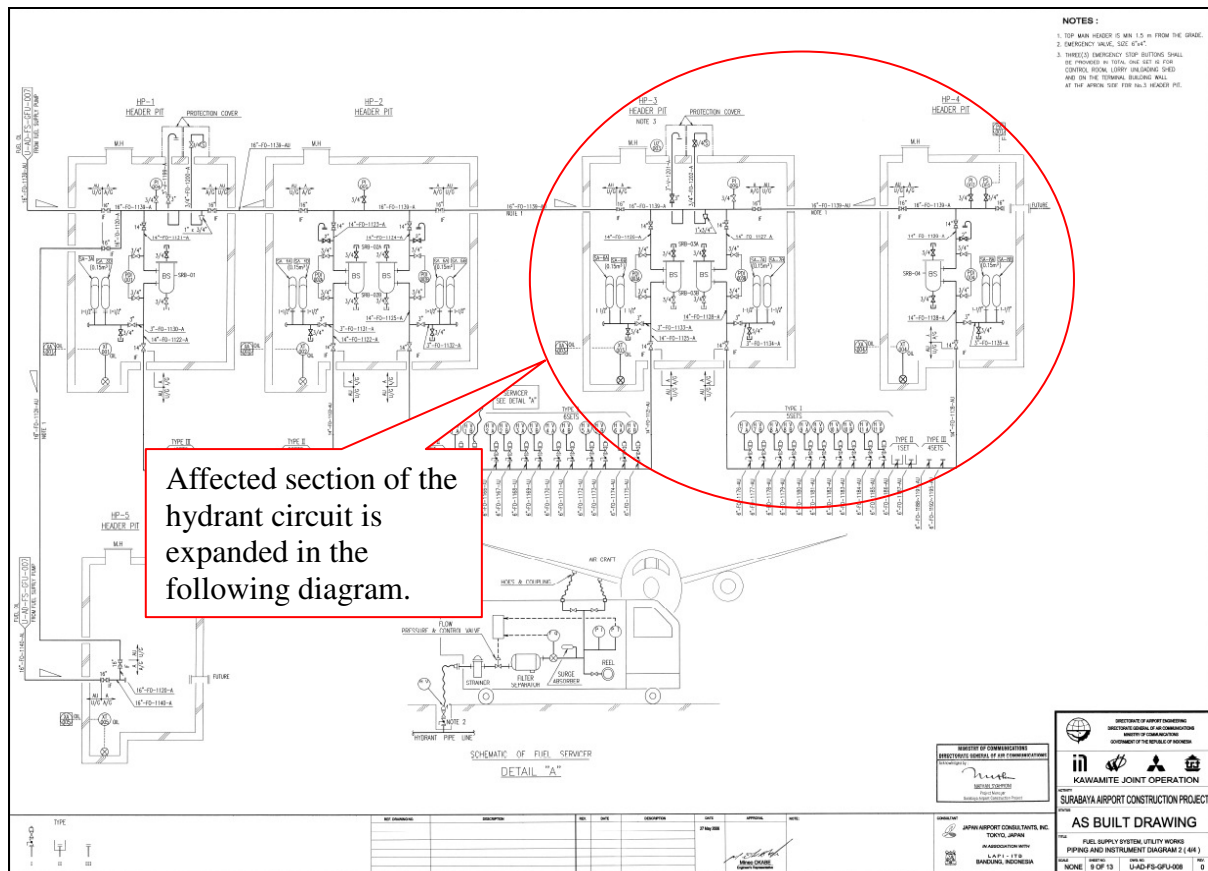
Fuel samples were collected from both the upstream and the downstream of the filter vessel on Dispenser JUA06, the ground refuelling hydrant at Stands No. 8 and 11, the fuel storage tank of WARR, and three low points of the WARR hydrant circuit. There was no sign of SAP spheres in the ground fuel samples. Water containing sodium chloride (NaCl) was found in the fuel sample collected from Header Pit 3 which was a low point in the hydrant circuit supplying Stands No. 1 to 10. Inspection of fuel storage facilities, which is located upstream of

the hydrant circuit, revealed no sign of NaCl corrosion. One SAP sphere was found trapped in the wire mesh of the gauze strainer which was fitted to the outlet hose of the dispenser (the hose end strainer).

Figure 22: The WARR Ground hydrant refuelling circuit

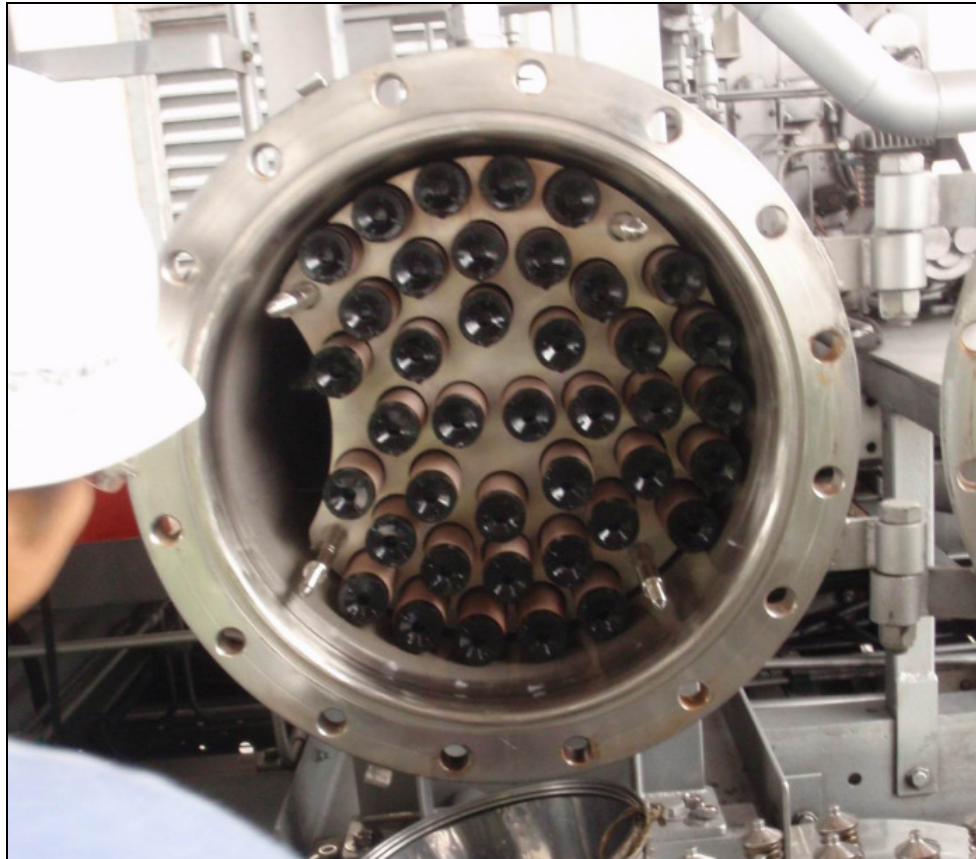
b. The 40 filter monitors (i.e. the accident filter monitors) installed in the dispenser JUA06 which had been used for the refuelling of CPA780 were removed six days after the accident. Twenty of them (Batch 1) were sent to UK for examination and analyses. Later, ten (Batch 2) of the remaining 20 filter monitors, which had been kept under quarantined in Indonesia were also sent to UK for examination and analyses. Another set of 40 filter monitors in JUA06 (Batch 3), which replaced the accident filter monitors and had been used for six weeks in WARR after the isolation of the disturbed Stands No. 1 to 10 hydrant circuit, were also removed and sent to UK for testing. These Batch 3 filter monitors which had been exposed to fuel but not to the contaminated hydrant fuel were used as reference standard to assist in the examination and analysis of the accident filter monitors.

Figure 30: Filter monitors (Batch 3) installed in the filter vessel of JUA06

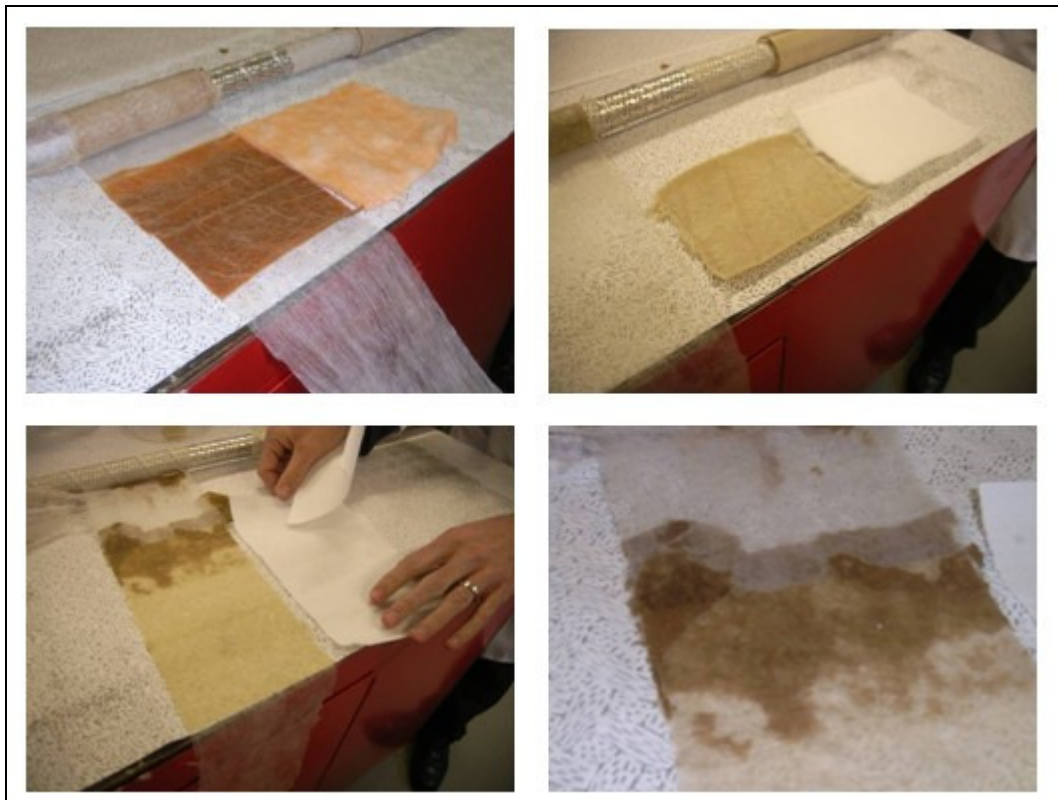
Figure 32: Dissecting one of the event filter monitors

d. Examination of the dissected filter monitors revealed that the construction of the accident filter monitors was identical in terms of media type to a recently manufactured element, and that the SAP layers had been exposed to water. There was very little evidence of dirt trapped in the media layers. Isolated SAP spheres were found in one filter monitor (see Figure 33). No SAP sphere was identified in the new pristine filter monitor when it was dissected and examined by using similar technique.

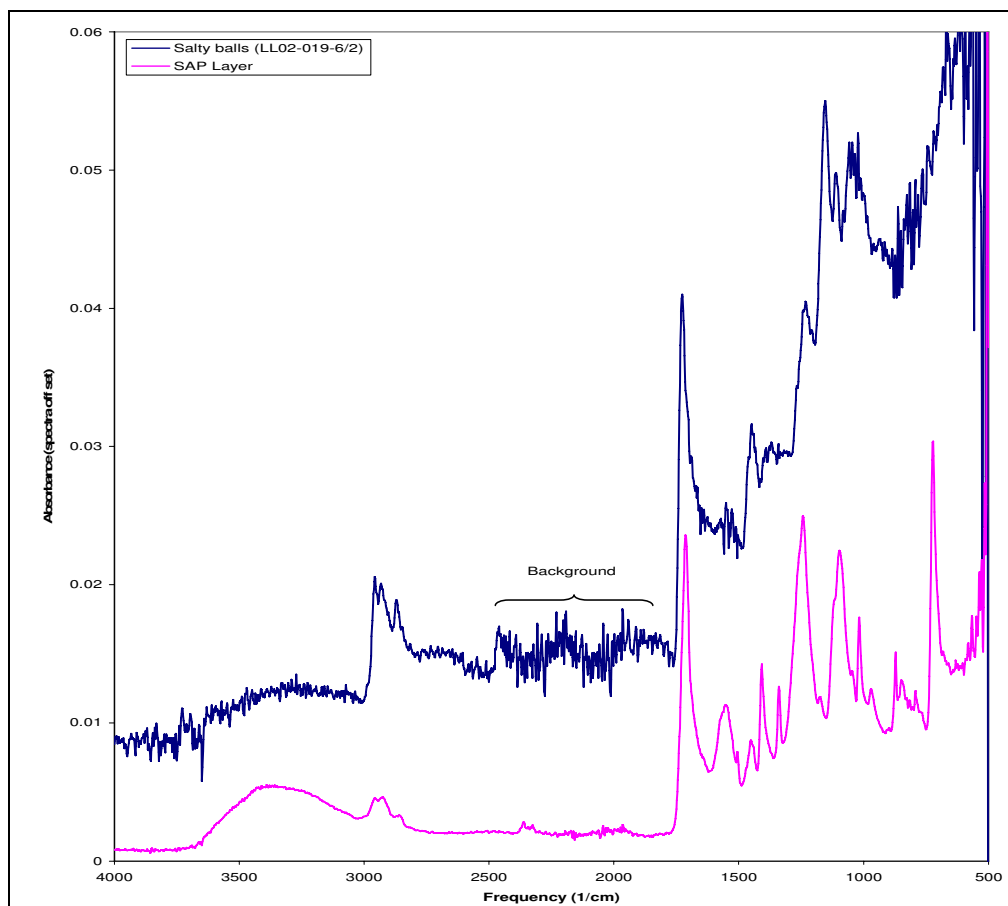
The presence of SAP spheres was identified in aircraft fuel samples, engine fuel samples, engine fuel components of the accident aircraft, as well as the fuel monitors of the JUA06 dispenser. Most of the SAP spheres found had a size ranging from five to 30 μm with majority in the order of five to 15 μm . Analysis showed that these SAP spheres contained the elements of carbon, oxygen, sodium, chlorine, and sulphur (see Figure 34), and were mainly sodium polyacrylate, which was consistent with the SAP material used in the filter monitors installed in a fuelling dispenser (see Figure 35). Further analysis revealed the presence of crystalline sodium chloride on the surface of some SAP spheres (see Figure 36). Refer to *Appendix 11* for results of examinations on SAP and SAP spheres by various techniques.

Figure 35: FTIR spectrum obtained from the SAP Layer sample compared to a sample of Na/Cl/S spheres indicating similar composition.

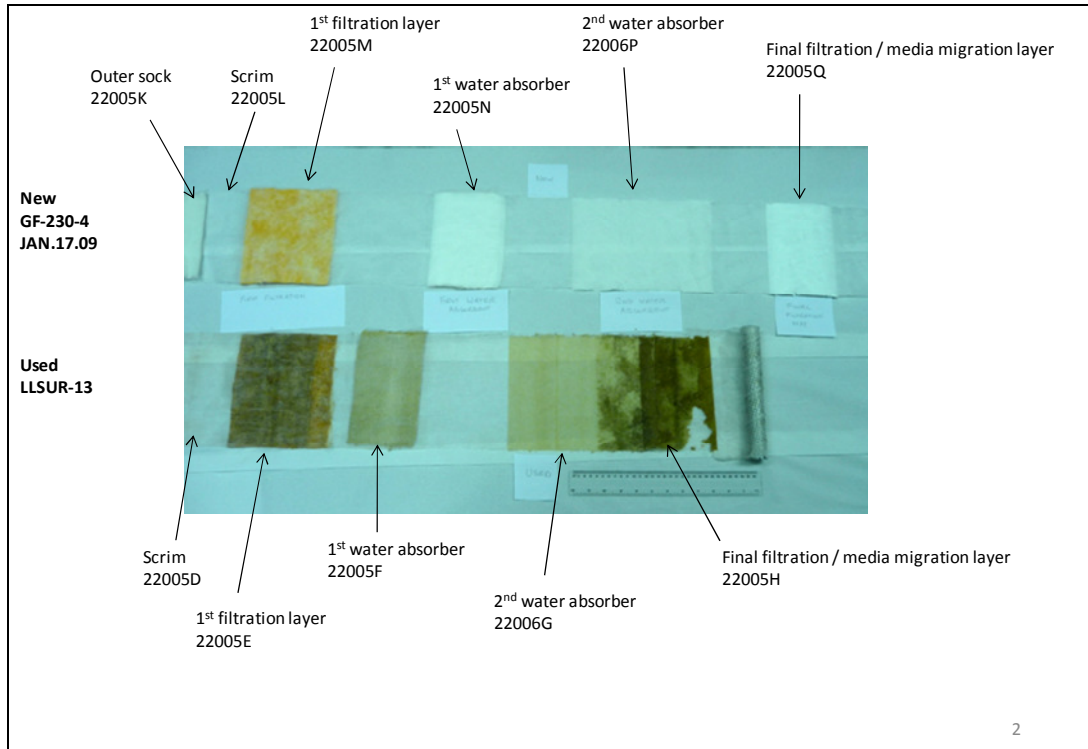
b. The accident filter monitors were manufactured by Facet International, part number FG 230-4, which were in compliance with the 4th edition of the EI 1583. These 50mm diameter filter monitors were of layered construction with the media being wound onto an aluminium centre tube of approximately 28mm diameter. The length of the FG 230-4 is 770 mm. The media is supported throughout by a polyester scrim and retained within an outer woven sock. The flow of fuel is from out to in across the filter monitor layers with a rated maximum flow-rate (FR) of 113 litre per minute per element. The layers in generic terms according to the flow direction are in the following order:

Figure 37: Media layers of filter monitor

c. The composition of the SAP spheres was mainly sodium polyacrylate which was consistent with the material used in the first water absorption layer of the filter monitor. Sodium polyacrylate is a kind of SAP which when in contact with water, activated to absorb the water, and turns into a gel that swells to fill the filter monitor. As stated in EI 1550, *“In extreme situations, the gelling process may shut off the flow [across the filter monitor] completely.”*

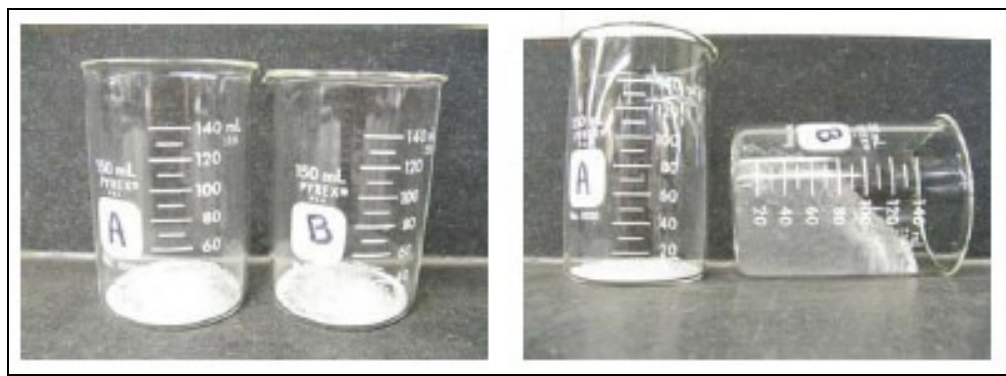
Figure 38: Beakers of SAP in powder form. After the addition of water to beaker B, the SAP powder swollen and turned to gel form

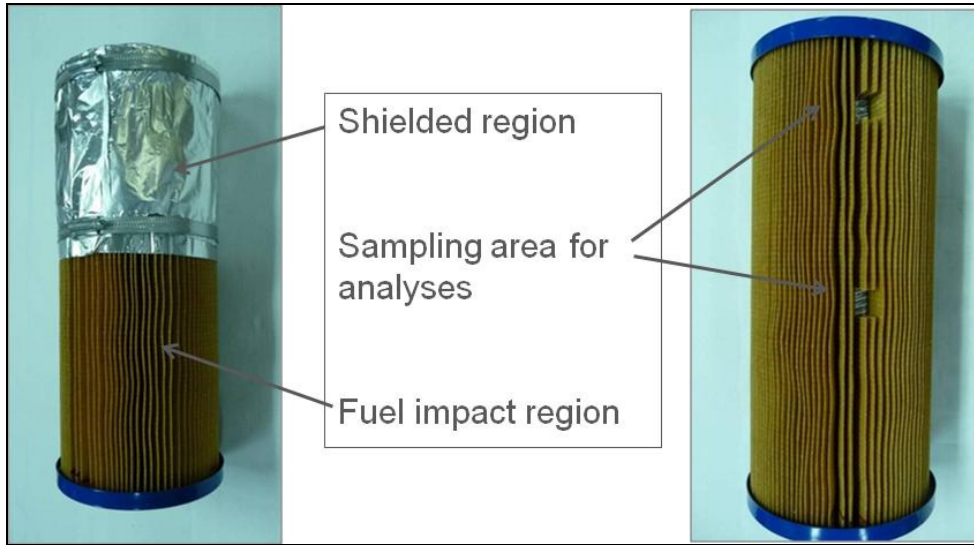
c. Examination of the microfilter media (Figure 42) after the flow tests of Batch 1 and 2 filter monitors revealed the presence of SAP spheres (Figure 43).

Figure 42: Microfilter used in clean up vessel downstream of test vessel to capture any media released during filter monitor testing

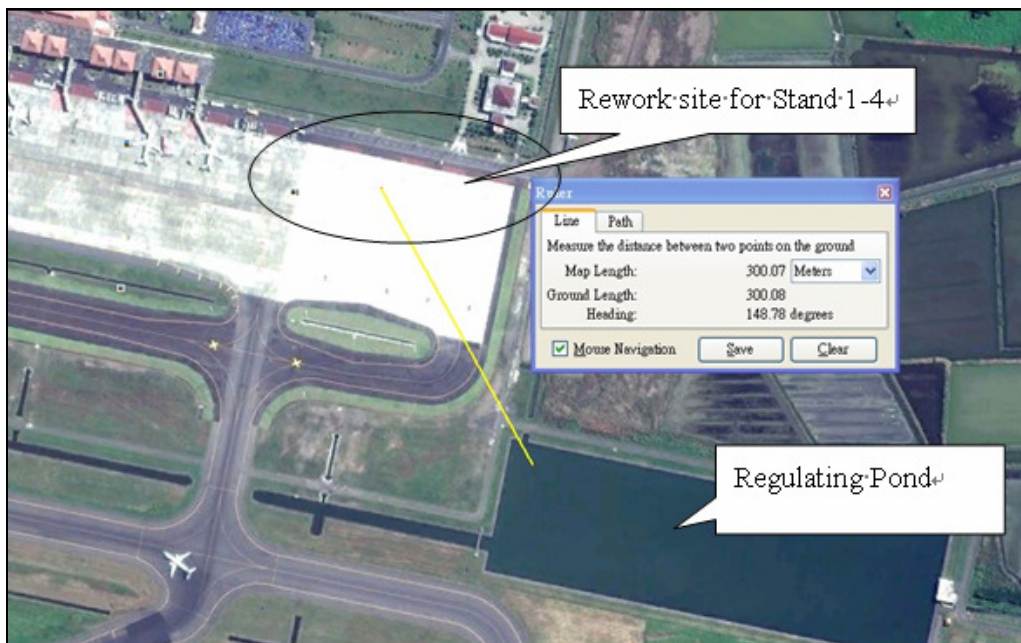
a. WARR is located close to the seashore and has three regulating ponds. As illustrated in Figures 52 & 53, the distance between the closest regulating pond and the work site was about 300 meters. After the accident, water samples were collected from the closest regulating pond and sent for analysis. The result indicated that the water in the regulating pond contained sodium chloride.

Figure 53: The extension work site and the closest regulating pond was approx 300m apart

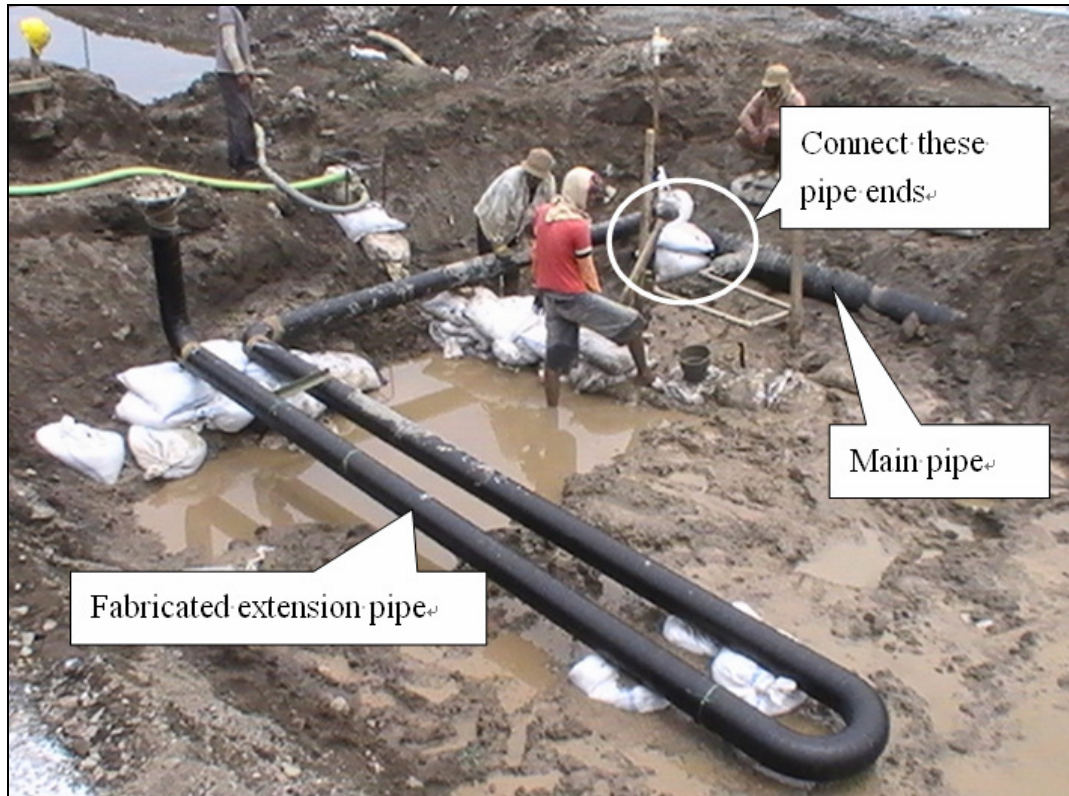
b. Before the "tie-in", the affected hydrant circuit was isolated and emptied to prepare for the connection of the extension pipe. During "tie-in" process, a fabricated 6" diameter extension pipe was transferred to the site on the day of connection. For each of the eight connections, the existing 6" diameter end pipe fitted onto the 14" diameter distribution pipe was cut open by hand sawing. The open end was blanked to be air tight with a "cap seal", and a "gas free" test of the open end was performed. The edge of the 6" pipe opening was grounded to create a bevel edge for subsequent joining by electric arc welding. The interior was swab cleaned by canvas or leather ball per specification. The fabricated extension pipe was then positioned and welded to the 6" diameter end pipe. According to the contractor, this "tie-in" process usually took 3 to 4 hours to complete. From the photos taken during the "tie-in" process (Figure 54), the work site was in a recess with water puddles, probably caused by recent rainfall, and with a drain pump to remove the water puddles in the work area.

Figure 54: The tie-in process to connect the fabricated extension pipe to the main distribution pipe

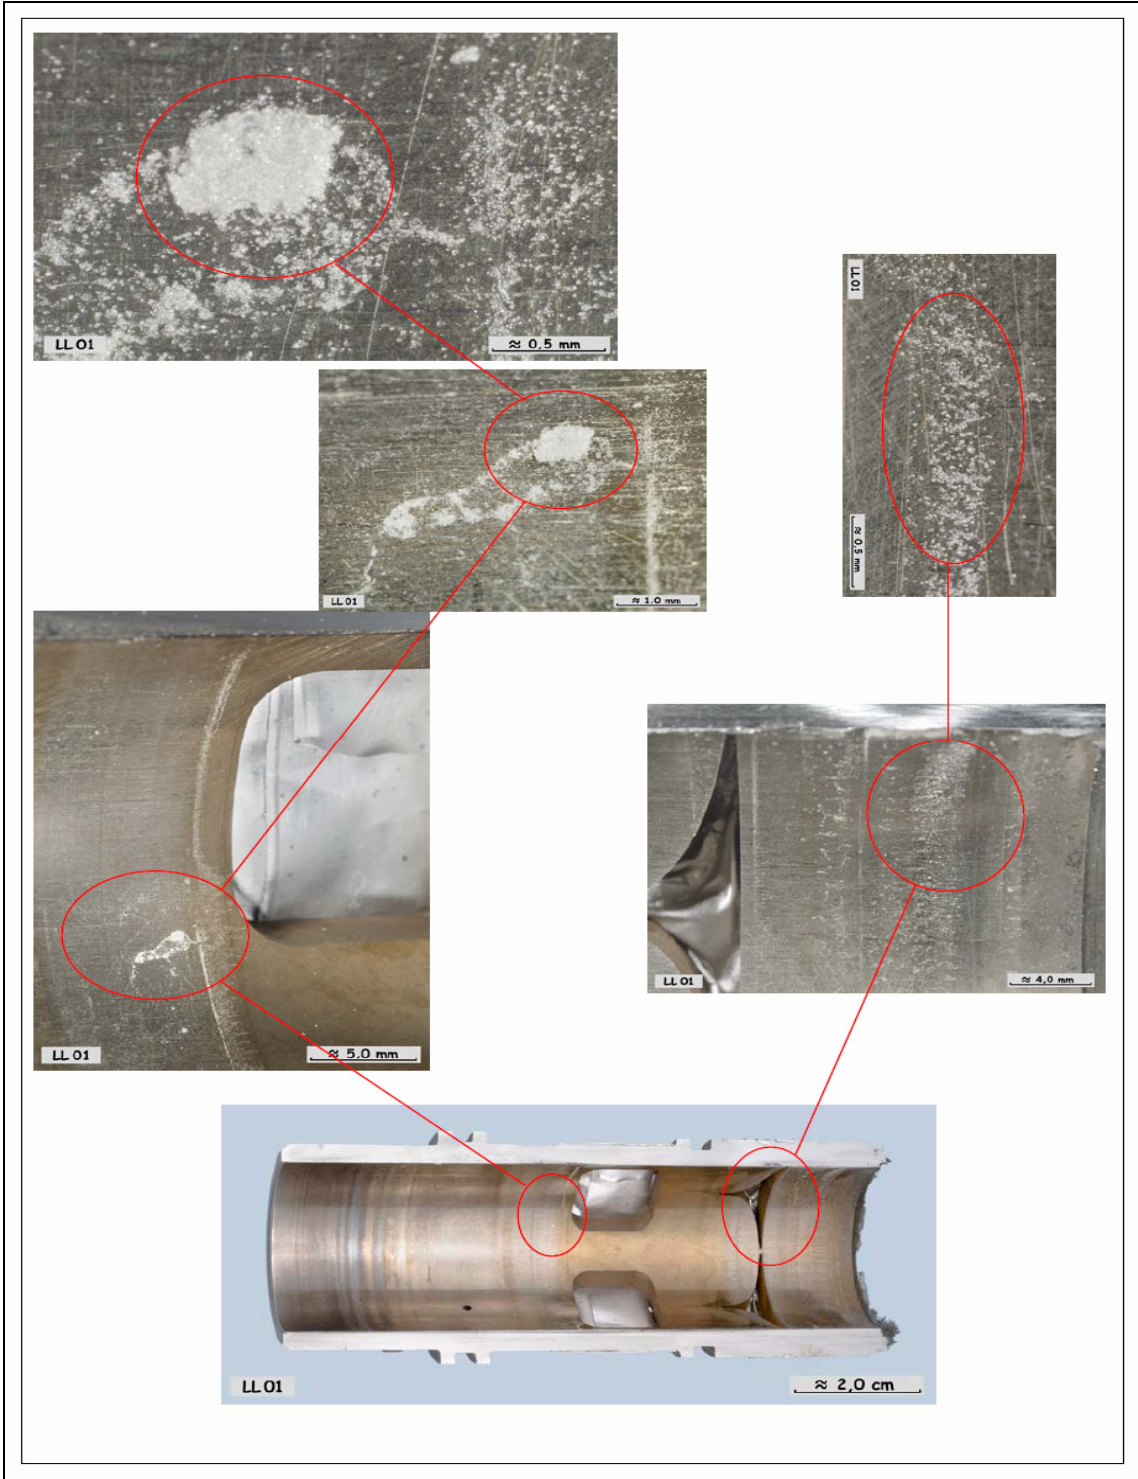
Appendix 10: No. 1 Engine MMV SAP Spheres

Engine No. 1 MMV cutaway view showing the presence of SAP spheres

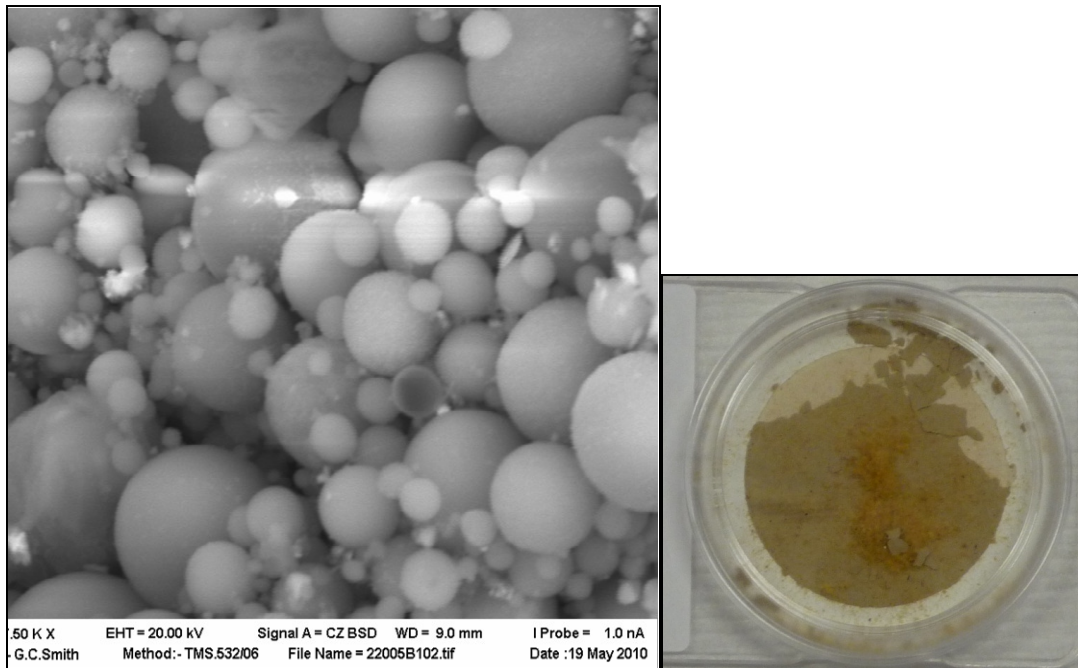
A11.1 - The Millipore filter containing material extracted from the low pressure fuel filter by Rolls-Royce (right), and the corresponding higher magnification SEM image (left):

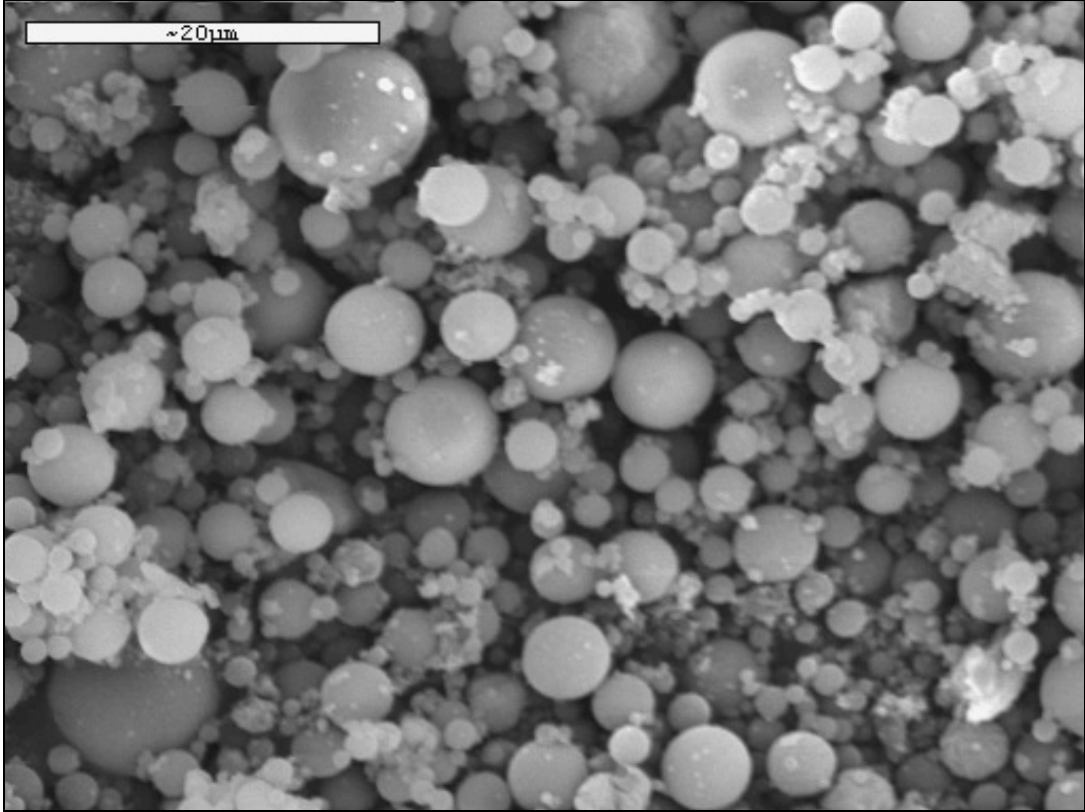
A11.4 – SEM image of the residue found on the core of the LP filter (No.2 engine):

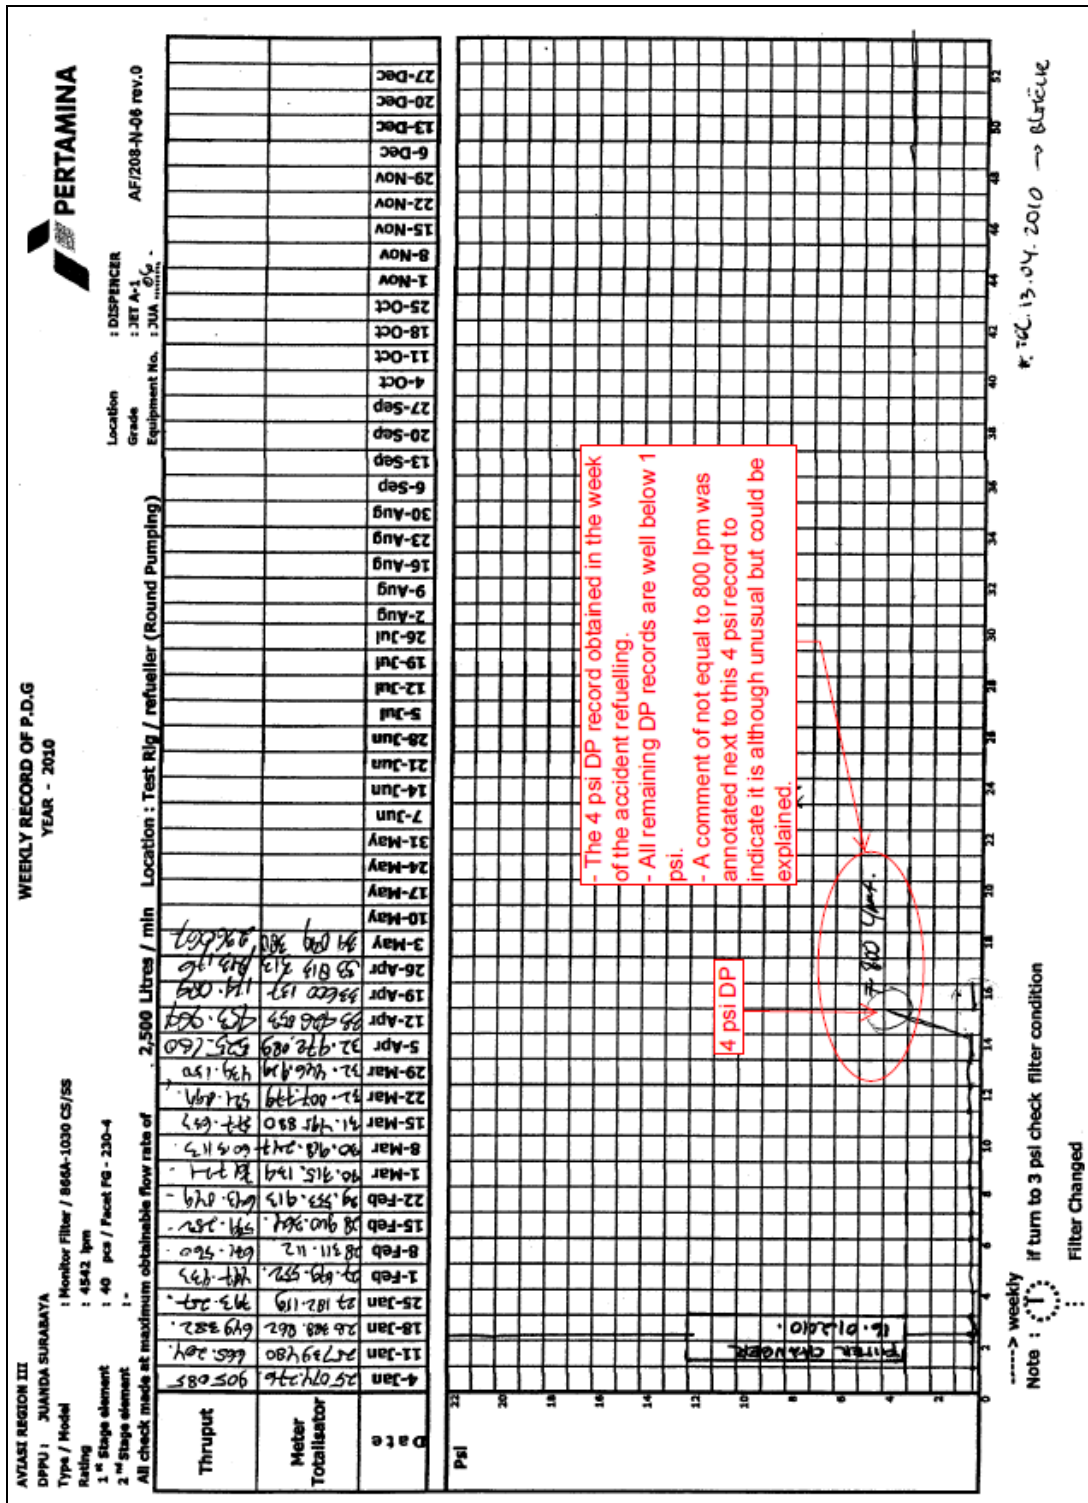
Appendix 15: Dispenser JUA06 Weekly DP Record Sheet

b. According to Pertamina’s maintenance program, the dispenser filter monitors would be replaced when there was abnormal change of DP in the weekly graphic record, or every 12 months in accordance with manufacturer’s recommendation. The following unscheduled filter monitor replacements in April 2010 were noted in the dispenser maintenance records:

d. The four unscheduled replacements for JUA01 to 04 indicated that the cleanliness of the hydrant fuel being handled by the dispensers JUA01 to 04 had deteriorated. However, such quality drop had not been investigated by Pertamina.
