*Accident
on 25 July 2000
at La Patte d'Oie
in Gonesse (95)
to the Concorde
registered F-BTSC
operated by Air France*

REPORT translation
f-sc000725a

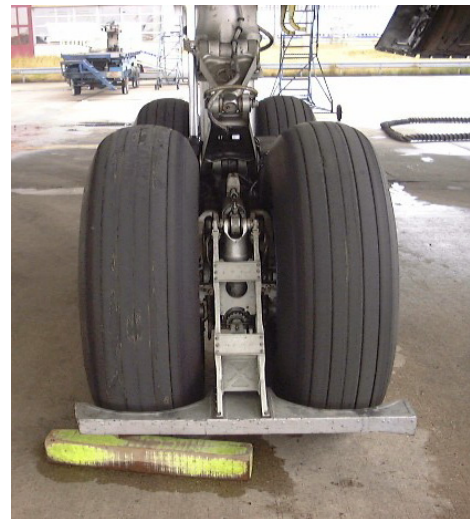
Figure 4: Water deflector

The deflectors are situated forward of each main landing gear. Their function is to deflect projected water so that it does not enter the engine air intakes. Weighing around four kilos, they are made of composite materials and fibre glass (to make them frangible) except for the bogie fasteners.

In 1995, these deflectors were the subject of an optional Service Bulletin (SST 32-103 of 12/01/95 modified on 28/02/95) which proposed the insertion of two cables in the leading edge in order to retain pieces of the deflectors in case of failure. Air France did not apply the aforementioned Service Bulletin.

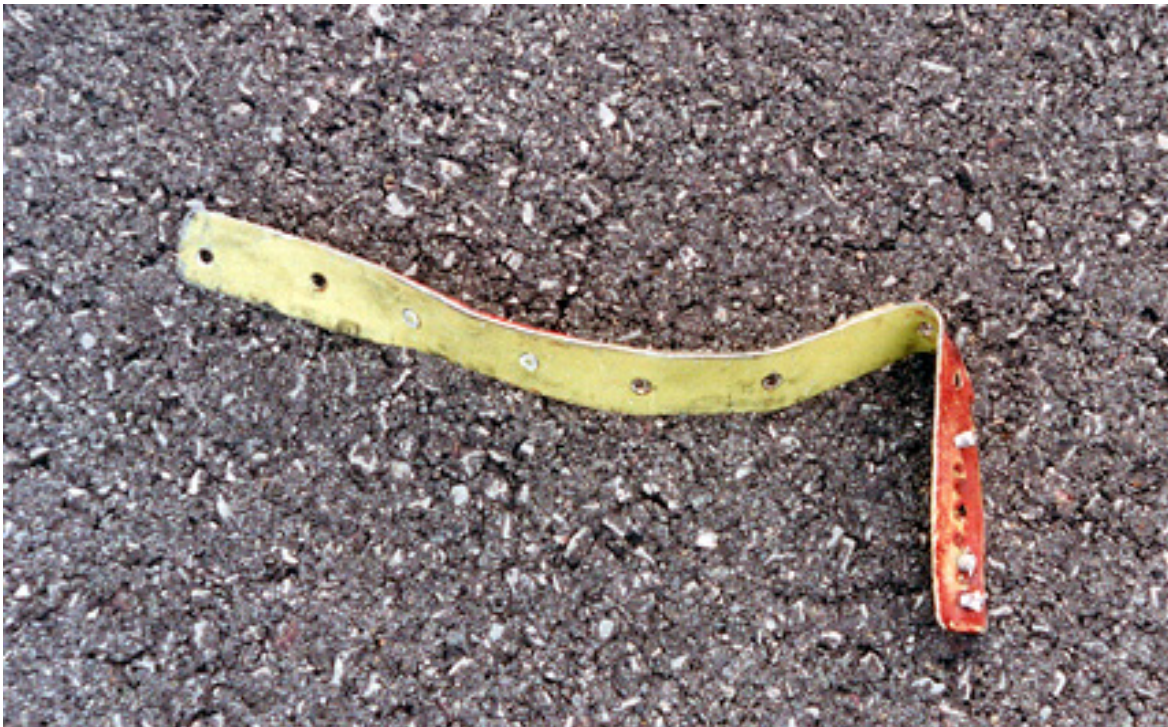
Figure 21: Piece found at line 152

On visual inspection, the piece appeared to be made of light alloy, coated on one side with epoxy primer (greenish) and on the other side with what appeared to be red aircraft mastic for hot sections (RTV 106). It did not appear to have been exposed to high temperature.

This piece was not identified as part of the Concorde.

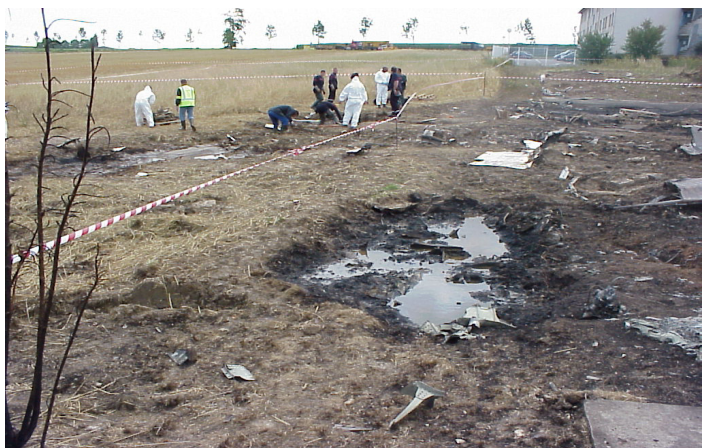
Figure 32: Impact marks

Signs of ground impact were found to the north of the site at the intersection of areas A and B. There was a row of trees about three metres high, oriented east to west, then a crater at the bottom of which was rear tank 11. Pieces of engine air intake were found half-buried at A3 and signs of ground impact were apparent at A3 and CB2-North. Wheel No 6 was embedded in the ground.

At B3, an impact mark was visible in the asphalt. Forward parts of the aircraft were in a line embedded in the earth, including the front left door sill and a hinge from the aircraft's droop nose. Near these items of debris, the grass was sparse.

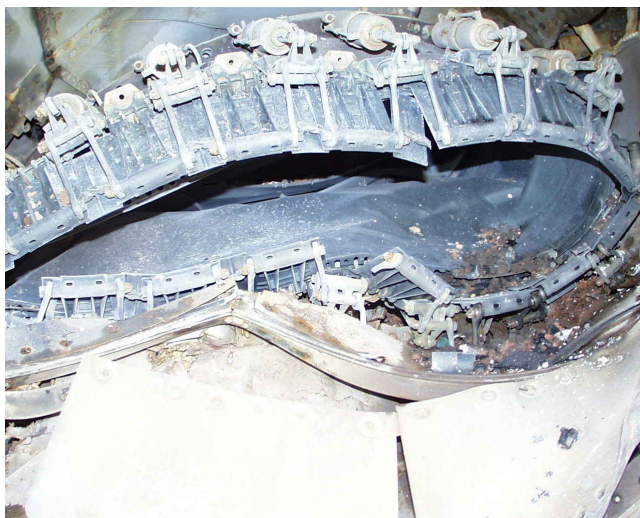
Figure 36: Engine 2 exhaust nozzle

The primary exhaust nozzle from engine 3 was separated from the structure of the secondary nozzle. The latter was torn away from the rest of the engine. The nozzles from engines 1, 2 and 4 were in place but flattened by the impact with the ground.

The primary and secondary nozzles showed no signs of overheat on any of the engines. Black marks were visible on the inner panels of the engine 1 nozzles. Traces of soot were also found on the upper right part of the structure of the engine 2 nozzles. No trace of damage caused by an uncontained engine burst was noted.

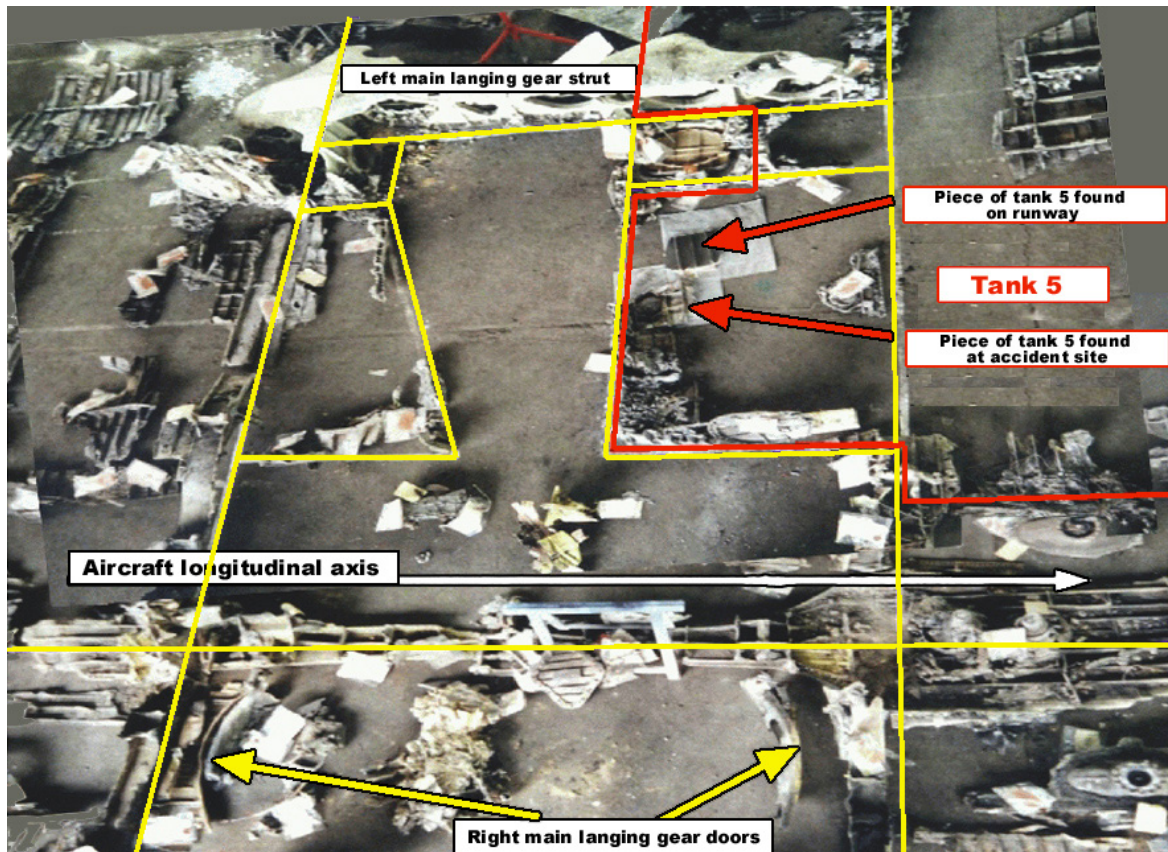
Figure 38: View of wing reconstruction in hangar

The parts found at the accident site were sorted according to geometrical criteria, so as to create groups of pieces before identifying and positioning them. The pieces of the wing were laid flat on two areas representing the upper and lower wing surfaces. The condition of the wreckage did not, however, allow much useful information to be gleaned for the investigation.

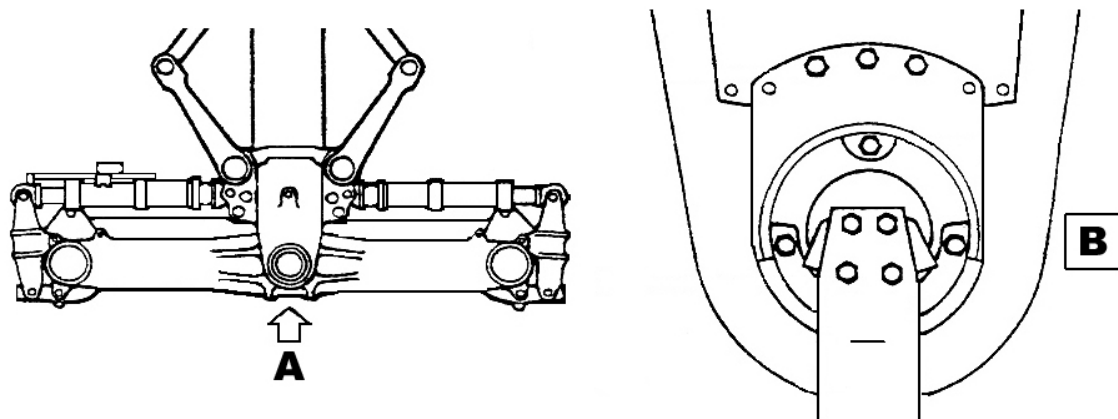
Figure 41: Leg-bogie coupling

- The forward and rear hinges of the right main landing gear inner door were identified.. The forward hinge was blocked in a position consistent with a closed door. The rear hinge was limited to a movement of about 20° around the normal closed position.
- A spacer, which holds two lateral rings in position, was missing from the oleo/bogie coupling on the left main landing gear. This retainer had not been re-installed during the A01 check performed from the 17 to the 21 July 2000.

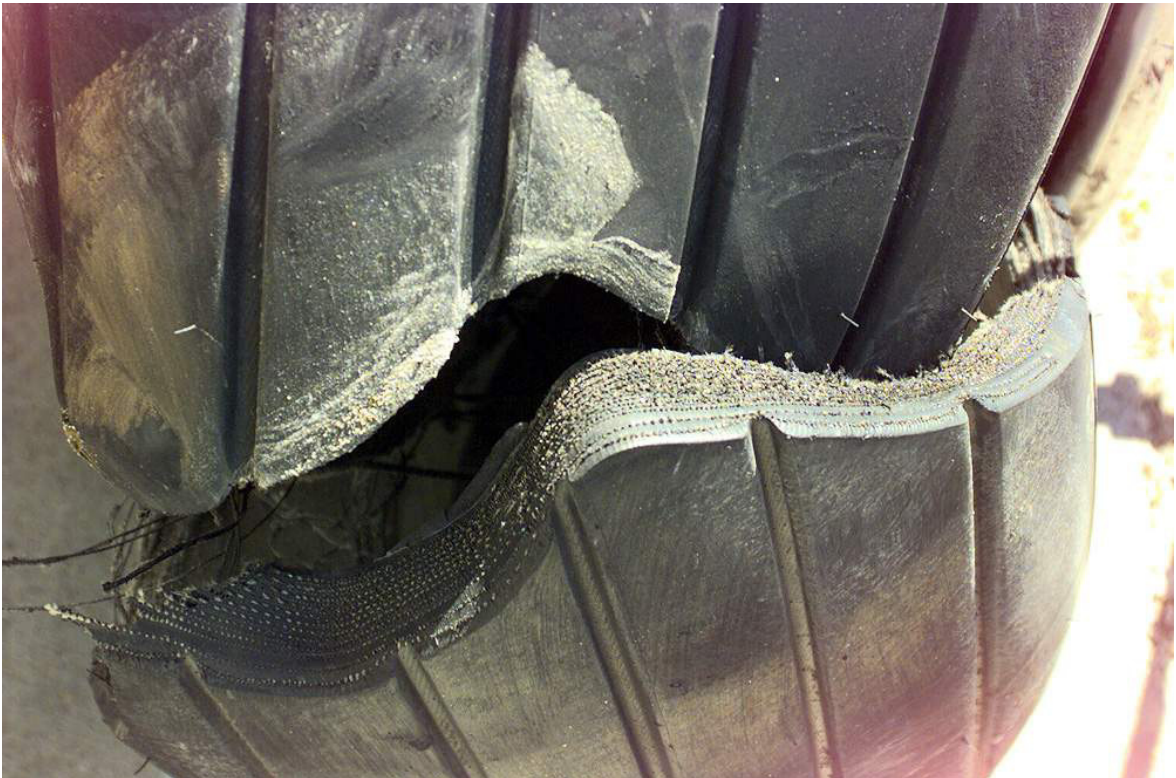
Figure 49: Tyre cut

- an initial positioning of the strip, done with the titanium strip, resulted in its being flattened by the tyre,
- in a second position, the strip remained stable on its cutting side and the tyre was cut into,
- the tyre cut went right through its thickness, practically all across the width of the area in contact with the ground and in accordance with the shape of the strip,
- this cut continued as tearing onto the tyre shoulders and sidewalls through a static rupture in the direction of the reinforcing material of the tyre body,
- the static tear spread as far as the tyre beads, in other words slightly more deeply than the tear noted on the remains of tyre No 2 on F-BTSC.

Extension of the lines from the tear demonstrates that the piece that could be released was comparable to the piece of tyre found after the accident near to the strip.

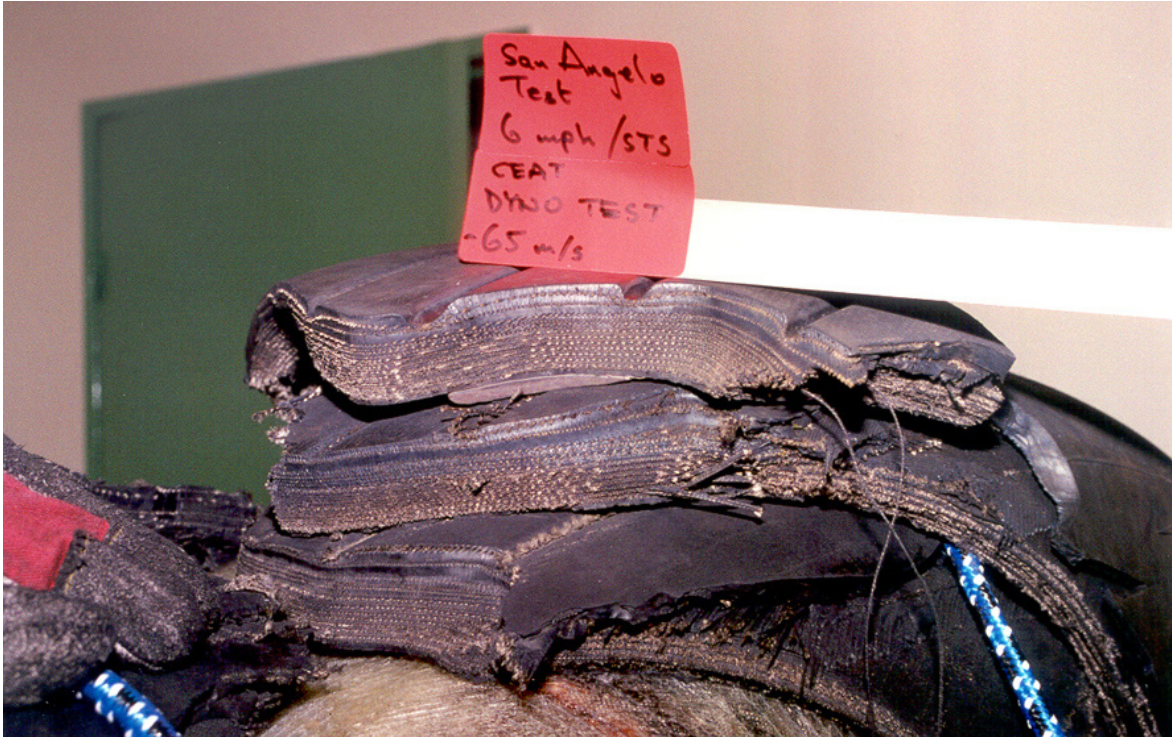
Figure 50: Cuts in various Concorde tyres

Various pieces of the tyre cut during the tests conducted in the USA and at the CEAT were examined at the LRCCP. Observation showed the resemblance of their rupture topography with that of tyre No 2.

The photo below shows the positioning of three pieces coming, from top to bottom, from tyre No 2 (speed of around 85 m/s), from a tyre tested at the CEAT with impact at 65 m/s and a tyre tried in the United States with impact at 2.5 m/s.

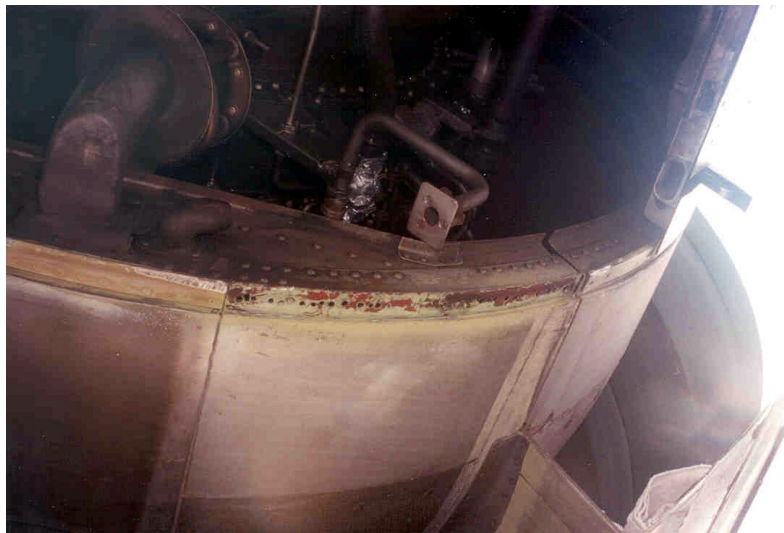
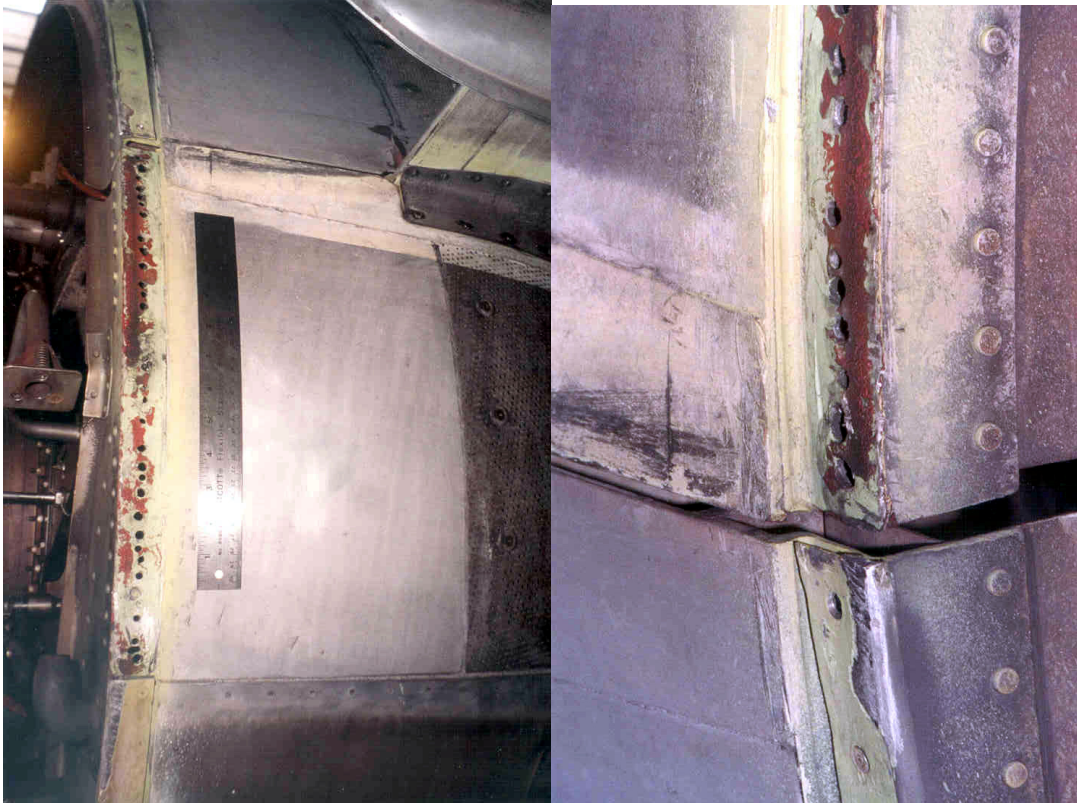
Figure 52: Pictures showing the position of the wear strip

- the lower left wear strip, about forty-four centimetres long, was missing. When closed, the forward part of the core door usually rests on the wear strip,
- the support was painted with green epoxy primer,
- in the position where the missing part would be, the support was covered in red type RTV 106 mastic,
- there was no trace of RTV 106 on the other parts of the support,
- there was no trace of RTV 106 on the wear strips which are in place,
- there were numerous paint runs on the support and on the wear strips and the paint,
- partially overlapped onto the fan reverser cowl,
- in the position of the missing part, the support still possessed several rivets,
- the support was drilled with thirty-seven holes, of which some had gaps between them,
- that were less than twice the diameter of the holes.

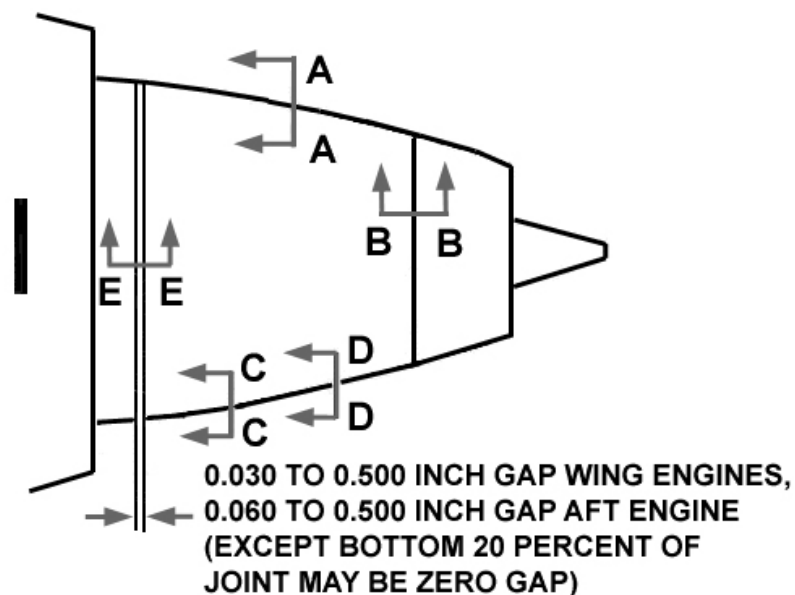
Figure 53: Diagram of cowl

The play between the core door and the fan reverser cowl must be between 0.030 inch (0.7 mm) and 0.5 inch (12.7 mm) as shown hereafter;

During the investigation, it was noticeable on various aircraft that the play measured with engines stopped could exceed these values without touching the width of the wear strip. However, with the engine running, particularly when under takeoff thrust, the pressure inside the cowls is very high. Their deformation then seems to explain loss of a wear strip, which would no longer be attached to its support.

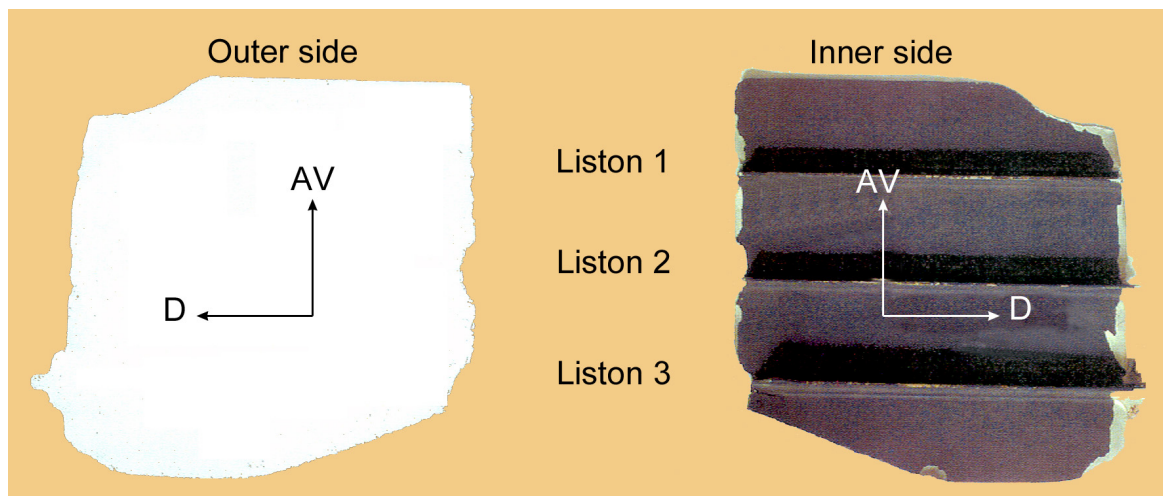
Figure 55: Piece of tank 5 found on the runway

The structural part found on the runway measured 32 x 32 cm. It was covered in white paint on its outer side and with a black mastic (viton) on its inner side. It had three stiffeners (strakes) separating four cells. A dimension check enabled it to be identified as coming from the underside of tank 5, and to locate it between spars 55 and 56 and ribs 23A and 24A. The piece and a skin thickness of 1.2 mm.

- some of the damage noted on the rear part was caused by impact with the ground,
- the cells possessed bulge deformations whose main line was perpendicular to the stiffeners. the radius of curvature measured in the areas away from the point of impact with the ground was of the order of 1.2 m,
- the ruptures in the thin skins were matt for the most part; the rupture face was angled at 45°, which indicates that these were static ruptures,
- the ruptures on the stiffeners displayed roughness characteristic of violent static ruptures following an abnormally high load.

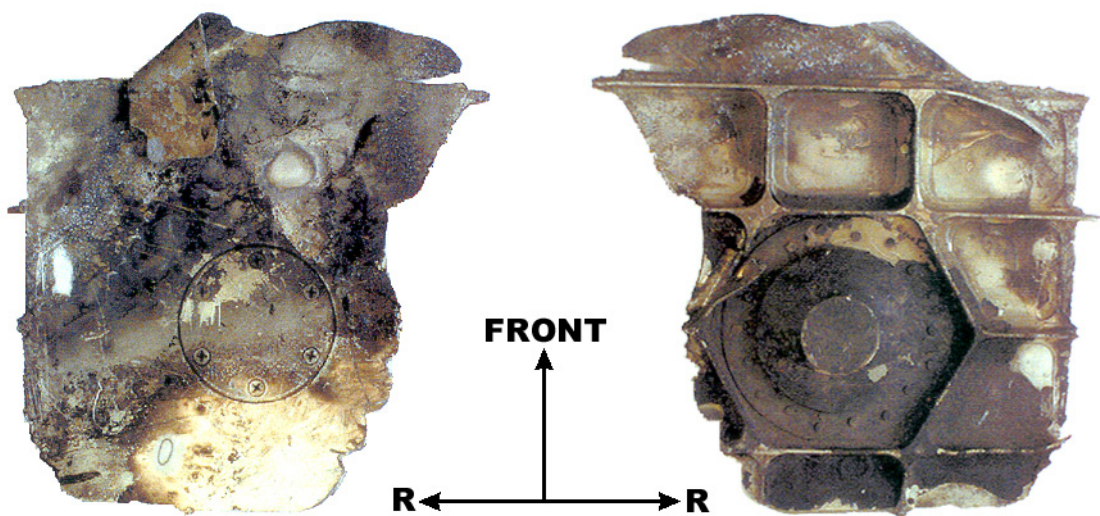
Figure 57: Piece of tank 5 found at site

A part found at the site was identified as coming from the underside of tank 5. It was located along spar 56 between ribs 24A and 24B.

The piece had not melted but the external paint and the internal black mastic were damaged on three-quarters of their surface and the material was overheated in this area. Only the remaining quarter, in the rear part, was intact.

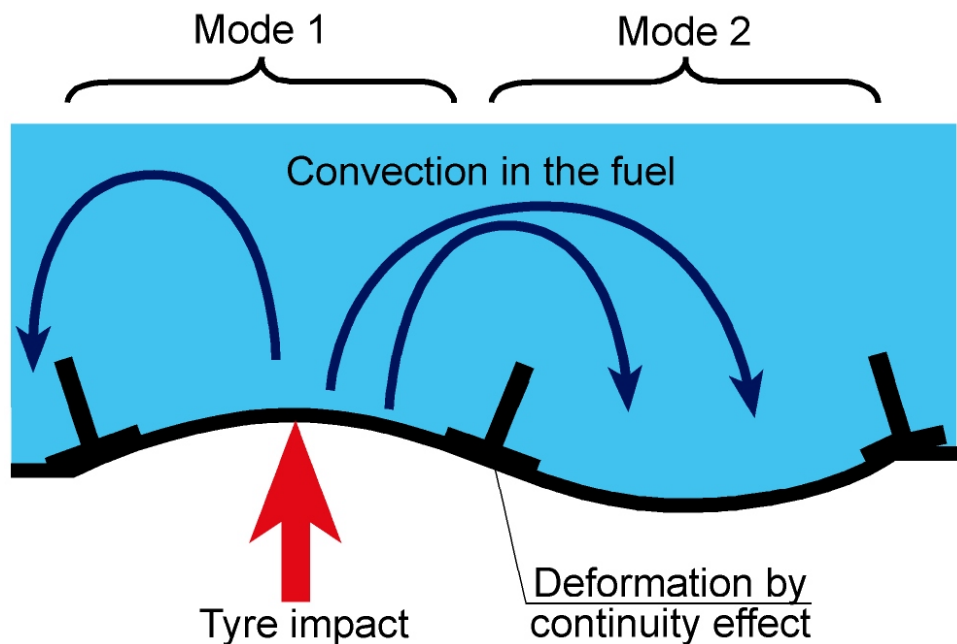
Figure 59: Effect of impact on wing box filled with fuel

- When the box contains liquid, a secondary effect can appear which contributes to the indirect mode, an effect due to:
 - the wave of pressure that is propagated in the liquid at the speed of sound, that is to say at about 1,400 m/s. This wave diminished rapidly and after an initial pressure of two hundred bars, it was only about ten bars in the area where the indirect mode was expected;

- the successive displacements of the liquid itself, at a speed of a few dozen metres a second. Because of the incompressibility of liquids, and in as much as the tank is “full”, that is to say there is no free surface too near the impact area that disturbs the phenomenon, this displacement tends to push the tank structure towards the outside, first of all in the nearest areas.

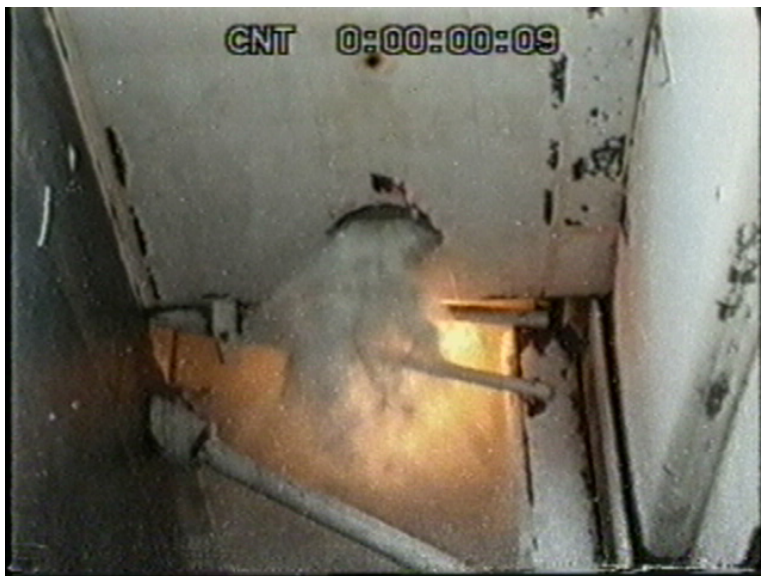
Figure 64: Ignition after spark

The tests simulated a short-circuit in the case of damage by crushing, tearing or cutting through the insulators of the electric line supplying the brake ventilators (3-phase 115 V, 400Hz). During the tests, the circuit breakers never tripped, apparently because the phenomenon was of too short a duration for them to detect it. The successive sparks had an energy estimated at twenty-seven joules, clearly above that required to ignite the vaporised kerosene, including in turbulent air conditions.

Although the electric cables are partially protected by the gear leg, possible damage due to the destruction of tyre No 2 cannot be entirely ruled out. It should, however, be noted

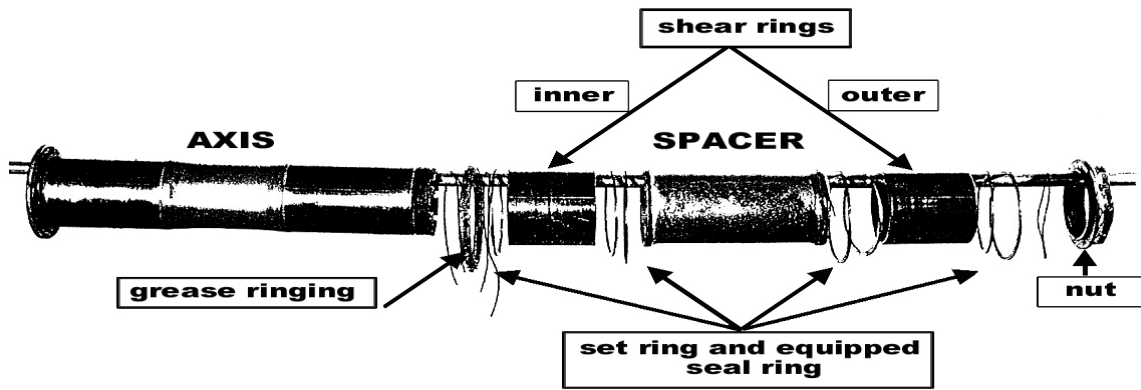
Figure 69: Landing gear, parts of the bogie beam

During removal of the bogie, the extractor tool was not used. Only the bushes were extracted after removal of the axle. The spacer remained on the bogie. Because they were using the tool reference in their working document, the AMM, the personnel did not find the extractor in the store. A check carried out after the discovery of the anomaly on 23 October 2000 confirmed, however, the presence of two extractors.

During reinstallation, the shear rings were positioned directly in their end bogie beam shock strut bores, before the axle was reinstalled. This made it impossible to detect the absence of the spacer on the new bogie.

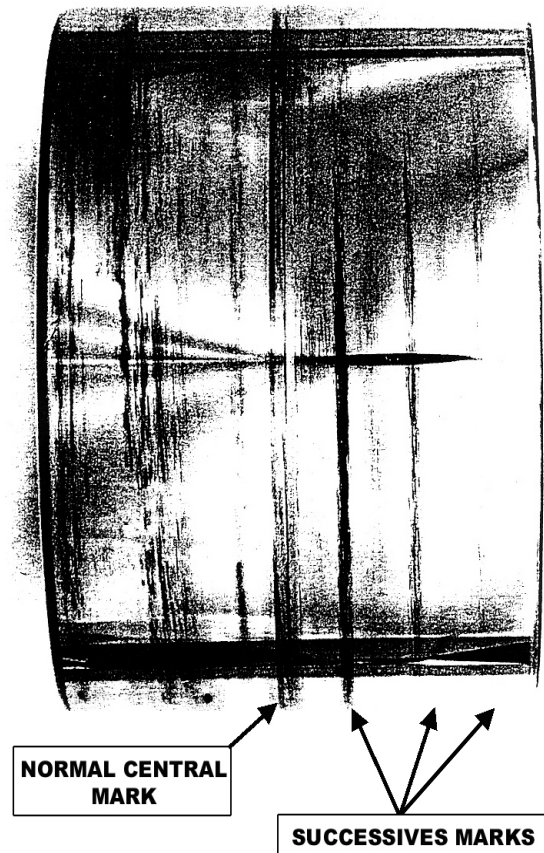
Figure 70: Left landing gear, inner shear ring

The condition of the various pieces (shear rings, bronze bearings, seals) show that the inner shear ring had moved from its position incrementally during the last few flights. The marks indicate that the mechanism was operational although the shear ring was no longer in its position on the bronze bearings of the shock absorber and bogie.

The exact chronology of this displacement is, however, difficult to determine since the ring was not new and certainly bore marks related to its previous usage. The only marks observed on the mechanical parts correspond to movements in the vertical plane alone or to normal oscillations of the bogie.

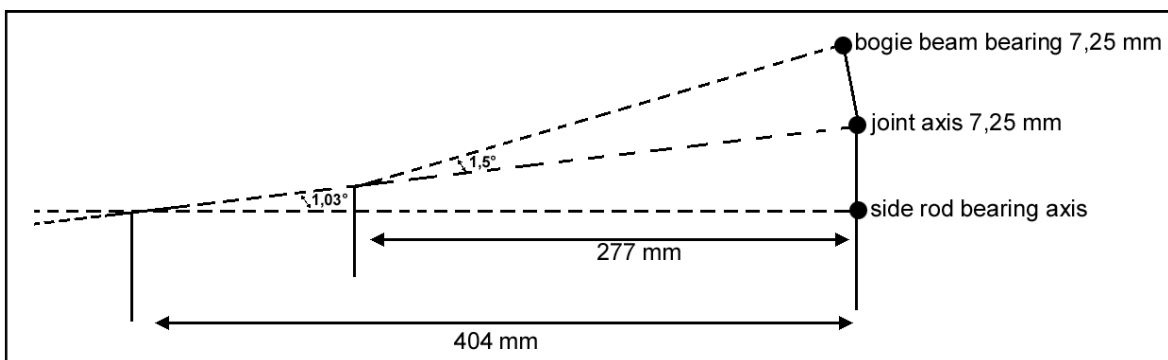
Figure 71: Effect of the lack of ring on the axle geometry

Maximum displacement of the geometrical axis of the bogie beam results from the combination of the two movements described above, which corresponds to 14.5 mm at the radius, thus a cone angle at the apex of 5° , the tip of the cone being located at the centre of the outer bearing.
