ARAIB/AAR0603

Aircraft Accident Report

**Hail Encounter During Approach
Asiana Airlines Flight 8942
A321-100, HL7594
20 miles South East of Anyang VOR
June 9, 2006**

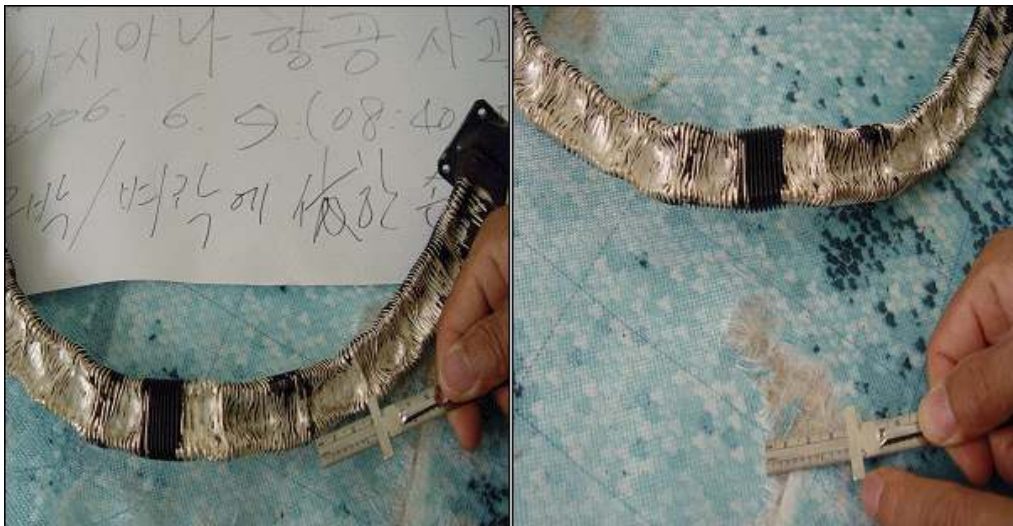
[Picture 17] Hail Size and Intensity

The hail size measured from the damage parts is approximately 2.0 cm or above in diameter inferring from the damaged mark on the Wave Guide connected to the radar antenna as shown in the Picture 17] and the hails hit in a thick dense. Considering the hail mark, it is estimated that the aircraft encountered with the hail under the cumulonimbus clouds.

The radar antenna was damaged by facing with the external environment installed the inside of the radome by detachment of radome. The antenna was still attached to the aircraft during flight after encountering with the thunderstorm and then fell on the runway due to impact upon landing.

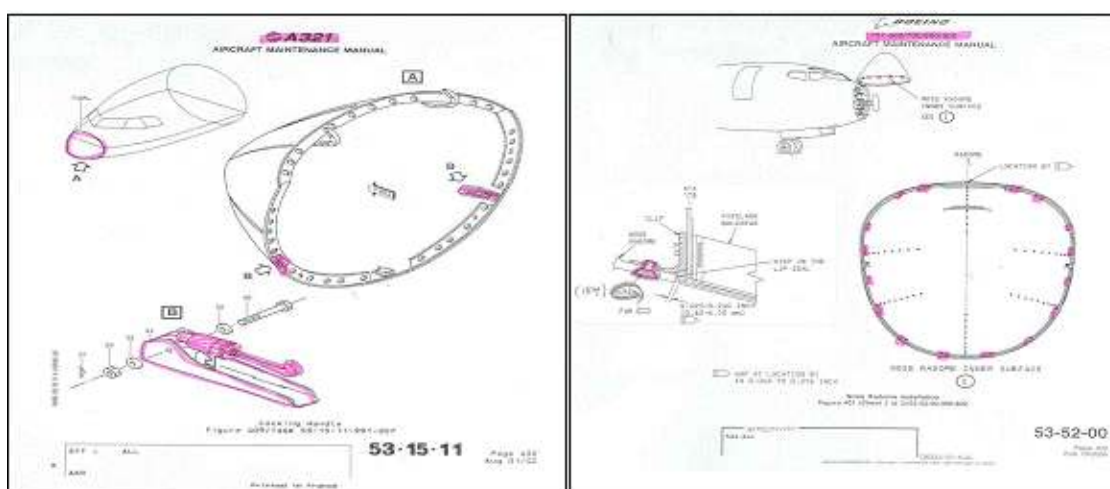
[Figure 20] Installation of Radome – Fix with 2 Latches (Left), Fix with 16 Bolts (Right)

The aircrafts of Airbus Series (A321, A330, A300-600) have two latches installed to the lower part of the radome at 4 o'clock and 8 o'clock direction; on the other hands, the aircrafts of Boeing Series (B737, B747, B777) have 6 or 8 latches installed on the circumference of radome in an even space and they are fixed by 16 bolts for B777 in order to protect the radome from detachment.

In this accident, the entire radome was detached from the aircraft, and similar case was investigated three times in the Airbus aircraft series. [Figure 20] shows the representative examples comparing the installation pattern of the radome between Airbus aircraft (A321) and Boeing aircraft (B777).

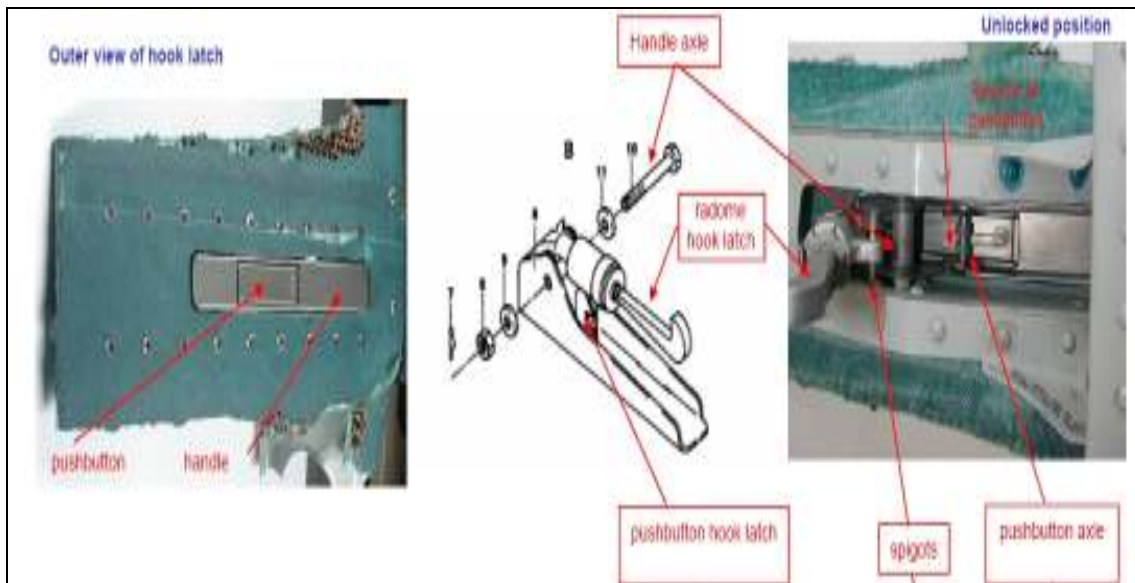
[Figure 22] Location of Hook Latch

The hook latch handle is used to hang/unlock the radome hook latch in the airplane fitting. The pushbutton locks the handle in the direction of handle shut. If pushing the mark of “push” on the back side of the handle, it is unlock.

In the unlocked position, the handle can be moved around the center of axle. The pushbutton latches are unlocked from the spigots on the radome hook latch. The return spring of pushbutton grips the radome hook latch making it align with the handle [Figure 22].

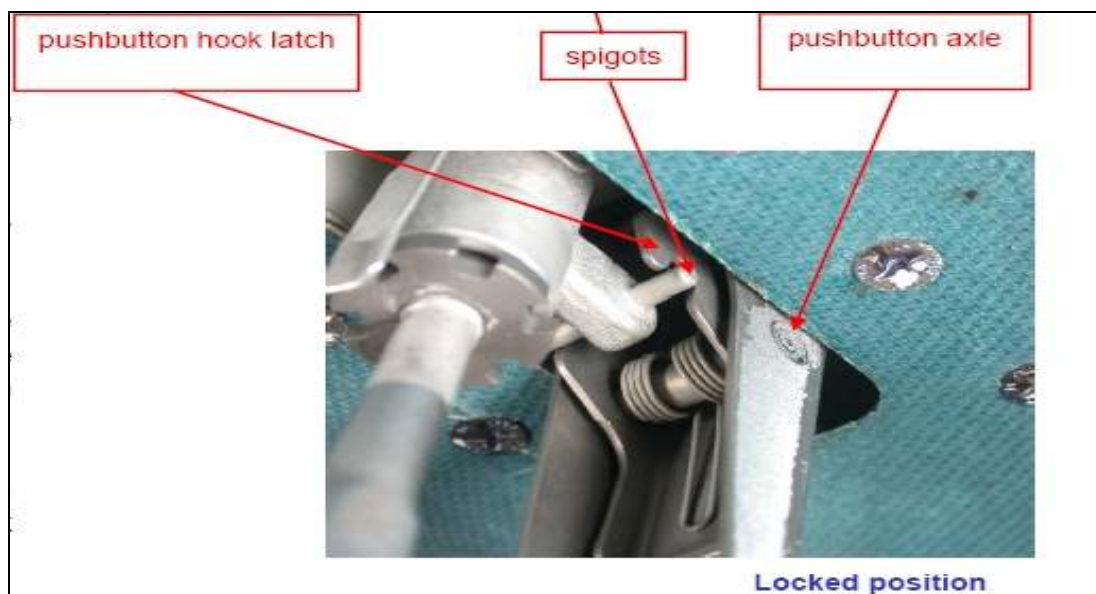
[Picture 19] Locked Position of Latch

In the locked position as shown in the [Picture 19], the pushbutton hook latches are hanged to the spigots. The pushbutton is directly connected to the radome hook latch. The handle has a same type of surface with the radome airframe structure surface.

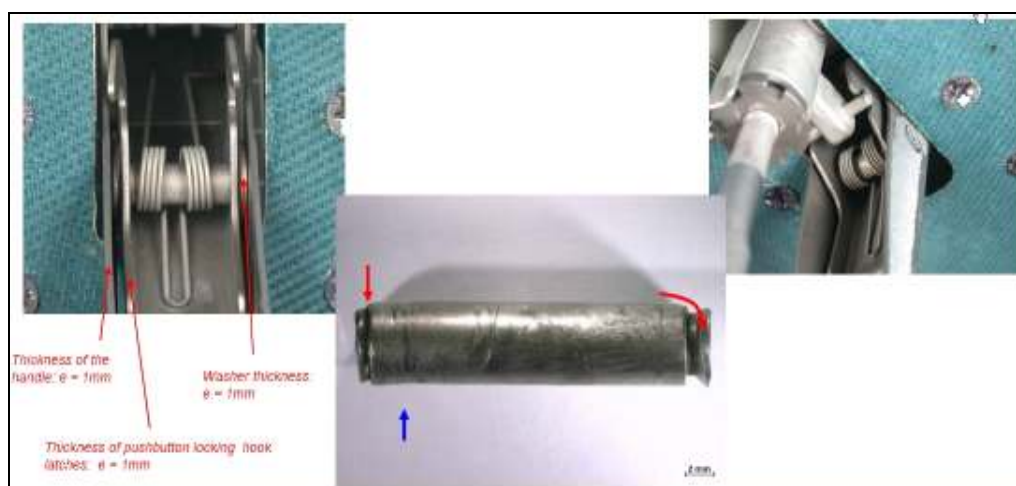
[Picture 25] Load Applied to the Pushbutton Axle

The force direction applied to the axle was marked with thick arrow and the red color indicates the load applied through the handle and the blue color indicates the load applied through the pushbutton. Opposing loads were exerted through the handle on one side and through the pushbutton on the other, respectively [Picture 25]. These high energy loads lead to disengagement of the axle.

- The left radome hook latch was in the locked position when the handle was ripped off.
- The tearing off was the consequence of opposing loads, exerted between the hook latch and its handle at the level of the pushbutton.
- The high level of energy present during this tearing off is incompatible with an impact by the hook latch on the engine nacelle.
- It is highly likely that the handle was pulled off by the radome body after the latter was damaged. This scenario explains the origin of the loads opposed to the locking loads exerted on the pushbutton. In addition, this is compatible with the observations made on the hook latch handle.

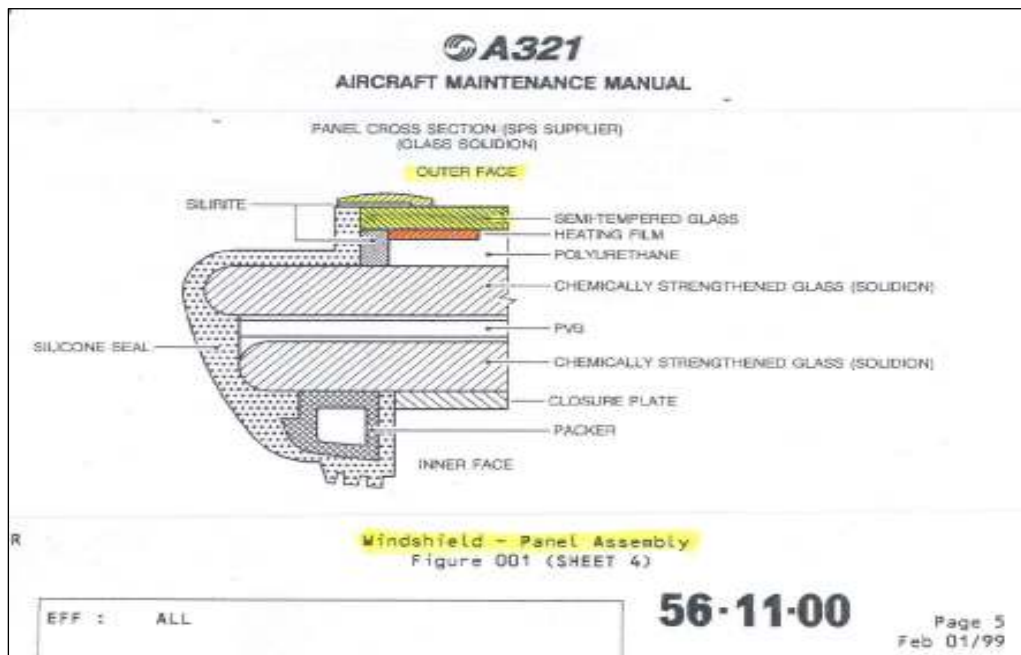
[Figure 23] Structure of the Aircraft Windshield

The size of the cockpit windshield shown in the [Figure 23] is 89.0 cm in width and 63.9 cm in height with a rhombic shape and its weight of 34.4kg and it is manufactured by “Saint Gobain Sully, France.”

As stated on page 5 of Aircraft Maintenance Manual 56-11-00, the windshield was made of several glass layers with specific material overlapped and manufactured for flowing of electric current all the time during flight by inserting heating film between the glass surface and polyurethane. When the current flows into the heating film, it emits the heat to cover the windshield surface to protect from icing.

When encountering with the thunderstorm, the windshield was damaged by the hail at 17:40:02 and the defect message of “left/right WINDSHIELD WHC” on MCDU^{81, 82} displayed and “ANTI ICE L+R WINDSHIELD” of the ECAM⁸³ warning message displayed. Inferring from these messages, it is estimated the Anti-Ice Switch of the aircraft was on the “ON” position.

Inferring from the damaged pattern of the windshield, it is estimated that the hails with 2.0 cm ~ 3.0 cm in diameter hit the outer face of the windshield heavily. It was sufficiently resisted from the wind outside since the inner face was not damaged; on the other hands, it was very difficult to secure the vision since the surface glass of the outer face was severely damaged.

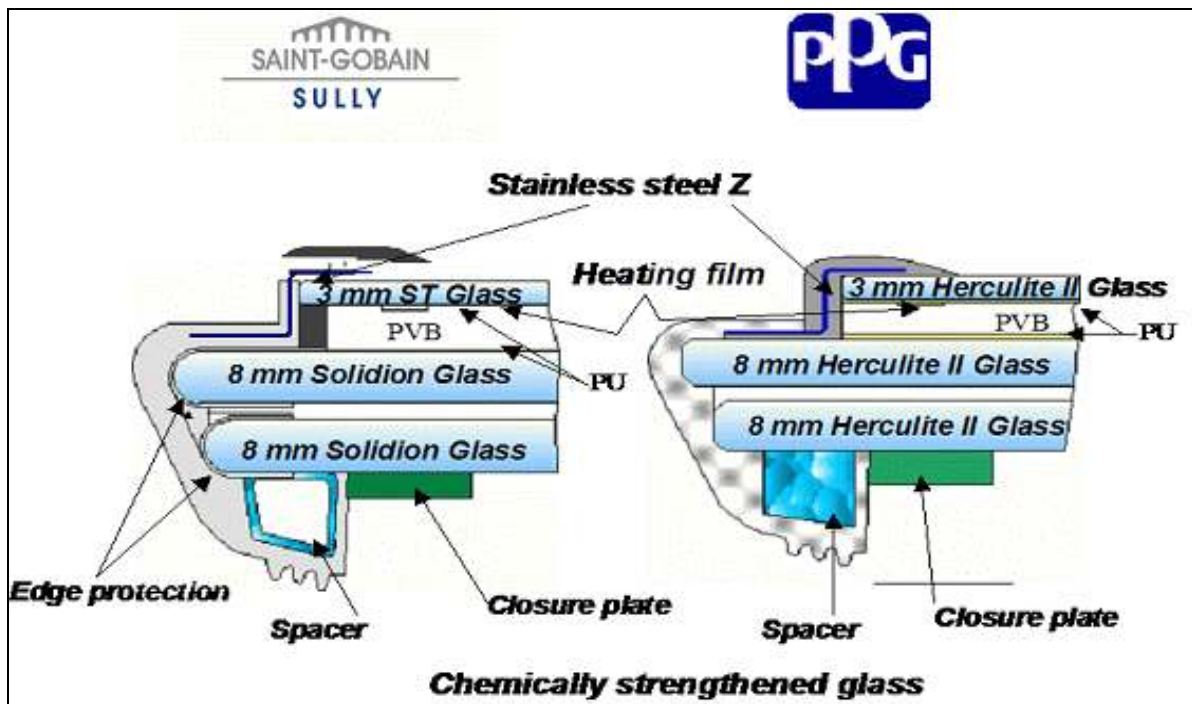
[Figure 24] Comparison of Windshield Manufactured by SGS (France) and PPP (USA)

A windshield currently used in the aircrafts is mainly manufactured by SGS (France) and PPP (USA) and it is composed of chemical composite glass and its strength and thickness meets the regulations. [Figure 24] shows the windshield comparison between two representative windshield

manufacturing companies of SGS (France) and PPP (USA) and it is verified that there is no difference found in size, strength and properties by the manufacturers’ technicians during the technical meeting.

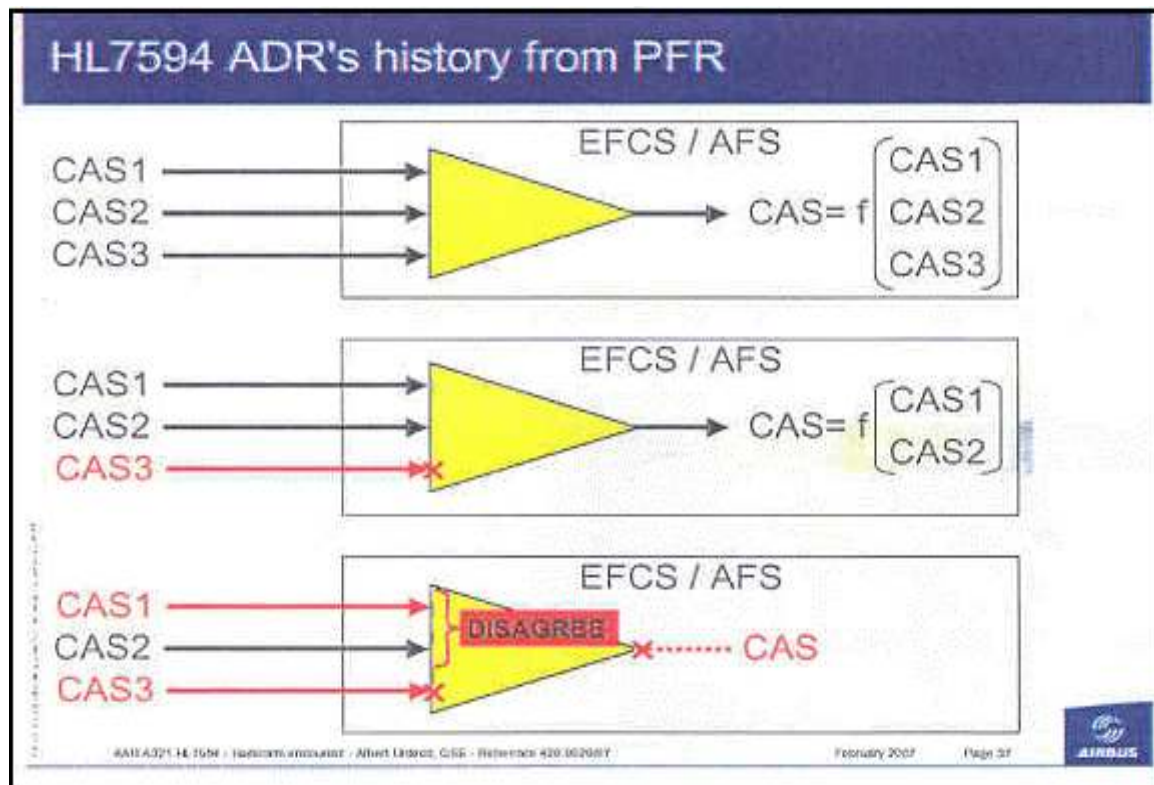
[Figure 25] Input Data to Weather Data INS (ADR)

It is presumed that the auto pilot system was disconnected by difference in speed input entering into the Air Data and Inertial Reference System (ADIRS) computer because of disturbance of air flow in the dynamic/static pressure pipe after detachment of radome and at the same time the inconsistency in speed was detected by the Flight Augmentation Computers (FAC) 1 and 2 which controls yawing.

As the radome was detached, there was a change increased aerodynamically by the change of the air flow in the direction of flight. There are three identical Air Data and Inertial Reference System Unit (ADIRU). Each of them computes and provides air data from the 3 probe sources to the users (including EFCS and AFS). When one of the sources differs from the 2 others, it is eliminated and systems compute airspeed with the 2 remaining sources. If then those sources also differ, system consider sources as unreliable. [Figure 25] is the diagram showing this procedure.

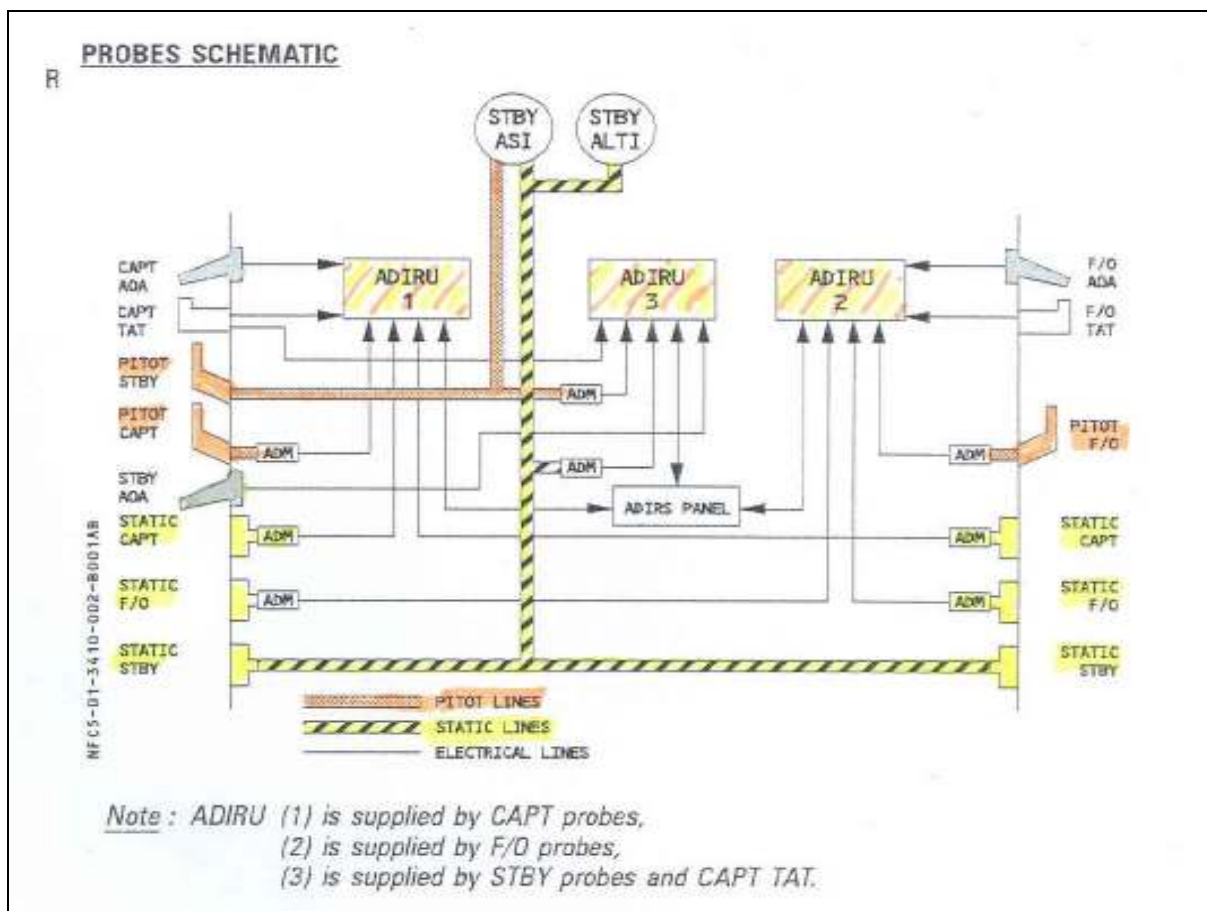
[Figure 26] Schematic Diagram of Probes

It is analyzed that the main cause of disconnection in the aircraft systems was that the essential probe could not detect the dynamic/static pressure accurately which was installed on both front sides of the aircraft as the air flow was scattered by not flowing smoothly due to detachment of radome from the airframe.

These probes detect the sudden change in air pressure and outside temperature as the outside air flow and then display them on the computer, speed meter and altimeter. [Figure 26] shows the schematic diagram of probes in relation with speed.
