**REPORT
ON
ACCIDENT TO AIR INDIA EXPRESS BOEING 737-800
AIRCRAFT VT-AXV ON 22nd MAY 2010
AT MANGALORE**

**THE COURT
AIR MARSHAL BN GOKHALE, PVSM, AVSM, VM (Retd)
FORMER VICE CHIEF OF AIR STAFF, INDIAN AIR FORCE**

**GOVERNMENT OF INDIA
MINISTRY OF CIVIL AVIATION**

**NEW DELHI
31st OCTOBER, 2010**

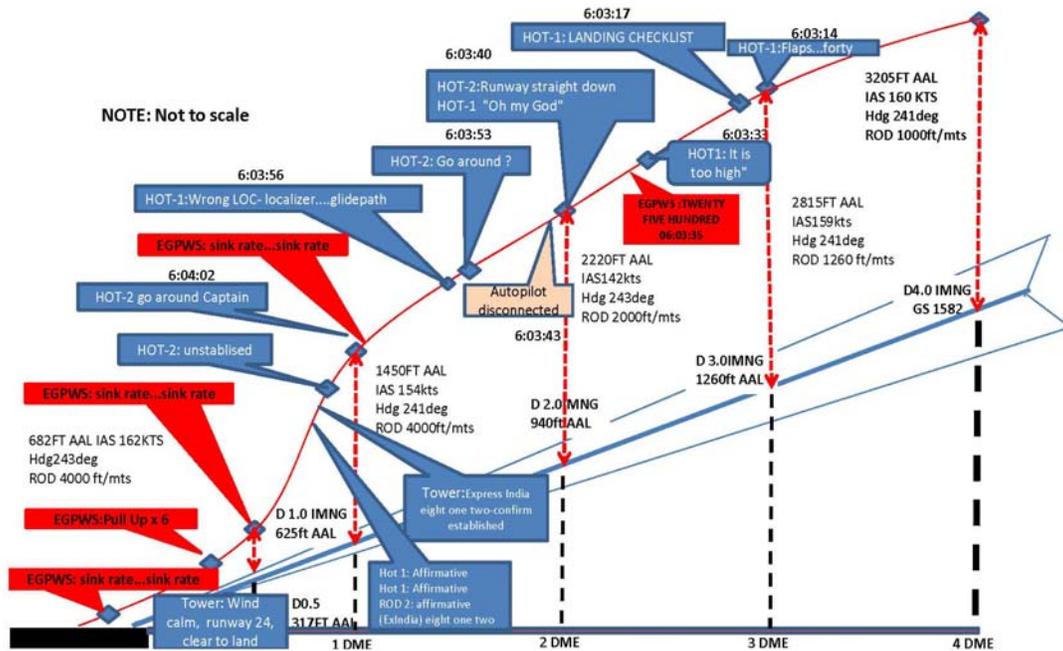
Diagram 3: Approach Profile Including Salient Recordings from CVR

Despite the EGPWS warnings and calls from the First Officer to go around, the Captain had persisted with the approach in unstabilised conditions. Short of Touchdown, there was yet another (Third) call from the First Officer, this time on VHF Channel “GO AROUND CAPTAIN” followed by “WE DON’T HAVE RUNWAY LEFT” on the intercom. However, the Captain had continued with the landing and the final Touchdown was about 5200 ft from the threshold of R/W 24, leaving approximately 2800 ft of remaining paved surface.

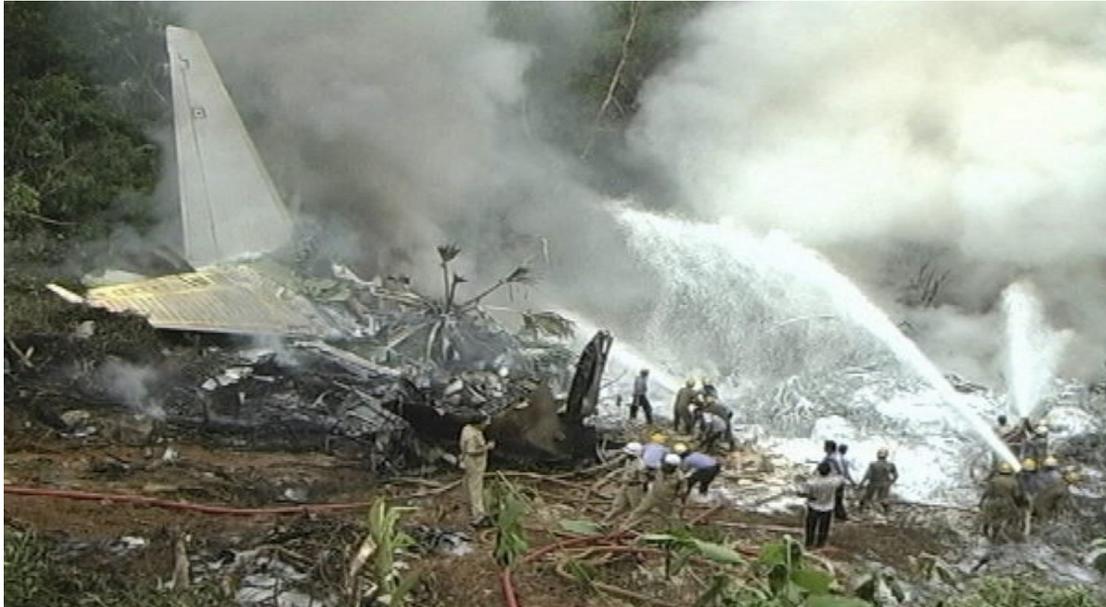
Photo 3: Rescue and Fire Fighting at the Crash Site

Although they reached as quickly as possible, the aircraft had already suffered major impact and a dense fire and smoke had engulfed the aircraft. Most of the other RFF crew, who were off duty and at residences near by, also rushed to the crash site with all available RFF vehicles and ambulances. With great motivation and involvement, the fire was partly brought under control by the AAI staff in the next 30-40 minutes by which time the Civil Fire Tenders had also joined fire fighting at the crash site. The entire fire could only be brought under control in about 2 hours.

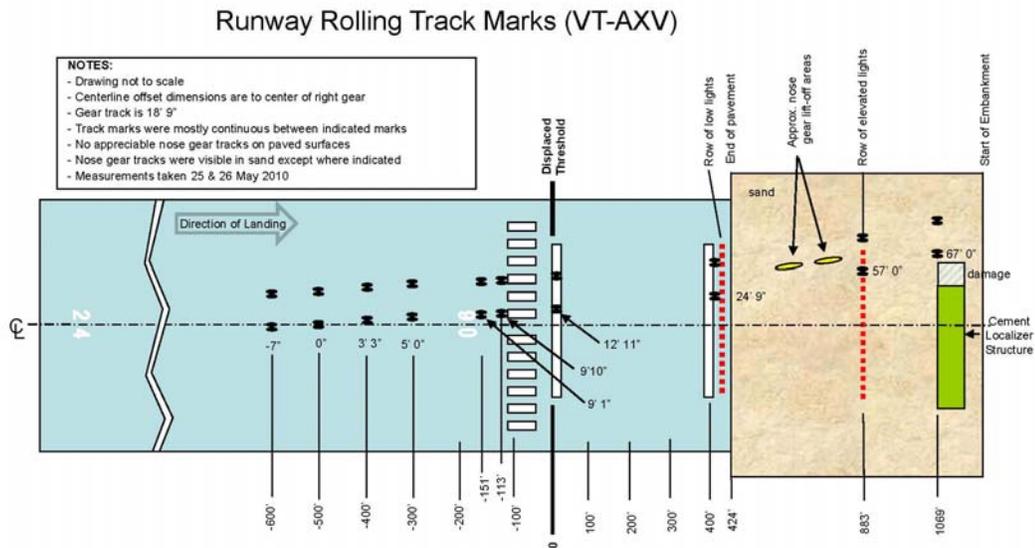
Diagram 10: Approximate Path Followed By the Accident Aircraft

Aircraft was cleared for the ILS approach Runway 24. As per the Fire personnel positioned at the Pre Determined Point (PDP) (Coordinates: 12° 57.376' N; 74° 53.366' E; 777 metres. from the beginning of R/W 24; height of the vehicle including surface elevation: 12 metres), the height of the approaching aircraft was above the height of the fire vehicle. Tyre marks for about 22 metres were observed in the area where aircraft had finally touched down, approximately 5200 ft from beginning of R/W 24, way ahead of the normal touchdown zone. The aircraft had veered off towards left of the centreline as shown below:-

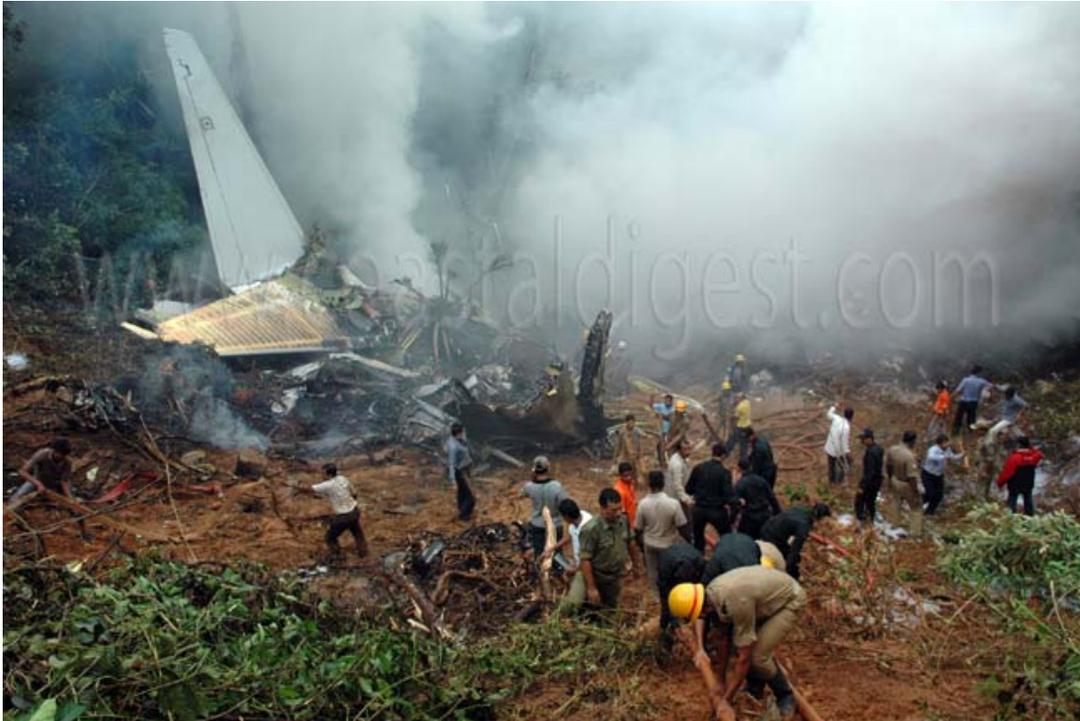
Photo 15: RFF Crew Laying Hoses to Fight the Fire

This RFF reached to the edge of the slope close to airfield perimeter and tried to throw water and foam towards the aircraft. But, the crash site was out of its range. It, therefore, extinguished fire of all parts of the right wing, which had broken off after the impact with ILS structure.

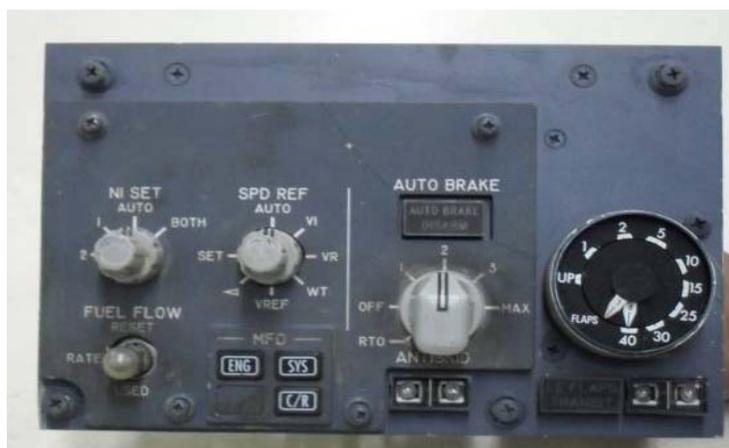
Photo 16: Brake Selector Panel and Flap Position Indicator

Part No.	233A2224-5 / 2061-15-1
Sr. No.	D02583 / 2806
CMM	73-31-01
General Condition	Connector plate bent at J1 connector. L2 Anti Skid Indicator & L4 indicator damaged. Flap position front glasses broken.
S/W Position	N1 Set – Auto SPD Ref – Auto Auto brake indicator – 2 S2 Fuel flow S/W – Rate R Flap position indicator – Flaps

Flap lever was seen on the Flap 40 detent, which corresponded to RH Flap position indicator needle. This also corresponded to the fully extended Jackscrews.

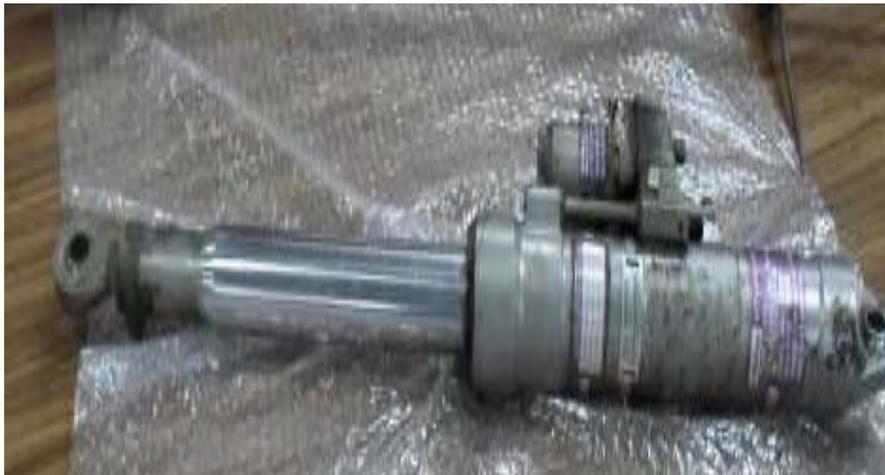
Photo 17: Leading Edge Flap Actuator

Part Number	382000-1001
Serial Number	10161
Position	# 2.
CMM	27-80-05
Total length	“L” :- 26.2 Inches (Between bearings centre)
Findings	(a) Actuator position - extended corresponding to flap extended. (b) Physical condition is ok. (c) No parts missing.

All the Leading Edge Flap / Slat actuators were found in the extended position, which correspond to the flap lever position of 40°. Therefore, it could be concluded that all Leading Edge devices had operated as per the cockpit input.

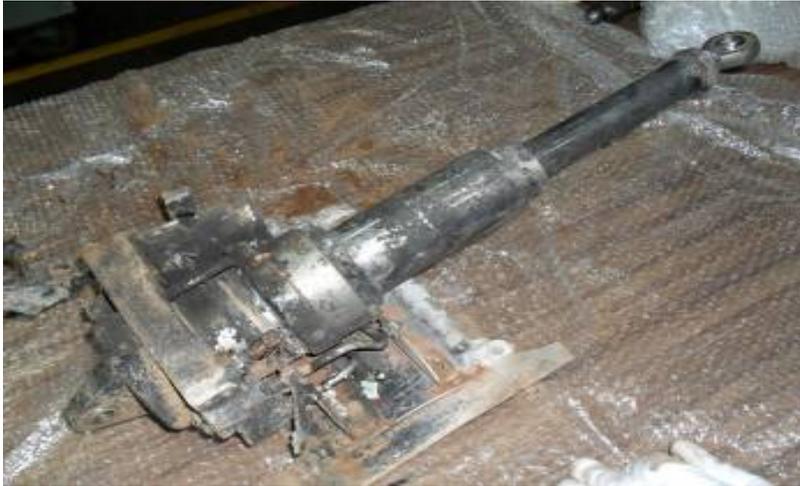
Photo 18: Leading Edge Actuator Assembly

Part No.	381800-1005
Serial No.	23103.
Position	# 07, LE SLAT.
CMM	27-80-06
Total length	"L":- 22.0 in. (From Piston eye end to Body eye fitting centre.)
Findings	(a) Actuator position-extended corresponding to flap extended (b) Full body found burn marks. (c) Piston rod is intact.

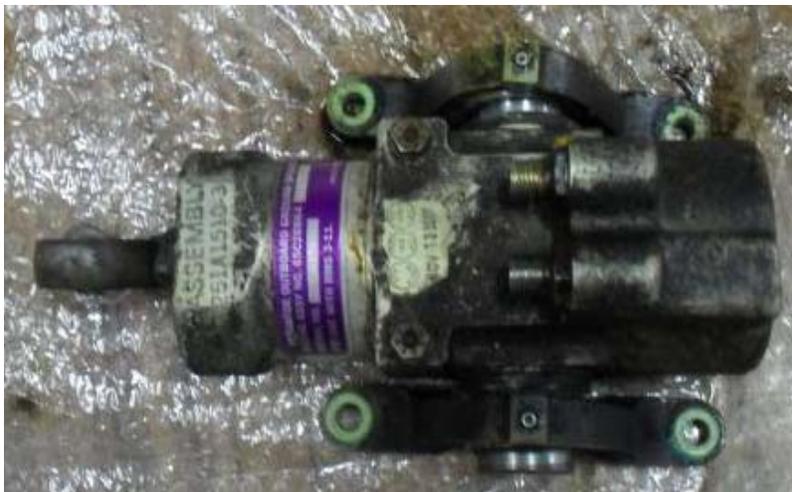
Photo 19: Ground Spoiler Actuator

Part No.	65C2684-3/251A1510-3
Serial No.	EFS08654
Position	#12
CMM	27-62-71
Findings	(a) Actuator position- Retracted corresponding to Spoiler retracted. (b) No parts are missing. (c) Actuator found burn marks.

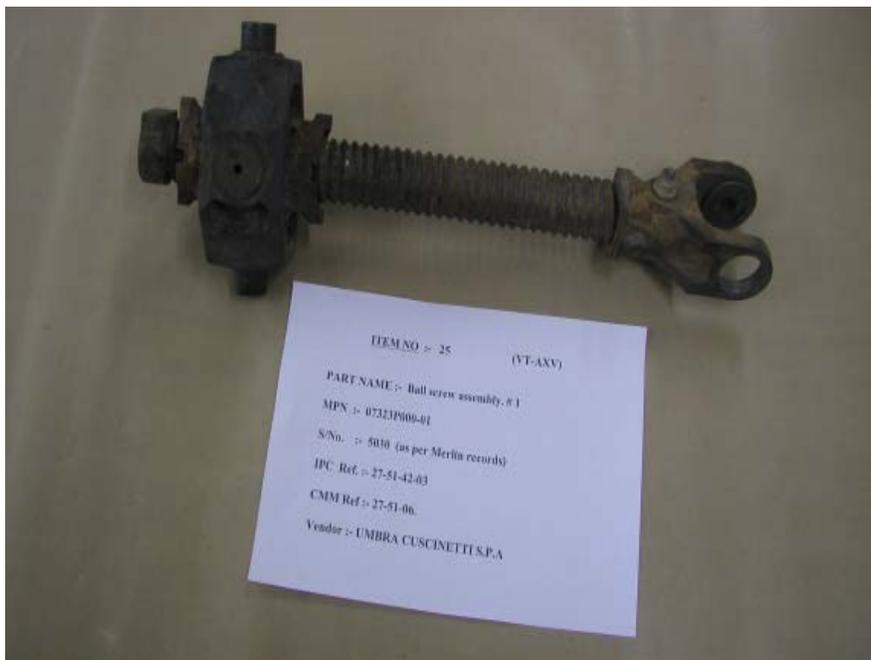
Photo 20: Trailing Edge Flap Ball Screw

Part No.	07323P000-01
Serial No.	5030
IPC Ref.	27-51-42-03
Total length	"L" :- 20.00 Inches (stop end to Centre of yoke end bushed hole)
Findings	(a) Ball nut & Gimbals assy. found in flap fully extended position

Flap handle was found in the 40 detent. Trailing Edge Flap Jack Screws were found in the fully extended position, which corresponded to the fully extended position of the flap. From DFDR data, it was seen that flap lever and the flap surface were in 40 degree position in flight from 06:03:23 to 06:04:16 hours IST. Thereafter, while the flap lever continued to remain in the 40 detent, the surface had retracted to 30 degree between 06:04:17 and 06:04:37 hours IST due to increase in speed of the airplane. Flap surface was again extended to 40 degrees from 06:04:38 hours IST till the time of the accident. From the above, it could be implied that Flap system had responded correctly to the commands.

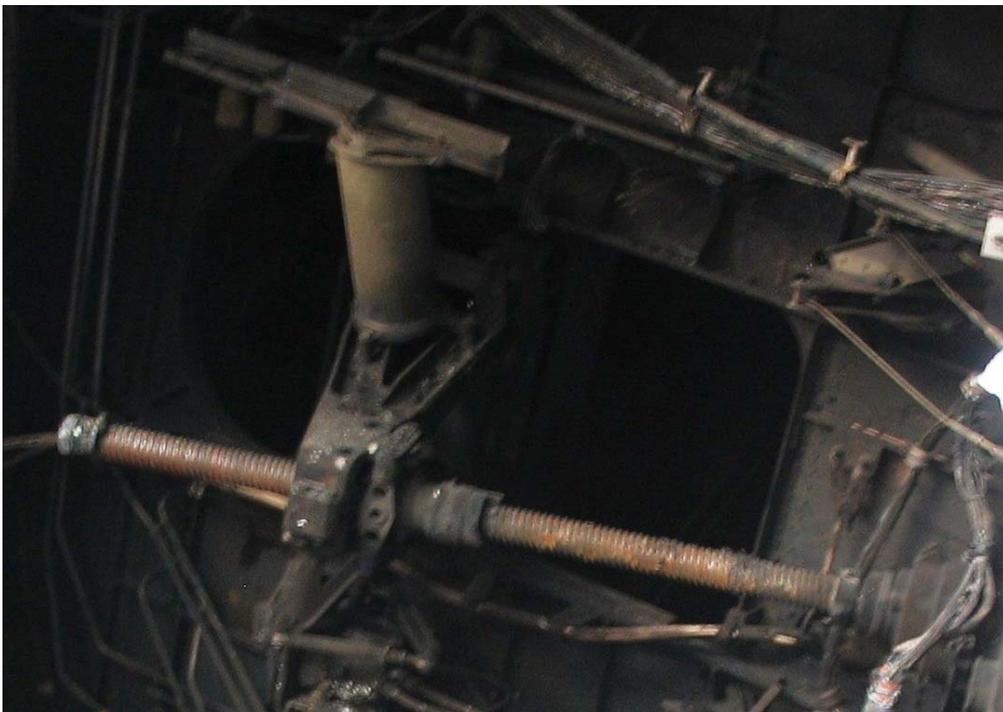
Photo 21: Photograph of Stabiliser Jack Screw

The dimension 'B' as given in the Diagram No 5 was measured from the debris. It was found to be 37 inches. This corresponds to 6 units of Stabiliser Trim. For airplane full nose 'UP' position, the dimension 'B' should be 21.32 inches and for full nose 'DOWN' condition, the dimension should be 45.84 inches. From this observation, it could be inferred that the horizontal Stabiliser was in nose 'DOWN' position, which is the landing configuration.

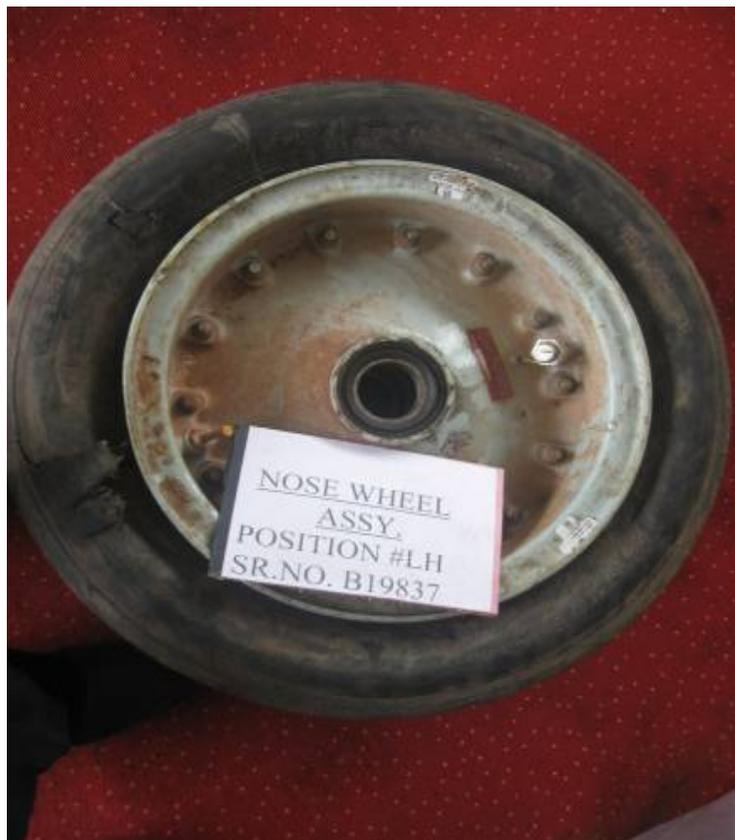
Photo 27: Nose Wheel and Tyre Assembly

Part No.	277A6000-453	277A6000-453
Serial No.	B19837	B 18600
Position	Left Hand	Right Hand
Date installed	25 th April 2010	19 th April 2010
Landings done	113	117
Tyre Findings	Tyre cuts noticed on sidewall towards O/B side at 2 locations.	Tyre cuts noticed on sidewall towards O/B side at 2 locations (2"x2" side wall tyre piece missing)
Hub Assembly Findings	All tie bolts found intact Pressure relief valve found intact Wheel bearing and seal found intact. No damage noticed on I/B and O/B HUB externally.	All tie bolts found intact. Pressure relief valve found intact Wheel bearing and seal found intact No damage noticed on I/B and O/B HUB externally.

From the above, there was no indication of any defect on both the nose wheel assemblies prior to the accident.

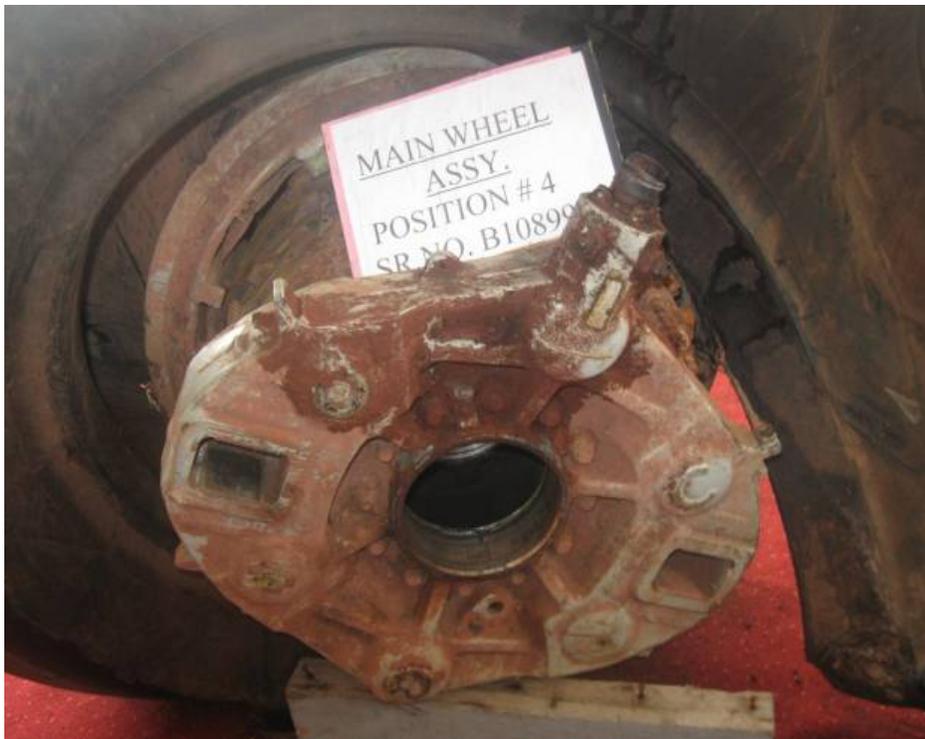
Photo 28: Main Wheel and Tyre Assembly

Part No.	277A6000-204	277A6000-204	277A6000-204	277A6000-204
Serial No.	B9061	B14941	B8266	B10899
Position	# 1	# 2	# 3	# 4
Date of Installation	07.05.2010	18.04.2010	01.05.2010	18.05.2010
Landings done	63	135	79	14
Tyre Findings	a) Deep cut noticed at 2 locations on sidewall. b) Burn marks noticed on tread area approx 2 feet by 10 inch on crown area. c) Wheel assy. Holding 30 PSI pressure	Tyre found burst and burn at about ¾ of tyre crown area	a) Tyre burst b) Tyre found damaged at four locations c) Tyre cut noticed about 4 feet due to burst towards I/B side	a) Brake and wheel found jammed b) Tyre burst c) Burn marks noticed on tread area approx 2 feet by 10 inch on crown area
Hub Assembly Findings	a) All tie bolts found intact b) All fusible plugs found intact c) No damage noticed on heat shields and keys d) Pressure relief valve found intact e) Wheel bearing and seal found intact f) No damage noticed on I/B and O/B HUB externally	a) All tie bolts found intact b) All fusible plugs found intact c) No damage noticed on heat shields and keys d) Pressure relief valve found intact e) Wheel bearing and seal found intact f) Minor Damage noticed on I/B and O/B HUB externally	a) All tie bolts found intact b) All fusible plugs found intact c) Minor damage noticed on heat shields and keys d) Pressure relief valve found intact e) Wheel bearing and seal found intact f) No damage noticed on I/B and O/B HUB externally.	a) All tie bolts found intact b) All fusible plugs found intact. c) No damage noticed on heat shields and keys d) Pressure relief valve found intact e) Wheel bearing and seal found intact f) Minor damage noticed on I/B and O/B HUB externally.

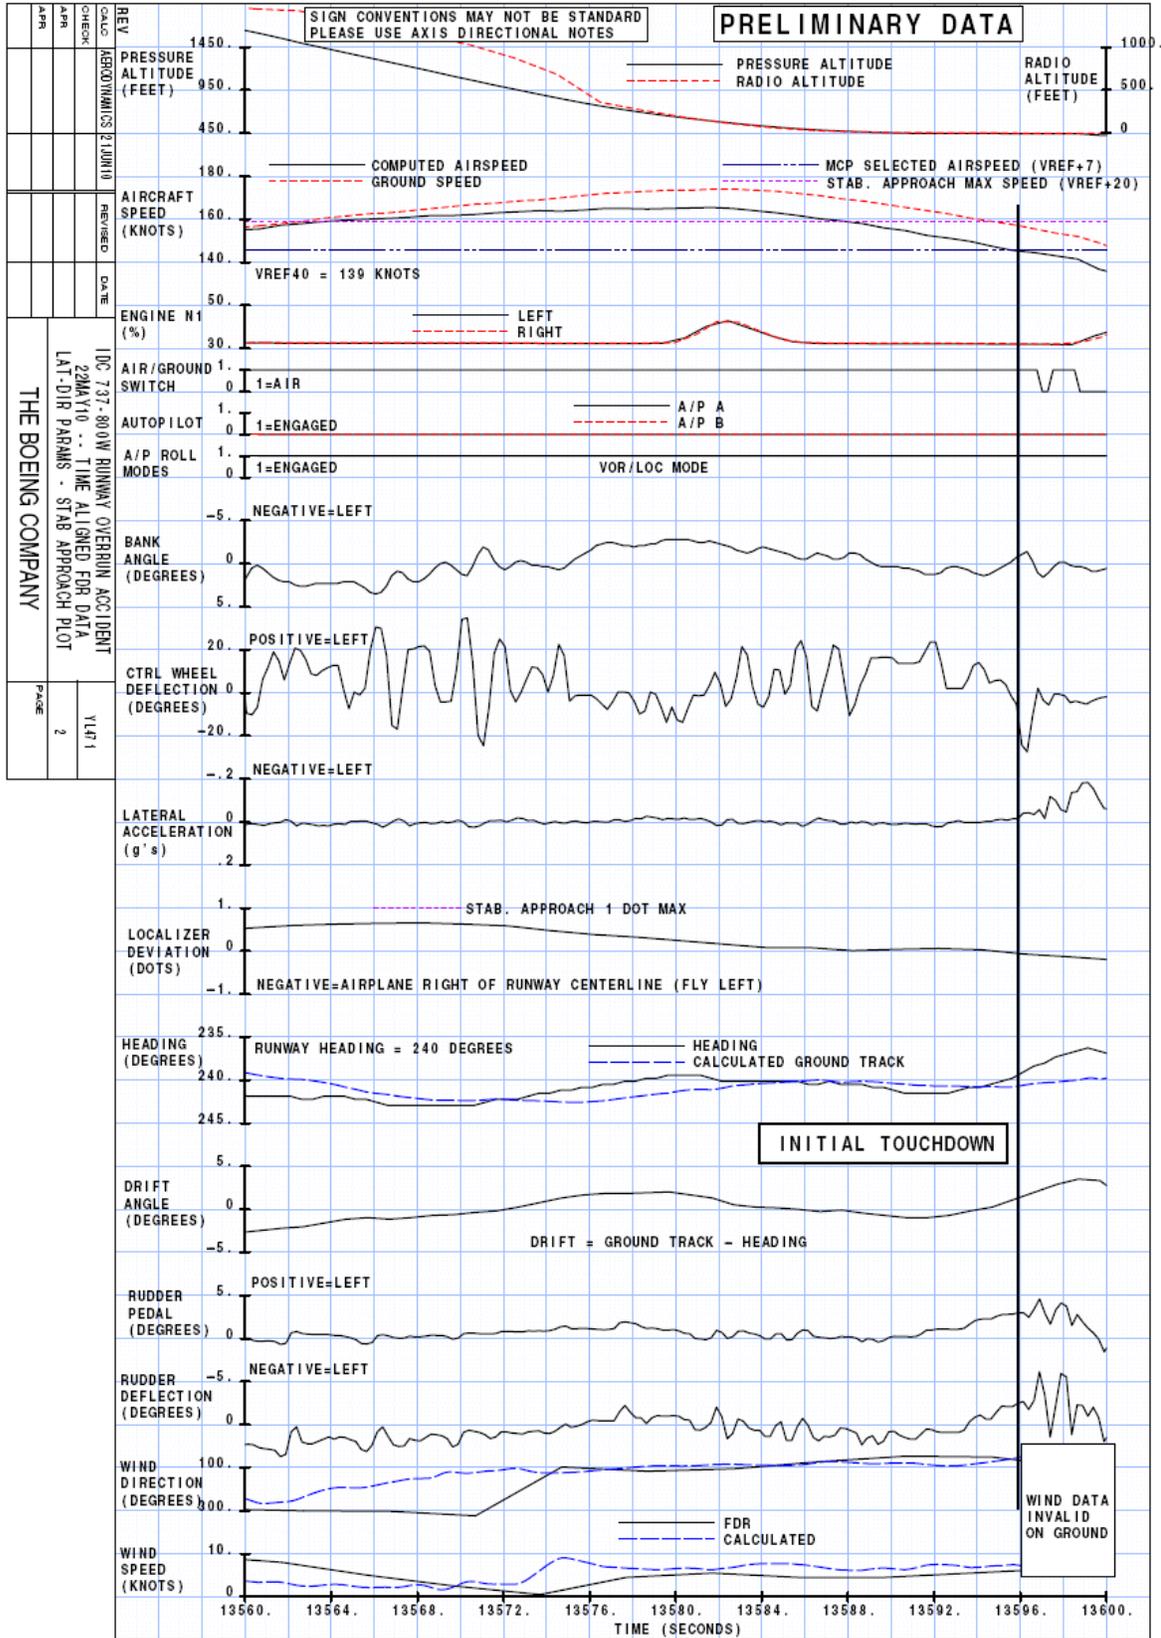
Figure: 2

The ILS approach criterion states "ILS and GLS approaches should be flown within one dot of the glide slope and localizer, or within the expanded localizer scale." Figure 2 shows the airplane was within one dot of the localizer all the way through the approach, but Figures 1 and 3 shows the airplane was not within one dot of a 3-degree glide slope.

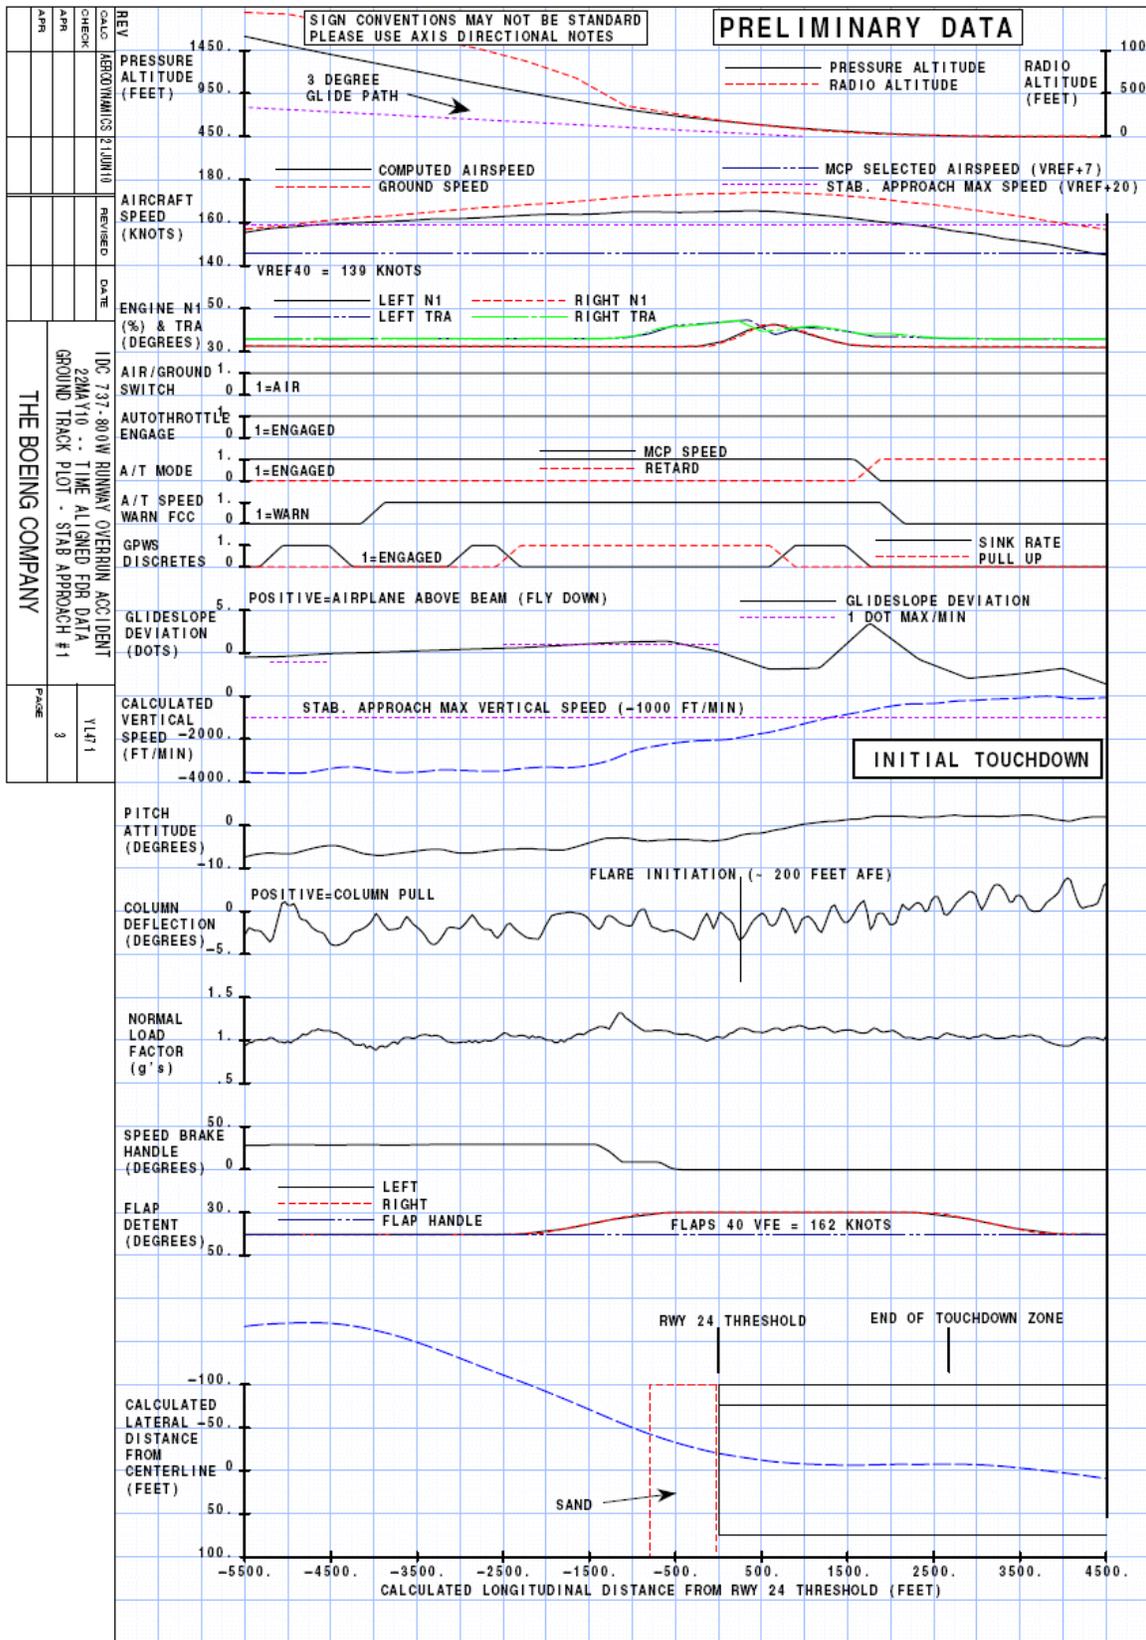
Figure: 3

The first criterion is "the airplane is on the correct flight path." As can be seen in Figure 3, the airplane was never on a 3 degree flight path during final approach. In order to be on a 3 degree flight path, the airplane should have crossed the final approach fix (FAF) at 2200 feet geometric altitude (airplane's true altitude above mean sea level (MSL)) but instead crossed at approximately 4475 feet, as can be seen in Figure 6.

The third runway-threshold-crossing criterion reads "as the airplane crosses the runway threshold, it should be . . . positioned to make a normal landing in the touchdown zone (the first 3000 feet or first third of the runway, whichever is less)." The airplane did not touch down within the touchdown zone. For Runway 24, the touchdown zone is the first third of the runway (~ 2679 feet). The airplane initially touched down approximately 4500 feet from the Runway 24 threshold (Figures 3 and 5). Thus, the touchdown point was approximately 1800 feet beyond the touchdown zone.

The airplane initially touched down approximately 4500 feet from the Runway 24 threshold. See Figures 3, 5 and/or 7.

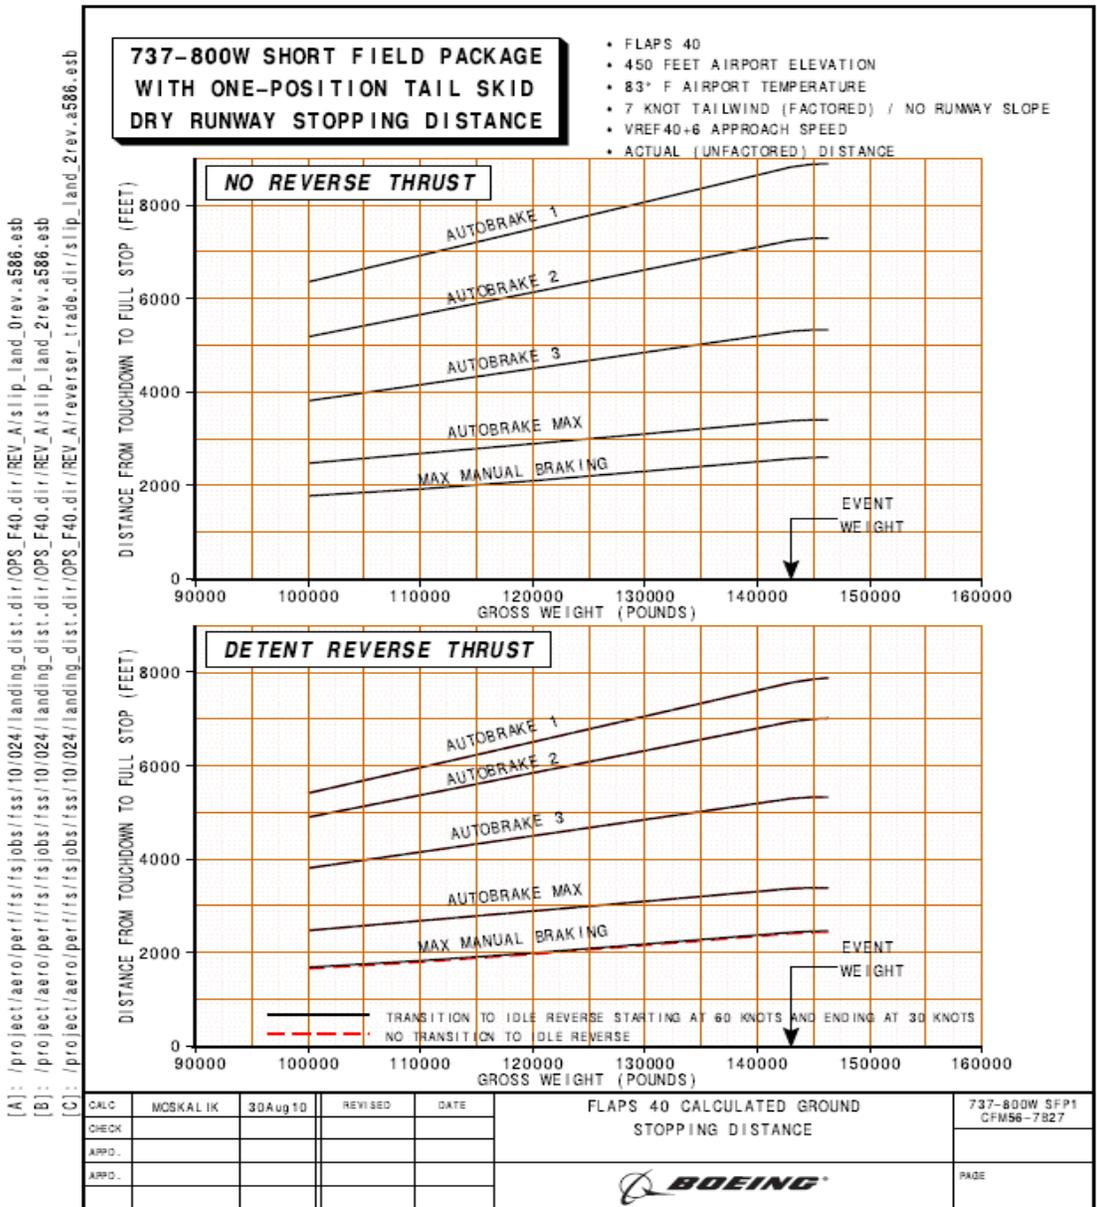
Figure: 8

The airplane does have adequate stopping performance to come to a complete stop on the improved surface available using a dry runway assumption. Based on the data from Figure 8 (described in the next paragraph) and the event airplane's weight (~143,000 pounds), the airplane could stop in approximately 2400 feet with the following assumptions: max manual braking, detent reverse thrust, Speedbrakes deployed, and reverse thrust maintained until fully stopped. Since the airplane's final touchdown point was approximately 5200 feet from the Runway 24 threshold, the airplane could have come to a complete stop at 7600 feet from the threshold (438 feet of runway remaining).

Figure 8 includes two plots showing airplane stopping capability. The upper plot assumes no reverse thrust, and the lower plot assumes detent reverse thrust. On both the upper and lower plots there are lines for auto brake settings of 1, 2, 3, and max along with maximum manual braking. The vertical scale shows the distance from touchdown to a complete stop. Transition from touchdown to full braking assumes: brake initiation (auto brakes) at touchdown (manual braking is one second after touchdown), speed-brake select one second after touchdown, and reverse thrust (if applicable) select one second after spoiler select. No flare distance is included.

The conditions are labelled in Figure 8 and are meant to reflect the actual conditions of the event: Flaps 40, 450 feet pressure altitude, 83° F outside air temperature, touchdown speed of VREF40+6 knots and a reported 7 knot tail wind. The wind value was conservatively factored by 1.5, so that the calculation assumed a 10.5 knot tailwind. This is consistent with the Airplane Flight Manual and FCOM calculation method. In addition, all airplane parameters used in the calculation are consistent with the databases used to develop the airplane flight manual and operational performance data provided in the FCOM.
